FLIGHT COMMENT

2000

SEEING the SHEAR

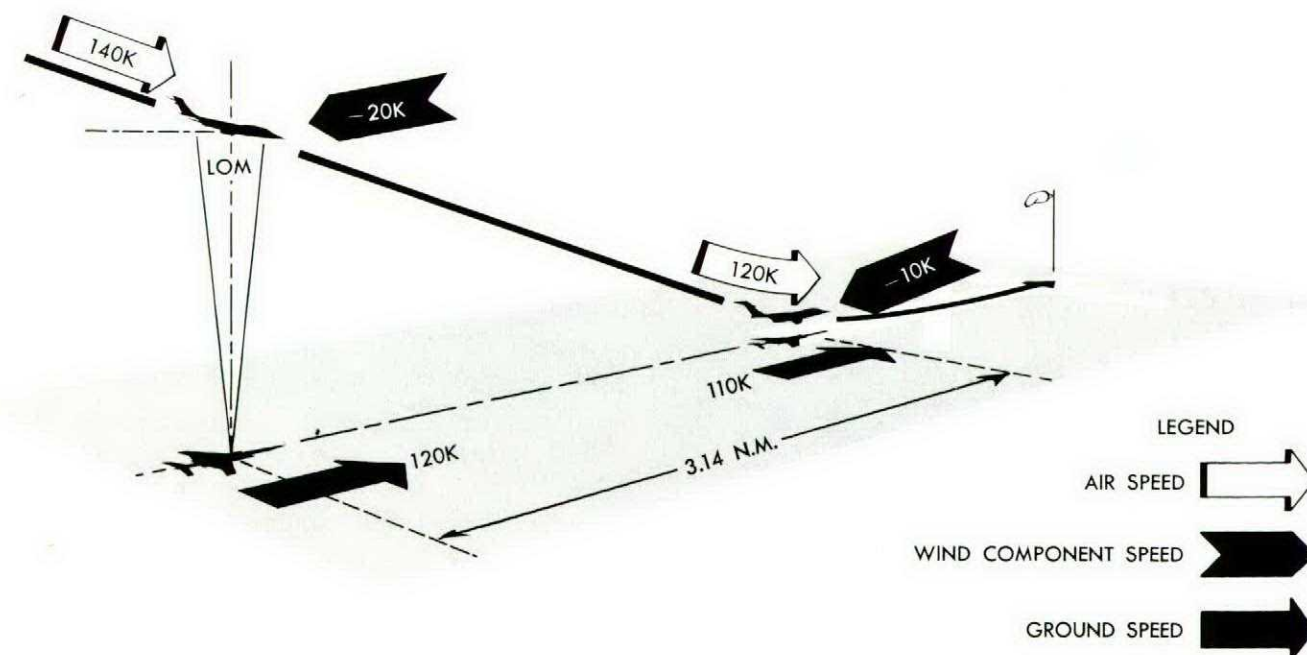
FIGURE 1

Figure 1 illustrates a normal glide path profile with a 3 degree glide path from the glide slope unit crossing the outer marker at 1000 feet. This gives a glide slope distance of 3.14 nautical miles from the outer marker to touchdown point. For our typical case we have chosen headwinds of 20 knots at 1000 feet and 10 knots on the surface. Speed selected is 140 knots over outer marker, tapering to 120 knots at touchdown. These conditions are considered as typical and will be used as standards for analyzing abnormal wind conditions in later examples.

From Figure 1 we can compute that the elapsed time from outer marker to touchdown in this case is 1.64 minutes, which results in an average ground speed of 115 knots and an average rate of descent of 610 feet per minute. Also, normal airspeed deceleration from outer marker to touchdown is 20 knots and the ground speed deceleration in this case is 10 knots. The change in ground speed becomes a very important consideration when analyzing abnormal wind shear conditions because it

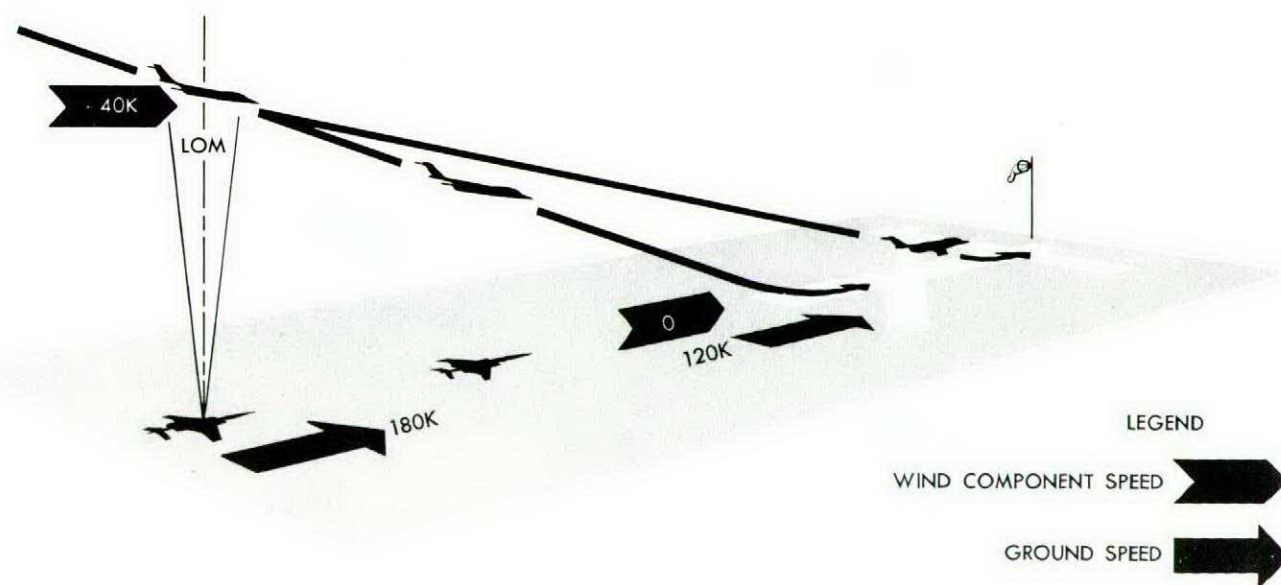
FIGURE 2

In Figure 2 we consider an abnormal tailwind approach in which a 40-knot tailwind exists at the outer marker with a zero surface wind. As can be computed in this case, the average ground speed from the outer marker to touchdown is 150 knots, which results in an elapsed time of 1.24 minutes and an average rate of descent of 800 feet per minute for a precisely executed approach. Comparing this example with Figure 1, we see that while the airspeed is decelerated 20 knots in both cases, the ground speed in the latter case must be decelerated 60 knots in a faster time than the 20 knot deceleration in the normal approach of Figure 1. This is the root of the problem, for whenever the wind environment changes faster than the aircraft mass can be accelerated or decelerated, the wind variations must be reflected by changes in airspeed. In the tailwind situation depicted in Figure 2, should the pilot be unable to decelerate his aircraft in the faster time required, he would find his airspeed had increased, very likely he would have gone above glide path in an effort to hold desired airspeed, and he would have to go around. (Assuming, of course, he wisely resists the temptation to land long.) One more point, the more gradual the shear the more likely the

pilot is to be able to decelerate to remain on glide path and at desired indicated airspeed.

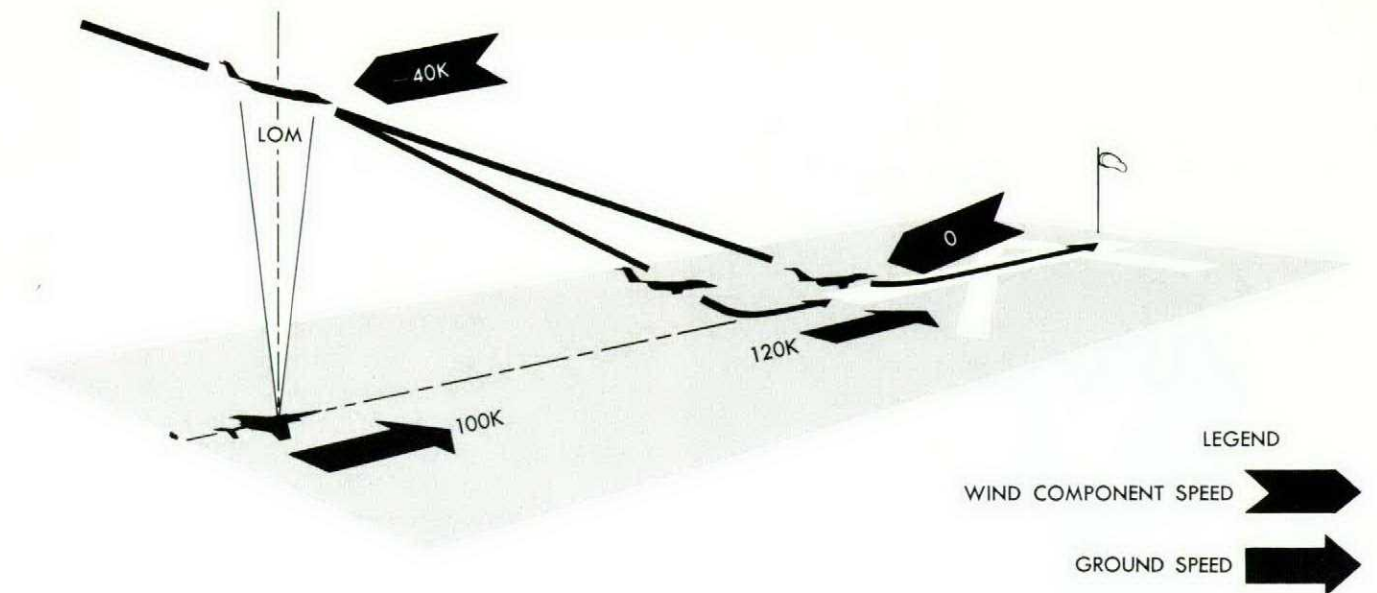
FIGURE 3

In Figure 3 we take up the strong headwind aloft condition. In this case we have a 40-knot headwind over the outer marker and a zero component on the ground. In this case we find that the average ground speed from outer marker to touchdown is 110 knots, which results in an elapsed time of 1.7 minutes and an average rate of descent of 580 feet per minute for a precisely executed approach. In comparing this situation with the normal profile approach depicted in Figure 1, we see that in the headwind shear approach the aircraft ground speed must be accelerated by 20 knots during the final approach instead of the normal 10 knot deceleration. Unless this acceleration is accomplished, the aircraft will sink below the glide slope and land short of the runway. Occasionally the shear will not be gradual but will occur rapidly. If the speed falls below stall speed the aircraft will lose altitude until it crashes or flying speed is recovered. Time required for acceleration to flying speed may exceed that available. To illustrate, following are calculations for a particular aircraft. Conditions are: altitude 1000 millibars, power setting constant, air speed 100 knots, headwind 20 knots. When the aircraft is instantaneously placed in calm air the times to accelerate to the indicated ground speeds are:

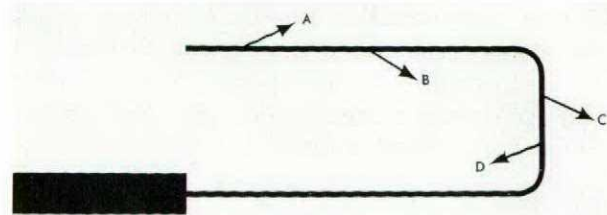
FIGURE 4

Figure 4 provides an indication of clues to wind shear that the pilot can pick up in the pattern. Assuming a calm, or near calm surface wind, if crabbing as depicted in A or B is necessary, lateral shear can be expected on final. If crabbing is required as depicted in C, a tailwind component is present at pattern altitude and over-shoot problems, as discussed in the section on TAILWIND APPROACH, should be anticipated. If crabbing is required as depicted in D, a headwind component is present and a short touchdown potential exists if the gradient is large enough, and occurs rapidly during the final approach path.

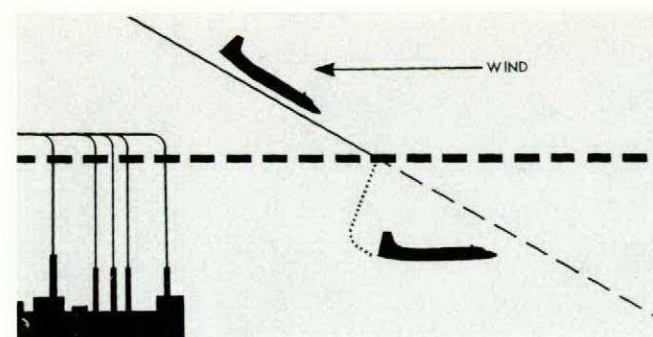
Shear can be anticipated whenever there is an inversion. (Fig 5). Shear is also a hazard potential with frontal passage and in and near thunderstorms. Severe down drafts associated with thunderstorms warrant delaying takeoff or landing when such storms are over or adjacent to the airfield. Shear should be anticipated when taking off or landing over cliffs, water, in hilly terrain and with large buildings or trees adjacent to the runway. Normally, the severity of such low altitude wind shear bears a direct relationship to the surface wind speed. Don't overlook the help you can obtain from the weather forecaster. Check with him before takeoff, and when you suspect shear, call him before making your final approach.

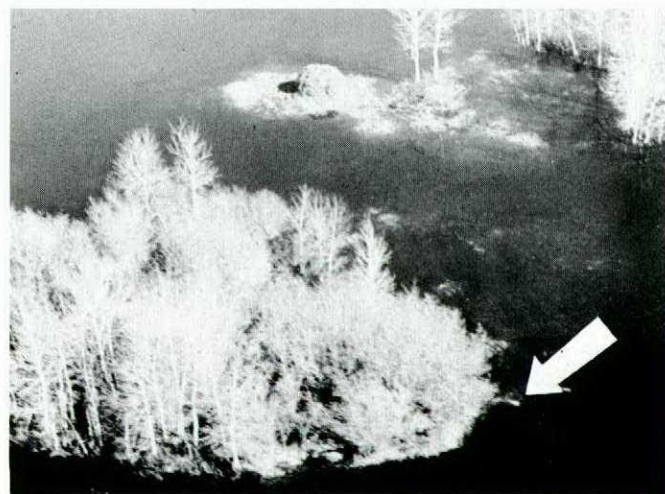
Spot where I landed (arrow) and haystack I sat upon.

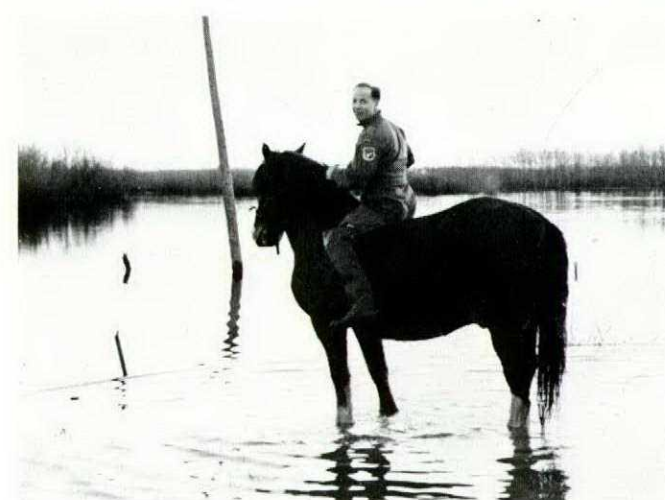
S/L Sherwood to the rescue.
