- 1 EDITORIAL
- 2 FROST - FACT AND FANTASY
- 4 GOOD SHOW
- 8 FALSE FIRE WARNINGS
- 9 SEARCH AND RESCUE
IN THE NORTH ATLANTIC
- 12 WINTER WONDERLAND
- 14 OXYGEN AGAIN
- 16 REVISED NOTAM SERVICE
- 17 ON THE DIALS
- 19 ALCOHOL - FRIEND OR FOE?
- 21 FROM AIB FILES
- 22 ARRIVALS AND DEPARTURES

FROST

Fact and Fantasy

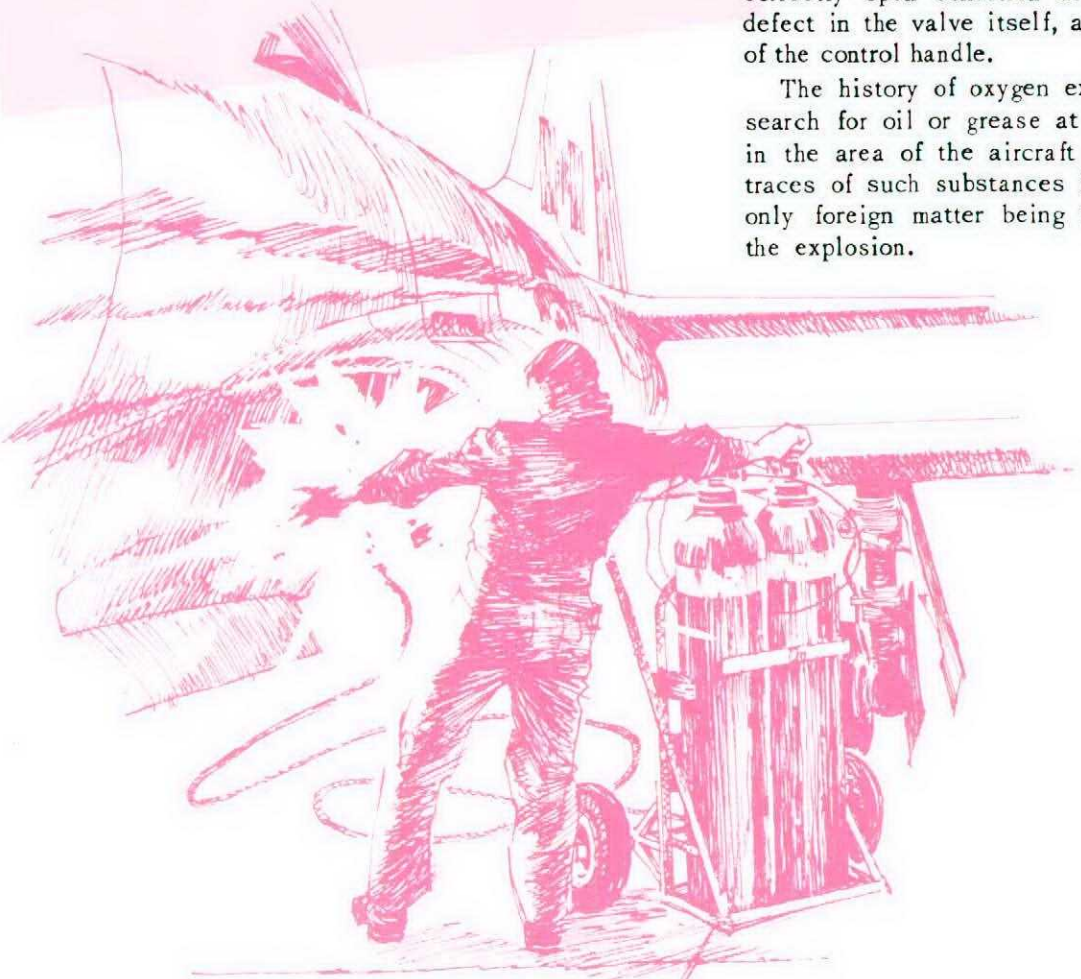
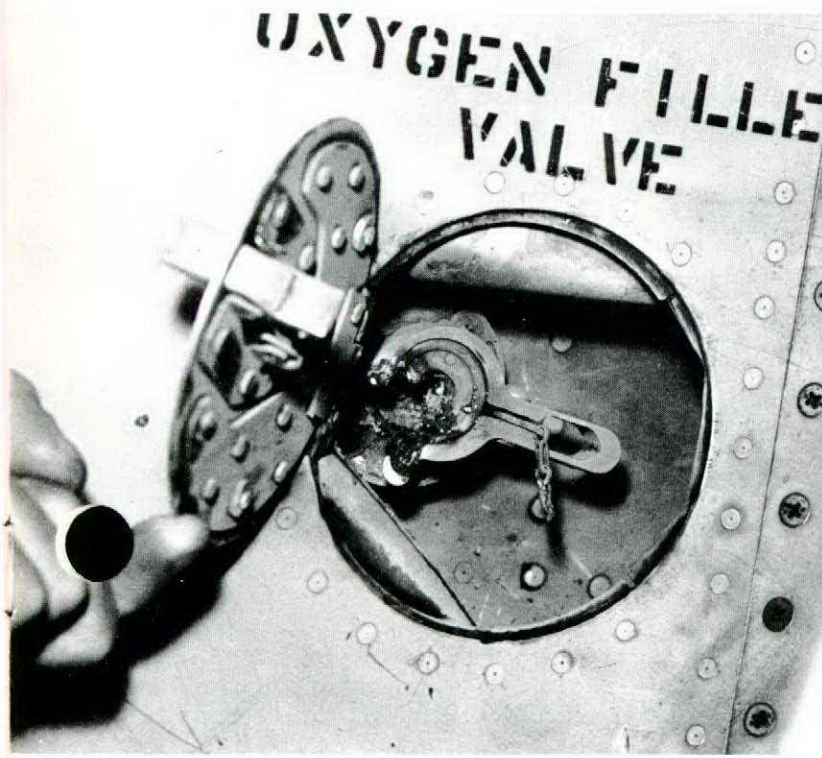
In this accident, which is a classic, two substances, oxygen and probably grease combined without either being detected. The explosion, as the pictures show, was severe enough to melt the metal on the filler hose nozzle and filler valve, and injure – fortunately not severely – an airman. This accident has given rise to further investigations into the equipment and methods employed in handling oxygen. The need for vigilance in handling this explosive gas cannot be overstated.

Filler Valve of T33 after the explosion

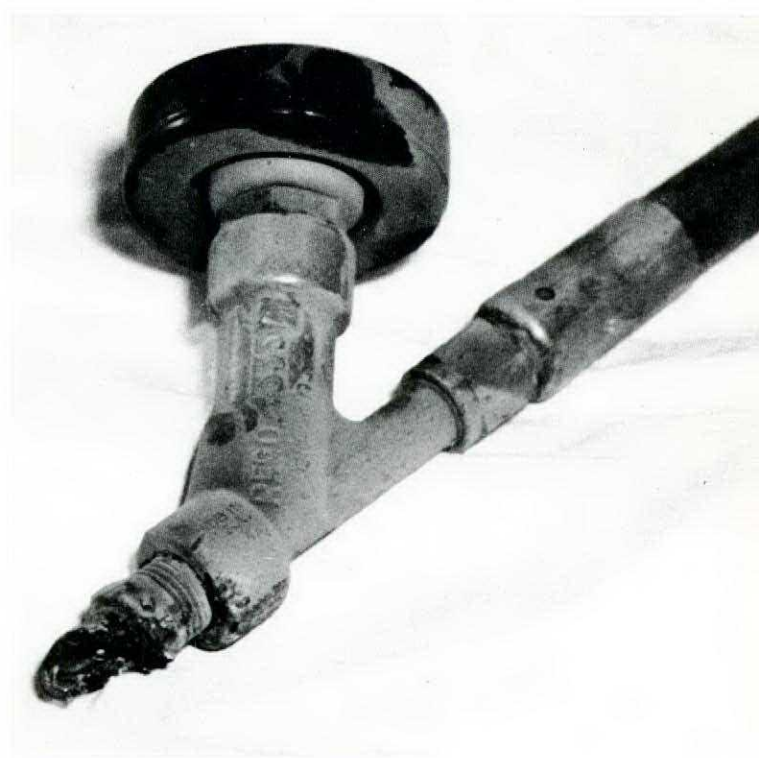
The partially-melted oxygen filler nozzle

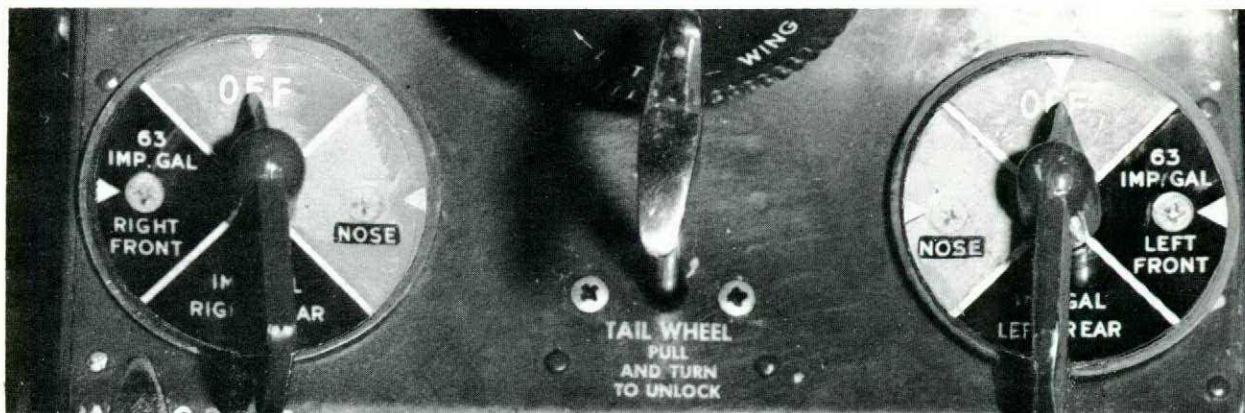
Does this layout look reasonable?

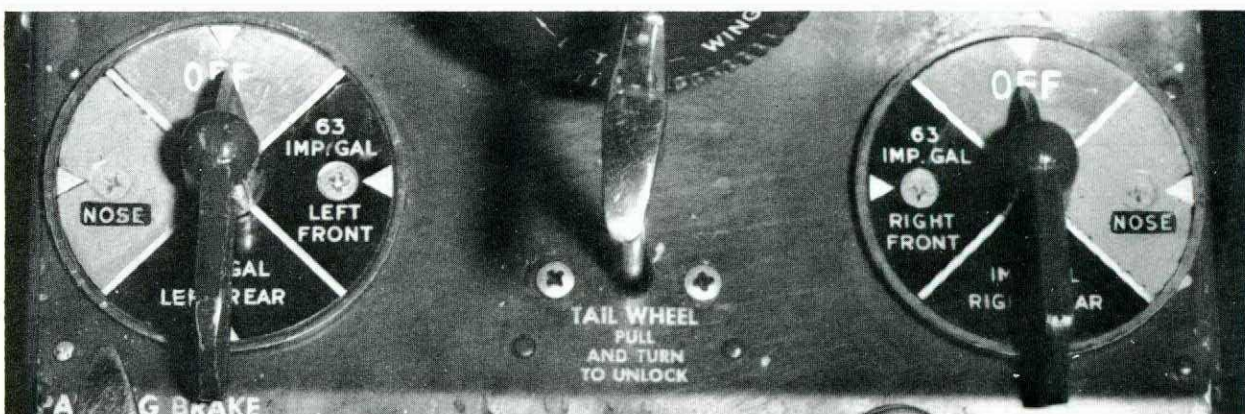
A rather inept technician had installed the fuel selector control assemblies in reverse, making an apparent front fuel tank selection, for example, actually come from the nose - see photo. The pilot, too, should have seen the difference, but the chap we're really annoyed with is the designer who built this part so that it could be assembled in the wrong position in the first place.

As designed . . .

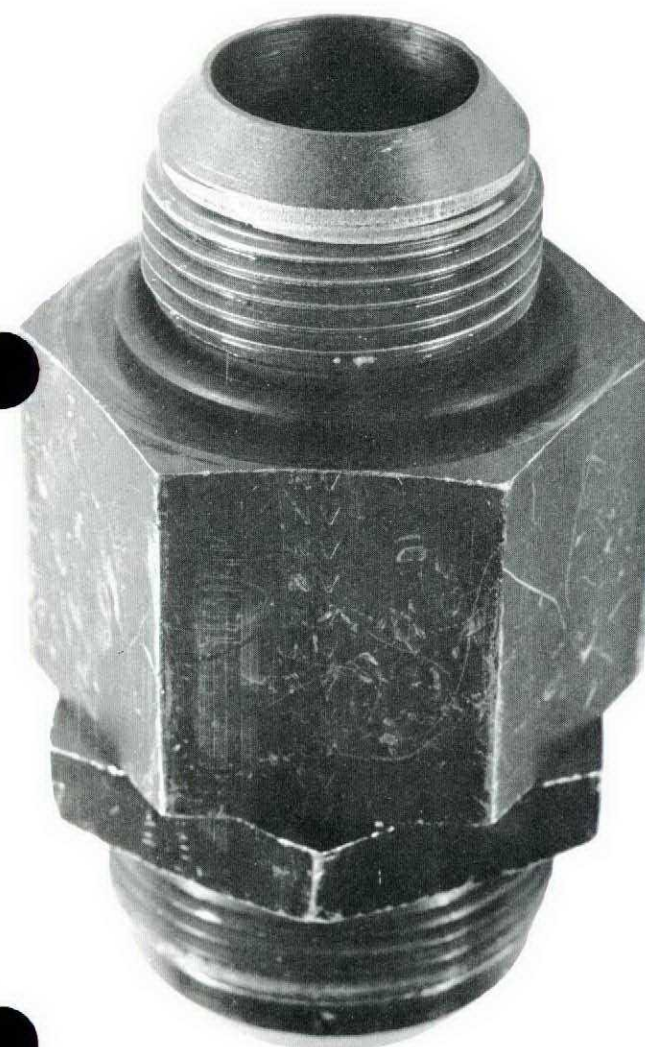
Thread damaged by side load and vibration

The oil leak came from the bushing where the line from the oil cooler goes into the top of the mix box. The exact reason for the failure of this bushing is still (at time of writing) under investigation. However, one of these bushings failed before - on an Army CH113A - but was discovered before any oil leak developed. Operators and maintainers take heed.

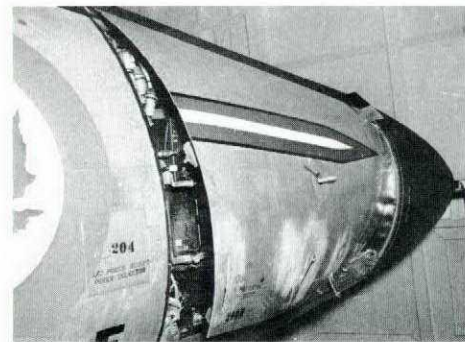
CF101, UNLOCKED PANEL The people who invented panels failed to invent something to ensure that they'd be closed before flight. We've been operating Voodoos long enough to have a fine set of orders, SOPs, cautions, etc, to fool-proof the system – or have we? In this case, an all-out Air Defence exercise was in progress and simply stated, the door was overlooked in the resulting

kafuffle. The aircraft scrambled; the thump felt by the pilot and thought to be the nosewheel retracting was actually the access door being damaged (see photo). At about 18,000 feet a control problem developed causing the pilot to return to base. Which is just as well; obviously the aircraft was in a dangerous configuration for high-speed flight.

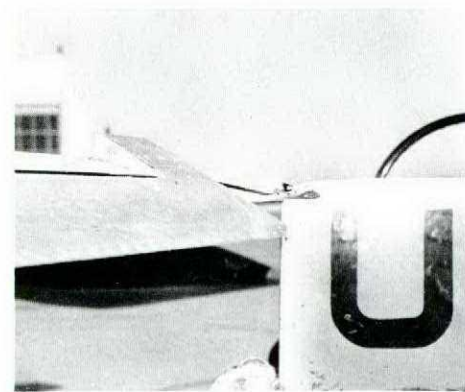
T33, VEHICLE COLLISION This one has a painfully familiar ring to it; it also has a lesson. The aircrew were strapped in waiting for a start when the energizer failed, setting up ideal conditions for what was about to occur. Another energizer was obtained which also failed to deliver. The "careless" airman in question returned with a third energizer and while towing it around the tail of the aircraft struck the tailplane damaging both the elevator and the stabilizer.

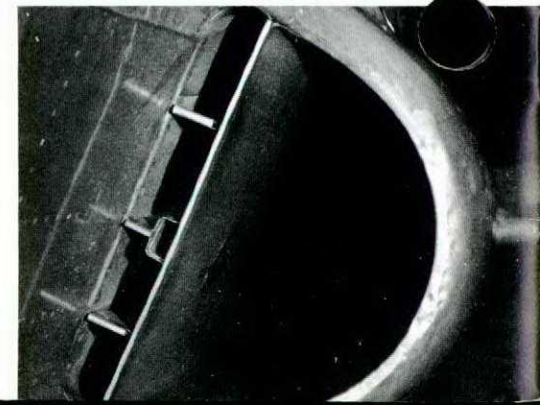
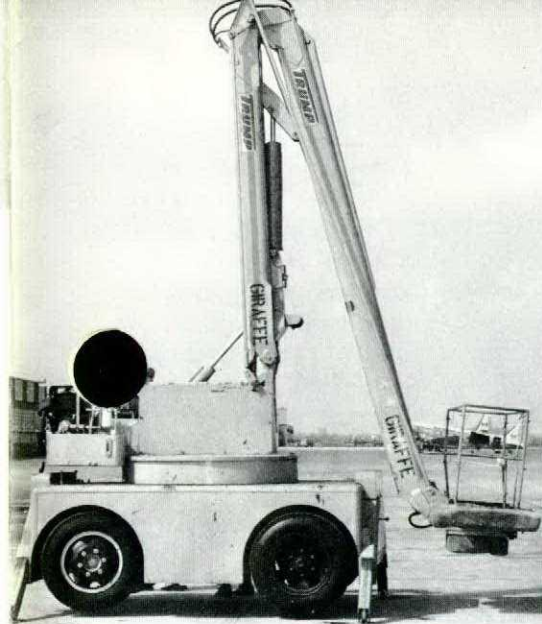
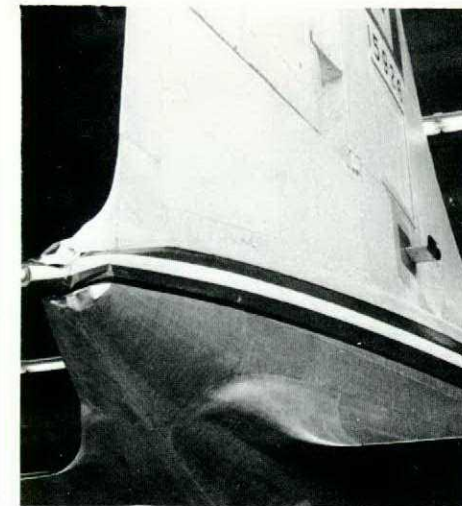
was not possible as there was a "15-mile line of CBs directly in front of them which they would be entering in 30 seconds". Three minutes of lightning, severe turbulence and hail was all it took to damage one aircraft.

YUKON, VS GIRAFFE That distant cousin to the forklift, the Giraffe, has unfortunately the same penchant for whacking aerodynes. The Yukon was the hapless participant in a comedy of errors. A driver with no official qualification was operating a vehicle which he described as "tricky" to operate. Further, he claimed, the Giraffe controls made smooth movement of the machine "impossible". The tail section of the Yukon which was damaged by the descending platform, was temporarily obscured by the boom. The Giraffe demands extreme caution – somewhat more than was exercised by this driver.

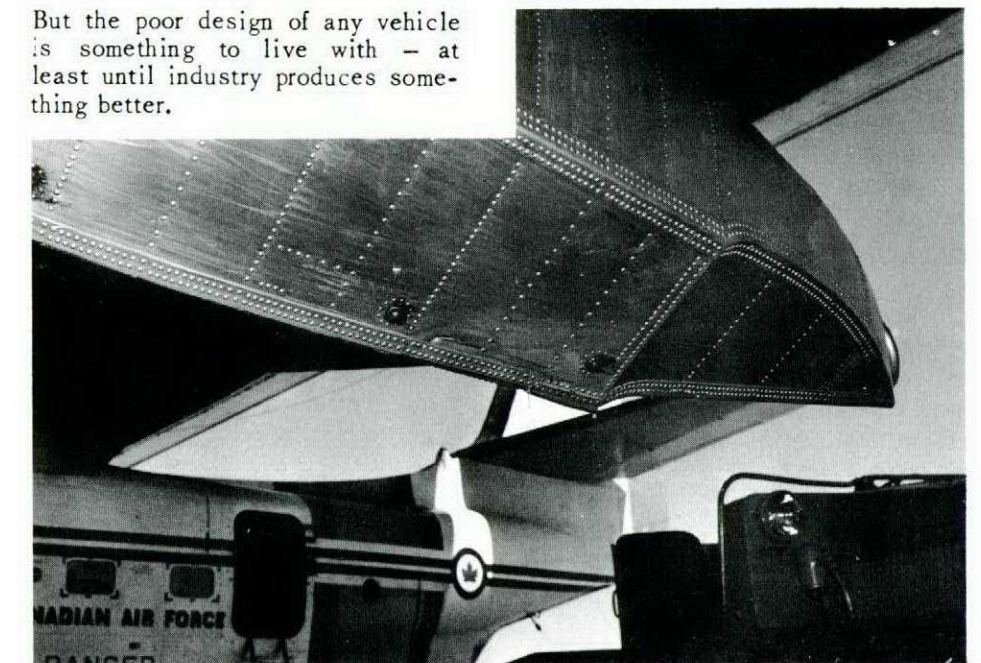
OTTER, WINGTIP INTO GROUND Following a touch-and-go landing (downwind) the pilot overshot, and did a 180 for an inspection pass over the small frozen lake. This inspection pass can best be described as equivalent to a very tight downwind on a normal circuit. The pilot was satisfied that the lake was in good condition for another touch-and-go landing (again downwind) the pilot entered into a very tight final turn – very tight, that is, for an Otter without flaps. The pilot having forgotten the flaps, tightened the turn by increasing bank and

states as "limited aileron movement, no airspeed indication and unusable flap due to poor control with flap down". This pilot can now advise anyone that continuing a maneuver which becomes increasingly difficult to cope with, is strictly for amateurs.
