FLIGHT COMMENT

JULY • AUGUST • 1966

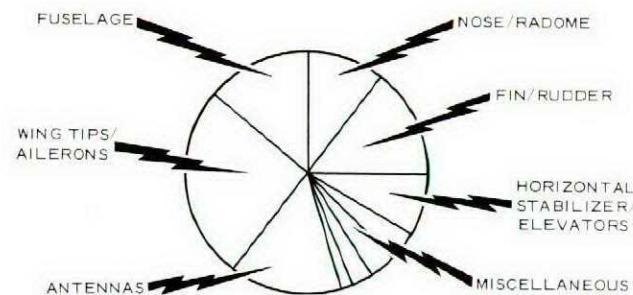
Fig 1

If the aircraft were a metal shell without insulated conductors such as antennas which lead into the vehicle, current would probably not extend inside. Aircraft are not, and cannot be perfect metal shells. The extremities - which most often serve as the electrodes for the strike - are commonly fitted with non-metallic radomes and antennas which project beyond the shield of the metal shell. Flight control surfaces, because of their shape and location at the extremities of the airframe, are also vulnerable.

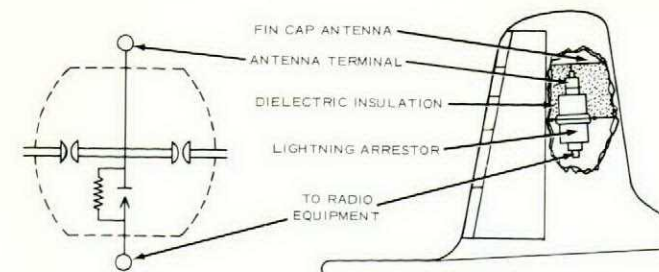
Fig 2

Argus 20735 had a lightning arrestor installed but because the antenna lead-in couldn't carry the current the first strike burned off the antenna terminal lead-in (Fig 2) isolating the fin cap from the airframe. When the second strike came, intense heat was generated by the large charge having to pass through a high-resistance conductor to the main aircraft structure. An indication of the damage which may result in such a case is shown (Fig 3) - a portion of the vertical stabilizer of aircraft 20735.

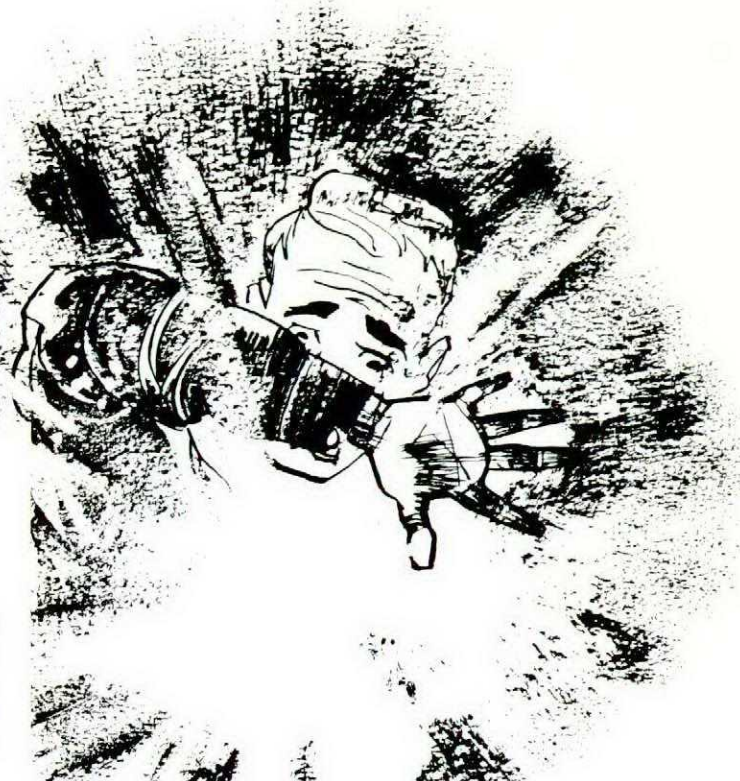
The electrical arcing had occurred in the pulse forming network (PFN), which is a factory-sealed, oil-filled unit. The arcing had cooked the oil and generated hydrogen gas bubbles. The highly-inflammable hydrogen had built up pressure enough to bulge the steel case of the PFN and force its way past a terminal insulator into the main transmitter cavity where a spark from a switch contact caused the explosion.

The set was turned on again, the pulse rate switching function performed – and the PFN exploded. A sheet of flame, black smoke, and oil erupted from the terminals. Had the explosion been confined in a pressurized transmitter housing (normal in aircraft installation) the transmitter would have completely shattered.

The radar explosion in 1959 obliged several agencies to devise a fix. There followed laboratory testing of the oil dielectric, and replacement of transmitter components which could contribute to a malfunction and explosion. Now, an automatic pressure-activated switch in the PFN cuts off electrical power from the radar system.

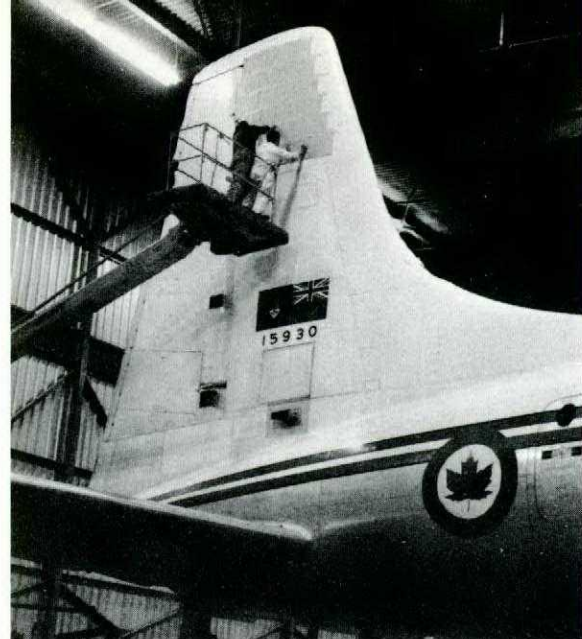
A radiographic crew applying X-ray film to the upper portion of the Yukon vertical stabilizer.

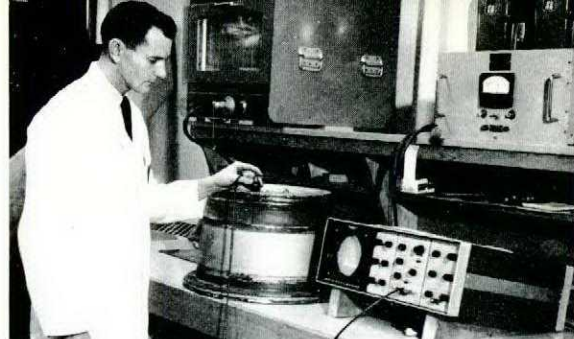
Operating ultrasonic reflectoscope on Yukon wheels to evaluate techniques for finding defects. Later, wheels will be ultrasonically checked in-situ on the aircraft.

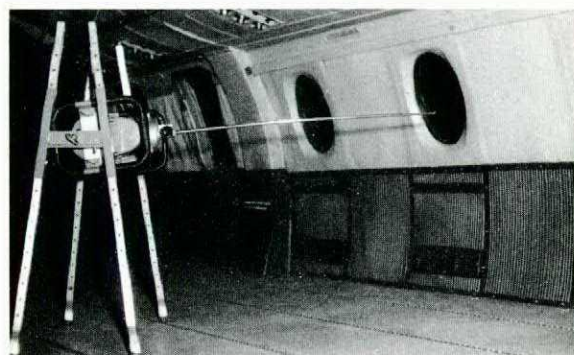
X-ray tube setup for inspecting Yukon cabin window frames.

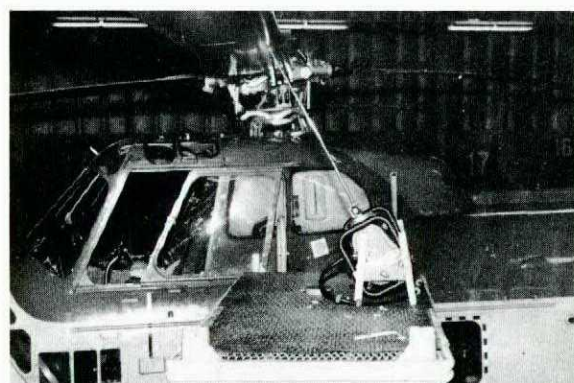
X-raying of S55 rotor blades at Shearwater.

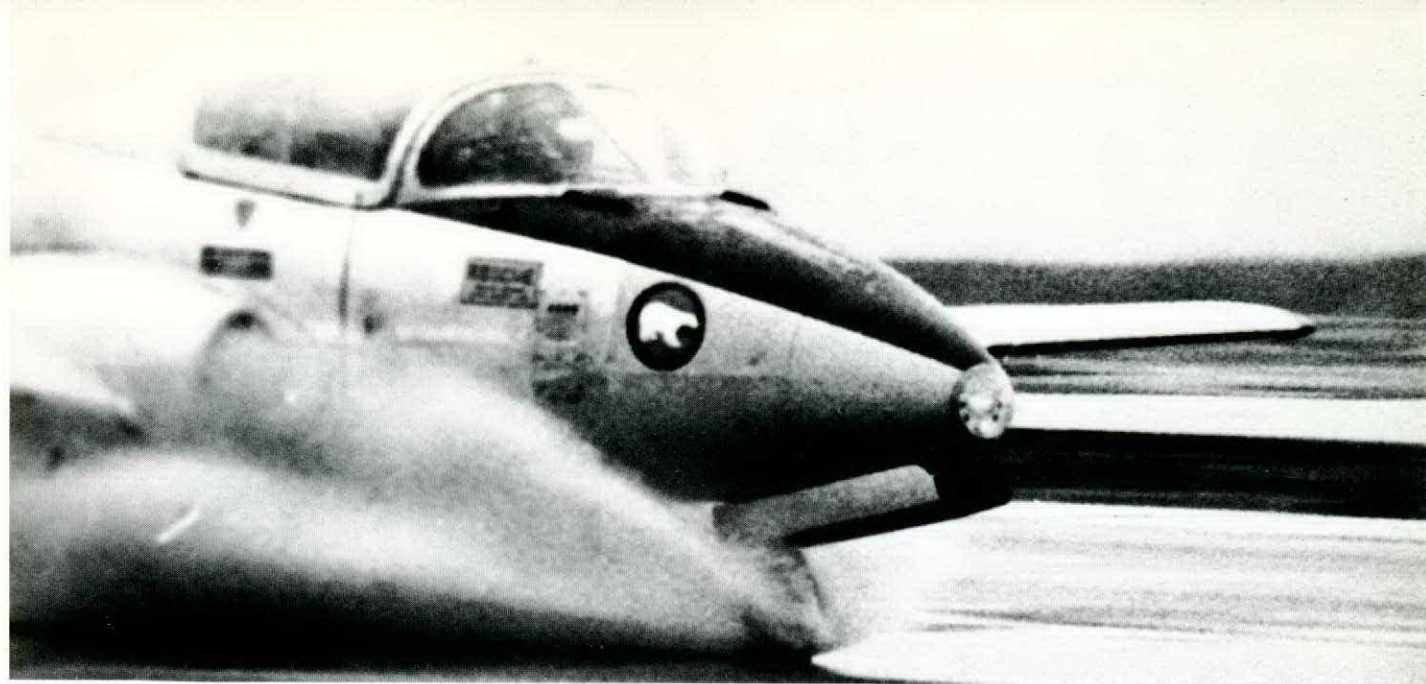
THE TUTOR'S WATER WHEEL

It was only 3/8 of an inch deep, but the Tutor at 70 knots on takeoff gulped in enough water to flame out the engine. The pictures show why.
