FLIGHT COMMENT

NOVEMBER • DECEMBER • 1966
(SEPT-OCT ISSUE NOT PUBLISHED)

- 2 THE GREAT LAKES - SURVIVAL CHALLENGE
- 7 TRAINING COMMAND'S FLIGHT SAFETY MAINTENANCE AWARD
- 8 GOOD SHOW
- 10 ICE ON WINGS!
- 11 A GOOD SHOW ALL 'ROUND
- 12 BIG DAY AT BORDEN, SASK
- 15 TIE BOLTS TAKE CARE
- 17 THE FORKLIFT HAS ITS POINTS - BUT...
- 17 INTERRUPTED MAINTENANCE - BEWARE
- 18 THE T DISPLAY
- 20 ON THE DIALS
- 21 GEN FROM 210

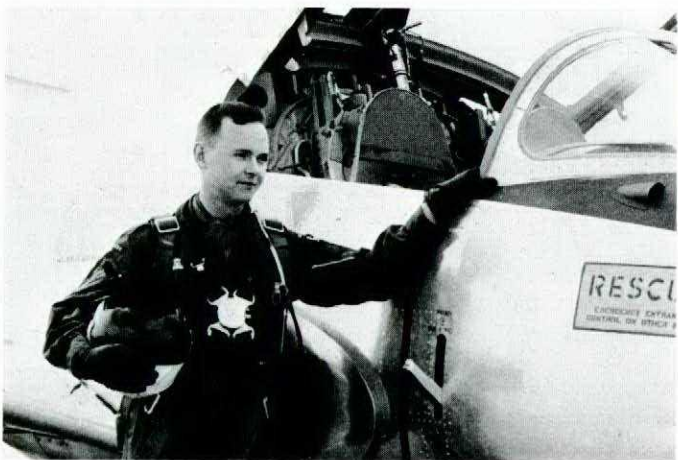
CPL GE ROBINSON

While based at Kamloops on an SAR mission, Cpl GE Robinson was performing an inspection on an Albatross when he discovered that the aileron control wheel, although free to move from neutral to port, could not be moved from the neutral position to starboard.

Investigation of the aileron control system revealed that an explosive rivet 1½ inches long, lying loose in the

Later, five more rivets were found in the area above the sprocket and chains.

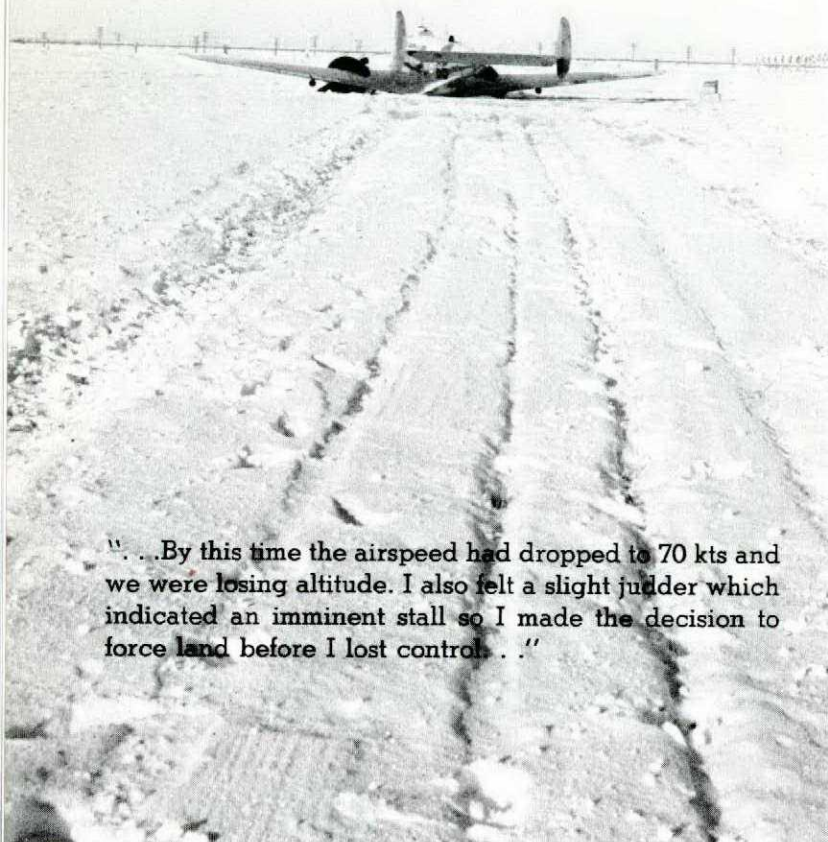
Ice on Wings!

"...By this time the airspeed had dropped to 70 kts and we were losing altitude. I also felt a slight judder which indicated an imminent stall so I made the decision to force land before I lost control..."

The investigation covered every conceivable possibility such as lack of power, false indication of speed, fuel load, and C of G (this was a TACAN-equipped Expeditor). Later on, returning to the aircraft the pilots observed the leading edge of the mainplanes iced to 1/4 inch and the tailplane approximately 3/8 inch. The top surface of the wings were clear.

1. It appears that the windshield/wiper check is inadequate as a guide for airframe icing.
2. While the TACAN equipment has shifted the centre of gravity, it is insignificant.
3. The captain denied himself (by using an intersection rather than the runway end), approximately 2500 feet of usable takeoff room. If a ravine, for example, is to be the only landing place available, these 2500 feet could come in handy.
4. The icing occurred when there was no clear or rime ice reported at destination or departure airports. The photo shows the considerable ice accumulation on the airframe.

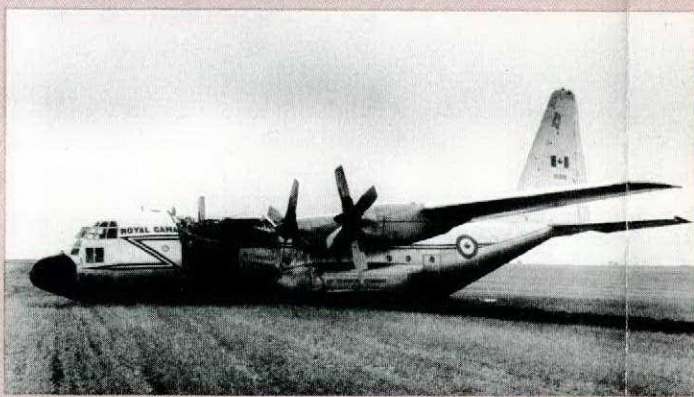
Farmer's-eye view of uninvited guest.

The cause? The door had opened, becoming detached from the aircraft in flight, (later found 15 miles away). It was the door components that were vital to the accident investigation.

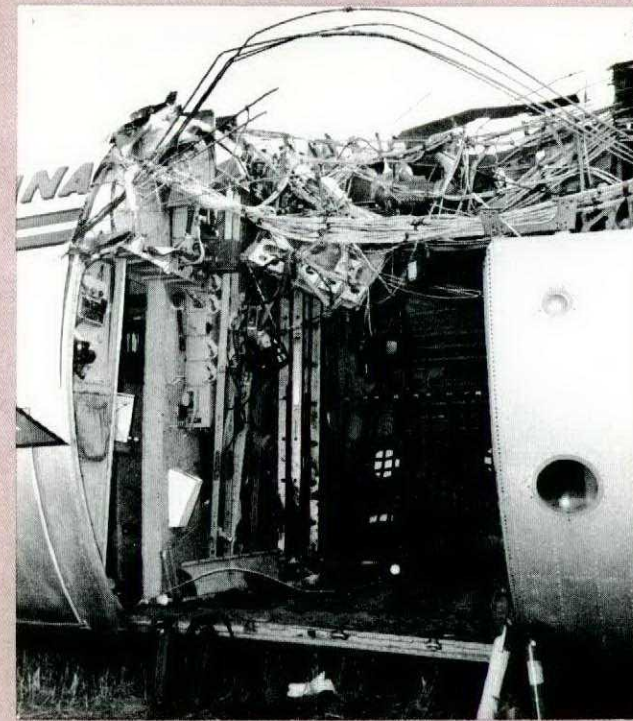
The causes were both material failure and maintenance error. The latching mechanism, consisting of four eyebolts, had failed allowing the door to tear off and with it, the top of the fuselage. The #1 eyebolt tying the door to the fuselage ruptured through over-stressing causing the #2 bolt to fail as the load was transferred to it. The fact that #2 eyebolt failed in this manner is strong evidence that the #1 eyebolt had been overloaded. Laboratory investigation disclosed that the #1 eyebolt had been cracked for some time; only 3/4 of the cross sectional area was carrying the load at the time of its failure. Analysis disclosed that both the initial crack and the ultimate failure were a result of overloading; also, rough machining during manufacture had helped the crack form. Misalignment during door rigging is strongly suspected as creating the overload.

Door locking mechanism failed, tearing away door, fuselage panels, and shredding control and systems connections.

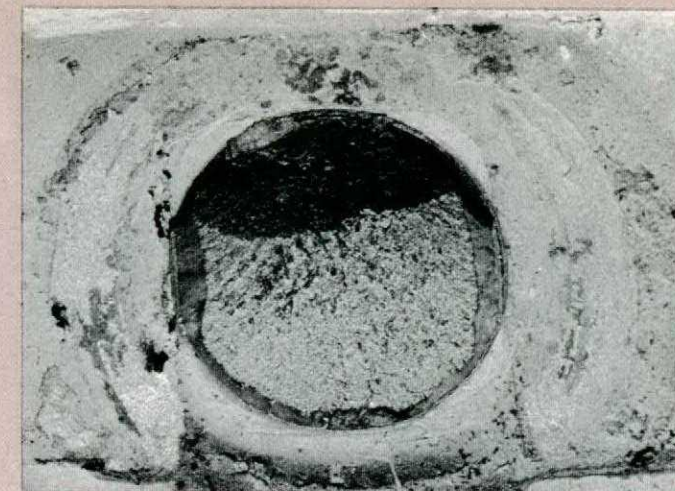
Had the eyebolt clearances been checked and adjusted when they were reinstalled on the previous periodic inspection, the load would have been distributed so that when an eyebolt failed, the remaining eyebolts would share the load. Thus, the accident could have been prevented.

Another disturbing fact – the dye-penetrant check on the eyebolt during the last inspection did not reveal the existing crack. This points to a lack of know-how. Qualifications and training in the use of non-destructive test methods are now under review.

The eyebolt that failed and caused the accident. Note the previously-cracked portion. Overstressed by incorrect rigging, it couldn't carry the load.

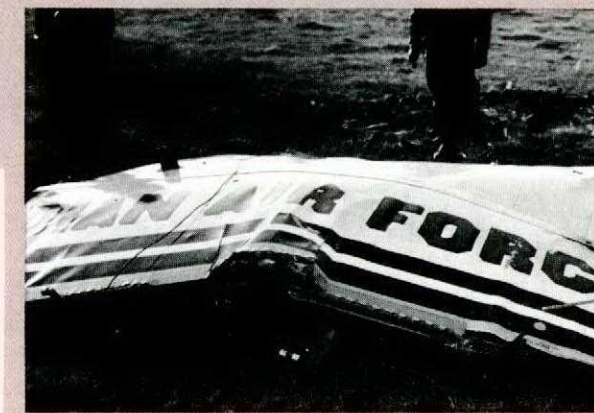
The upper fuselage section torn off by the cargo door.

New eyebolts for the repairs to the fractured fuselage were first thoroughly checked at the Materiel Laboratory in Ottawa for manufacturing defects. Two of these bolts were found defective.

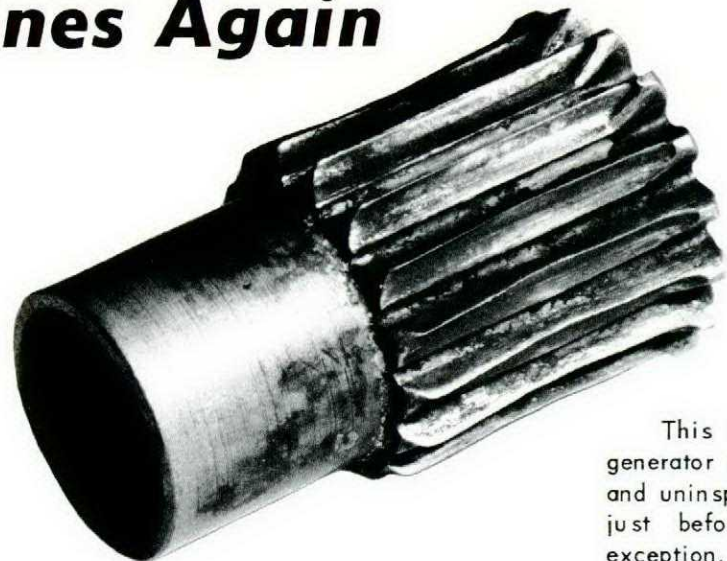
Splines Again

This is what could happen – and did – to a T33 generator drive shaft spline if it remains unlubricated and uninspected. This part was uncovered by chance – just before it failed. Admittedly this one was an exception, but spline wear is a common, well-documented and researched phenomenon.

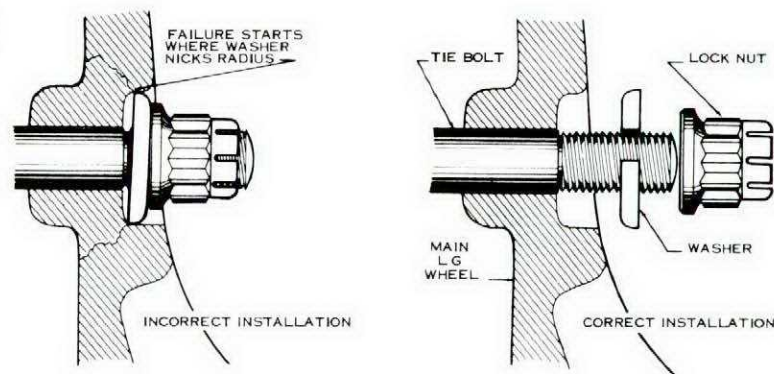
FIG 1

Carelessly installed saddle washers lead to fatigue cracks.

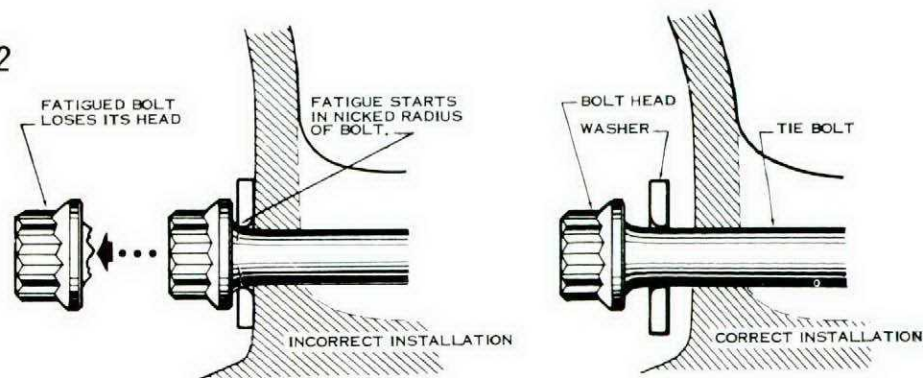
FIG 2

Reversed countersunk washers cause failure at radius of bolt.

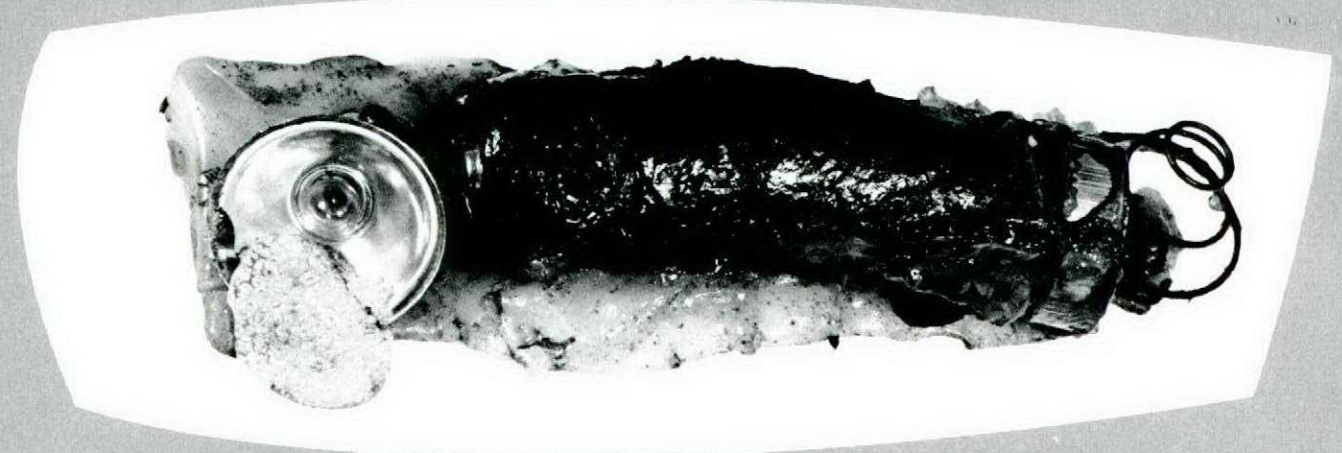
No, it isn't a new species of lamprey and it isn't a fishing lure; it's what is left of a flashlight after being heated for about 150 hours in an Argus wing heater duct (adjacent to the port side of number 2 engine.) Fortunately, no damage or hazard was caused by this limp lump of light.

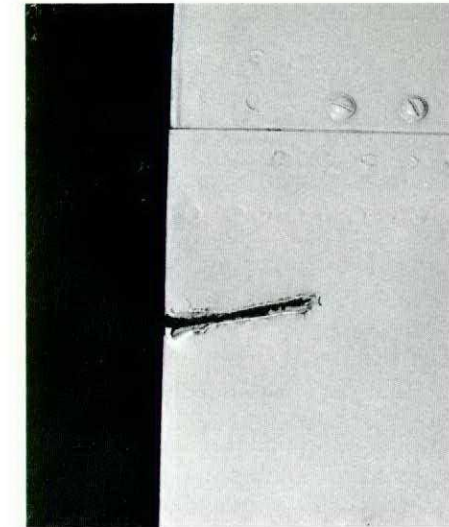
T33, HANGAR COLLISION The T33 was being manually pushed backwards into a hangar, (described by one of the interested parties as "far too crowded"), when it came in contact with the elevator of a Tracker.

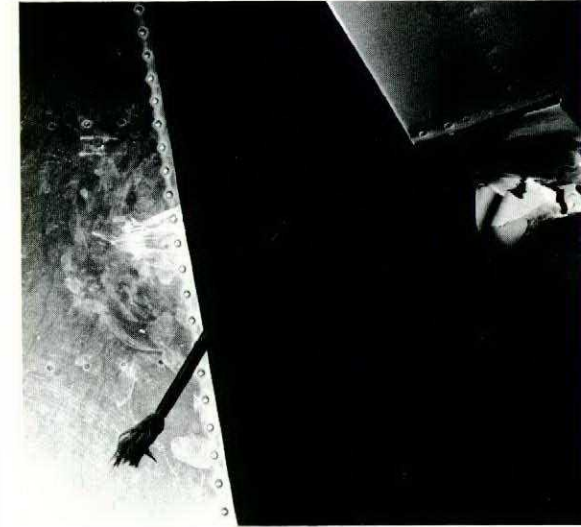
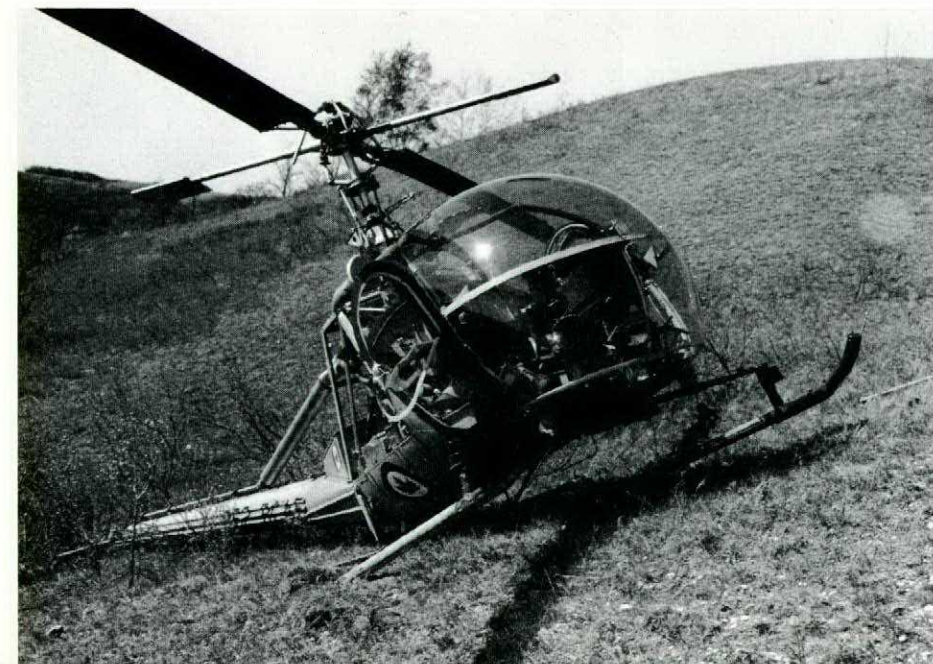
CH112, MYSTERIOUS BANG Returning from a training mission this pilot (with few hours on type) experienced a "zing-twang" sound accompanied with a violent yaw to the right. Assuming a tail rotor failure, he elected to autorotate. He misjudged, approached short of his intended landing spot, and in the ensuing panic accomplished what an investigator described as a "fairly gentle crash".

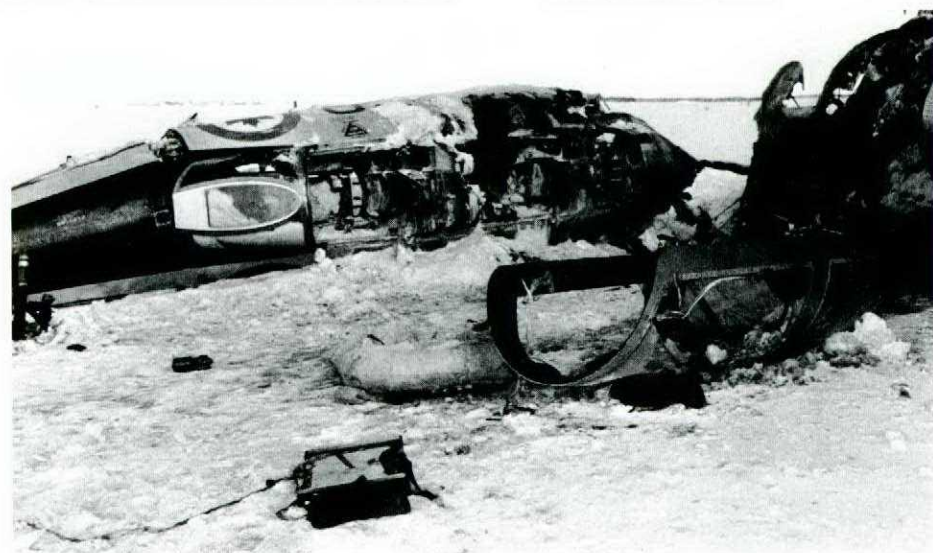
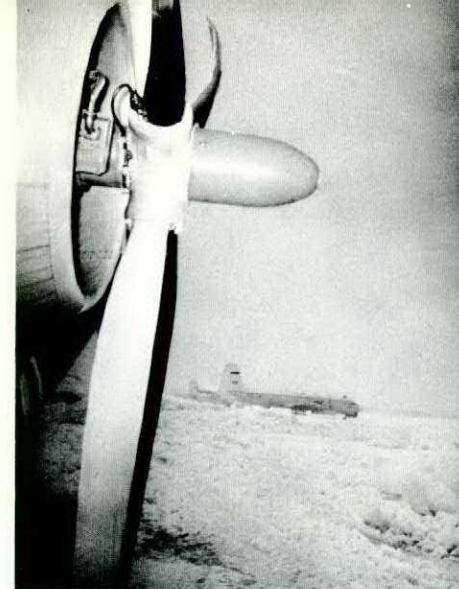
ARGUS, SNOW BENDS PROP Twenty-three hours on duty in the previous forty-eight left the Argus crew in no mood to accept a diversion from homebase to a nearby airfield. To compound the situation the pilot was faced with a taxi and ramp area incompletely cleared of snow. Accepting the advice of the tower to taxi via an alternate route to avoid possibly striking a hangar with a wingtip, the captain pressed on until heavy wet snow piled in front of the bogies bringing the aircraft to a halt. Reverse pitch did not free the aircraft, even when the
