FLIGHT COMMENT

MARCH / APRIL 1987

- 2 you ask . . . we answer
- 6 Good Show
- 8 STOP!
- 10 The Squeaky Wheel
- 14 The Bird Watchers' Corner
- 16 Another "Isolated" Accident
- 20 A Science-Friction Tale
- 21 On the Dials
- 22 Impact Survival
- 26 Gen from 210

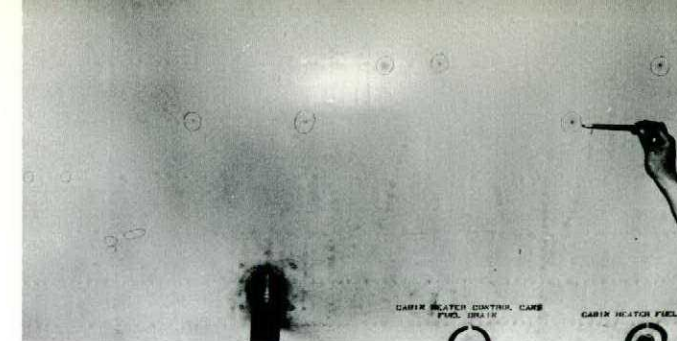
Repeatedly, the aircraft had been reported unserviceable for compass errors. This snag was later found to be caused by magnetism created by static discharge from the wingtips. All this time the aircraft flew with extensive lightning strike damage to the airframe as shown in the photos.

- No reports from aircrew who had flown this aircraft indicated a strike although the damage inflicted to the airframe attests to the severity of the charge.
- During frequent walk-arounds by both groundcrew and aircrew the widespread damage to the airframe remained undetected.

Port side of fuselage was pocked in several places

A persistent and unexplained compass error should alert aircrew and groundcrew to a possible lightning strike or discharge damage. The need for a careful walk-around is obvious. □

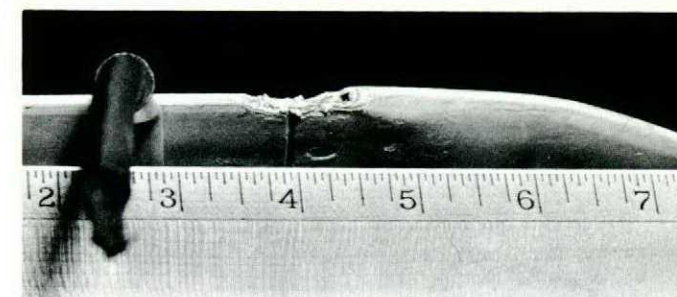
Starboard wingtip — heat melted the aluminum

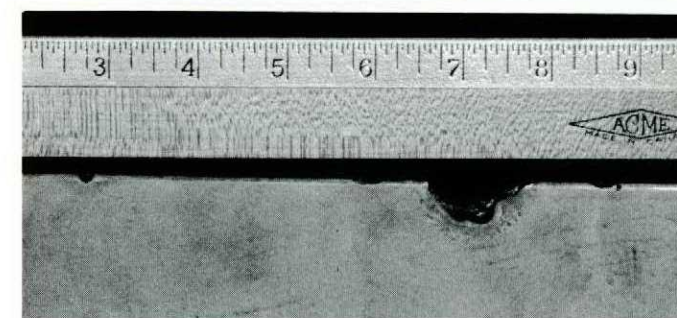
Port aileron trim tab damaged.

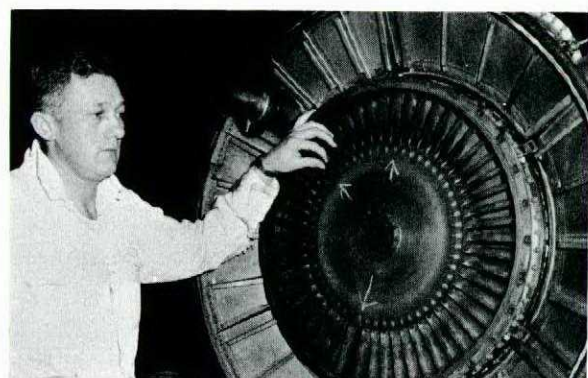
On a routine inspection of a T33 engine, Cpl Enns noted a turbine blade out of position. He drew this to the attention of a supervisor, who examined it and thought it normal. Later, Cpl Enns returned to the T33 and was able to remove the blade with his fingers. He then initiated a thorough check of the turbine section.

A large bolt securing the labyrinth seal had broken or come free and rubbed on the forward face of the turbine wheel. The bolt head had worn off several locking lugs permitting blades to move rearwards in their pinetree slots in the turbine wheel. Other bolt heads had been badly scored; the forward surface of the turbine wheel was extensively damaged. None of this damage was visible from the tailpipe.

Failure of these parts could have lost us both the engine and the aircraft.

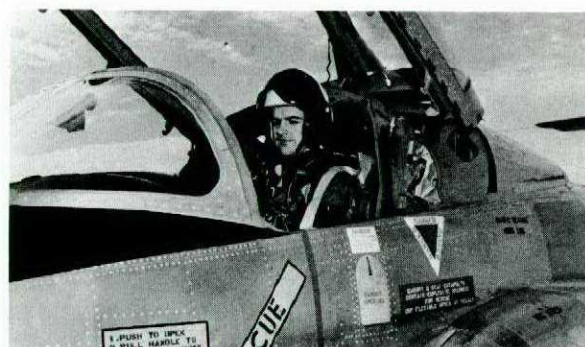
F/O WM Wright and a student were climbing their Tutor through 8000 feet with 100% rpm and 220 kts; the oil pressure began to fluctuate from 30 to 60 psi accompanied by a small noise. This was followed by a loud bang, illumination of the high oil temperature light and rising EGT. F/O Wright took control, flamed out the engine, and carried out a successful forced landing on the runway.

The engine oil filter had been blocked by metal particles, indicating a bearing failure. There was also evidence of high overheat.

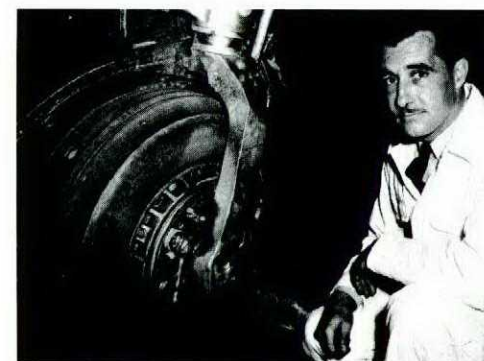
Cpl Lawrence, a member of the CF101 maintenance test crew, while on an external inspection prior to a test flight, noticed a very small hydraulic leak on the bottom side of the starboard wheel brake drum. He informed the pilot of the leak, and requested that he start one engine to test the brakes. The pilot did so, with heavy loss of hydraulic fluid through the leak. The brake piston and seal were found to be broken.

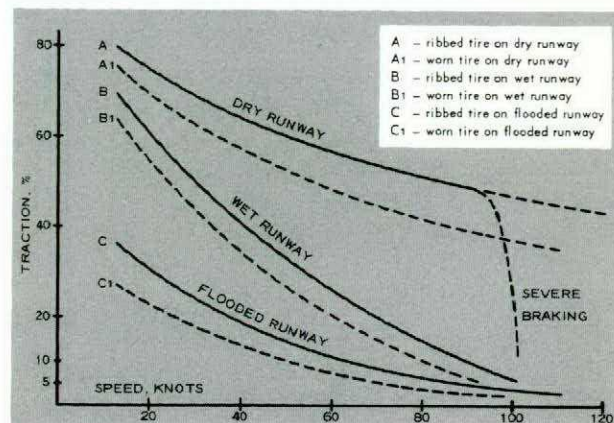
The pilot landed on a wet runway, too fast for fuel load – he didn't have a chance as the aquaplaning (white lines) continued right off the landing strip...

Cement truck on highway brought runaway T-bird to a halt.

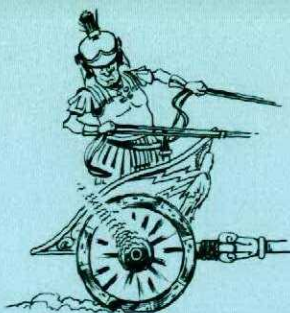
On touchdown, the starboard wheel separated from a CF104. Prompt action by the pilot prevented the aircraft from leaving the runway till forward speed was reduced, limiting the damage to C category. The accident resulted from disintegration of the wheel's outer bearing. Investigators assessed the most probable cause of bearing failure as under-lubrication.

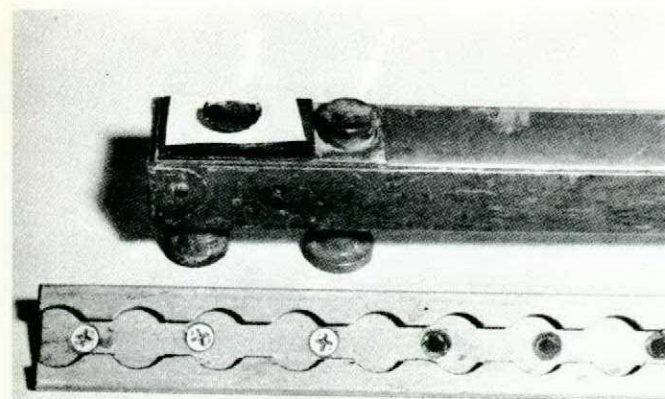
Most seats have little lateral strength (1.5 to 3G), and seat legs will readily bend sideways placing a large prying load on the track and particularly on the tie-down buttons. Both of these components are of non-ductile metal and will fail suddenly and completely if their load limits are exceeded.

Typical anchorage failure. Button failure (solid arrow) as a result of side load. This type of seat anchorage has low resistance against floor distortion and/or bending of the seat legs. The dotted arrow indicates the locking pin which engages the floor track to prevent fore and aft movement of the seat.

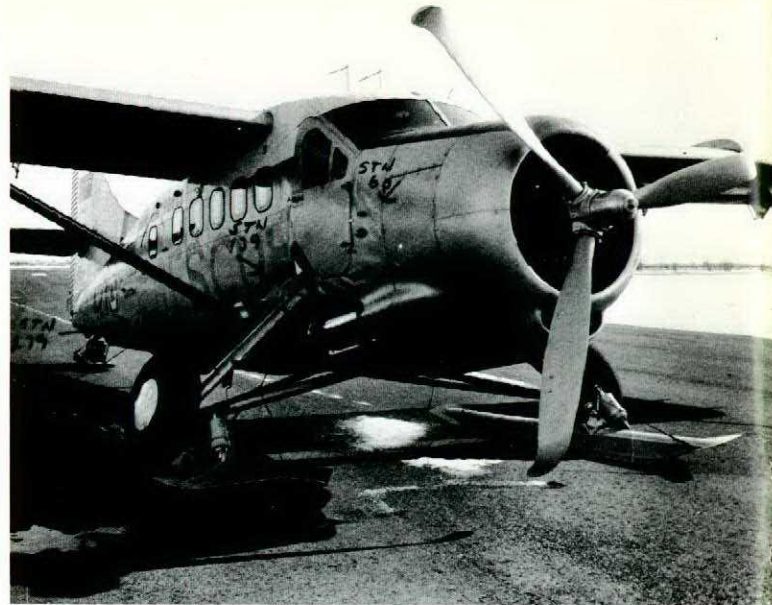
The student at the controls misjudged, rounded out too high, sensed his predicament and applied power to halt a developing rapid rate of descent. The engine failed to respond in time and another aircraft was unnecessarily badly damaged.

Overstressed Otter at rest.
