-
- 2 the '68 story
 - 6 Koffee Klatch
 - 8 Good Show
 - 10 The mysterious case of the LOST CAUSE
 - 11 H-orendas' FOD
 - 12 the WALKAROUND
 - 14 Murphy's Muddle
 - 16 Near Miss at sea...
 - 19 On the Dials
 - 20 Gen from 210
 - 24 Comments to the Editor

WHAT'S IN A CAUSE?

the '68 story

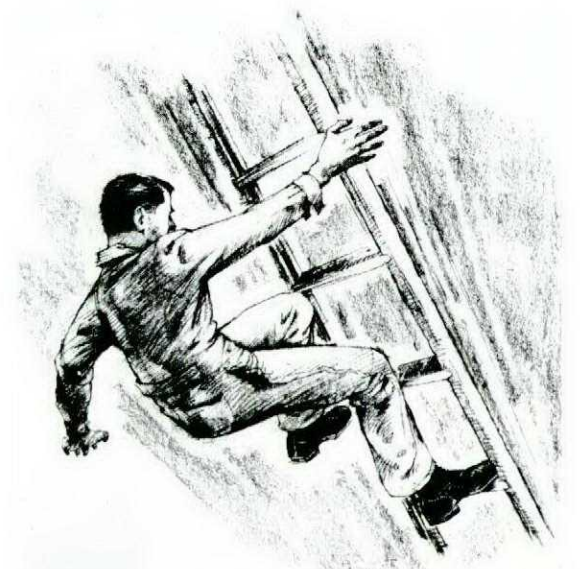
Well, not deliberately...

Almost at the top of the ladder by the Yukon's front passenger door, a technician is suddenly hurled to the floor as the ladder separates from the aircraft. The 10-foot fall causes injuries to a hand and his back with possible permanent disability.

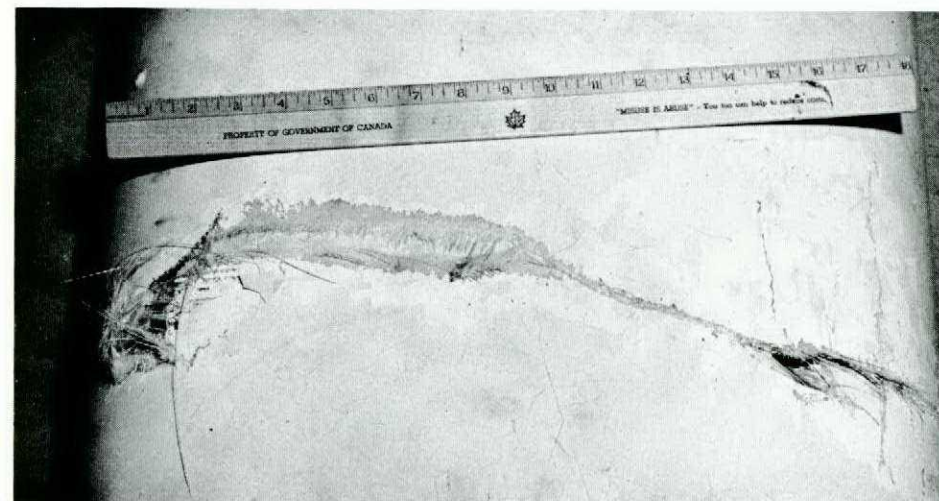
CH113, WIND HAZARD On returning to base from a helicopter rescue mission, the tower notified the pilot of winds at 35 gusting to 40 - within limits for rotor shutdown. However, when the rotors had almost stopped,

the crew heard a thump on the top of the fuselage. Just then, a "special" from the Met section reported the wind as 36 gusting to 49. Probably, a gust caught a rear rotor blade, forcing it down sufficiently during

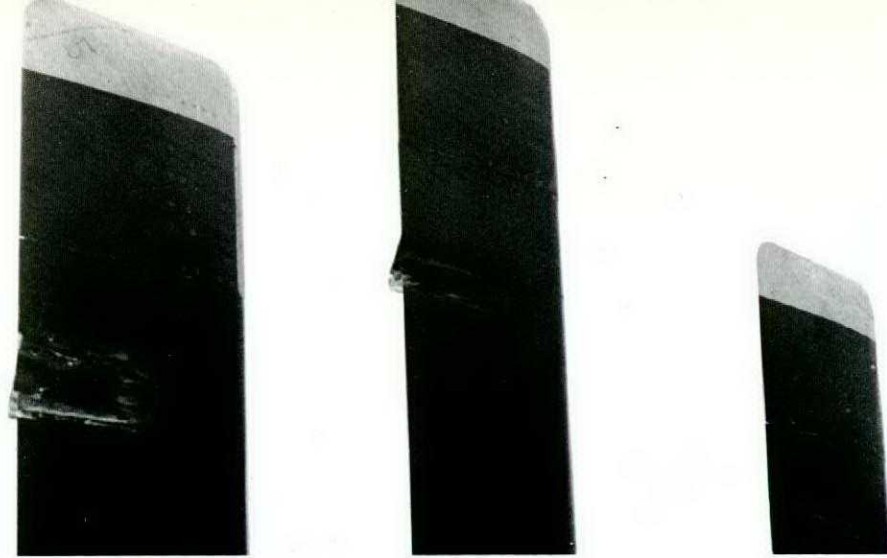
Five blades needed replacing...

SEA KINGS, BLADETIP COLLISION During a demonstration formation flypast the six helicopters - two vics of three - flew along the port edge of the flight deck. The starboard wingman of the first vic momentarily glanced away from his leader when distracted by something to his right

CFAOs for a helicopter display flight of 6 require a minimum of 500 feet between the lowest aircraft and the highest obstruction. (The formation was flying at 150-155 feet on the radar altimeter - the height of the carrier mast is 132 feet.)
