FLIGHT COMMENT

SEPTEMBER • OCTOBER • 1969

COL R. D. SCHULTZ
DIRECTOR OF FLIGHT SAFETY

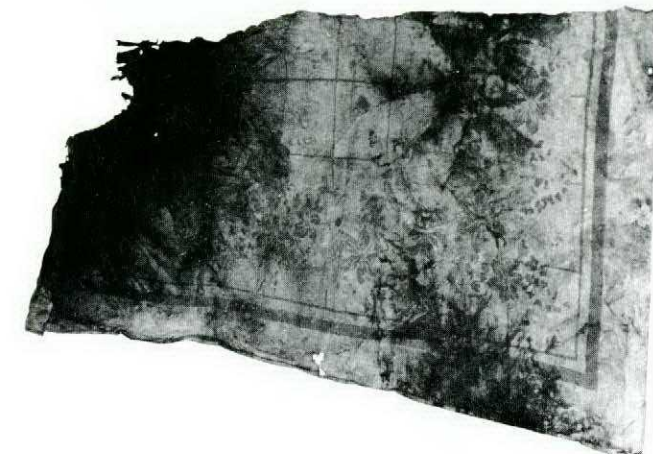
The Dak had oil pressure fluctuations in the starboard engine twice in one week; this prompted an in-depth investigation of the whole system. It drew a blank. However, on the second hour-long run-up the boys got what they were looking for - a momentary pressure fluctuation. Now that both sides of the fence had witnessed the fluctuations, an even closer look was made.

How long had it been there? We looked back and found that there was quite a history of problems with the starboard engine in this aircraft between 1950 and 1964. There were six single-engine landings - half of these involving oil pressure fluctuations, one of which was attributed to oil starvation.

However, in 1963 the oil tank was overhauled by -6A mod on the oil standpipe - at which time surely, someone could have spotted the rag. Also, there's the assurance by the base that since 1960 at least, the 14 x 16 reusable rag has replaced tablecloths!

...and out came a 4' x 2' piece of tablecloth (after cleaning).

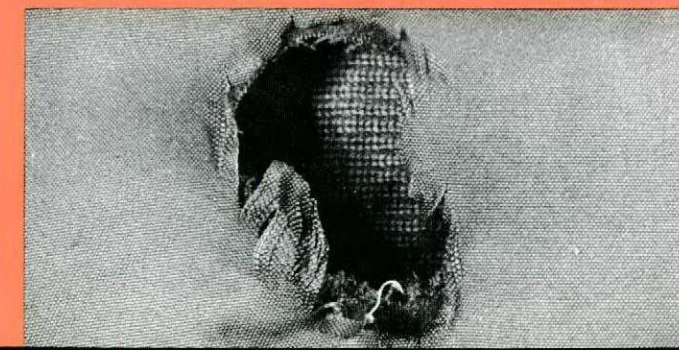
As the canopy was raised on the tarmac before a flight, smoke was seen coming from behind the rear seat. A burning flying jacket was quickly extracted and extinguished.

A 2-1/2" hole was burned in a flying jacket.

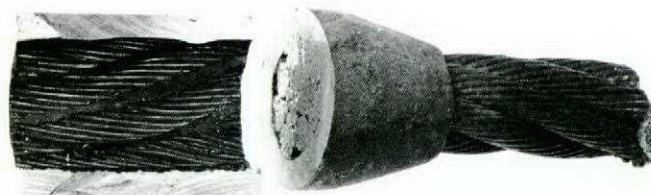
Note how properly swaged joint has cable wire embedded into sleeve.

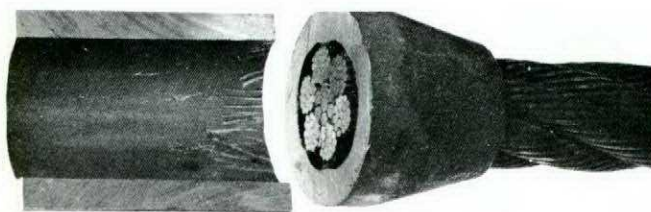
Improperly swaged, the cable slid loose on launch; the smooth sleeve interior and gaps between cable sleeve (end view) show why the loop couldn't take the strain.

- ▶ Materiel - Related Facilities. Failure of catapult bridle.
- ▶ Personnel - Other Personnel/Civilian Contractor. Non-compliance with orders. Failure to ensure that each bridle is serial numbered to facilitate control of proof testing.
- ▶ Personnel - Other Personnel/Quality Assurance - Inattention. Did not ensure bridle met specifications.

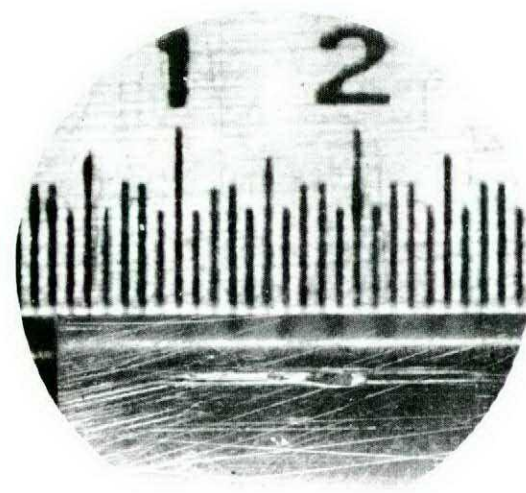
Fig 1 The enlarged photo shows that scoring of spool surface

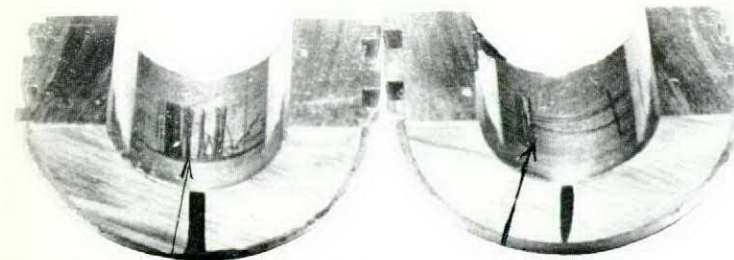
Fig 2 Control valve sleeve cut open to show extensive scoring

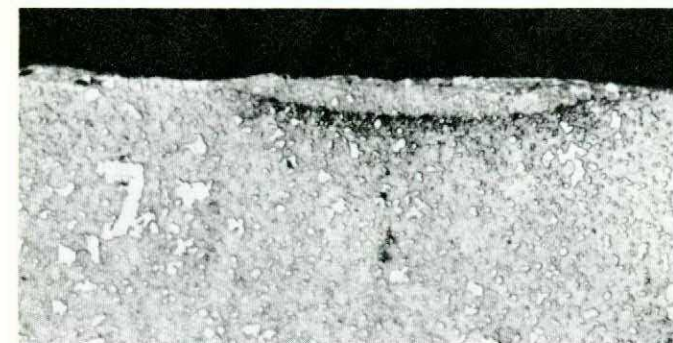
Fig 3 Cross-section of controller galled area. This micro-photograph shows depth of damage.

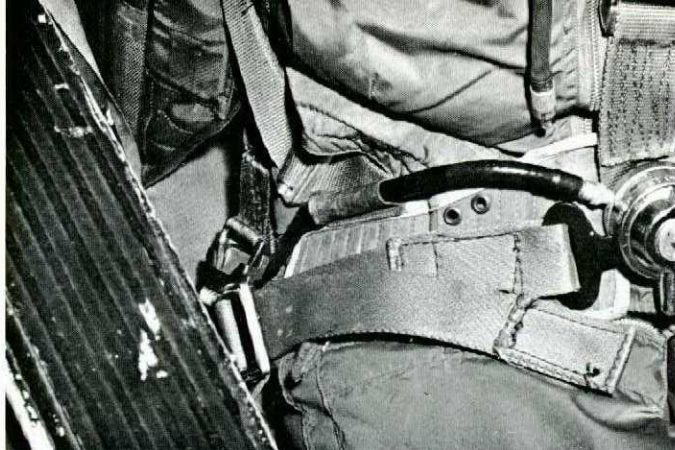
The survival pack strap overlapping the seat belt below the wider padded portion (described above).

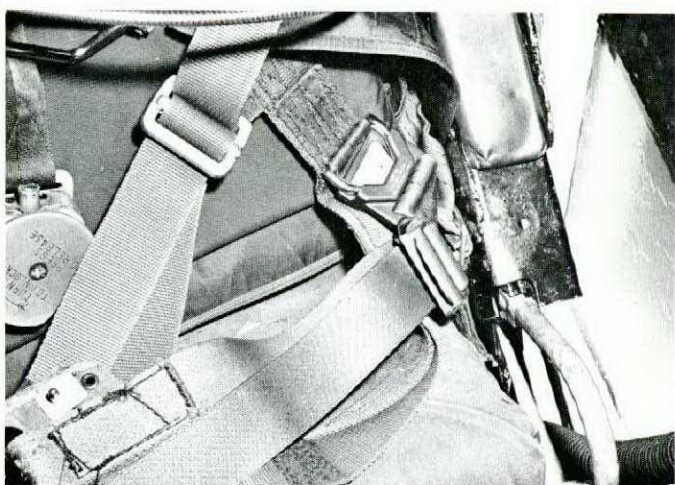
A possible configuration involving the right lap strap. Note that the seatpack strap is hooked over the gas line to the seat buckle. In the event of ejection, seat separation could only be effected after the survival pack buckle connection had been undone. At low level this could easily be a fatal mistake.

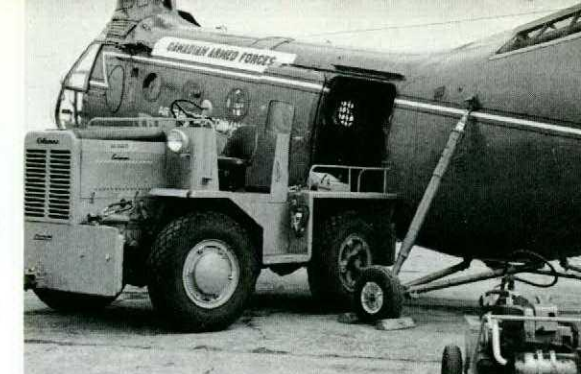
The corner of the rear platform on the mule punctured the skin of the helicopter causing a 1½-inch tear in the skin and slightly bending a vertical stiffener aft of the door. The gearshift linkage was found to be out of adjustment caused by

transmission hold down bolts being loose. Tightening these rectified the problem. All other towing tractors on the base were found serviceable. Could it be that DIs on aircraft support equipment are not as thorough as they should be?

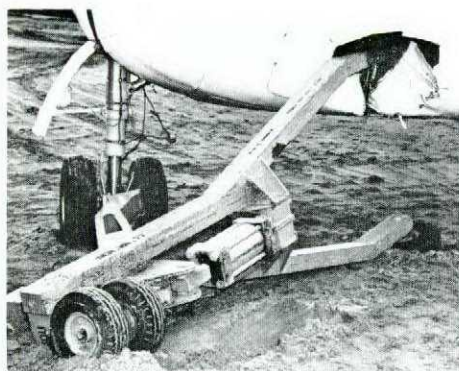
CARIBOU, NOSEWHEEL JACK TIPS Supervised by CHQ personnel acting as part of the towing crew, the aircraft was positioned for a trial in a portable canvas hangar. In order that the tail would pass into the hangar, it was necessary to raise the nose with a towing jack. The tractor began to back the aircraft but, after only a few feet, the tail suddenly moved laterally possibly due to a gust of wind. The nose of the aircraft was moved sufficiently to tip over the jack which punctured the side of the aircraft.

trial was taking place, while firm enough to support the weight of the aircraft on its own tires, was not able to support the smaller tires of the jack with the weight imposed on it by the aircraft. The track of five feet between main wheels of the jack
