FLIGHT COMMENT

NOVEMBER • DECEMBER
1969

Winter woes – part III
Snow illusions
Temperature low?

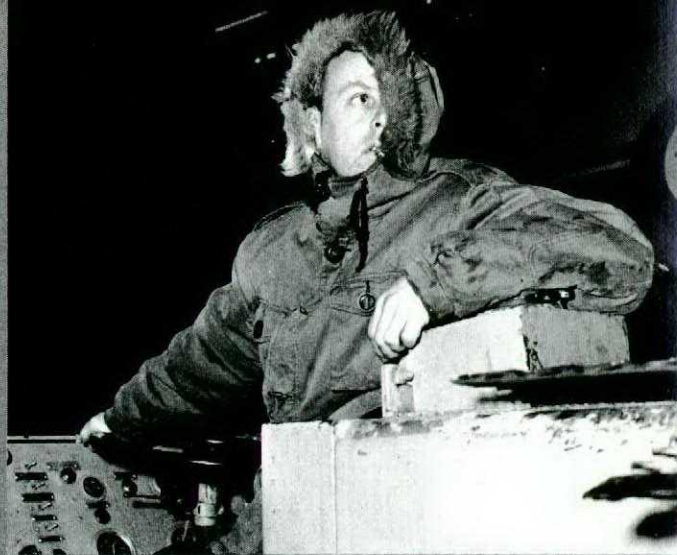
Clothing can be a nuisance - particularly, if the user incorrectly fastens his parka...

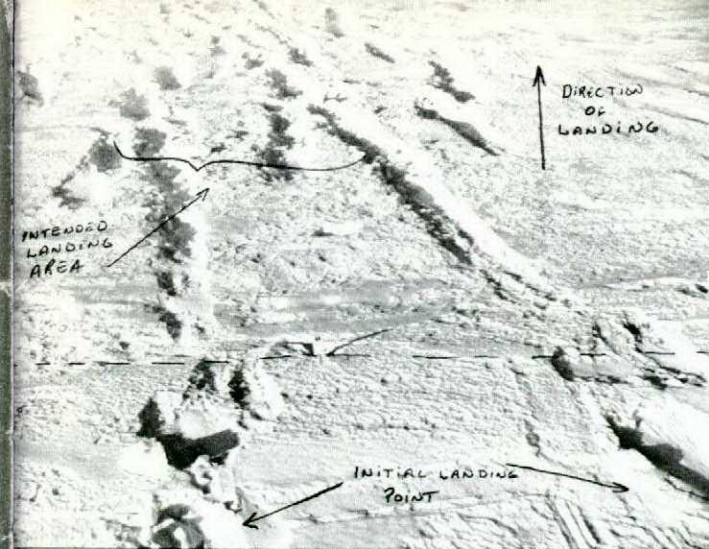
Snow can hide bad ground. In this case, a CH113 hit a "bump" buried beneath the snow.

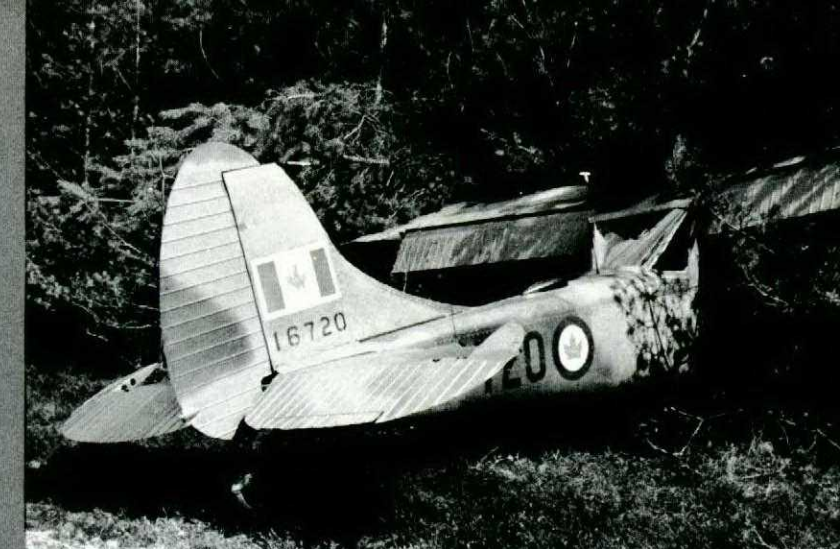
Frost on aircraft - still with us.

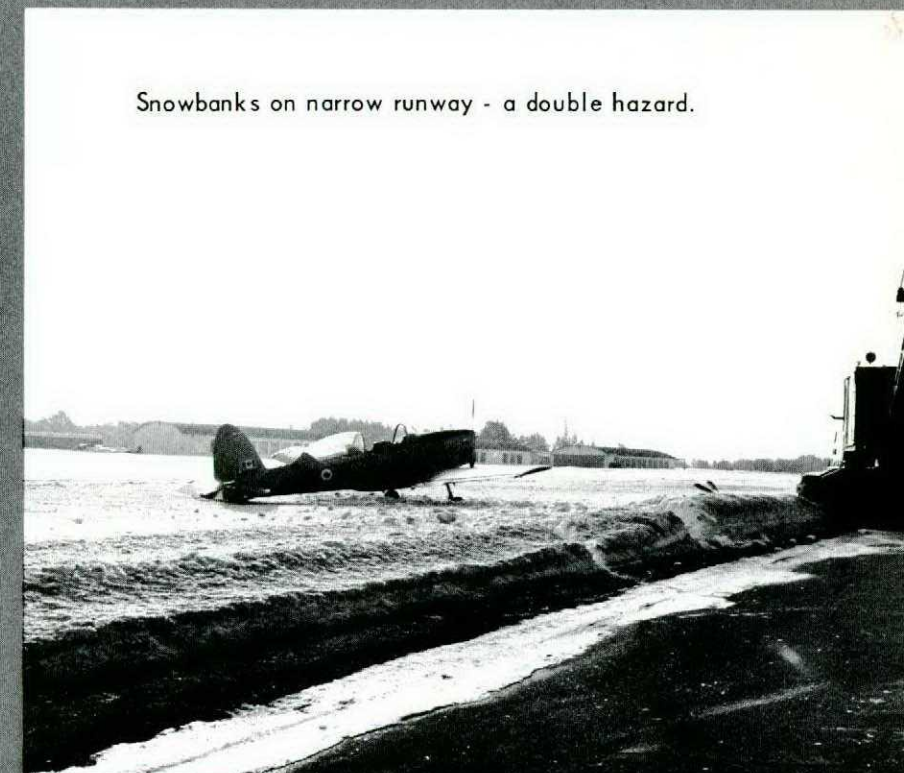
Snowbanks on narrow runway - a double hazard.

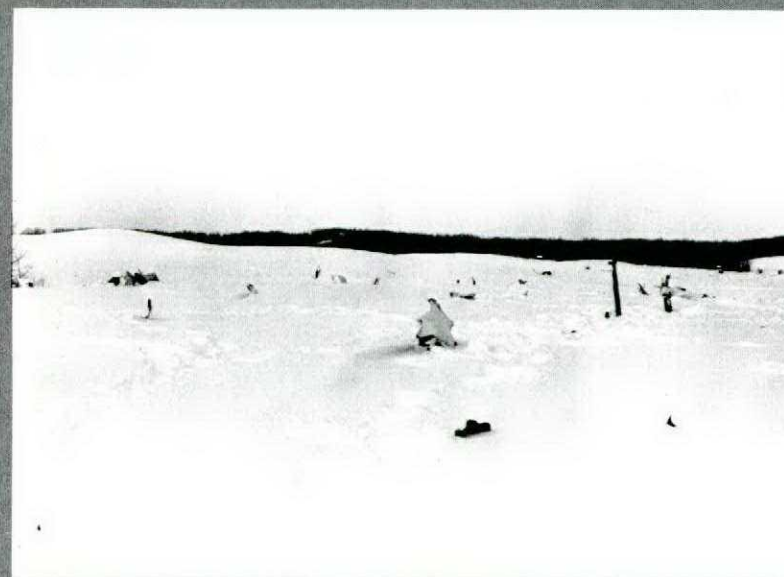
Pilot was last seen flying low-level in a heavy snow-storm...

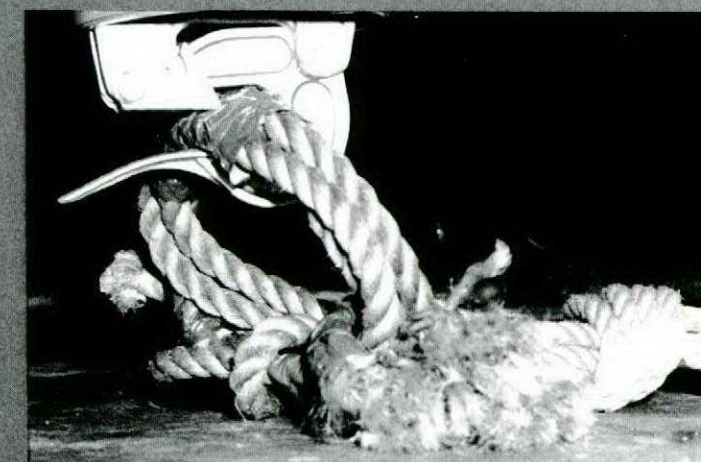
Sling-load was incorrectly attached - technician exposed to very severe wind-chill beneath helicopter.

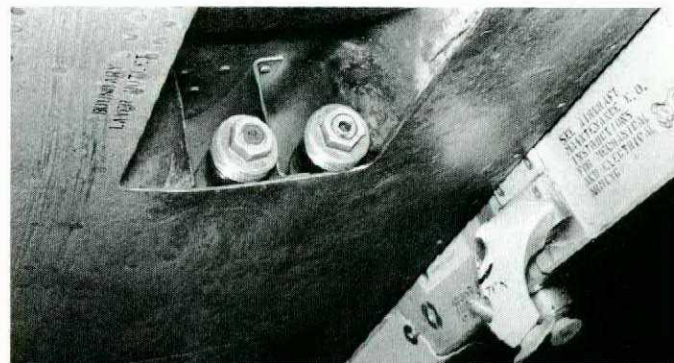
A badly-damaged cartridge holder was found halfway down the engine left intake; a second cartridge holder was lodged in the boundary layer control (BLC) intake. The cartridge holder access door was open and the cartridges missing. It was evident that they had been sucked up the BLC duct in the reverse flow from the outlet and one had entered the engine. This explained what happened - but not why.

The two cartridges were stowed in the duct because it formed a convenient shelf...

After the occurrence, the door was still not noticed until the aircraft had been returned to the hangar. The unit recommended painting bright orange the part of the rack covered when the cartridge access door is closed. Also, another proposal was to include a complete re-certification check as part of each Supp I check, which would mean that the Supp I check must be done by uninterrupted checklist. EOs will be amended.

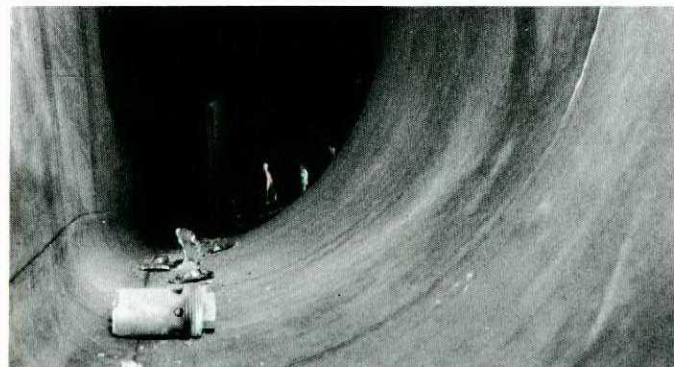
On the run-up prior to takeoff after a few seconds at 95% the CF104 pilot heard a very loud bang; the rpm then wound down. The rumbling continued until the engine stopped rotating. In both intakes there were damaged blades and the nozzle area was covered with fine metal particles. Compressor blades were found on the runway as far as 150 feet in front of the aircraft.

The aftermath - a severely damaged J79.

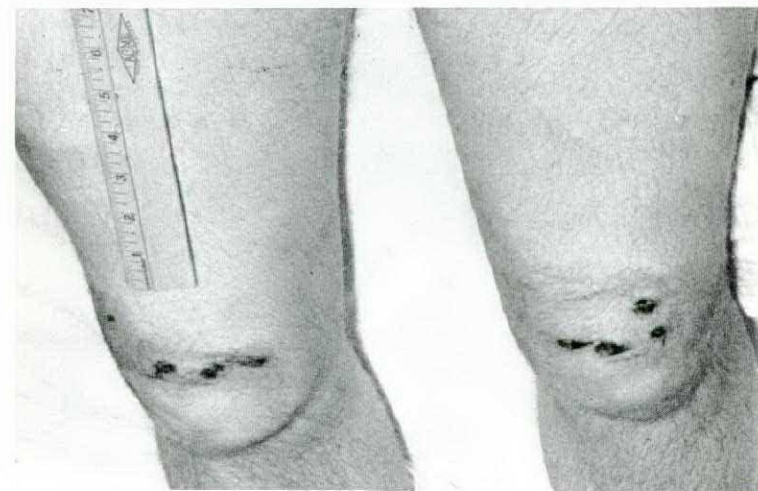
Flight surgeon: I'm not trying to baffle you with facts and figures, but let's look at our ejection experience. Since 1952, of the 60 successful T33 bailouts six pilots suffered "minor" knee injuries from striking the front windshield frame. Here's a photo of a typical T33 ejection knee

injury. The puncture wounds you see were caused by the upper windscreen bolts and the defroster tube bolt; you will note that they are more than one inch above the kneecap. The pilot had slumped considerably in the seat on ejection; his thigh length was only 23 inches. In the proper ejection position - with lapbelt tight - pilots with thigh lengths up to 27" would have cleared the frame. Three other pilots had similar injuries - all due to slump, as their thigh lengths were less than 24 inches. We have little data on the remaining two ejection knee injuries; one was a pilot 6'1" who suffered a "cut on the knee"; the other was 5'8" and received "bruised kneecaps".
