FLIGHT COMMENT

MARCH • APRIL • 1971

Comments

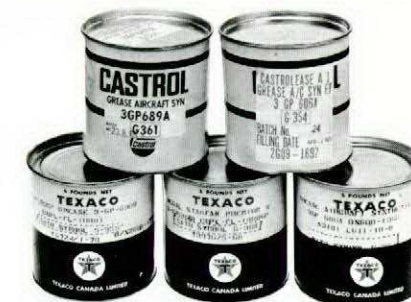
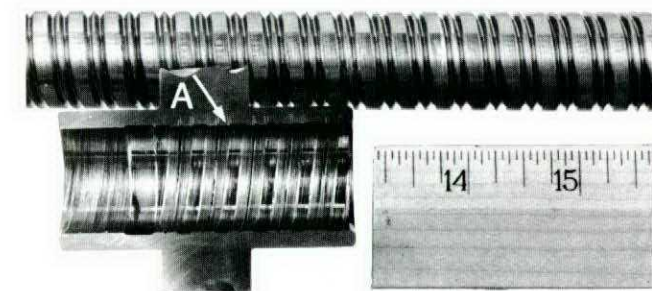
On the ground, an inspection of the flap located the problem in the screw-jack assembly, which they found stripped of its threads. The assembly was removed and forwarded to QETE for analysis in the metallurgy lab.

Buffalo screw jack actuating screw and the sectional aluminum-bronze mating female thread. Arrow points to the worn area of the V-thread.

Pitted face of the
screw jack
actuating screw.

Did someone decide that a substitute was in order because the proper grease was not available from oil stores? Or was the wrong grease in the right can? Had this failure occurred just at lift-off or just prior to touch-down, the consequences could have been tragic. Hopefully the incident will create a greater awareness of this inherent hazard. Careful checking to ensure you are using the right lubricant should be SOP.

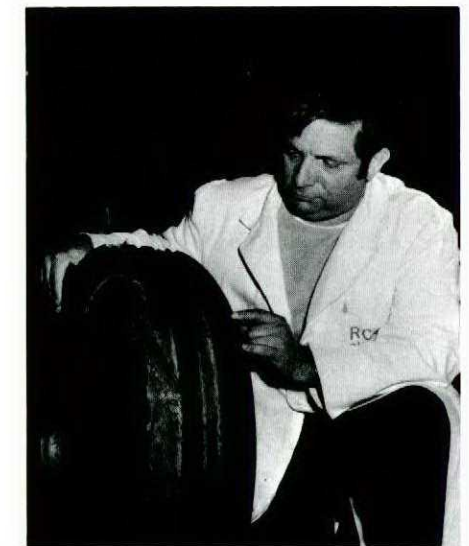
Technician Paul Legault examining a CF101 mainwheel tire which failed on its first takeoff. Failures of this sort led to the development in QETE laboratories of a method and the necessary equipment for detecting poor adhesion between tire plies. In this case the failure resulted from poor adhesion between the tread material and the fabric of the tire carcass.

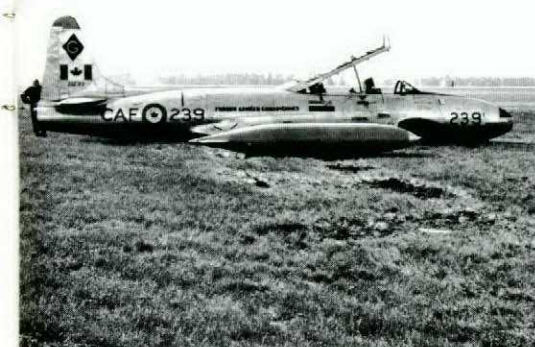
T33, LOSS OF CONTROL ON TAKE-OFF The aircraft was number two, flying echelon left on a two-plane formation. During the latter part of the roll the pilot encountered dif-

ficulty maintaining directional control, and as the formation was becoming airborne he found himself overlapped on the lead with his right wing down. To avoid a collision, he pulled up and passed over the lead, but during this evasive action, the aircraft stalled. To recover from the stall, he had to set the aircraft down in the infield - on the right side of the lead. The pilot now found that he was heading straight for a taxiing aircraft, so he selected the landing gear up. The aircraft came to a stop in the infield between the runways. Investigation revealed that the pilot had lined up with only "a foot

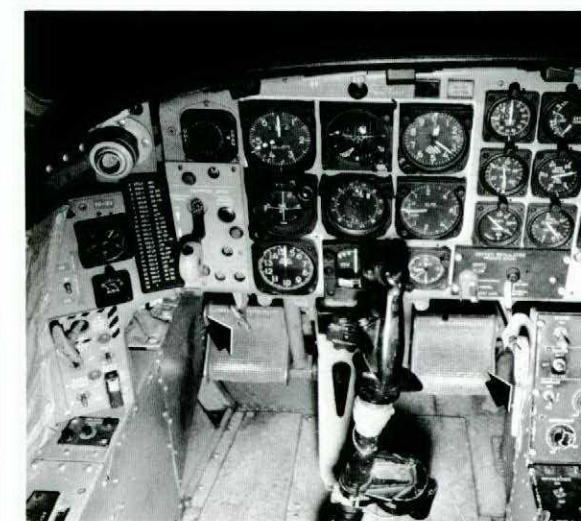
pilots to pull the wrong handle. Renewed efforts are being made to prevent such accidents. Pilots converting to the Tutor from the T33 are being given blindfold tests. As an interim measure the canopy jettison handle has been fitted with a paper shield to warn pilots that they are about to jettison the canopy.

Parking brake handle, left canopy jettison, right.

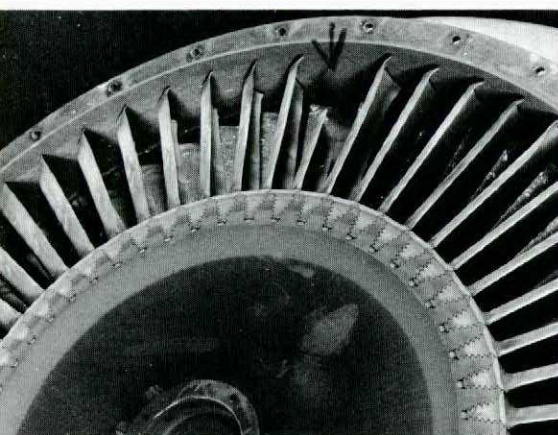
T33, OVERTEMP The pilot's uneventful cross-country was interrupted by a loud bang as he was cruising along at FL270. The bang was followed by a light airframe vibration, but otherwise all indications were normal. The pilot obtained clearance to descend, levelled at 8000 feet and completed the flight to his destination at a reduced airspeed. The vibration continued until he shut down the engine.
