FLIGHT COMMENT

JANUARY • FEBRUARY

1972

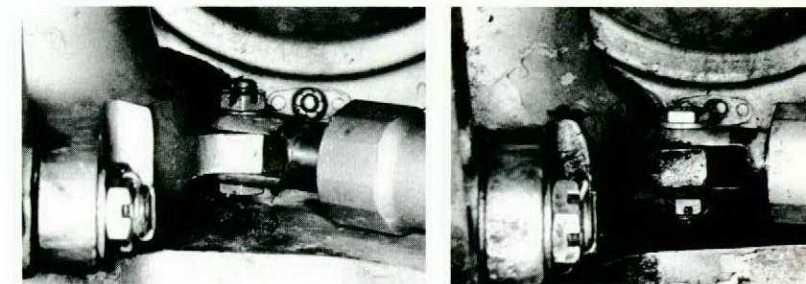
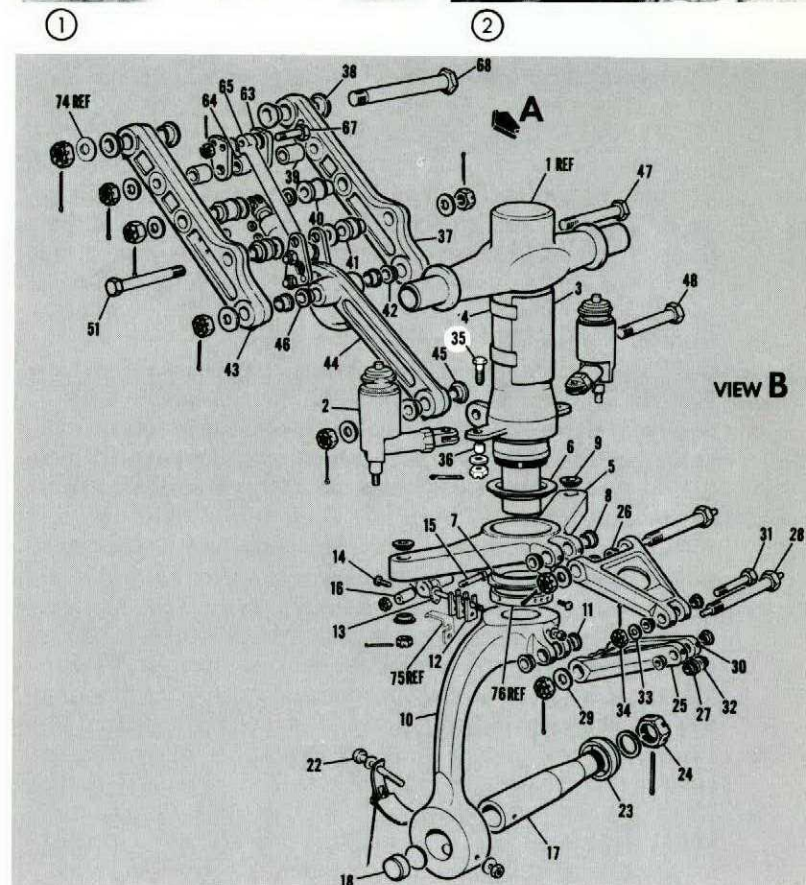
Figure 70 (Issue 1) Nose Landing Gear Strut

Landing away from home in a crosswind recently, one of our SOsFS noted that his T33 required extra left brake to keep straight, and that this condition persisted while taxiing in. Investigation revealed that the threaded end of a bolt which holds the shimmy damper in place had been rubbing against part of the nosegear. The resultant friction prevented the nosewheel from centring.

- Dash-four parts lists must never be construed as authorities for configuration or assembly methods - only the dash two contains this authority.
- Be alert for hardware items with special part numbers - they're designed for a special job, which may mean they've got to be installed in an unusual way.

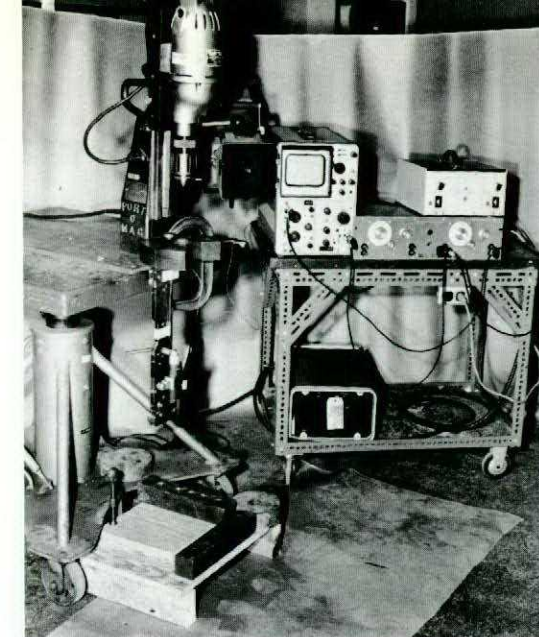
Vibration test of bomb rack. The unit functioned perfectly under heavy vibration when loaded with a dummy torpedo.

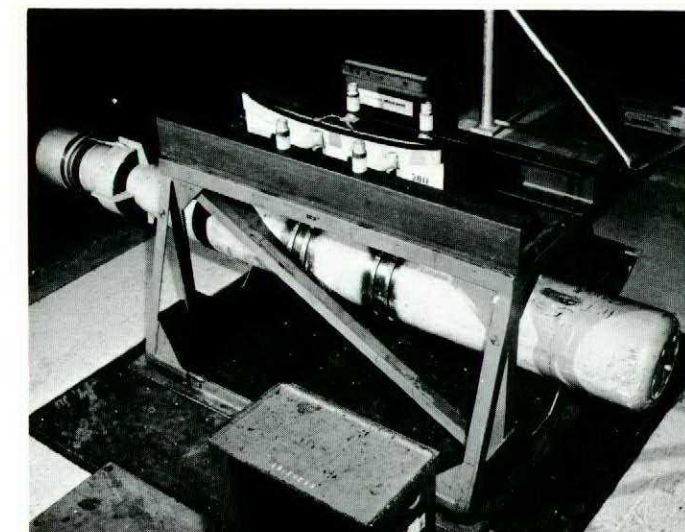
Set-up used in developing a drop test to detect faulty bomb release units in the field. A combination of floor materials and drop height was found which would trigger the faulty release while not affecting serviceable units.

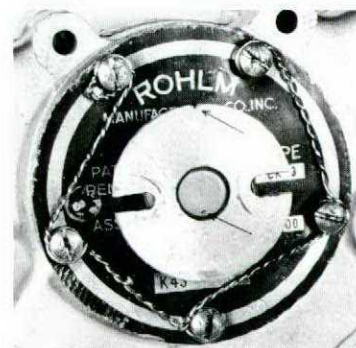
"Murphied" selector

DAKOTA, "MURPHIED" FUEL SELECTOR
The pilot was surprised to find both main fuel tanks almost full at the end of a flight, since these tanks had been selected "on" for most of the trip. His first reaction was to suspect the fuel gauges, however a dipstick check confirmed that the tanks were indeed full. Turning to the fuel selector, it was soon found that the selector had

Correct installation: The punch mark on the cam shaft matches the position of the v-notch on the driver plate.

While the problem is being corrected, messages have been sent to all operators advising them of the situation.
