FLIGHT COMMENT

MARCH • APRIL 1972

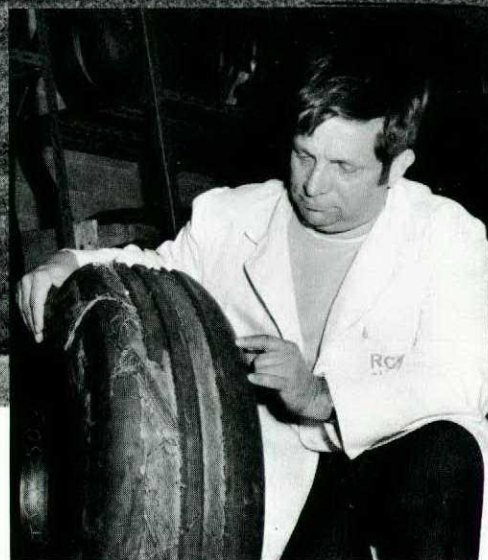
Photo #1

CF101 main wheel tire failure. The ribs of this tire were torn off during the first landing. The adhesion between the first reinforcing ply and tread material was found to be low, and was probably the cause of failure. In the latest procurement specifications the Canadian Forces have stipulated minimum values for adhesion between the various components.

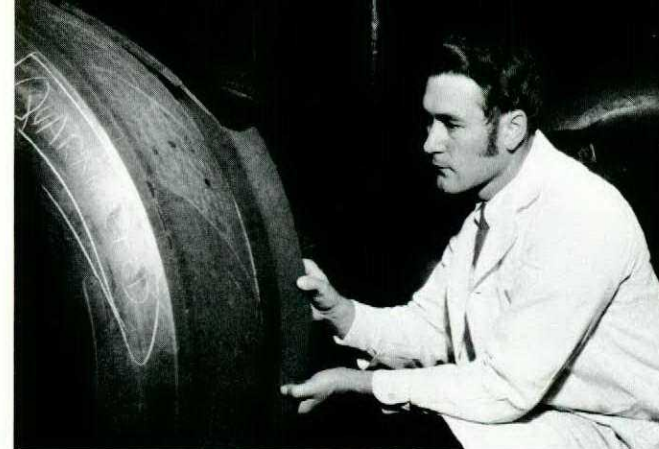
Photo #2

Hercules main wheel tire failure. The tread material of the tire separated from the carcass ply. The failure was caused by low adhesion between components. During service the tread material and the carcass delaminated and the tire failed due to tearing-off the ribs of the tire.

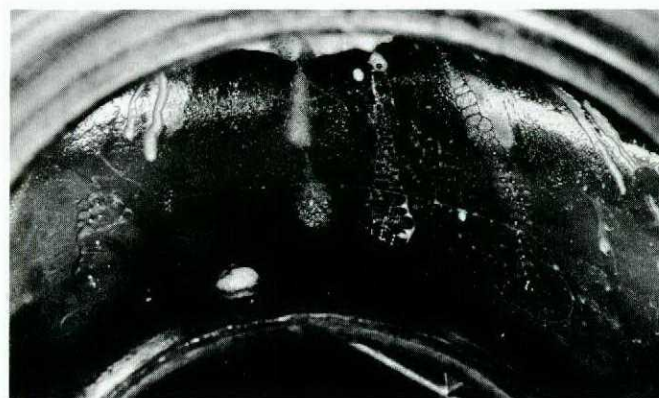
Photo #3

Buffalo main wheel tubeless tire failure. Interior surface of the tire, which should be the air barrier of the tire and serves as a tube for the tire, shows air leakage. Every group of air bubbles indicates a spot where the interior layer of the tire leaks. Tubeless tires which show air leakage are unserviceable.

Similarly to the adhesion requirements, the QETE Rubber Laboratory has proposed air permeability tests on tubeless tires to improve tire quality. By the application of this air leakage test, the air retention characteristics of a particular tubeless tire were determined and the Rubber Laboratory was able to prove the inadequate quality of the inner layer of this tire, (see photo no. 3) which must be replaced with good quality rubber

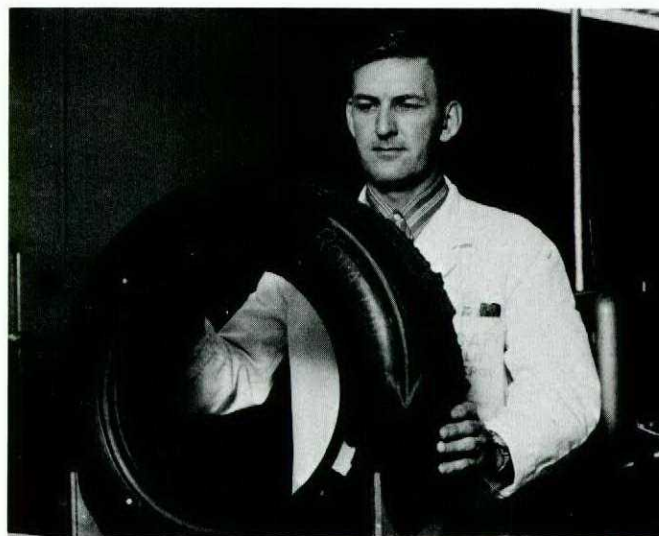
Photo #4

In some cases, however, such as hydroplaning, (see photo no. 4) the Rubber Laboratory is unable to help reduce tire failures. It is well known that hydroplaning is caused by a combination of factors, including the speed and the thickness of the water layer covering the runway. Hydroplaning may be reduced only by the care and skill of the pilot.

T33 main wheel tire damaged by hydroplaning. This phenomenon cannot be controlled by the quality or by the design of the tire.

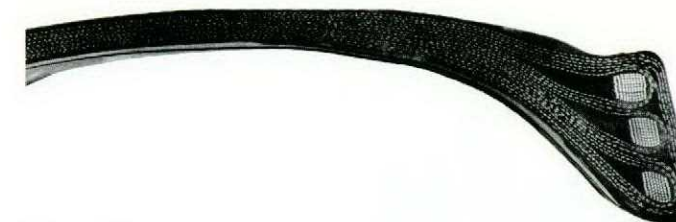
Photo #6

Properly designed Hercules main wheel tire. The number of carcass plies was increased and three wire bundles were used in the bead instead of two.

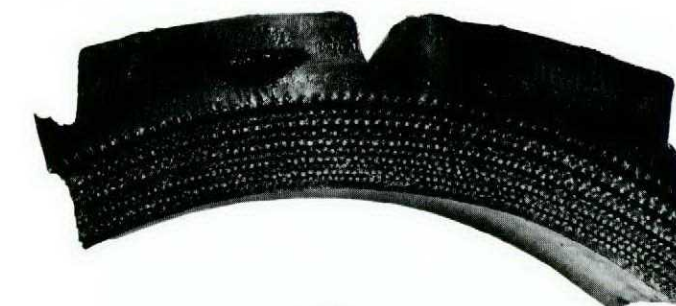
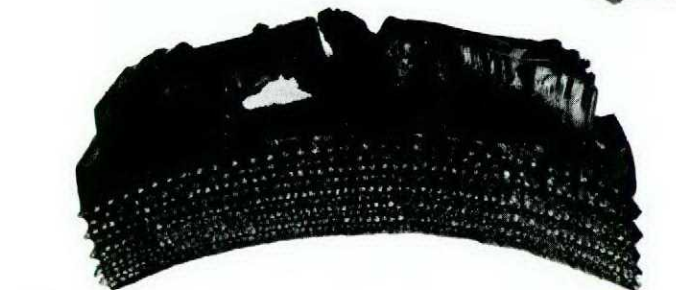
Photo #7

Photo no. 7 shows sections of T33 main wheel tires which failed the dynamic test because of overheating of the crown area of the tires, due to faulty retreading. In this case the QETE Rubber Laboratory, in close cooperation with the manufacturers, were able to suggest corrective action and now the retreaders are able to supply properly retreaded tires.

Sections of T33 main wheel tires. Both tires failed during dynamic test. The failure was caused by excessive heat which developed in the tread material of the tire. The upper tire section was taken from a tire which failed because of inadequate ventilation provided by the narrow groove. The lower section was taken from a tire which had entrapped air bubbles initiating excess heat and blowing up the crown of the tire.

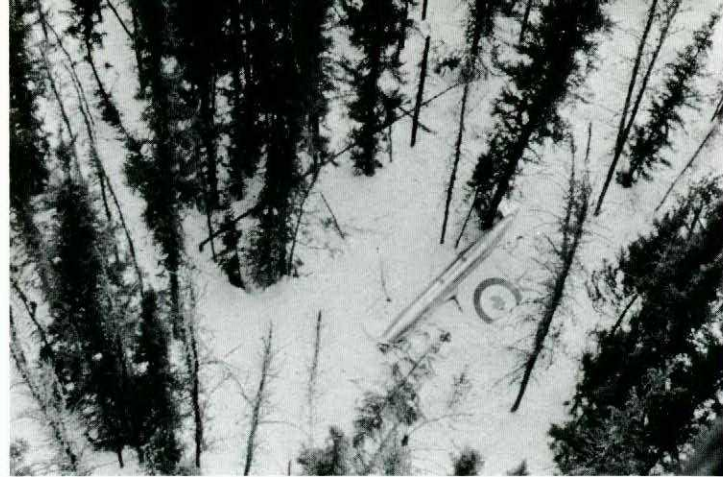
The right outer wing portion and tiptank as first sighted from the air.

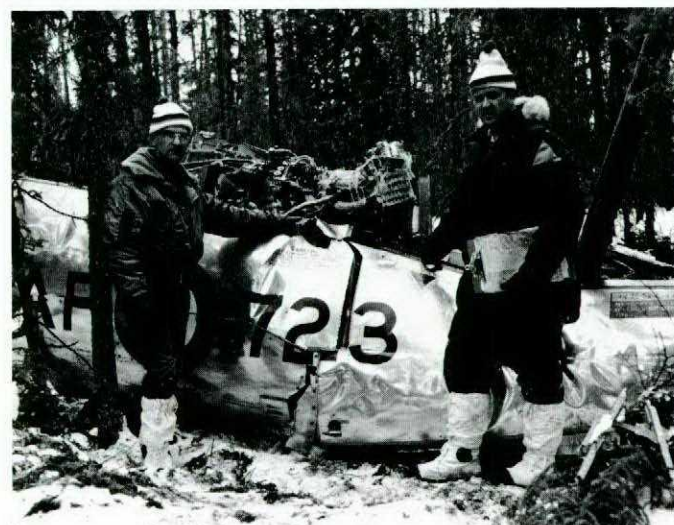
The Technical Member of the Board, Capt G.P. Grant (left), examines the cockpit section with Capt Rumbold.

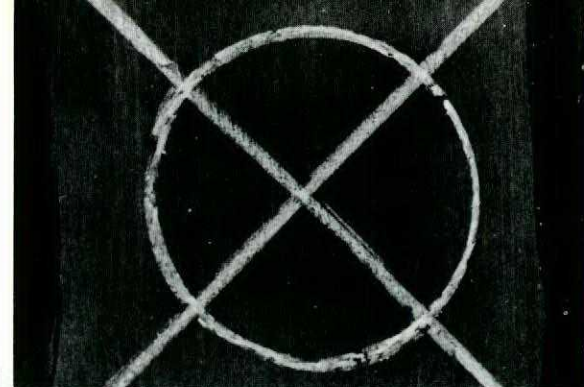
Photo 1 Alodized Panel - Grease Pencil - 20 hrs exposure showing no localized and minimal general corrosion.

The alodized 7075 panels marked with "Magic Marker" and grease pencil showed very little corrosion after 20 hours and were comparable to the unmarked control panel (photo 1). The panel marked with regular graphite pencil, however, showed definite localized corrosion along the marked lines (photo 2). When the period of exposure was extended to 64 hours, the localized reaction continued while no general corrosion occurred (photo 3). In terms of actual penetration, photo 4 shows the 0.0005" penetration typical of the localized pitting after 112 hours. After 300 hours exposure the corrosion became less localized and pitting depths reached as much as 0.004 inches.

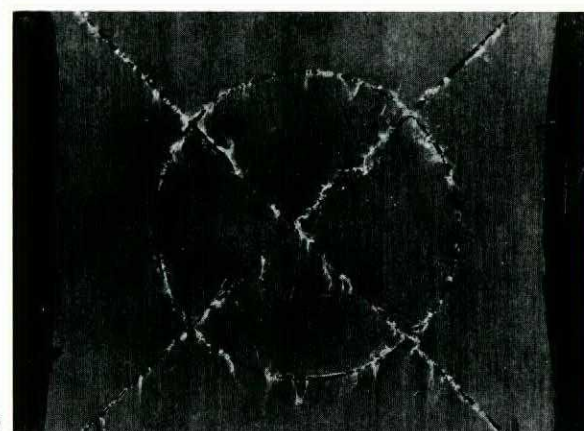
Photo 2 Alodized Panel - Graphite Pencil - 20 hrs exposure showing localized corrosion along the scribed pencil lines.

barrier layer due to the hardness of the pencil; or some combination of these effects. The QETE conclusion: graphite pencils do represent a corrosion hazard when used on high strength aluminum alloys; accordingly, their use should be forbidden.

Amendments to EO 05-1-2AU and EO 05-1-3/21, are being printed, stating that grease pencils are to be used. Meanwhile, all aircraft publications are being reviewed in order to delete any reference to the use of graphite pencils for marking out repair areas.

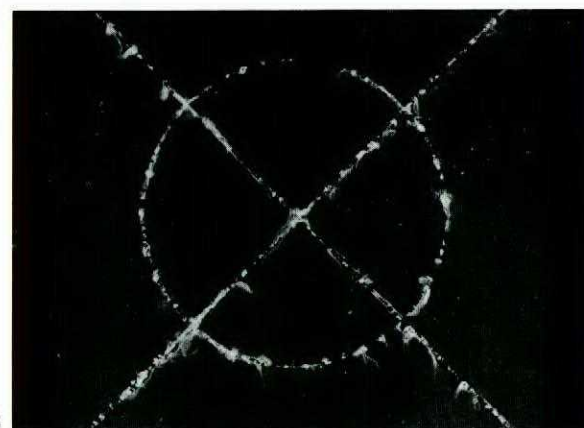
Photo 3 Alodized Panel - Graphite Pencil - 64 hrs exposure showing more severe localized corrosion and minimal general corrosion.
