FLIGHT COMMENT

SEPTEMBER OCTOBER
1974

T33 Parachute Pack Failure

The Story of UCR No. 4208/A37

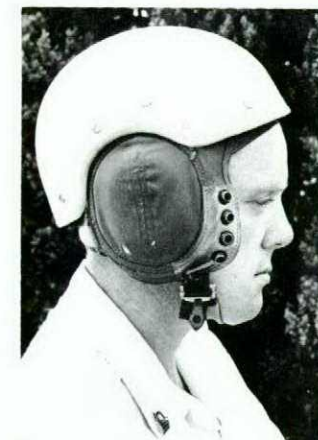
Basically a poorly fitted helmet is too small or too large. The symptoms of a helmet which is too small, photo 1: the dual visors will not meet the oxygen mask; the rubber beading on the back edge of the helmet is worn off; the helmet is perched on the top-back of the head; the inner is tight around the forehead and the buckles on the suspension straps are digging into the scalp. The helmet is uncomfortable.

Photo 1 Too small

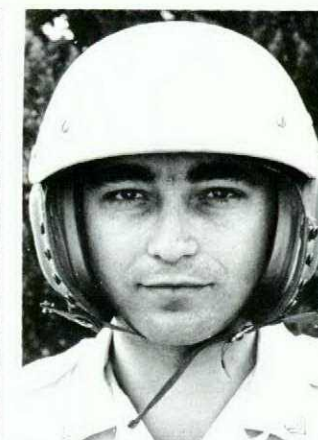
Photo 2 Too large

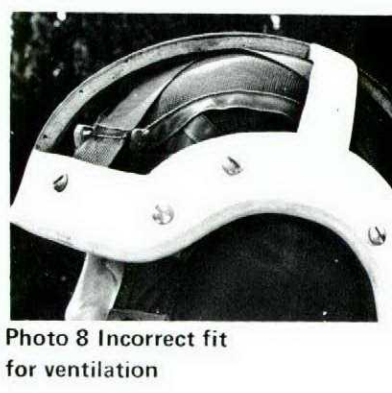
Photo 8 Incorrect fit for ventilation

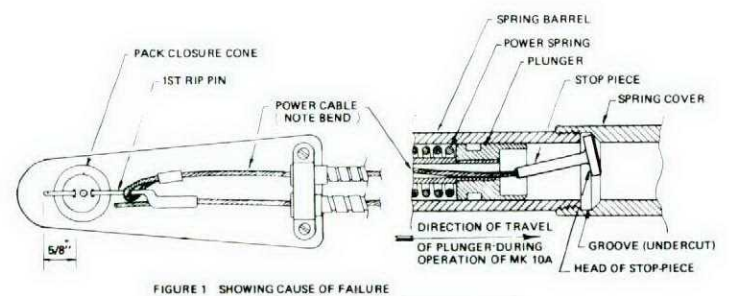
The U.C.R. referred to damage marks observed on the groove in the spring cover and on the stop piece, which is fitted to the end of the power cable. Examination confirmed that the marks were present and this supported the statement contained in the U.C.R. that the stop piece had struck the spring cover when the MK10A opener was activated and jammed in the groove, thereby preventing normal operation of the system.

The partly withdrawn rip cord pins allow the power cable to move to the extent that the stop piece escapes from its location in the plunger. The bend in the cable causes the stop piece to deflect into the groove in the spring cover.

With this set of conditions created on the subject pack assembly, the MK10A was operated and the plunger struck the stem of the stop piece and jammed it in the groove, thus preventing free ejection of the plunger to effect total withdrawal of the rip cord pins.

Subsequent examination of the stop piece and the spring cover revealed damage identical to that observed during the preliminary examination. This was evidence to support the almost certain knowledge of the cause of the original failure.

FIGURE 1 SHOWING CAUSE OF FAILURE
LEFT: RIP PIN PARTLY WITHDRAWN FROM PACK CLOSURE CONE
RIGHT: STEM OF STOP PIECE OUT OF ALIGNMENT WITH PLUNGER AND HEAD OF STOP PIECE FOULING GROOVE

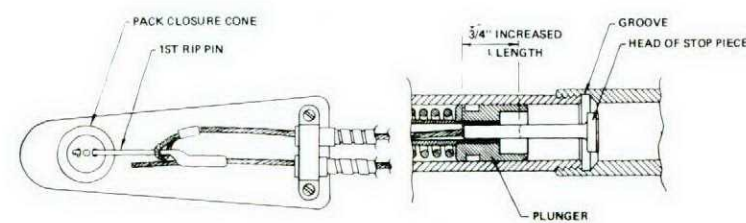
FIGURE 2 SHOWING EFFECT OF MODIFIED STOP PIECE
LEFT: RIP PIN ALMOST TOTALLY WITHDRAWN FROM PACK CLOSURE CONE
RIGHT: EXTENDED STEM OF STOP PIECE LOCATED IN PLUNGER ELIMINATING POSSIBILITY OF STOP PIECE FOULING GROOVE

Action is being taken which will involve the introduction of a redesigned stop piece to increase the length of the stem by 3/4 inch. Such an increase in length will ensure that the stem cannot possibly come out of its location in the plunger even if the rip cord pins are minimally engaged in the pack closure cones, (Figure 2). As an additional safeguard, a larger chamfer on the front edge of the head of the stop piece is specified.

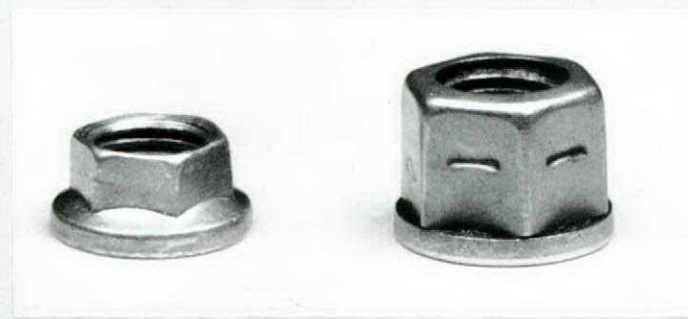
Could you mistake the nut on the right for the one on the left? Someone did and installed an engine starter with six of them. The correct nuts (left) are self-locking but the others are not. Consequently they all backed off allowing the starter to come loose. Fortunately the problem was discovered during the DI before any damage had resulted.
