FLIGHT COMMENT

THE FLIGHT SAFETY DIGEST OF THE CANADIAN ARMED FORCES

No 2 1979

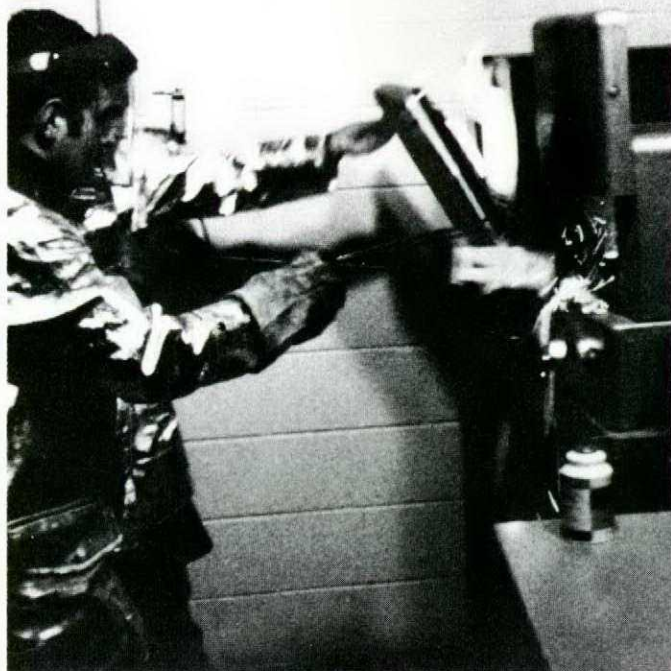
Our subsequent involvement came about when the same item was again found to be failing. This mechanical logic component had been heat treated close to its impact sensitivity region and was failing in brittle fracture. Now we become involved in a complete engineering study of the mechanical logic components of the QRB system. What had not been clearly delineated in the initial investigation (1) was that severe hydrostatic pressures were generated at the head of the pin component such that regardless of the hardness or the composition of the pin mechanical deformation, leading to mushrooming of the head, was going to take place with consequent lock-up and failure. Thus instead of curing one problem by changing the material, an additional problem had been created. This material known as AISI M2 tool steel is predominantly selected for its excellent hot hardness in machining applications. The high hardness of Rockwell Rc 61-63 had been chosen by the manufacturer to overcome the head deformation problem and to ensure a hard wearing component. In this case a better approach is to use a more ductile material and surface harden to achieve good wear resistance.

FIG 1. Heat treatment of M2 tool steel at 1100°C to draw QRB locking pins to Rc55 prior to machining to new design.

Because of the nature of the problem and long lead times involved with procurement of an all new pin a salvage programme was devised to upgrade the present stock of M2 pins to a desirable degree of toughness without compromising their wear resistance to a significant degree. The design was changed to accommodate the severe hydrostatic pressures and function testing of 1000 cycles carried out. It was of note that the majority of wear seen on this item, occurred in the first few cycles; the new designed pin is shown in Fig 3 (2).

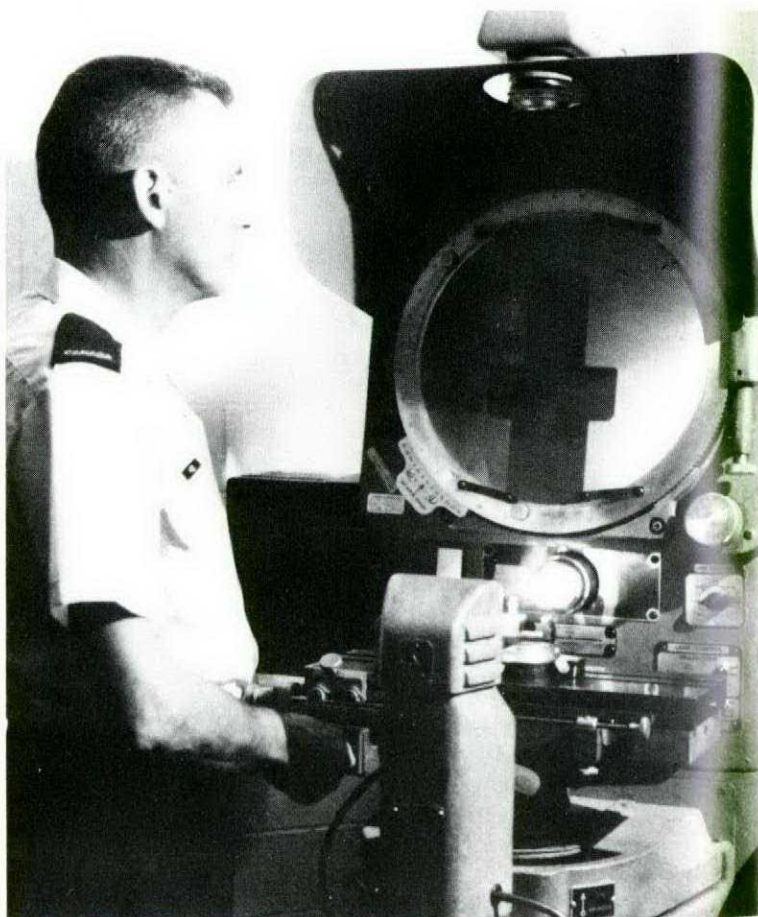
FIG 2. Checking pin profile for compliance with drawing dimension requirements on an optical comparator.

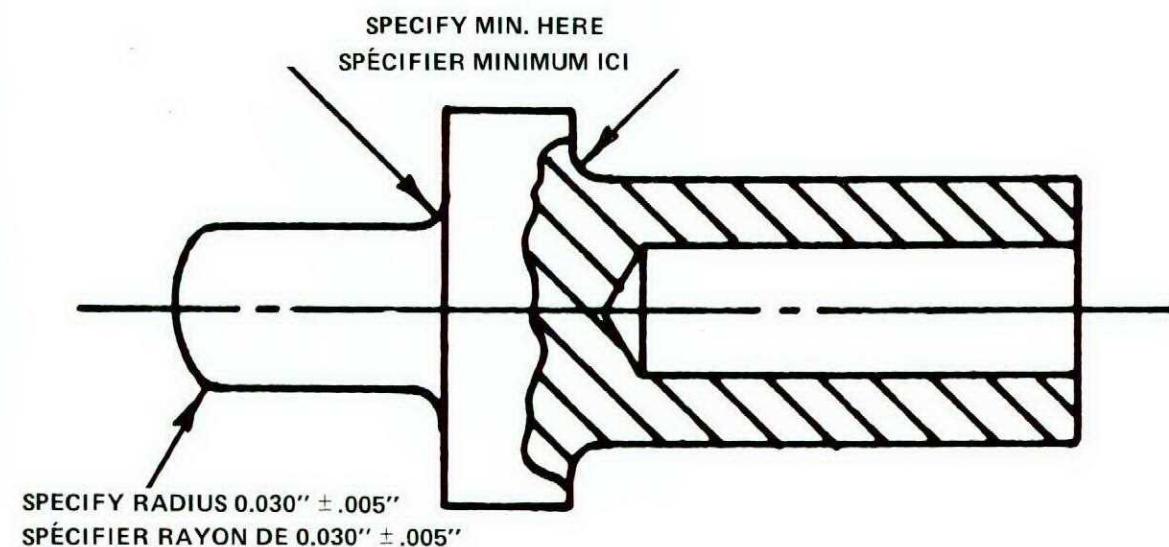
PIN LOCKING ID-54-275
TIGE DE VERROUILLAGE ID-54-275

FIG 3. QRB locking pin redesigned to eliminate "mushrooming" and lock-up.

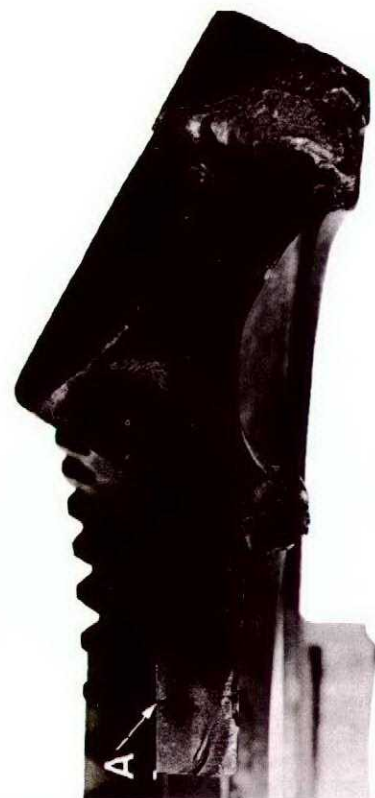
Some three years ago a Canadian Armed Forces Aircraft was lost with all the lives of its complement of men. Subsequent work revealed that the craft had crashed due to the failure of a gear component. Classic fatigue features were seen on the fractured gear Fig 4. Subsequent fractographic and metallographic data revealed that the initiation site was an aggregation of non metallic inclusions. X-ray analysis of this material showed that there was a strong probability that they arose from the original material manufacture, Fig 5. Despite all the circumstantial and hard evidence found it was not sufficient to assume at that stage that this aggregate or raft of extraneous material was the prime cause of gear failure and subsequent aircraft loss. Most of the necessary ingredients were there to place this aircraft loss in the category of those few that can without a shadow of a doubt be attributed solely to a material problem, thus to become a classic of its kind (3). All there was left remaining was to determine if the extraneous material was of sufficient magnitude under the typical operating stresses of this component in the Canadian role for the aircraft in the area within which it was located to have initiated fatigue cracking. Strain gauging of a like gear in the appropriate location gave the stress levels at which this component operated in the Canadian content. It was then possible to calculate the minimum size defect likely to cause fatigue cracking to initiate by using fundamental data of threshold stress intensity values for the appropriate material from which the gear was made. It was calculated that the actual defect found was greater than the minimum required to initiate fatigue cracking and thus a high level of confidence was placed upon the cause factor for this aircraft loss.

FIG 4. Spiral bevel combining gear fracture face showing classic fatigue features, crack origin at 'A'.

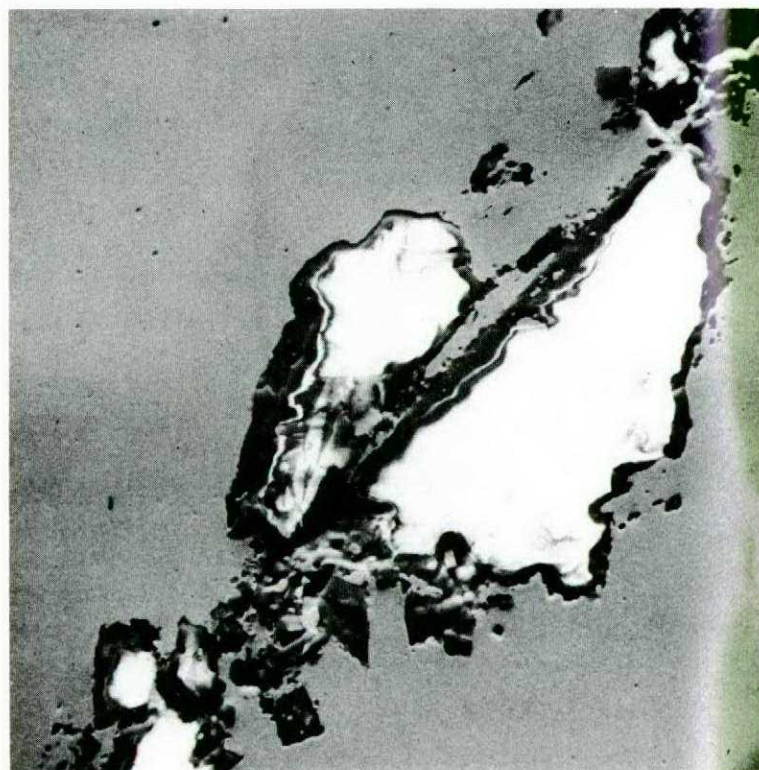
FIG 5. SEM image of non metallic aggregate seen using primary electrons that led to fatigue cracking.

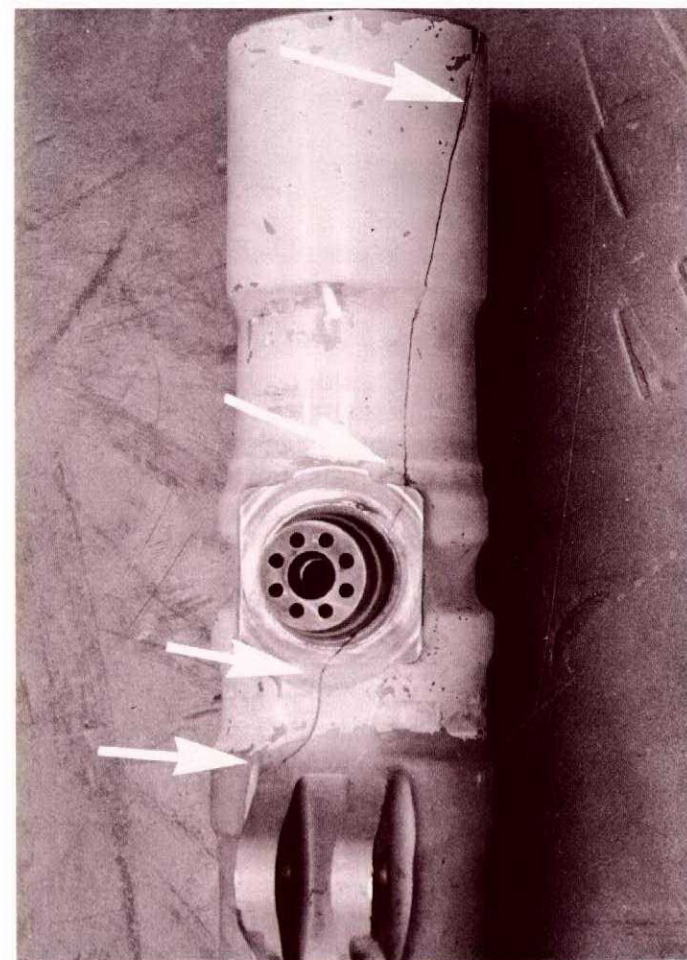
This was a nose landing gear cylinder that had failed on a STOL training flight under apparently ideal flying and landing conditions, Fig 6. The failure of this item had initiated at the trunnion boss from a small fatigue precrack, a second fatigue crack being found nondestructively approximately 180 degrees away from the crack at which failure of the cylinder initiated. As is often the case in such investigations close cooperation between a number of engineering directorates was necessary to coordinate and coopt the necessary expertise within DND

FIG 6. Nose landing gear failure initiating at larger of two fatigue cracks initiating from fretting damage at the transition radius of the trunnion. Total failure crack length was 15.5 inches.

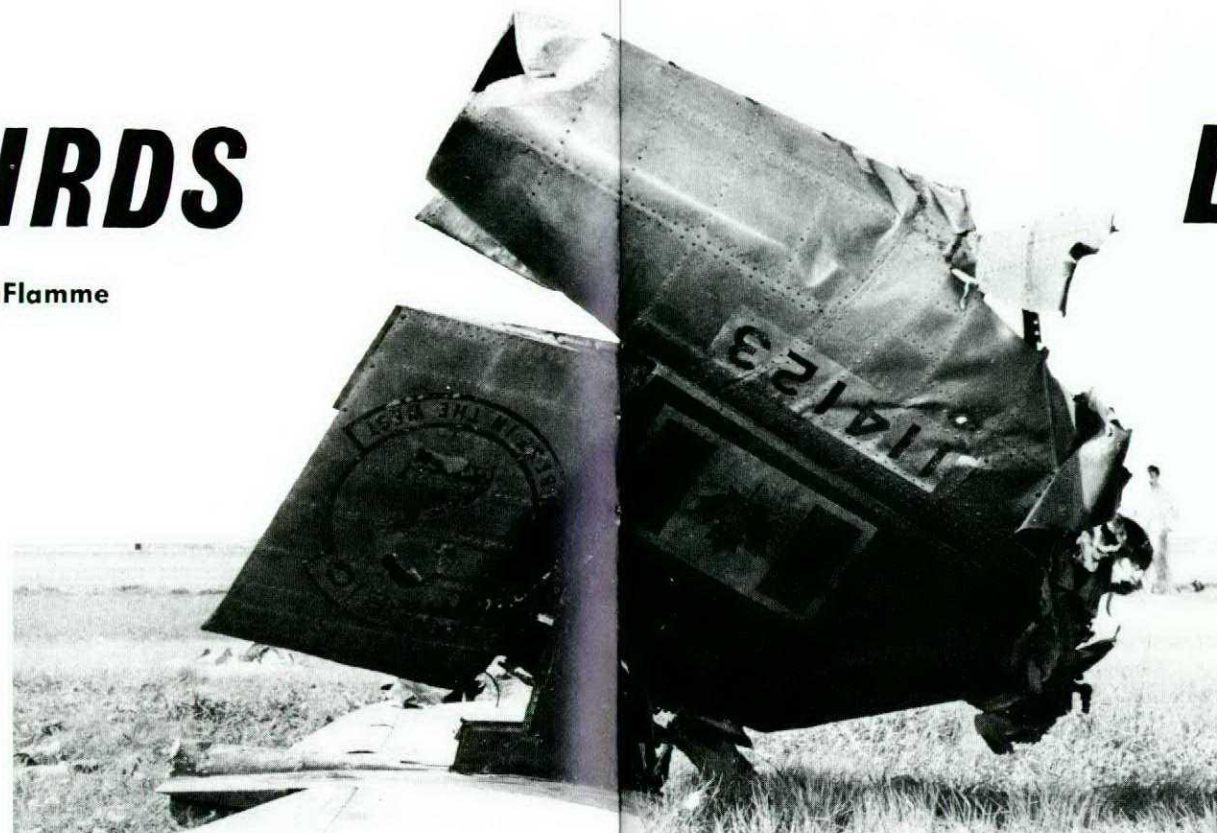
Tutor — Bird caused engine failure — No relight.
Tutor — Panne moteur causée par un oiseau —
Le pilote n'a pu rallumer.

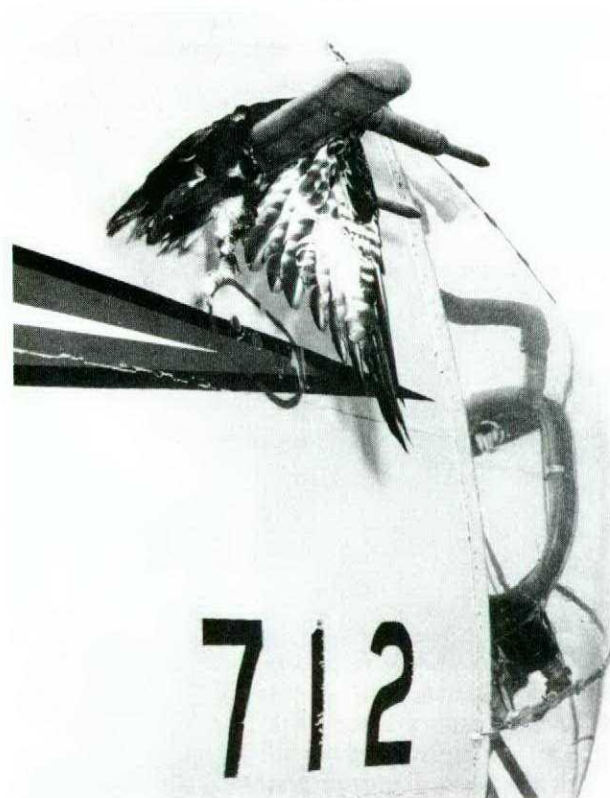
Argus — Birdstrike on nose on takeoff.
Argus — Impact d'oiseau sur le nez, heurt survenu au décollage.

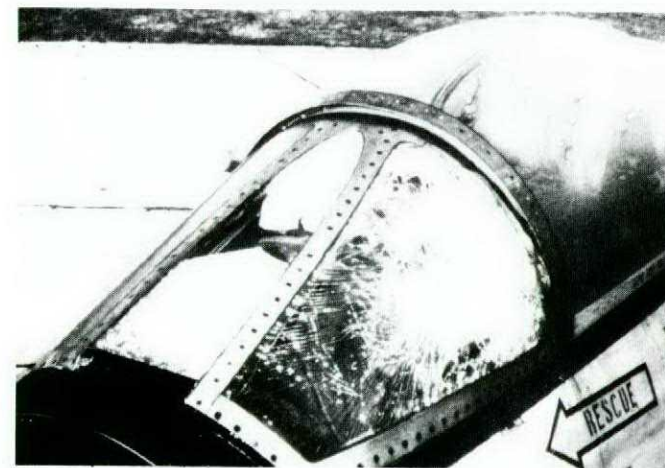
CF104 — Birdstrike at 420 KTS, 800 feet AGL. Pilot suffered cuts to face.
CF104 — Heurt d'oiseau à 420 Kt, à 800 pieds-sol. Le pilote a été coupé au visage.

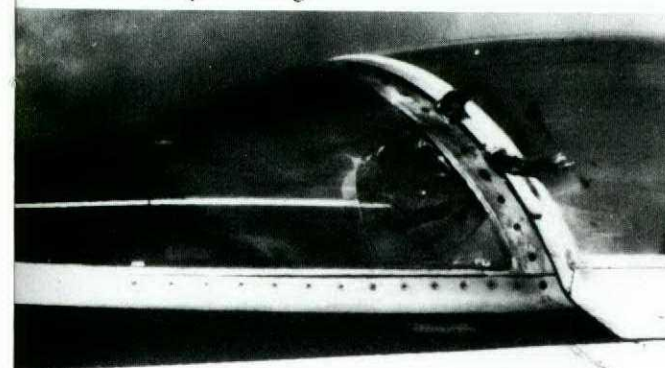
CF5 — Pelican strike. CF5 — Restes de pélican.

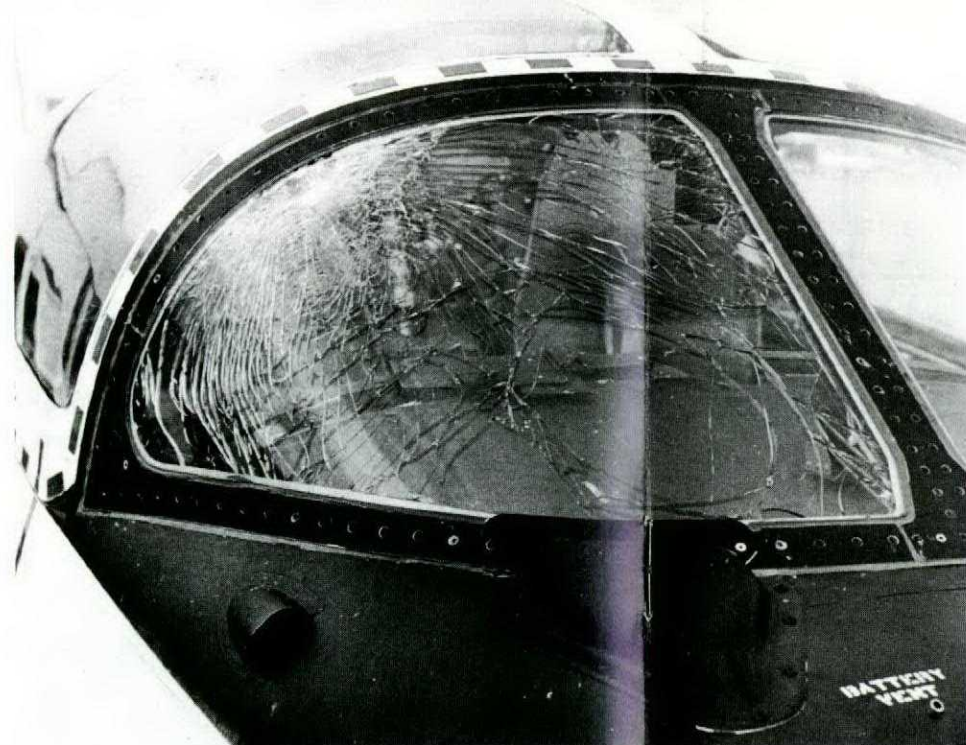
Tutor — Bird hit windshield at night. Pilot sprayed with glass but uninjured. — L'oiseau a heurté le pare-brise en pleine nuit. Le pilote n'a pas été blessé par les éclats de verre.

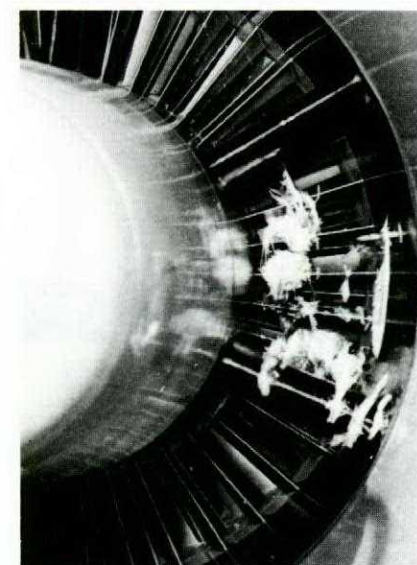
CF100 — Bird went in right engine. CF100 — Oiseau ingéré par le moteur droit.

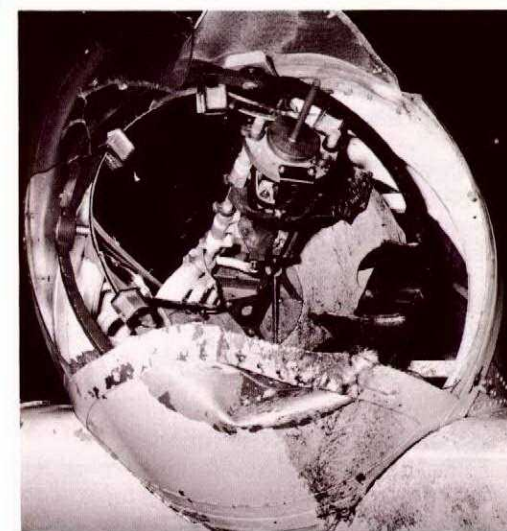
Tracker — Gull strike. — Restes de mouette.

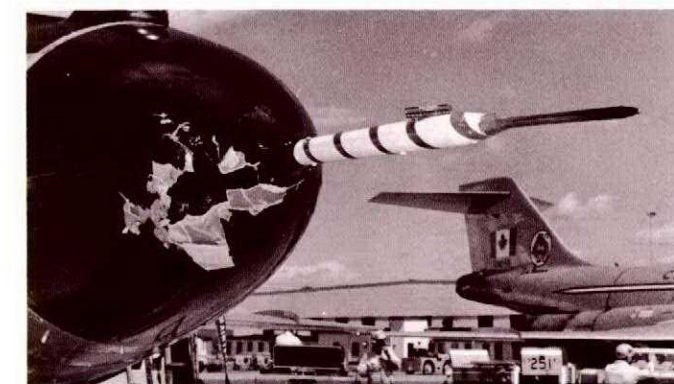
CF101 — Strike on nose. — Impact sur le nez.

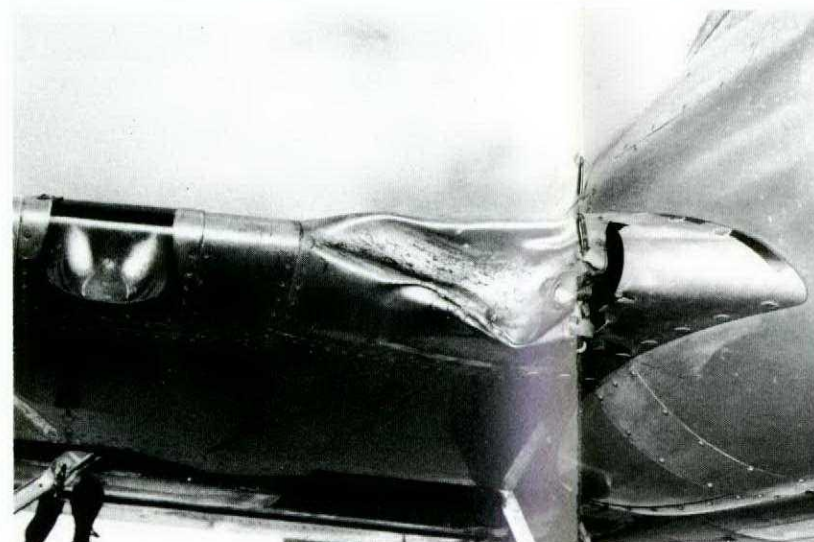
Tutor — Strike on wing root. — Impact au niveau de l'emplanture d'aile.

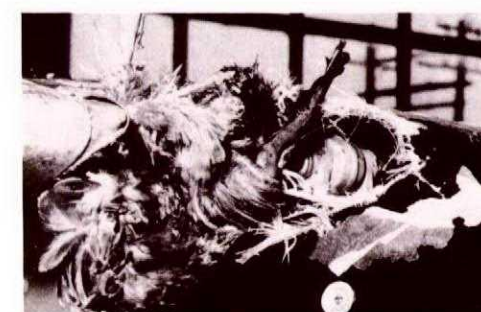
Tutor — Birdstrike on horizontal stabilizer. Tutor — Impact d'oiseau sur le stabilisateur horizontal.

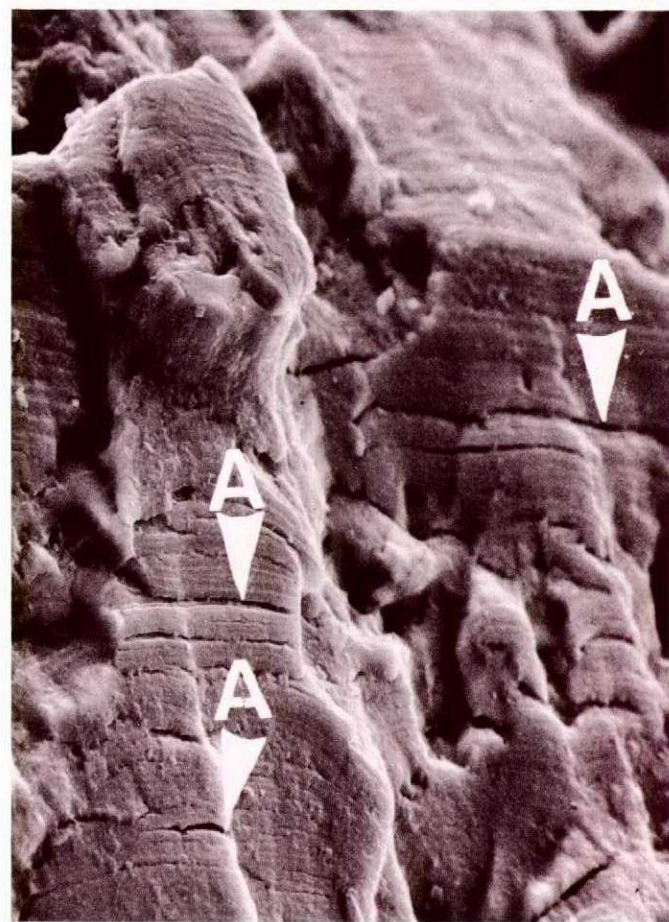
FIG 7. Scanning Electron Microscope fractograph taken at 1200X showing fatigue striae with auxiliary cracking indicative of high stress levels.

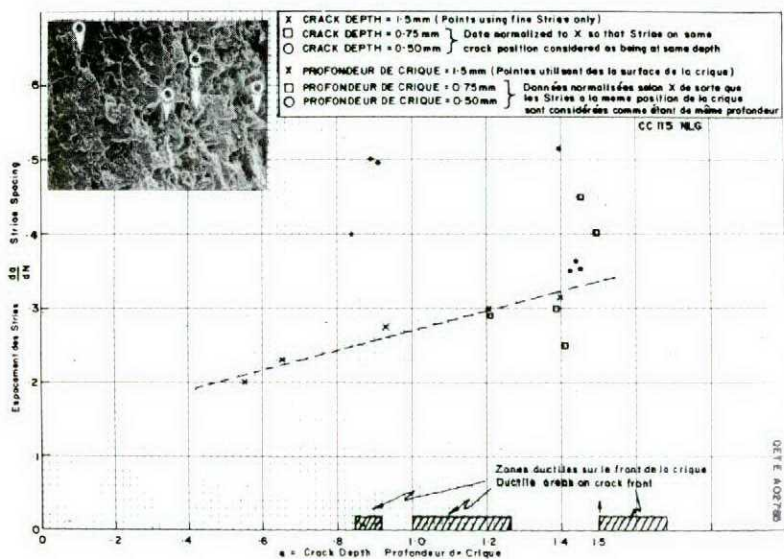
FIG 8. Shows the normal linear relationship for crack depth versus striae spacing with superposition of effects of periods of over-stress. SEM Micrograph inset at 1200X shows bands of over-stress seen on fracture face.

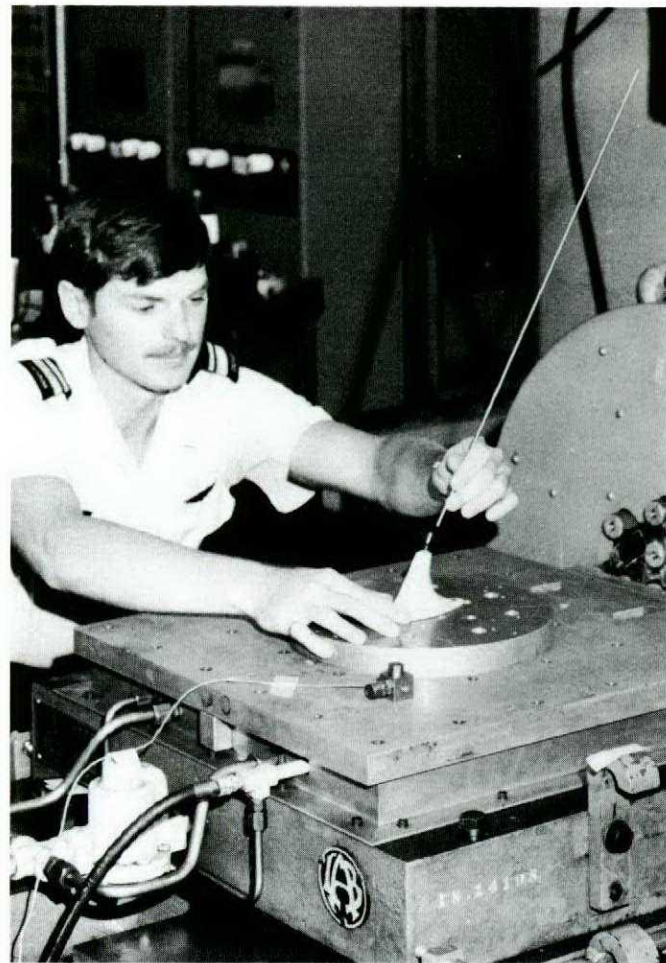
FIG 10. Failed DF 88 antenna after laboratory testing on the U.D. vibration machine 89B simulating actual service conditions.

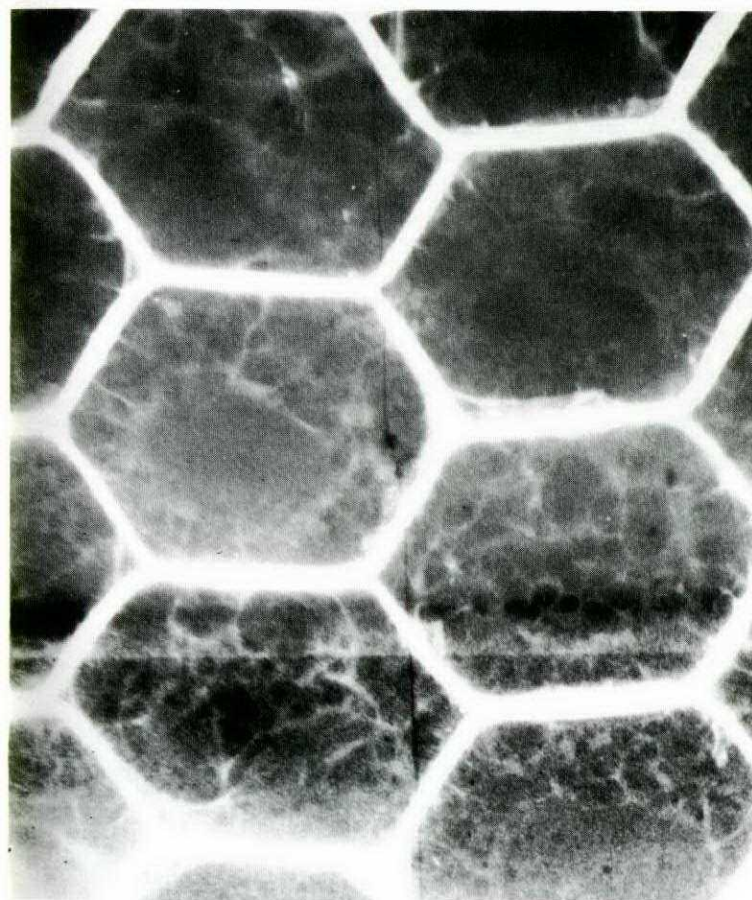
Such is illustrated by the enlarged photograph of a crack in a rotary rudder blade after re radiography, Fig 11. The QETE investigation found that the technique used on the blades was inadequate for reasons of too high Kv for detection of corrosion, which in this case had initiated the fatigue cracking, and for obtaining good sensitivity (7). As can be seen

FIG 11. Enlarged photograph of radiograph showing fatigue crack in skin of rotary rudder blade that was missed in field inspection. Corrosion pitting of skin and of S.S. honeycomb was also seen on the radiograph.
