National
Défense

FLIGHT

COMMENT

4/1995

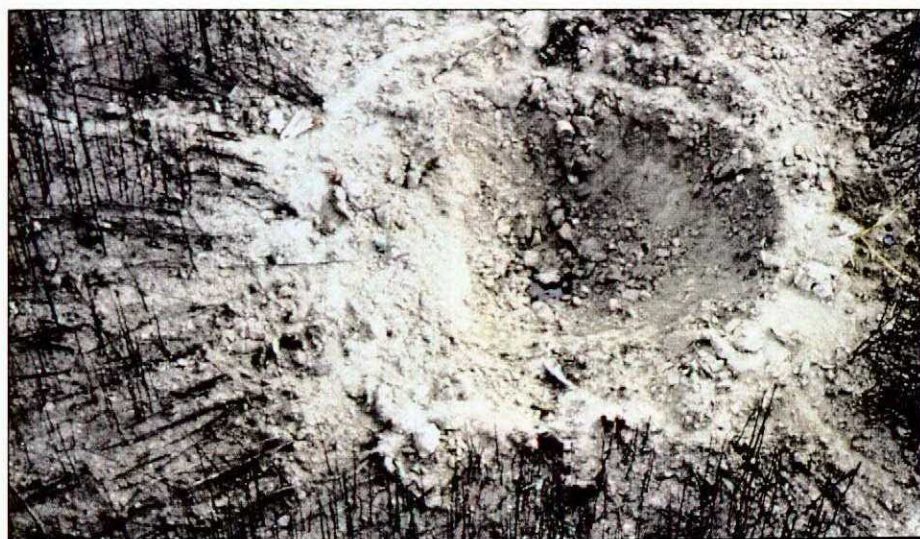
Aircraft impact crater.

simultaneous roll to the right which placed it in an inverted attitude. The aircraft then continued to accelerate as the pitch angle continued to steepen. At the time of impact, the aircraft was inverted with a pitch attitude

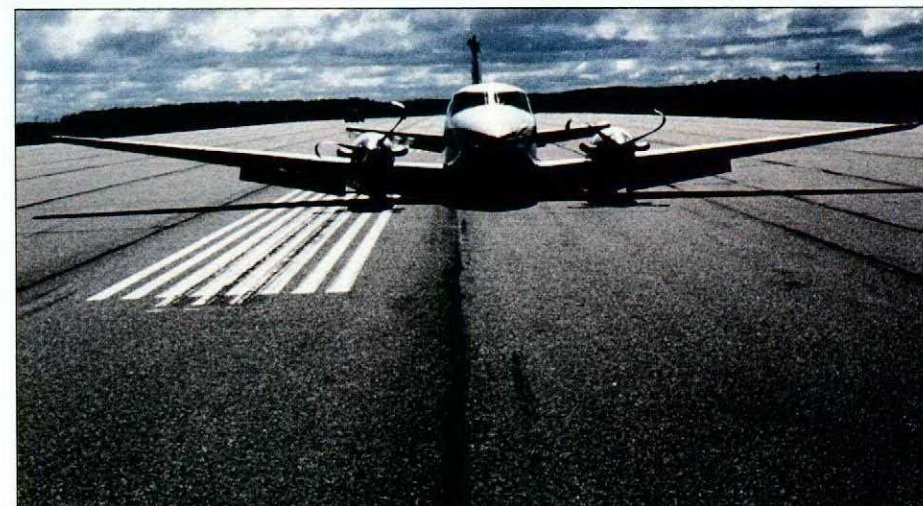
Front view, final resting place.

airspeed and full flap configuration to deactivate the weight-on-wheels switches, thus allowing the landing gear to begin the retraction cycle. The AC saw what had occurred and applied power in an attempt to overshoot. The airspeed was still too low for take-off and as the right propeller struck the runway the AC chose to abort. The aircraft settled onto the runway and skidded for approximately 800 feet. The crew carried out the emergency procedures and exited the aircraft unassisted.

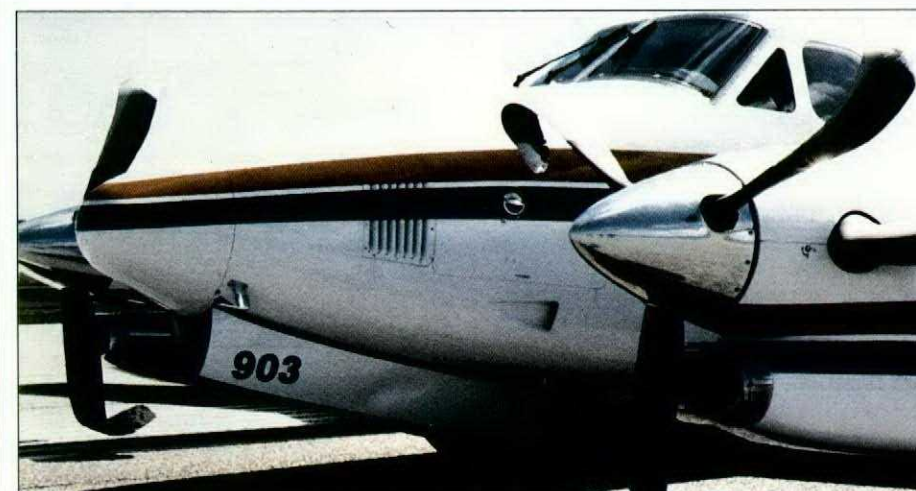
Close up of left side view.

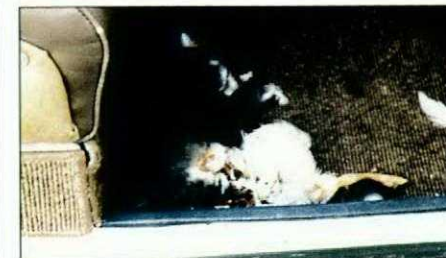
Student Stunned - Duck Dead

portion of the bird entered the cockpit, passed over the head of the student and ended up in the right rear seat. Windshield plexiglass fragments were all over the cockpit. The standards officer took control and determined the engine and controls were

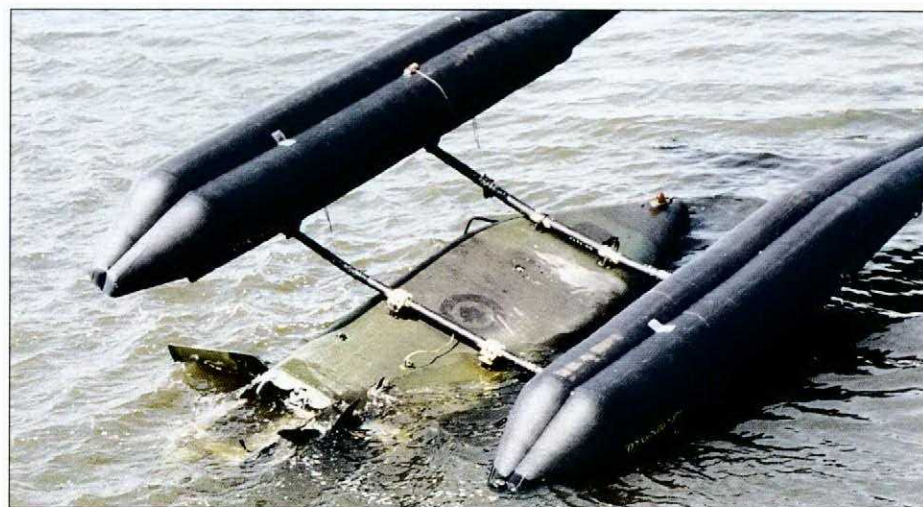
Wreckage as found.

copter was in a slightly nose-high attitude, banked approximately 40° to the right, and moving laterally to the right.

Damage to the main rotor blades suggests that they both contacted the water lightly with the white blade eventually causing a sudden deceleration as it was advancing. The white blade was bent around the mast and it entered the cockpit and contacted the instrument panel. It also sheared off the upper Wire Strike Protection System (WSPS), VHF-FM antenna, and damaged the upper hinge assembly of the right pilot's door causing it to depart the aircraft.

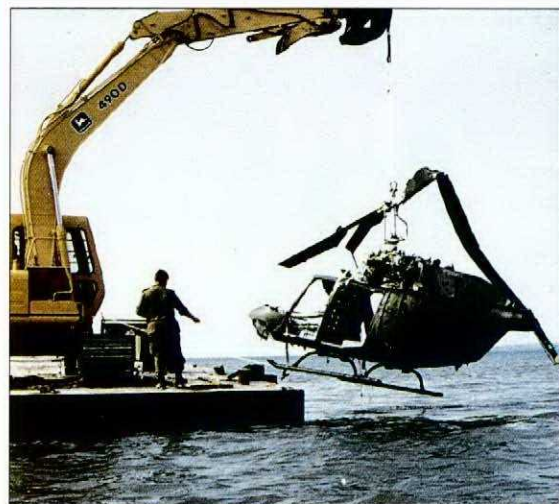
CH136213 being recovered.

The helicopter sustained considerable damage during the crash sequence. The upper roof support assembly and transmission were almost completely torn free. The tail-boom was bent to the left during initial contact. Damage to the right aft tube assembly suggests that the right float contacted the water as the heli-

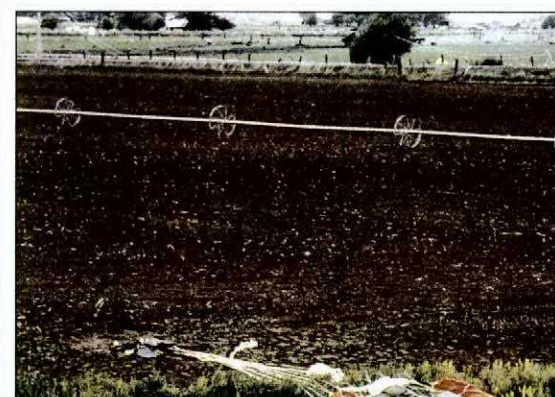
Landing zone of the pilot.

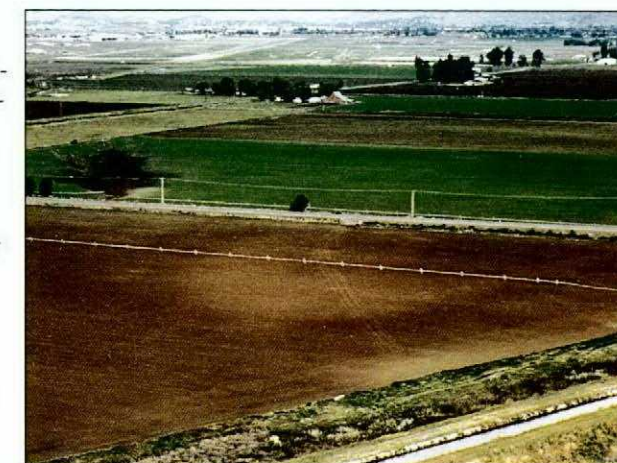
Crash site looking North, destination aerodrome in background.

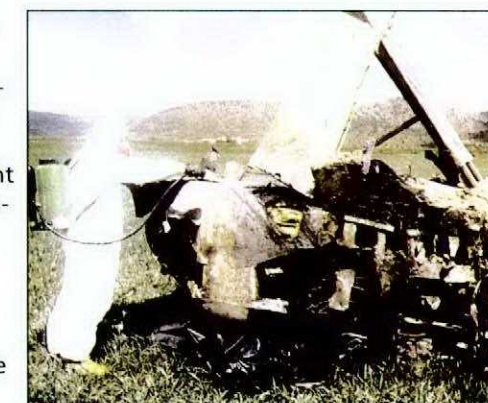
From the initial investigation, the Board determined that a technical failure of the AC electrical system had occurred, a subsequent failure of the emergency DC power system then caused a reversion to the MECH mode, and that an uncontrolled roll to the right had resulted in the pilot's decision to eject. Investigation into the cause of total AC power failure was limited due to the lack of obvious indica-

tions in the wreckage. All electrical components that may provide information are undergoing lab analysis. The Board was certain that a depletion of battery power was the cause of the reversion to MECH-OFF-OFF mode and controllability was undoubtedly affected by the degraded Flight Control System. In addition, the flaps would not cycle without battery power leaving the pilot no option but to perform a flapless approach for which there are no recommended speeds in the CF18

Aft section of CF188713.
