# FLIGHT

6/1995

The Canadian Forces  
Flight Safety Magazine

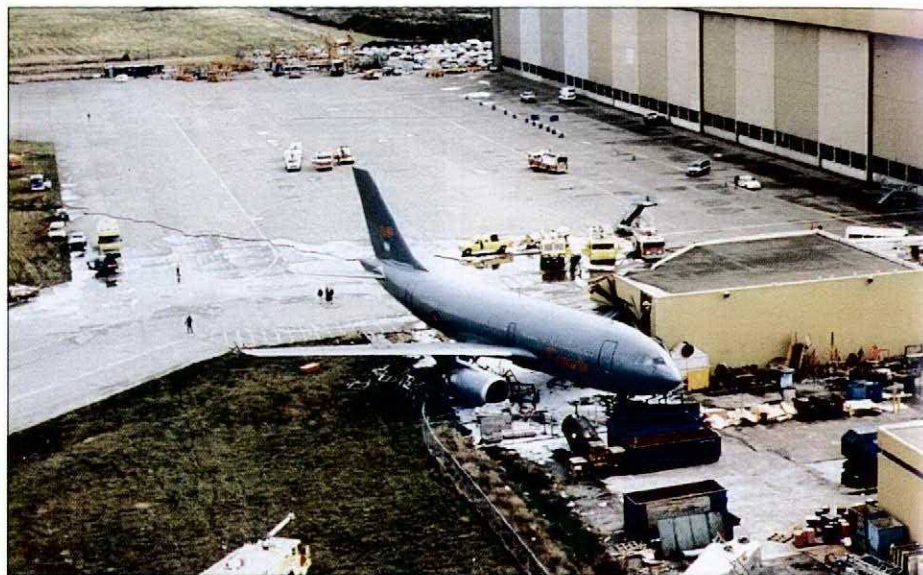
The contractor had been carrying out heavy maintenance (four and eight year checks) on the aircraft. The aircraft was positioned on the ramp adjacent to the contractor's hangar to conduct engine run-ups. The run-ups proceeded normally until the aircraft rolled over its chocks, travelled 220 metres across the ramp, and struck a storage building. After coming to rest, the aircraft was shut down and the four technicians evacuated the aircraft. The lower fuselage, wing leading edges, and engines were damaged by the impact but there was no fire.

Aerial view of crash site.

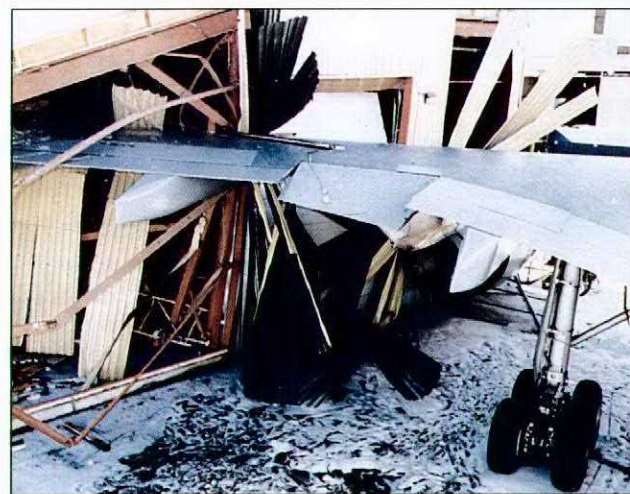
View of left hand engine.

The investigation determined that pulling the circuit breakers would not have displayed the desired information. It would, however, put the aircraft

into flight mode, disabling normal brakes, thrust reversers and nose-wheel steering. Additionally, it would cause the engines to go to "approach idle" speed after the throttles are retarded - producing significantly greater thrust than they would at a normal "ground idle" setting and increasing the aircraft's rate of acceleration across the ramp.

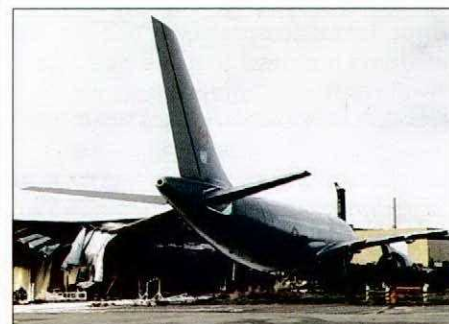
Rear view of aircraft.

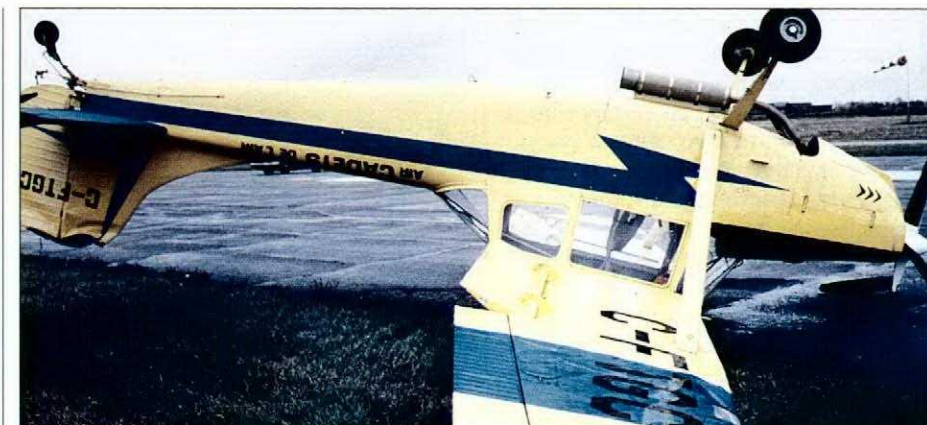
The accident aircraft was participating in cadet familiarization flying at the Saint-Jean Airport. The weather was acceptable with ceilings around 2,000 feet above ground and with strong winds at 15 to 20 knots gusting to 25 knots down Runway 29. The accident occurred prior to the second tow of the day when the pilot attempted to do a 180 degree turn on the runway to return to the launch point for a glider hook-up. As the pilot was turning through the 90 degree position, the tail of the aircraft began to rise. The pilot reacted by closing the throttle and pulling back on the control column. As he did so, the tail continued to rise until the propeller hit the runway surface and the engine quit. The aircraft was now in a 45 degree, nose-down position resting on the main gear and the nose/propeller while the pilot shut off all switches and egressed. The aircraft remained like this on the edge of the runway with the tow rope still attached.

View of left side. Damage to wing, propeller and vertical fin.

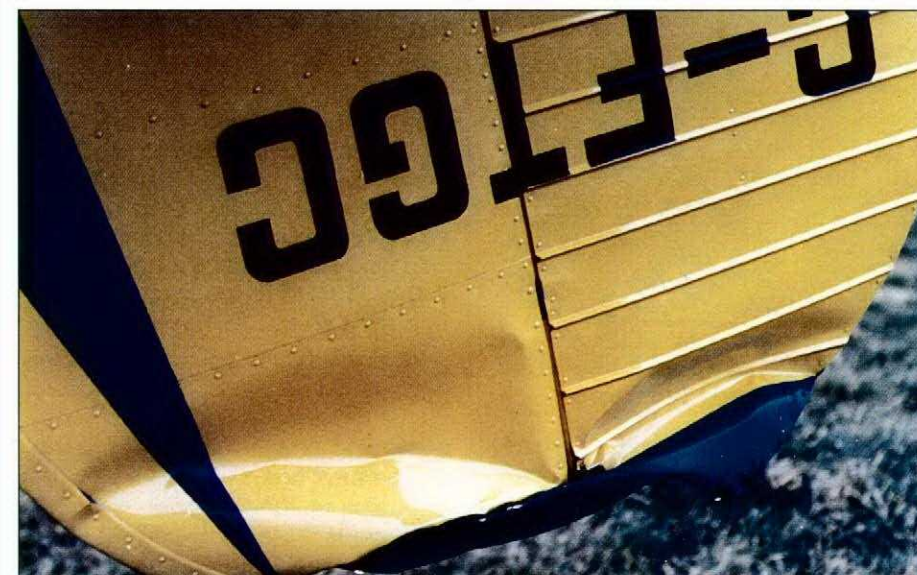
The investigation is ongoing, however it is apparent from the factual testimony that there was a misunderstanding between the Tower Controller and the Site Commander. The aircraft should have been secured to prevent further damage, regardless of the Tower instruction to not move the aircraft. This was truly an unfortunate accident that was preventable had there been better, clearer communications between the Tower Controller and the Site Commander. ♦

Impact damage - vertical fin and rudder.

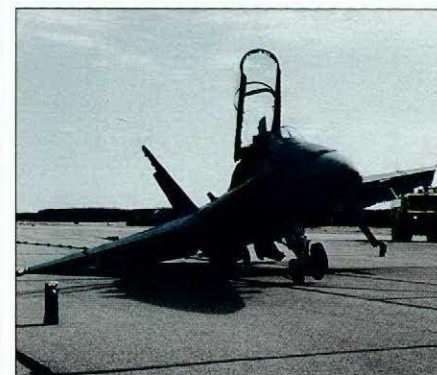
The aircraft was recovering from a Fighter Weapons Instructor Course work up trip at Primrose Lake Evaluation Range. When the gear was lowered at approximately 4 NM the right hand gear indicated unsafe and a low approach by the Tower confirmed the right hand gear was not down. On his recovery at Cold Lake, the pilot was able to keep the right wing up until cable engagement at which time the right wing contacted the runway. The damage was assessed as D Category.

Final position of CF188937 after landing.

The investigation revealed that the hinge pin retaining screw used to secure the RH MLG door forward hinge was not the length specified in the CFTOs. (Investigators found the screw still in the socket.) As a result, the retaining screw was not tightened enough to engage the self locking

feature of the nut. The aircraft flew about three hours before the nut and retaining screw came loose causing the forward door hinge pin to fall out during the trip on 21 April 94 leaving the leading edge of the door retained by the uplock assembly only.

In response to this incident, a CF18 fleet wide Special Inspection on the condition of the MLG forward door hinges was completed and a Maintenance Alert Bulletin was issued to emphasize the hazards of improper installation of hardware. In addition, Cold Lake maintenance has changed its supervisory structure to improve its accountability and NDHQ has clarified its policy and guidelines regarding fastener substitution for CF18 aircraft. ♦

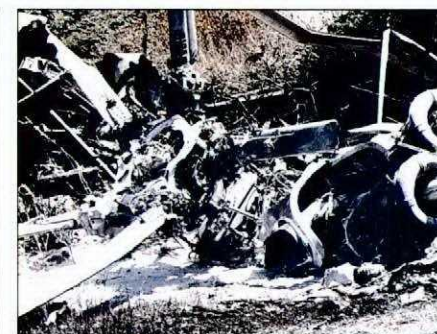
Accident site CH12425.

The investigation revealed that the engine malfunction was caused by a leak in an engine main fuel line.

The fuel line had been chafed through by another braided steel line from the turbine section of the engine. When the engine compartment filled with the fuel-air mixture, it exploded, causing the double-engine failure. The fire very quickly burned through the wires that control the fuel shut-off valves and therefore, the pilots were unable to turn off the fuel flow as they autorotated. The integrity of the engine firewall deck was compromised by two, six-inch diameter, pre-heat vents that allowed aircraft engine fuel to enter the cabin. The situation was further exacerbated by the numerous holes that were being created as the aluminum firewall rivets began to melt allowing more fuel to enter the cabin.

Following this accident the fuel lines were re-designed and new clamping and routing procedures were put in place to eliminate any further chaffing problems. The pre-heat vents have been permanently sealed and the recommendation to replace the aluminum rivets is underway. The Aircraft Operating Instructions have

been amended to include a caution that the fuel should be turned off as soon as possible before there is a possibility of the lines being burned through. Finally, the Aircraft Captain must be commended for his skill and courage under the most severe and trying circumstances in saving the lives of two crew members in this tragic accident. ♦

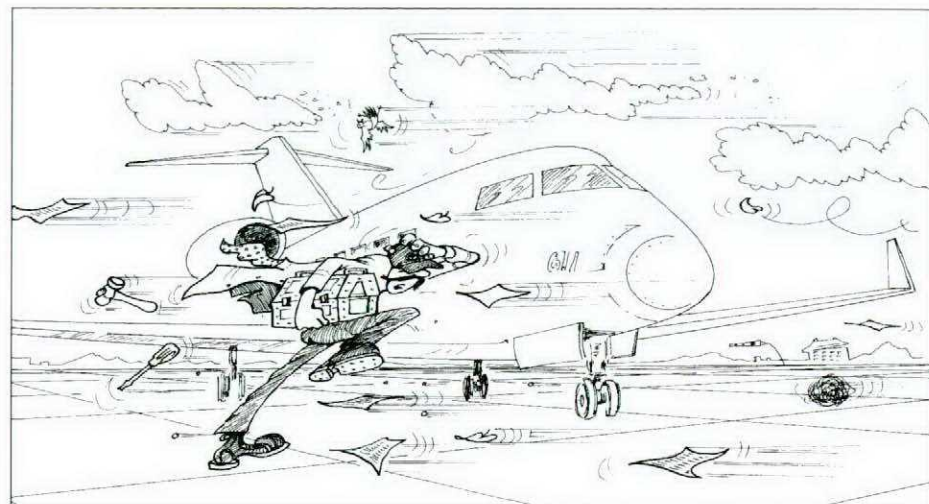
Last year, during an "A" check being performed on a Challenger, the engine tech opened the cowlings in order to carry out his portion of the check. He anchored the lower cowlings with its securing rod and opened the upper cowlings slightly to check the oil level. The tech found that the engine required oil, so he dropped the upper cowlings back into its normal position, and left the aircraft to obtain oil. The weather was quite windy and, unfortunately, this was not to be this tech's day. The wind lifted the upper cowlings from its normal position and blew it forcefully past the upper limits of travel.

The damage was confined to the upper cowlings, and the upper and lower apron panels, as well as the beating that the tech's ego received.

Don't forget to take weather conditions into account any time you open a panel on an aircraft. Always ensure panel security. It can get expensive when you don't! ♦

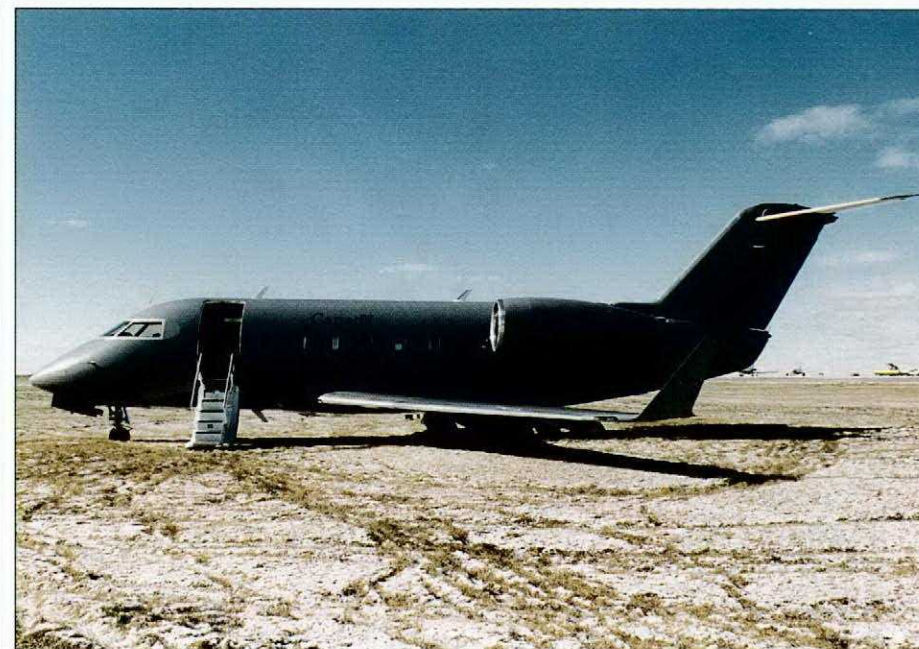
The initial downwind tail swing can most likely be attributed to crosswind and thrust reverse on a contaminated runway. Information from the Flight Data Recorder distinctly shows that control inputs created the subsequent oscillations. Aggravating the situation further was the left seat pilot's use of nose wheel steering and the right seat pilot's incorrect use of aileron. The investigation is now complete.

Final resting place CC144602.

In response to this incident, all pilots received a review of cold weather ops and the appropriate pubs will be amended to increase emphasis on the use of nose wheel steering techniques. In addition, prospective aircraft commanders will be more comprehensively trained in Cockpit Resource Management so that they may recognize situations where taking control or directing action is a viable option.

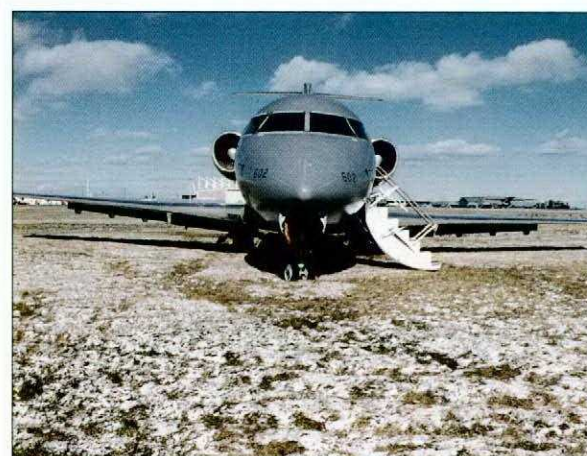
Front view of the aircraft.

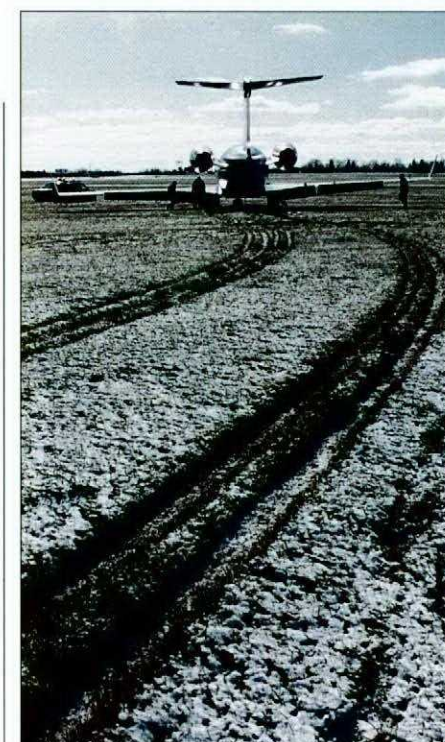
Rear view of the aircraft.
