FLIGHT

COMMENT

4/1996

The Canadian Forces
Flight Safety Magazine

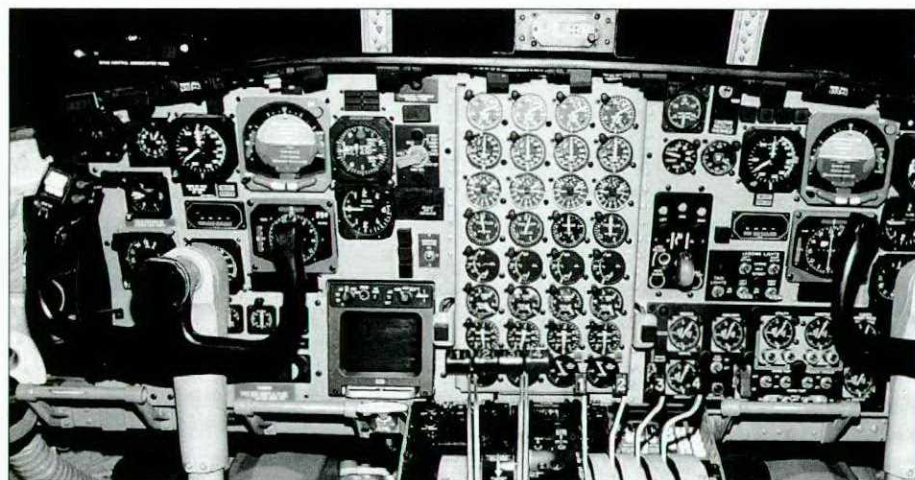
During a CC130 take-off roll, the Flight Engineer's (FE's) seat fore/aft lock pin mechanism failed allowing the seat to roll back to the full aft position. The take-off was aborted and the problem investigated.

Prior to the start the FE's seat lock mechanism had failed. The technician had found the failed part was a cotter pin where a rolled pin should have been installed. The technician tried to install a roll pin as per technical orders however it would not fit. To expedite the mission a temporary repair using a steel cotter pin was completed. The cotter pin failed on take-off and the seat rolled back!

View of a CC130 Hercules cockpit from the Flight Engineer's seat.

investigated. Thorough analysis of options may result in the conclusion that a temporary repair is reasonable, however, the process will also identify the need to follow up and either get the repair accepted as permanent or to permanently fix the component.

In this case because previous seat repairs were not followed up the non standard fix became accepted by default and the root cause of non availability of proper parts or techniques were not addressed. ♦

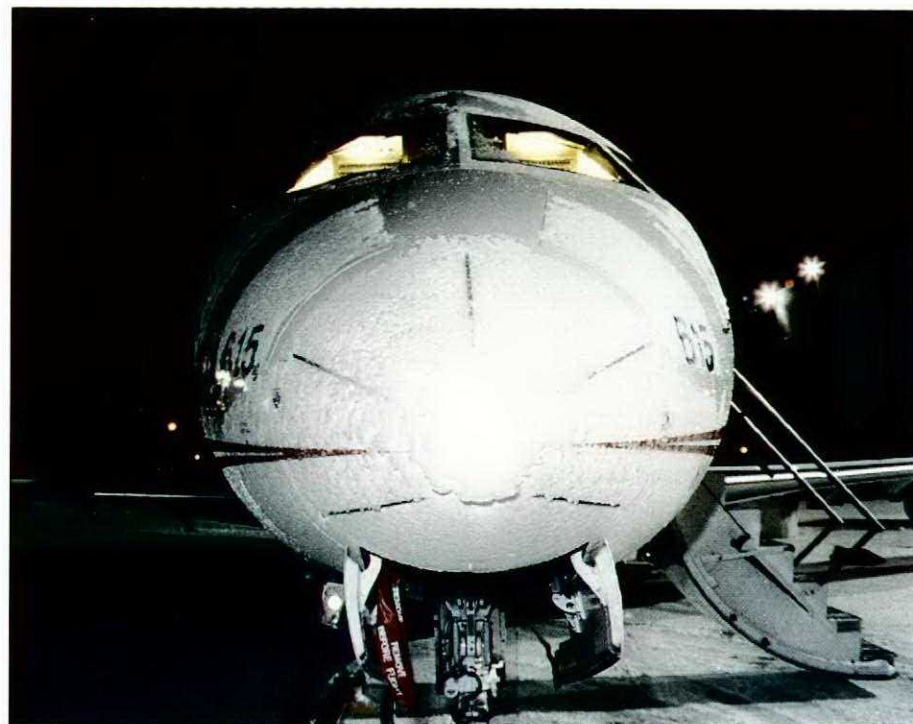
Challenger aircraft 615 was on a holding pattern over Ottawa on the evening of 5 March 1991. After 20 minutes of maintaining 11,000 feet in cloud, 615 was finally given clearance to descend for landing. On approach the crew had to employ full nose up elevator trim to maintain altitude and a further 10 knots was added to the threshold landing speed because "it felt better". After a successful landing, the crew noticed a significant quantity of rime ice on the nose (8 cm) and tailplane section of the aircraft where deicing equipment was not available. A little longer on the holding pattern and 615 may have been featured on the late evening news broadcast.

Nose of Challenger aircraft with 8 cm of Rime ice!

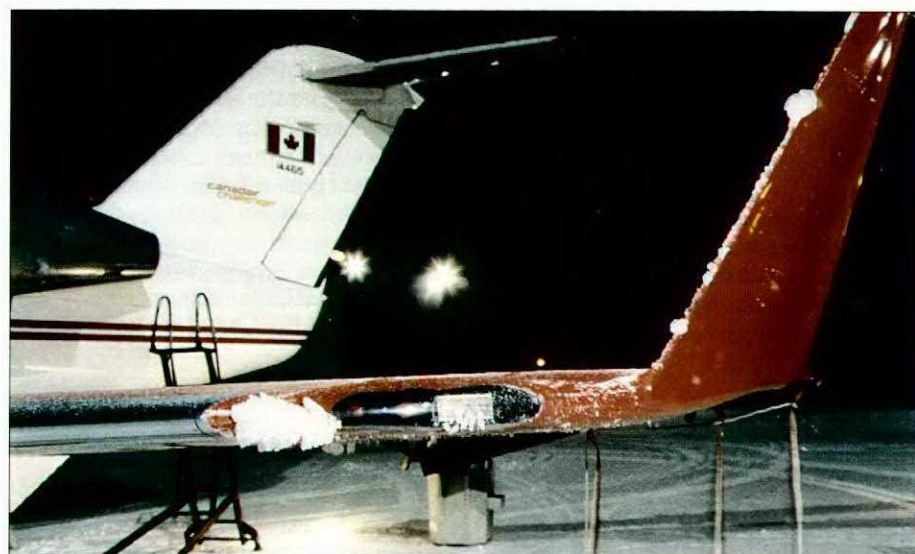
Left wing tip.

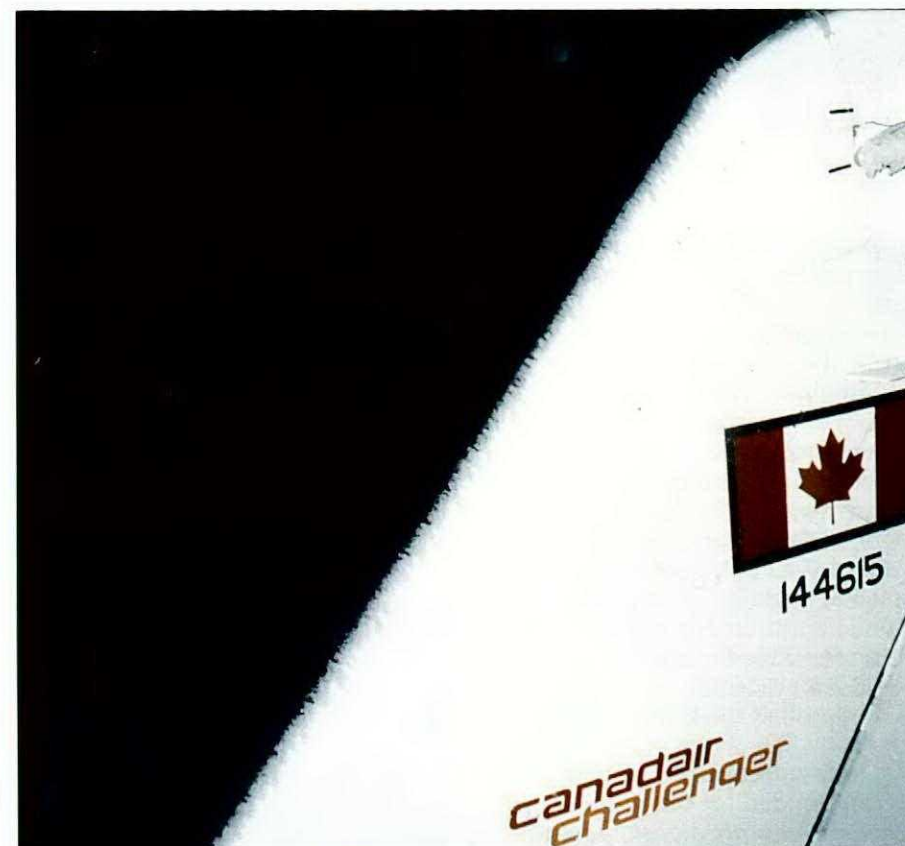
Leading edge of tail.

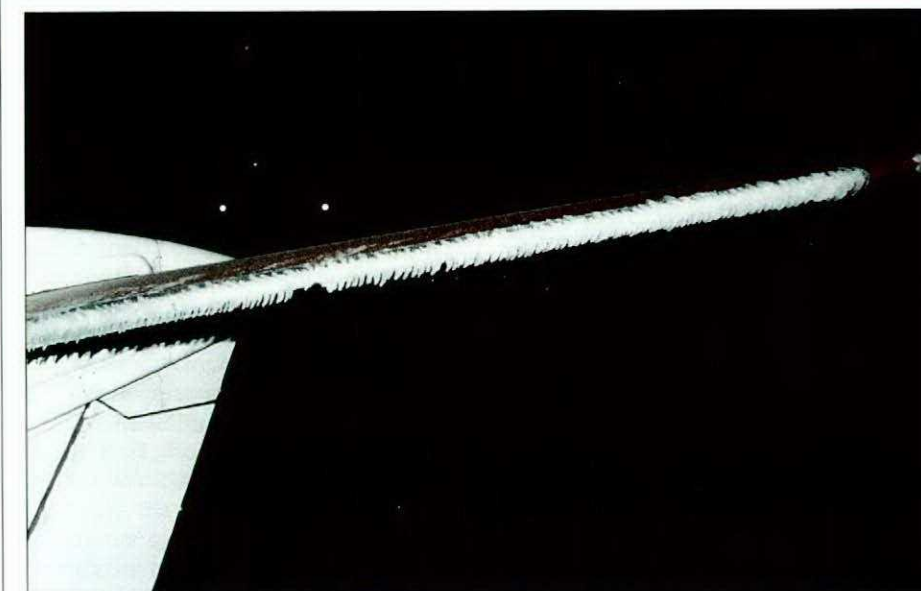
Top of tail area.

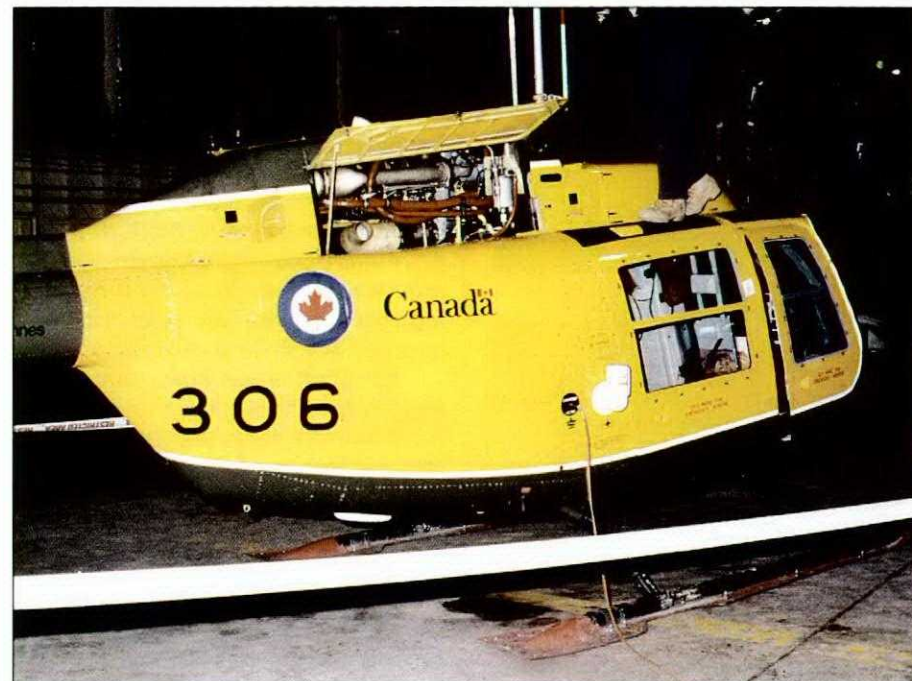
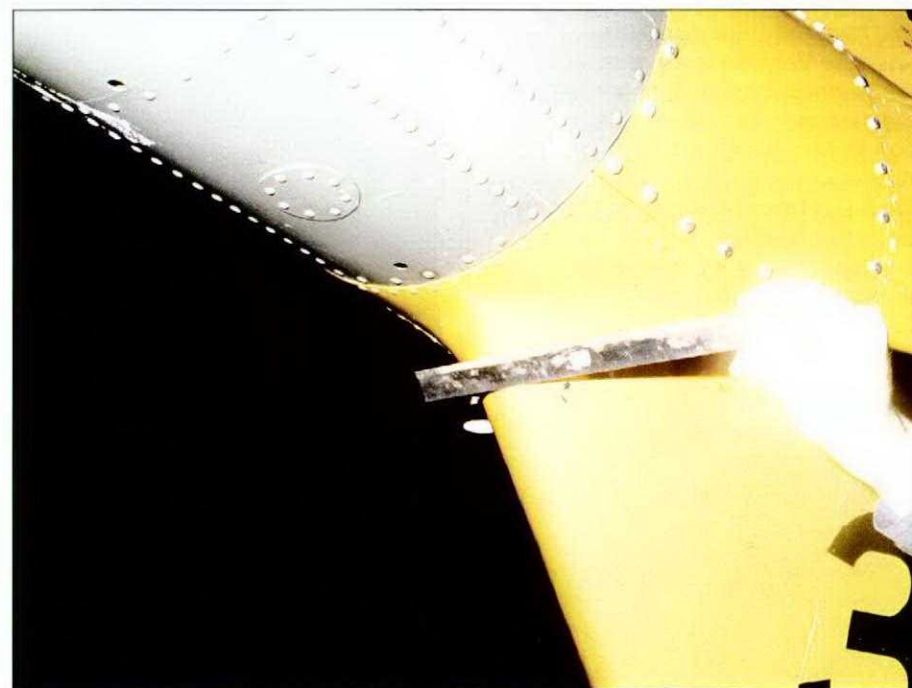
During A Night 1 mission, CH139306 experienced a hard landing at Pad 2, resulting in a B category damage. On a demonstration of a night autorotation, the aircraft touched down hard in a low nose altitude, bounced and came to a rest about 170 feet short of the Pad 2 landing area.

First, the instructor in this accident failed to assess the correct winds for conducting the night autorotations. In addition, the instructor displayed noticeable pilot technique weakness while conducting this manoeuvre both prior to and during the mishap mission. Investigation revealed that the pilot's proficiency levels for night autorotation had degraded due to service and self-imposed demands. In fact, the school had been trying for some time to address the shortages in manpower and heavy course loads affecting the helicopter side of 3 CFFTS operations.

3CFFTS/BHS has been conducting night autorotation training for quite some time with a relatively safe flying record. Yet, most pilots will readily admit that this sequence does require a high level of technical competence as the margin of error is definitely smaller due to the reduced visual cues. Due to the high work load at this school and the demands on individuals to be proficient at this manoeuvre, DFS has recommended a full risk assessment study for the conduct of night autorotations. ♦

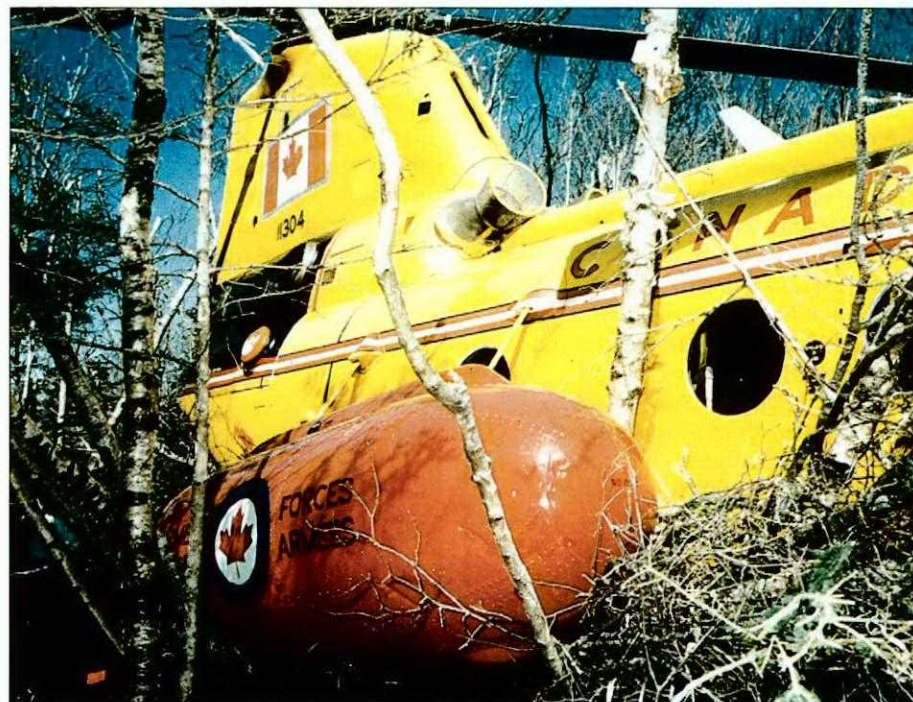
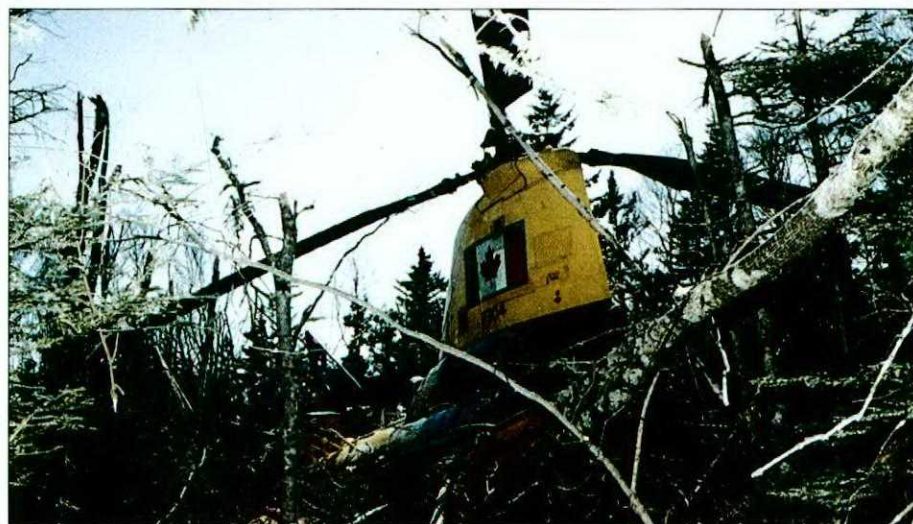
This accident took place during an authorized Search and Rescue (SAR) training mission approximately seven nautical miles from 14 Wing Greenwood, Nova Scotia. On the afternoon of 01 May 95 the crew of CH11304 had completed one training sequence and were in the middle of the SAR sequence when the problem developed. The Aircraft Captain (AC) had flown the initial phase of the training mission and had just handed control over to the First Officer (FO) who was flying the helicopter when the accident occurred. The FO established the helicopter in a stable 60-foot above the aground (AGL) hover and was in the process of moving towards two SAR tech who were below them, when all the crew members heard an audible decrease in engine noise as the helicopter began to settle towards the ground. The Flight Engineer (FE) immediately called for the FO to pull up but the aircraft would not respond.

Investigation revealed that the number two engine had failed during the hover due to the failure of the main fuel control unit (MFCU). QETE laboratory analysis further determined that the MFCU had been subjected to excessive external forces during installation at the contractors which led to the internal failure of the MFCU. Measures have been instituted to prevent a re-occurrence of

this nature. Also as a result of this and other engine-related CH113 occurrences, a new engine control system is being designed to replace the existing system. Finally, the crew of CH11304 must be commended for their quick and appropriate actions in averting a more disastrous outcome to this accident. ♦

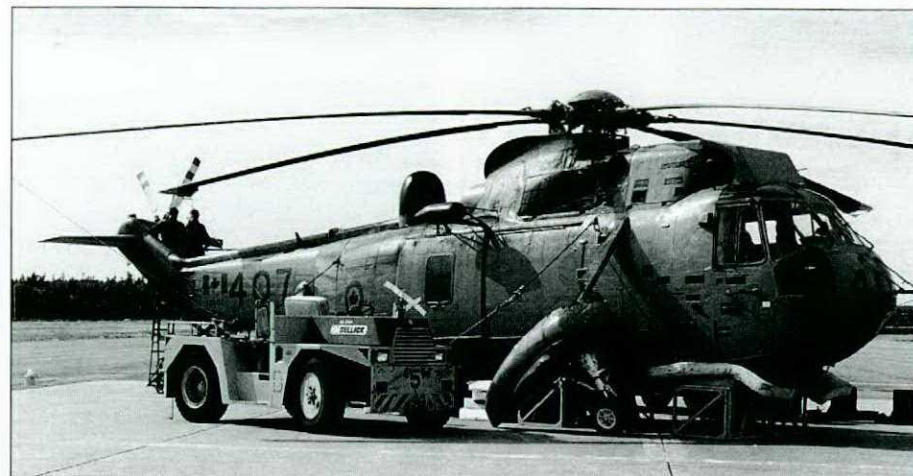
CH12407 resting on cradles.

coupled with the light winds, warmer temperatures, and higher DA set up the ideal conditions for Vortex Ring State (VRS). At approximately 100 ft the pilot levelled the aircraft and applied collective cushioning. Little deceleration was felt as the aircraft fell through its own disturbed air. At 50 ft full collective was applied to arrest the descent but this only served to aggravate the condition.

In fully developed VRS rates of descent can reach 3000 fpm. Recovery involves entering autorotation, lowering the nose to gain airspeed, or combining both. Altitude loss during recovery can exceed 1000 ft, therefore successful recovery at low altitude is extremely unlikely. Even if the pilots had recognised the VRS condition they did not have sufficient altitude to prevent the impact.

The low level environment is very unforgiving, particularly for heavy helicopters. Encounters with VRS can be prevented with a thorough knowledge of the conditions that lead to its formation and by avoiding, whenever possible, the regimes of flight where it is likely to occur. ♦

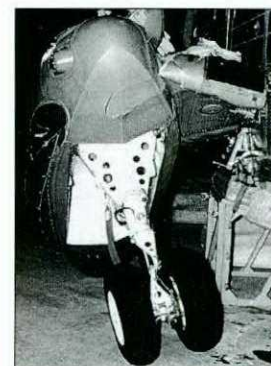
Front view starboard main landing gear.

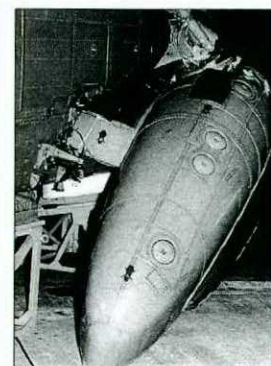
Rear view of starboard main landing gear.

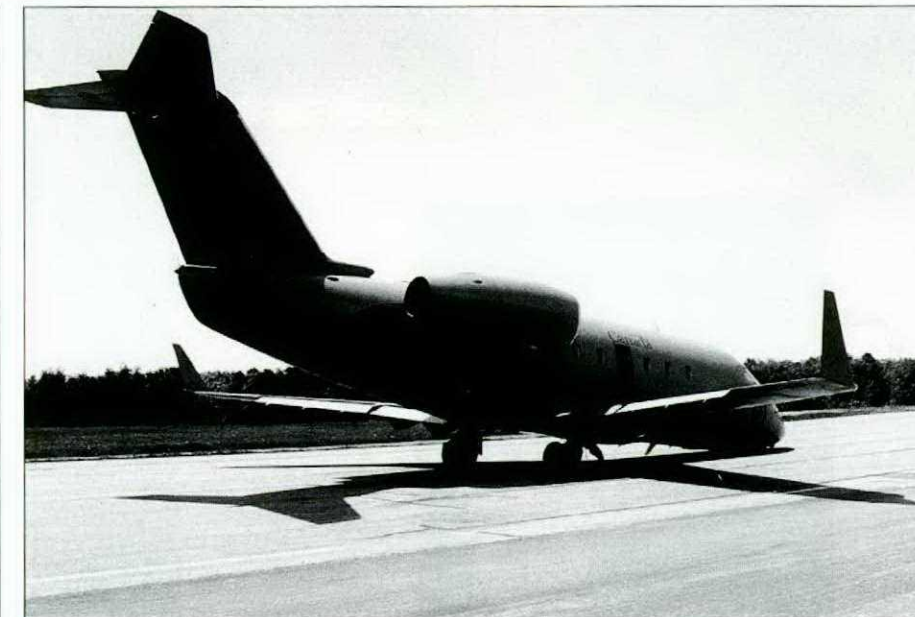
While the aircraft was serviceable until the point of gear retraction, the investigation did identify a defect in the nose landing gear selector valve. This condition, combined with the power interruption, resulted in a bypass condition to the retraction side of the valve. Laboratory tests are ongoing.

CC144604 resting on nose on the taxiway.

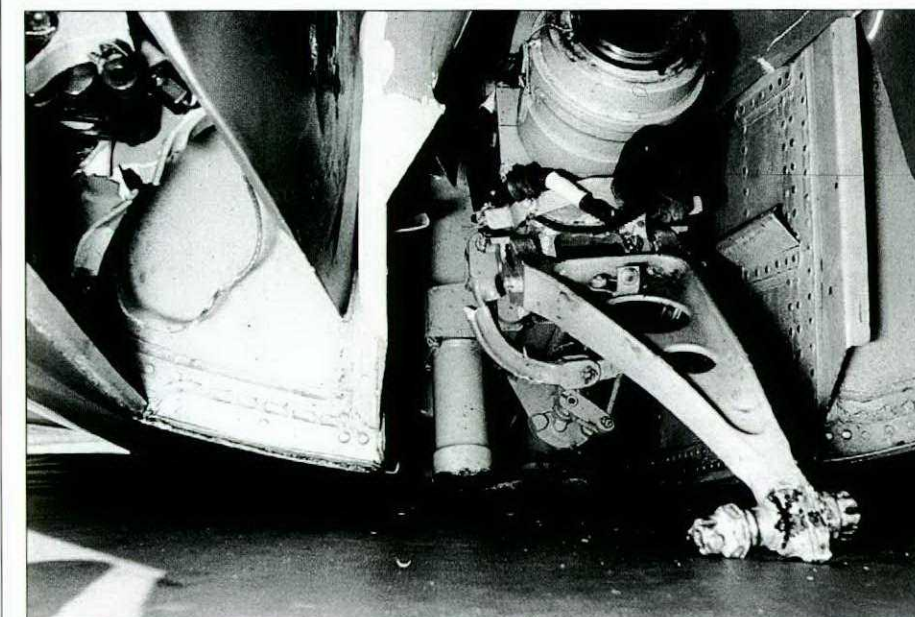
Nose landing gear compartment.
