# FLIGHT

## COMMENT

4/1997

## FLIGHT COMMENT

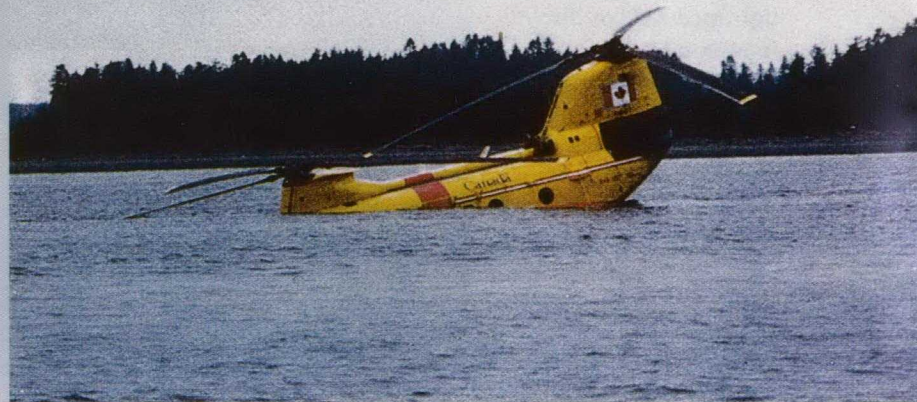
Maximum submersion point of CH11307

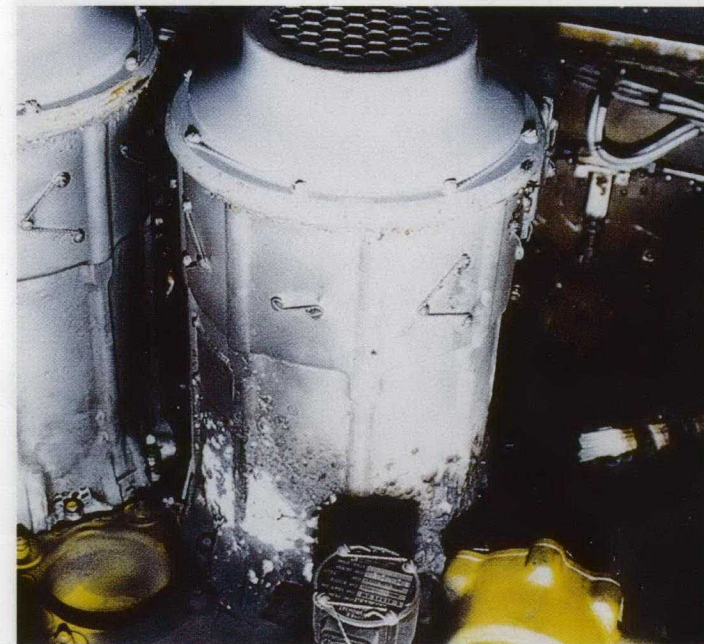
The aircraft remained upright in the water and was towed to the shoreline where it was lifted onto a barge several hours later. It was then transported to 19 Wing Comox via the barge initially and then by road. The ditching caused no fuselage or structural impact damage but most of the other aircraft systems were damaged by salt water corrosion. Damage has been assessed as B Category and the aircraft has been shipped to Boeing Arnprior for repairs. Subsequent investigation by DFS and Quality Engineering and Test Establishment (QETE) revealed that the No 1 generator had sustained a catastrophic failure when the drive-end bearing failed.

Records indicate that there have been 15 mechanical generator failures dating back to 1980. All the failures have involved the "dash 1" and "dash 2" versions of the generator. The last two incidents having occurred in Trenton and Comox in 1993 and 1994 respectively. All "dash 1" and "dash 2" generators have been removed from service and replaced with the "dash 3" version. It appears that although recommendations were made by QETE in 1980 and 1994, follow up action has been lacking. DAEPM (TH) is currently investigating the situation to determine where the problem exists. We were indeed fortunate that the outcome of this accident did not have more serious consequences. ♦

Generator area

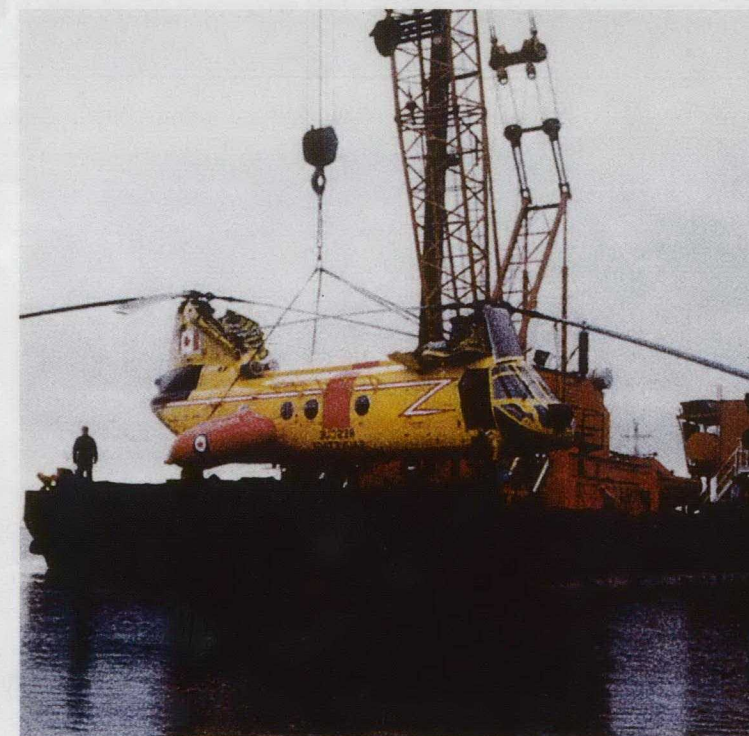
CH11307 on barge
