SUMMER 2000

# Flight Comment

- 1.....Fuel Imbalance Cited in  
Learjet 35A Control Loss
  - 7.....Cockpit Voice Recorder Transcript,  
U.S. Air Force C-21A,  
April 17, 1995
-

The Canadian Forces  
Flight Safety Magazine

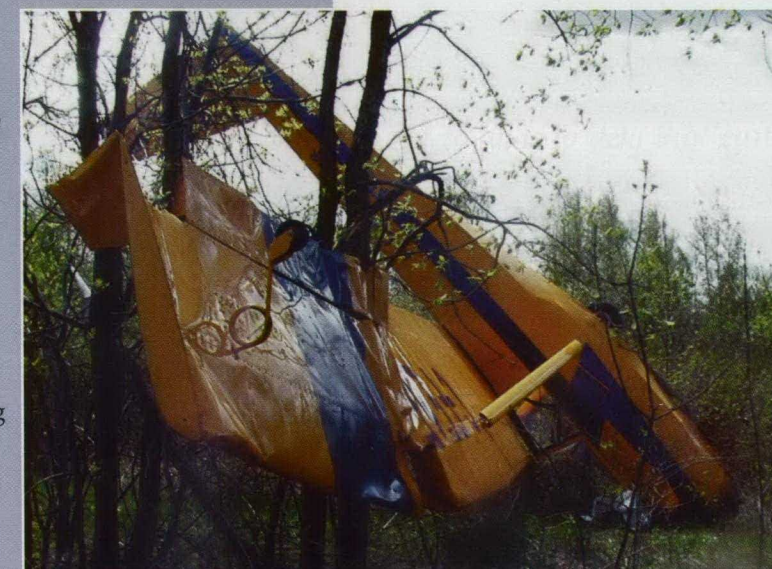
The glider came to rest approximately 1300 feet from the normal touchdown point on the gliding site. The accident occurred at 1415Z (1015 Local) during daylight hours.

We were indeed fortunate that the injuries suffered in this accident were limited to some minor cuts and bruises. Once again the robustness of the glider used in the Air Cadet Gliding Programme and the four-point harness securing the occupant saved him from more serious physical injuries.

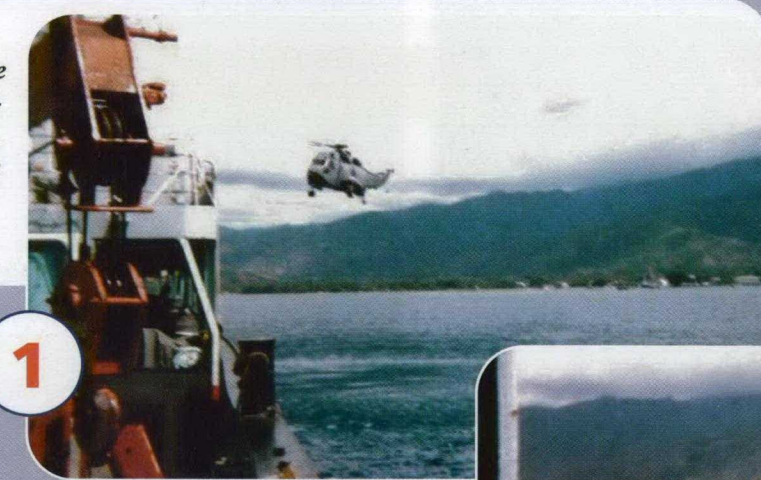
1

Most readers will be familiar with the circumstances leading to this incident. The following three photographs are of the actual event. ♦

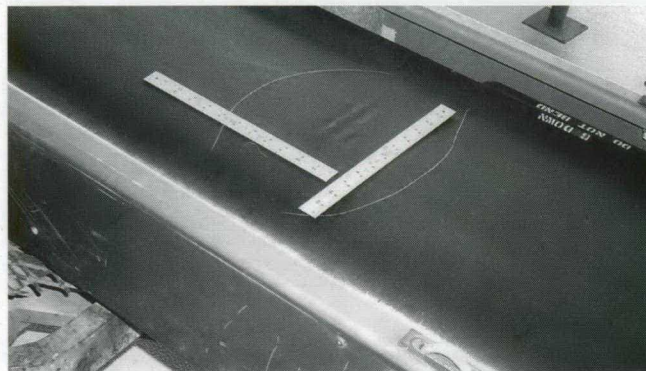
During the towing of a Labrador helicopter, Master Corporal Clarke thought he noticed a deformity on one of the aft rotor blades. Unable to confirm his suspicion from ground level he decided to utilize a maintenance platform to carry out a closer inspection of the blade. Master Corporal Clarke's examination revealed significant de-lamination on the top and bottom sides of the blade. He immediately notified his supervisor and the aircraft was declared unserviceable.

Further research by the rotor blade repair shop revealed that the blade had been over-pressurized by excessive water ingestion. The over-pressurization had resulted in blade warping and de-lamination. The deformity was virtually undetectable from ground level.
