ISSUE 2, 2016

Flight Comment

Closing Action Report

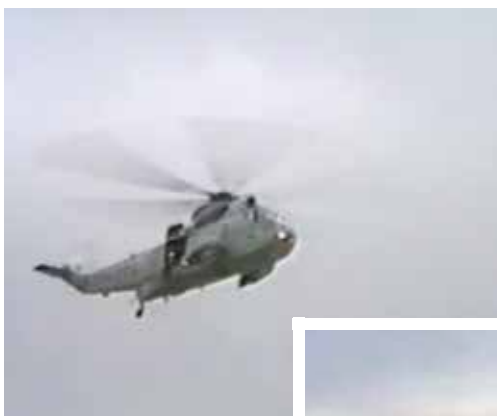
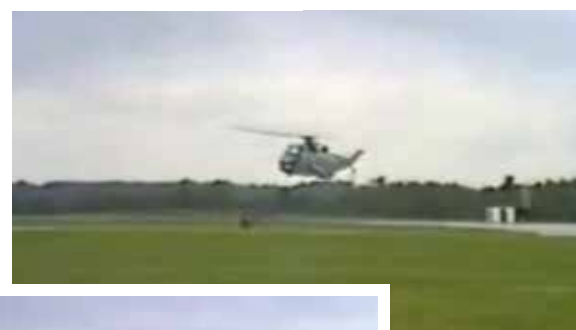
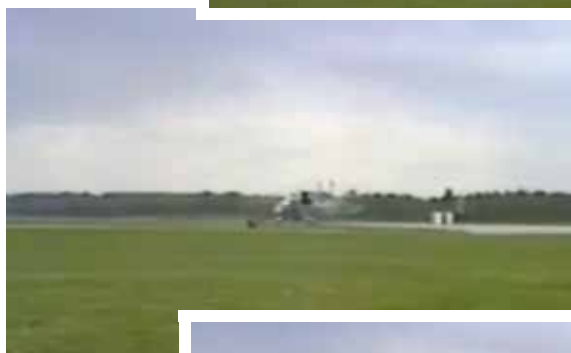
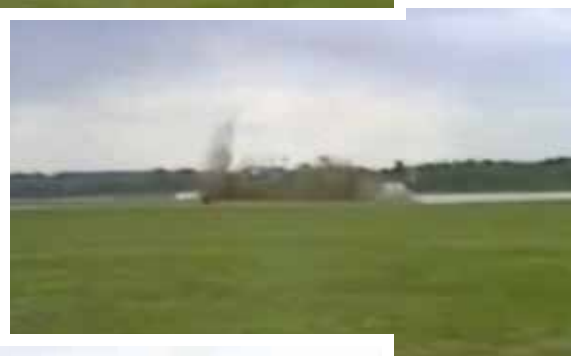
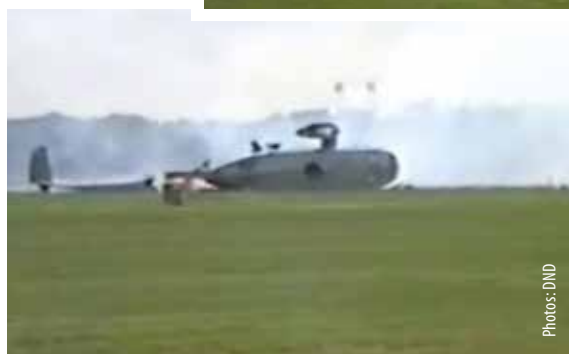
The aircraft was established in a higher than normal hover, 80-100 feet above ground level (AGL), over the runway in front of the crowd. Numerous pedal turns were conducted and then the aircraft was climbed vertically to approximately 300 feet AGL. Two crew members were seated in the open cargo door throughout these maneuvers while the navigator stood behind the pilots' seats. Pre-landing checks were not initiated. The aircraft was established in the hover using visual references only and a gentle uninitiated descent began shortly

thereafter. The pilot attempted to correct with a collective input which was ineffective. The rate of descent increased rapidly to the point where the AC decided to turn away from the crowd and attempt to fly out of the situation. The turn to the right was just being completed as the aircraft struck the ground.

The only phenomena which can explain the high rate of descent is a condition known as Vortex Ring State (VRS). VRS is caused by the recirculation of vortices about individual rotor blades. Conditions favorable to development of VRS are:

All of the conditions required for VRS were present during the accident flight. The aircraft weight at the time of the crash was approximately 19,000 pounds (maximum gross weight is 20,500). Airfield elevation at Schenectady is 378 feet above sea level, while the density altitude at the time of the crash was 1678 feet. The wind was light and variable and the

- Personnel-Flight Crew/Pilot-Carelessness: In that the AC conducted the flight in such a manner as to endanger his crew and aircraft by placing his aircraft in a 300 foot AGL hover in conditions conducive to Vortex Ring State.
- Personnel-Flight Crew/Pilot-Complacency: In that when he was established in a high hover, the aircraft captain allowed the aircraft to descend and enter Vortex Ring State/power settling.

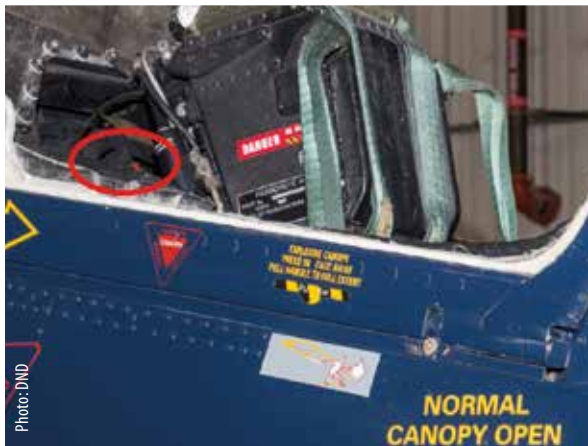
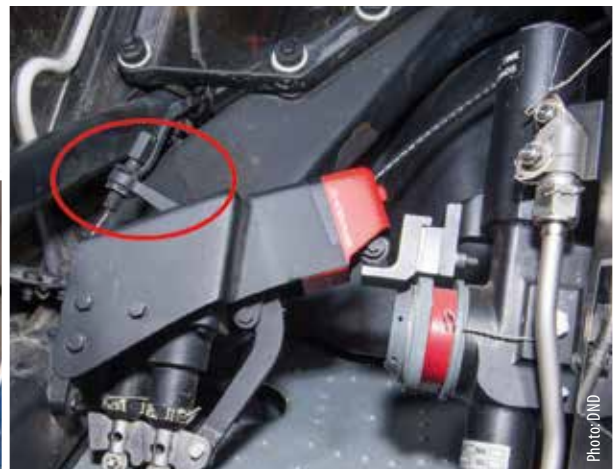
focusing on operational and human factors, primarily the procedures and requirement to carry and store a publications bag in the cockpit. The investigation is also looking at possible ways to protect the MDC firing unit from being inadvertently activated. ✈

This photo is of a serviceable MDC firing unit in the front cockpit of a different aircraft.

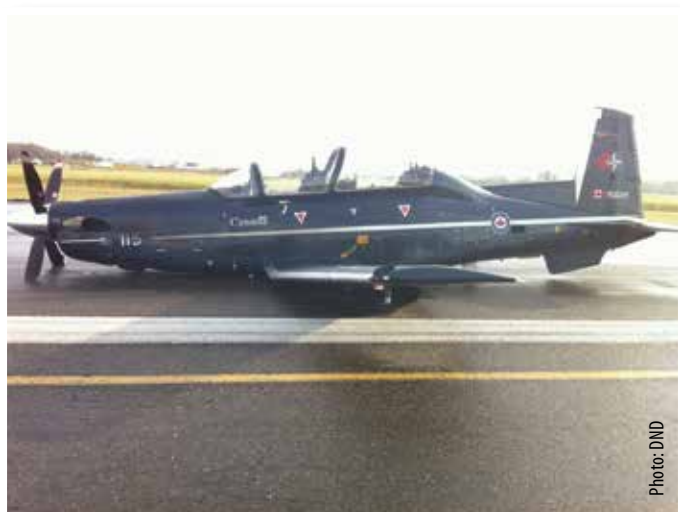
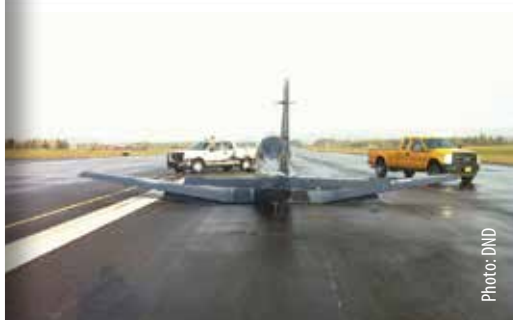
The investigation is focussing on the technical functionality of the landing gear system. To date it has been determined that the LG up lock switch failed internally, preventing completion of the electrical circuit to ground. A failure of this type will not allow a down and locked indication in the cockpit even if the gear is physically down and locked. 4
