CRASH COMMENT

JULY AUGUST SEPTEMBER 1950

ISSUED BY
ACCIDENT INVESTIGATION BRANCH
R.C.A.F. HEADQUARTERS OTTAWA ONT

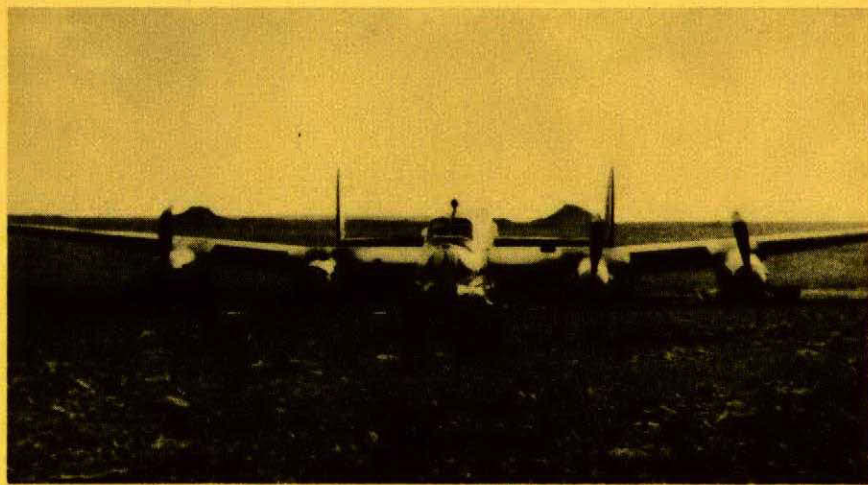
The captain opened all throttles fully, called for wheels and flaps up and endeavoured to keep the Lancaster airborne. However, even with full right rudder and aileron he was unable to maintain directional control and was forced to close the throttles and crash land to the left of the runway. The resultant "write-off" is shown on the front cover of this issue.

Subsequent investigation disclosed that the fuel selectors had been on No. 2 tanks at the time of the crash. The investigation also brought to light that there was no fuel remaining in the No. 2 and No. 3 port tanks and that the port engines had failed as a result of fuel starvation.

At the time of the crash there were still at least 1000 gallons of fuel on board approximately 475 of which were in the port No. 1 tank. The primary cause of the accident was assessed as mismanagement of the fuel system. A contributing cause was the unserviceability of the pilot's fuel gauge for the No. 2 port tank. The captain was also criticized for not exercising sufficient supervision over his crew.

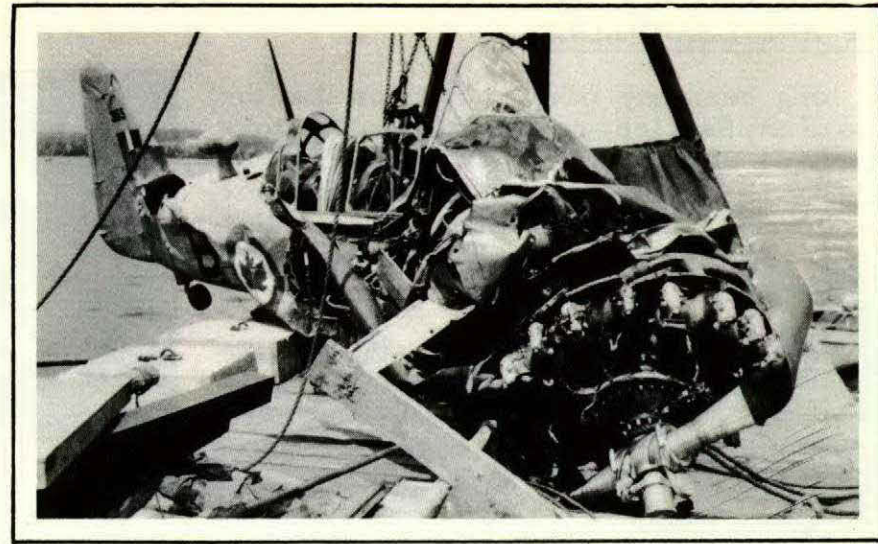
LOW FLYING

During an authorized low level formation flight at 300 feet above all obstacles, one of the pilots broke formation, descended and according to witnesses flew so low he had to raise the wings of his aircraft in order to get over the trees. He was also seen to complete a slow roll at an altitude of approximately 100 feet. Shortly after the pilot was seen to dive his aircraft within a few feet of the surface of a lake, pull up to about 150 feet, and commence another roll. The roll ended disastrously with the aircraft crashing into the lake. Both the pilot and passenger were killed.

The formal investigation into the accident disclosed no evidence of structural or engine failure or malfunction of controls but uncovered one very important fact---'prior to the flight the pilot had advised his crewman that he would be flying upside down'.

The actual cause of the accident was obscure. However, the evidence obtained very strongly suggests that this accident was caused by the pilot losing control while executing unauthorized aerobatics at an altitude contrary to CAP 100, Chapter II, Section 8, Para 97(2)(b)(c).

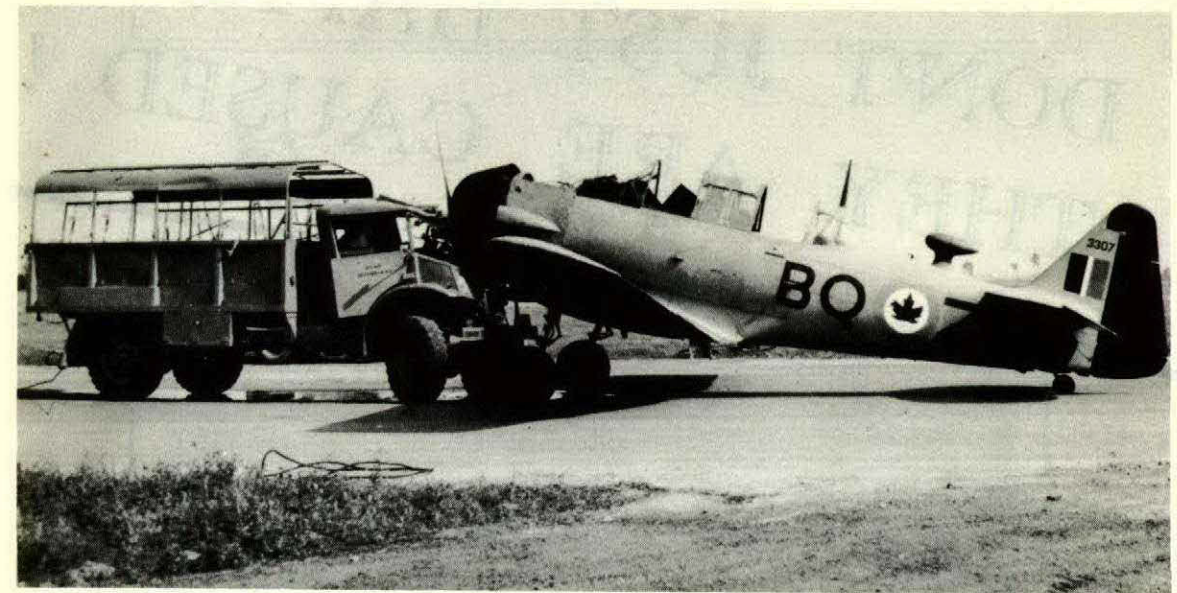
TAXYING ACCIDENTS

This was the outstanding taxiing accident for the quarter. Damage amounted to \$6000.00.

Two other collisions occurred which raised the dollar cost for Harvard taxiing accidents this quarter to almost \$10,000.00.

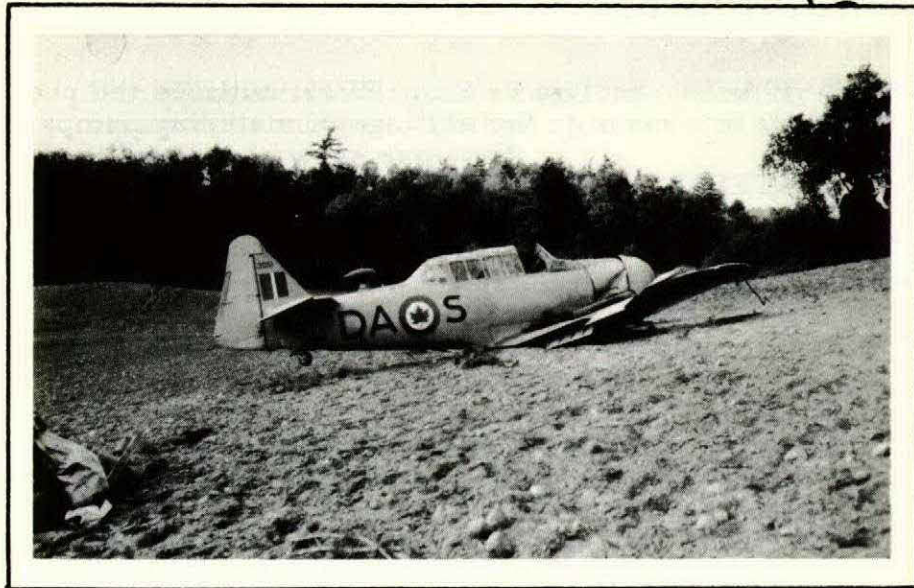
* No. 7 -- WHAT - NO GAS?

It's not hard to imagine the look of chagrin on the Chief Instructor's face when he learned that this student had failed to switch over to a full tank before commencing a forced landing practice.

The student forgot his cockpit check and as a result the RCAF had another "A" category crash on its hands.

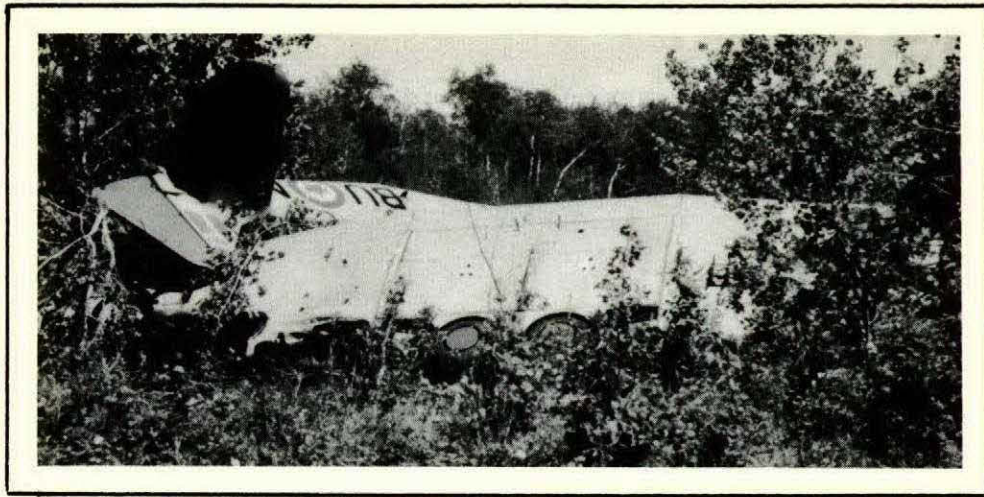
* No. 12 -- CARBURETTOR TROUBLE

While on a ferry flight at 5000 ft, the pilot experienced surging and sputtering of the engine when about two-thirds of the way over a large lake. Constant use of the wobble pump and primer resulted in the engine catching intermittently and enabled the pilot to lose height slowly enough to be able to reach land. Shortly after, at about 50 - 100 ft the primer jammed and the engine cut completely.

The pilot landed the aircraft in a clump of trees - the impact resulting in "A" category damage to the Harvard. Neither occupant was injured.

The cause of the accident was not definitely determined. The engine was removed and shipped to a Repair Depot where it was test run and performed satisfactorily. In the absence of any materiel defect it appears most probable that a blockage occurred in the carburettor fuel nozzle occasioned by either foreign particles or carburettor icing. It is worthy of note to mention here that temperature and humidity conditions were ideal for carburettor icing.

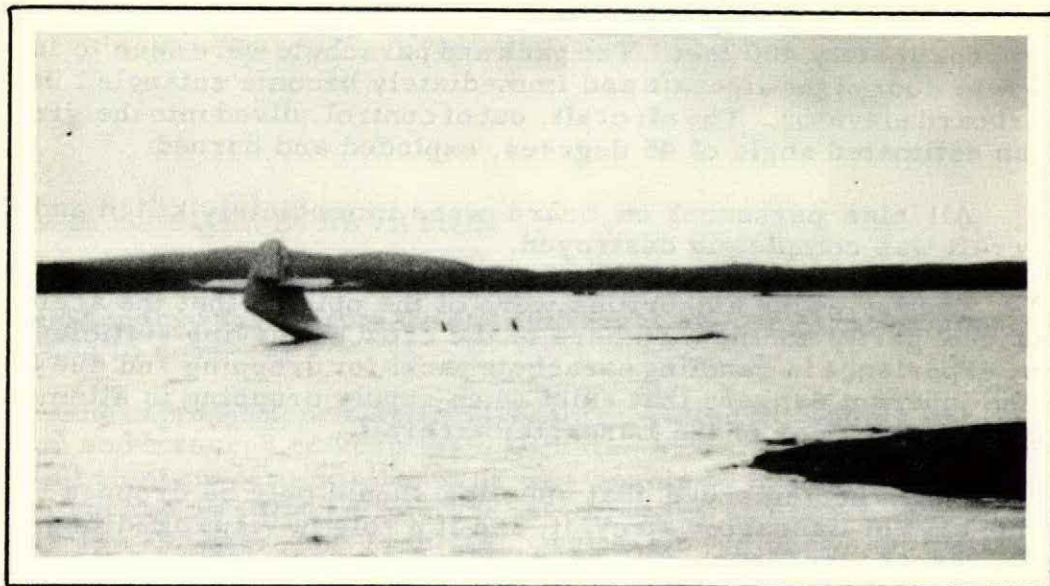
* No. 19 -- UP PERISCOPE

The day previous to the accident pictured above, the captain had flown over the lake and carefully selected a landing and take-off area and a suitable path to taxi into a sheltered beach. The subsequent landing and beaching were uneventful.

The following day when taxiing out to take-off, the captain chose a different taxi path. The consequences were disastrous, as shortly after the undercarriage was raised the hull struck a submerged rock or reef.

The captain attempted to take-off but the aircraft filled with water so rapidly that take-off had to be abandoned. An effort was made to beach the aircraft on a nearby island but the Canso sank when still about 150 feet off shore.

The cause of the accident was considered primarily an error in judgement on the part of the captain in that he did not use the same taxiing path that he had used previously. Limited experience on flying boats was a contributing factor.
