CRASH COMMENT

FOURTH QUARTER 1951

ISSUED BY
ACCIDENT INVESTIGATION BRANCH
R.C.A.F. HEADQUARTERS OTTAWA ONT.

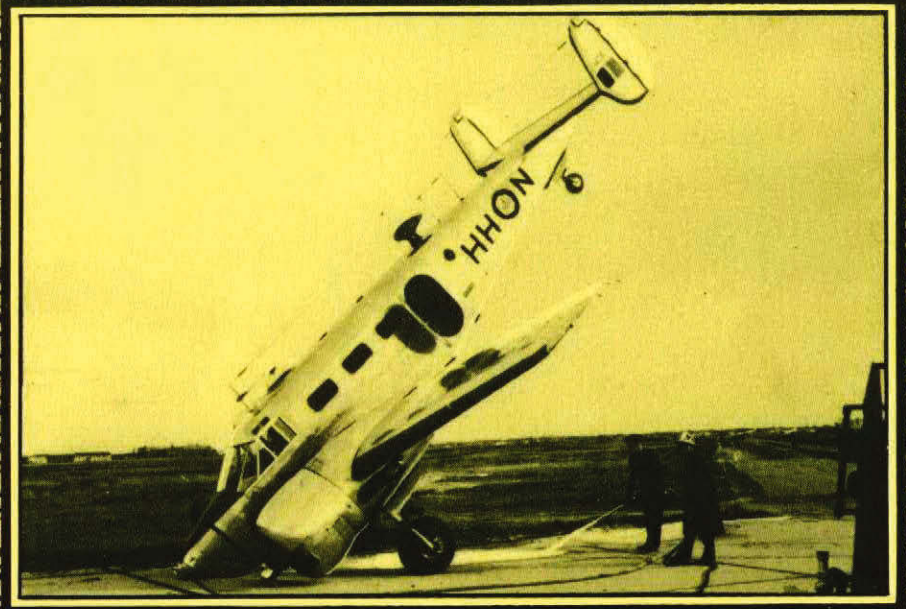
This aircraft had a flat tire on the starboard side which required inflating before the aircraft was able to take off on a navigation exercise. Upon approaching to land after completion of his exercise, the pilot decided to touch-down on his port wheel first as he was doubtful if the starboard tire was serviceable. This caused the aircraft to start a ground loop, the pilot used harsh brakes to correct the swing and the aircraft nosed up. The result is depicted on the front cover.

This accident is still under investigation but we consider the pilot should not have accepted the aircraft if he was doubtful of its serviceability.
