CRASH COMMENT

APRIL - DECEMBER, 1952

ISSUED BY
ACCIDENT INVESTIGATION BRANCH
R.C.A.F. HEADQUARTERS OTTAWA ONT.

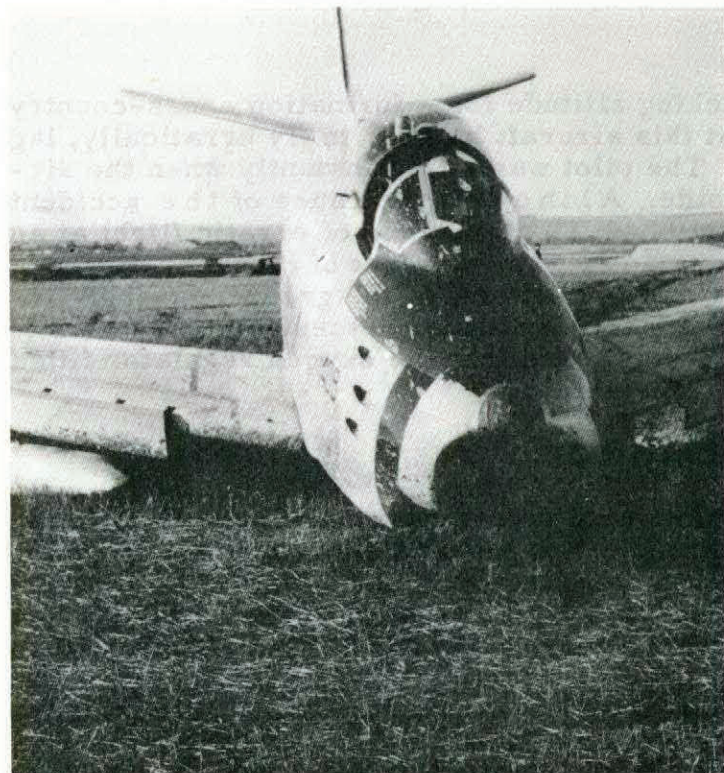
NO. 4 -- USE OF RUNWAY

On take-off the number two pilot in a two-plane formation attempted to lift his aircraft off the runway when the leader did, but he was unable to do so. The pilot throttled back and applied full brake but he was unable to stop the aircraft before it ran off the end of the runway into the mud. The nose wheel collapsed resulting in extensive damage to the nose of the aircraft. Subsequent examination revealed all aircraft controls and systems to be fully serviceable. Through the erroneous decision of the section leader to take-off from

the intersection, the pilot was denied the use of the first 2,000 feet of an 8,000 foot runway. This accident has been assessed our old familiar enemy "Pilot Error". The pilot aborted his take-off 1,600 feet before the end of the runway after a take-off run of only 4,400 feet during nil wind conditions. (The pilot used less flap than the leader, therefore, necessitating a longer take-off run). A mitigating factor in the cause of this accident was revealed in the ensuing board of inquiry. The pilot had not flown a Sabre aircraft for approximately six weeks. The section leader, however, exercised poor judgement, particularly under the existing circumstances, when he failed to make full use of the runway available.

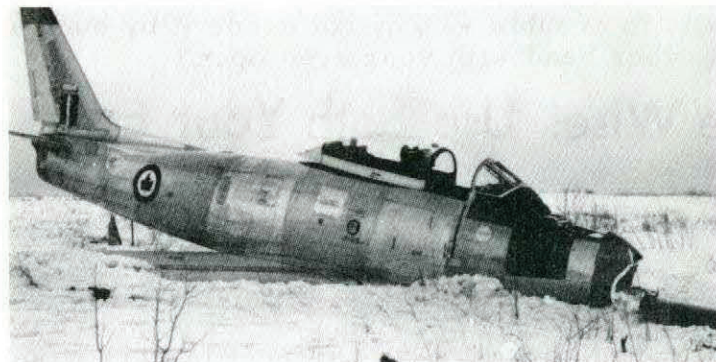
NO. 8 -- BRAKES

During the take-off run, the pilot attempted to ease the control column back at an airspeed of 110 knots and found that it was necessary to apply pressure with both hands. As the aircraft had, at this time, used up most of the runway, it became apparent that he would not get airborne in time. The pilot cut the throttle and applied full brake.

The Sabre ran off the end of the runway into the overshoot area and was damaged considerably.

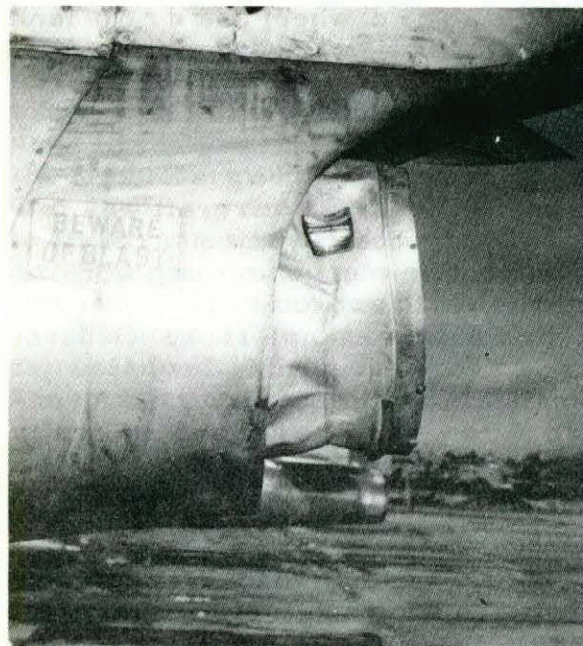
NO.11 -- NOT ALL ACCIDENTS ARE "PILOT ERROR"

This negligence on the part of a maintenance section could have caused a fatal accident with accompanying loss of an aircraft. A Sabre had been released after a P50 inspection and certified as serviceable. On the engine run up all gauges indicated proper functioning. On take-off, just after the nosewheel was lifted, the pilot felt severe vibrating in the aircraft accompanied by a loss of power. He closed the throttle and braked the aircraft to a stop on the runway. On inspection of the aircraft the tailpipe was protruding about two feet from the rear of the aircraft and badly buckled. Technical investigation revealed the tailpipe had not been properly installed nor fastened. Furthermore, the clamp bolts were not safety lock-wired permitting the tailpipe

to slip back out of place. Heavy maintenance work loads, shortage of supervisory personnel, and inexperienced technicians are all mitigating factors in such accidents but nevertheless such cases of laxity and negligence are inexcusable.

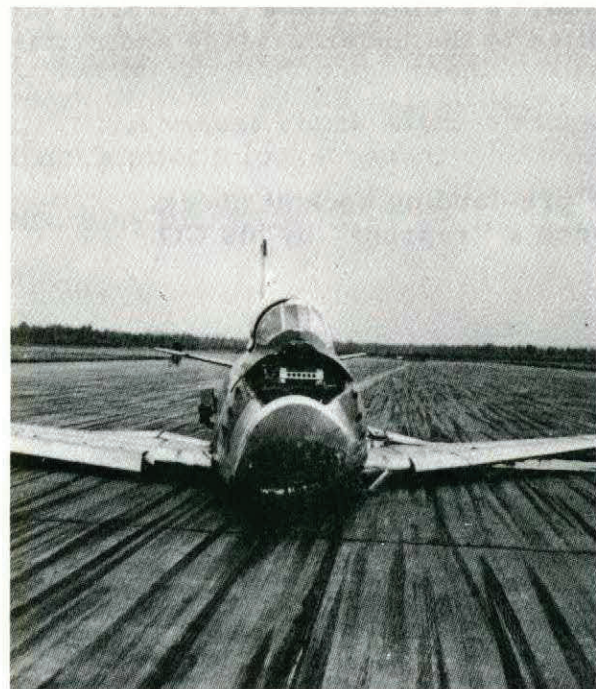
NO. 12 -- ANOTHER JET WASH CRASH

The number four of a four-plane section suffered a much too familiar landing accident. On the return to base after a formation exercise, a normal fighter break was made. The first three aircraft carried out successful landings but on the final approach number four was seen to lose considerable height plus falling way behind. Approximately 300 feet from the end of the runway the aircraft stalled when it hit number three's jet wash. The pilot applied corrective action with full throttle but it was far too late. The starboard wheel and drop tank struck an eight foot mound of earth and were torn off. The aircraft slid onto the runway shedding appendages and sections like a dog shakes off water. The aircraft was totally destroyed as a result of

the "A" category crash. Two construction men, who were working on the drainage ditch by the mound of earth, were injured. Despite Pilots Operating Instructions for the F86E, station Pilots Orders, and repeated warnings and instructions regarding low, slow jet approaches, the pilot failed to maintain sufficient power for overshoot, struck his leader's jet wash at low air speed and stalled in wiping out an expensive aircraft.

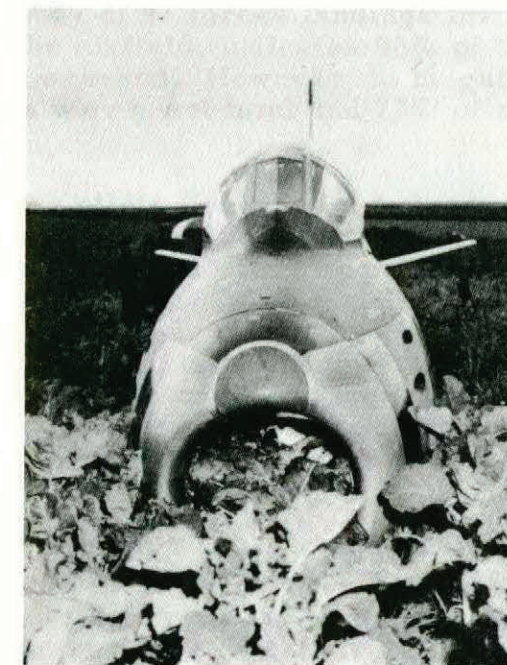
"This aircraft arrived over the field with sufficient height to enable a wheels-down forced landing on the aerodrome with complete safety to the pilot and airframe. The pilot dived at the aerodrome in excess of 200 knots. The aircraft first made contact with the runway 1,000 feet from the approach end by forcing the aircraft on the runway. The drop tanks were torn off at this point. Due to excessive airspeed the aircraft again became airborne, covered the remaining runway distance, and passed through two hedge rows before settling into a beet field one-half a mile from the runway's end".

The aircraft was an "A" category crash and there were heavy casualties among the beets.

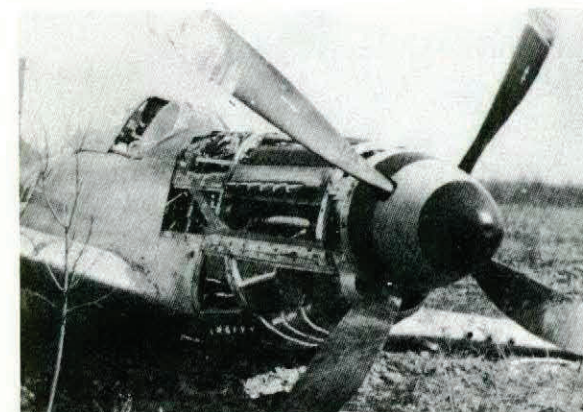
NO. 21 -- OBSCURE

The pilot was taking off on an air test and had just become airborne when he felt that he was not getting enough power. He glanced at the manifold pressure gauge and noticed that the pressure had dropped off to 35 inches. The pilot cut the throttle and attempted to land straight ahead but harsh application of brake caused the aircraft to swing and leave the runway.

The port undercarriage collapsed and the wing tip dug in, causing a groundloop and subsequent damage to the propeller and fuselage.

The primary cause of this accident has been assessed as "Obscure" as a test run and strip inspection of the engine failed to reveal any reason for the loss of power.

The secondary cause was "Pilot Error" in that the pilot took off on a short runway (approximately 3,000 feet) when there was a longer runway (approximately 6,000 feet) available. We feel that the pilot should have used the long runway for take-off on an air test in order to allow himself sufficient room to get back on the ground in the event of engine failure. The wind at time of take-off was between the two runways in question and only 5 mph.

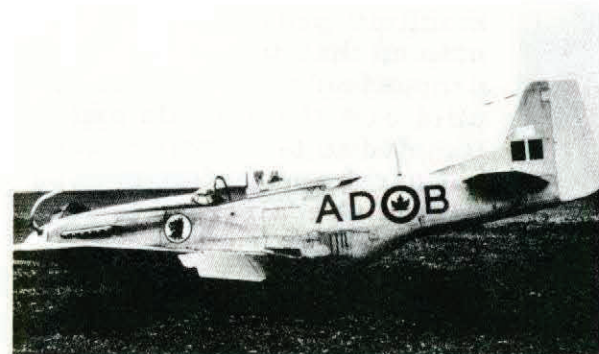
NO. 23 -- IT PAYS TO KNOW

45 minutes after take-off, the pilot decided to practise forced landings. At a height of 1300 feet above the ground, he advanced the throttle to clear the engine, only to discover that no power was available. A quick cockpit check revealed no fuel pressure so he changed his tank selection. The engine did not respond so a crash landing was made in a farmer's field.

The inquiry into this accident revealed that the engine failed through fuel starvation.

Had this pilot managed his fuel system in accordance with EO 05-55C-1, Part 2, Para 4, undoubtedly his AOC would not have awarded him a "reprimand" for causing this accident.

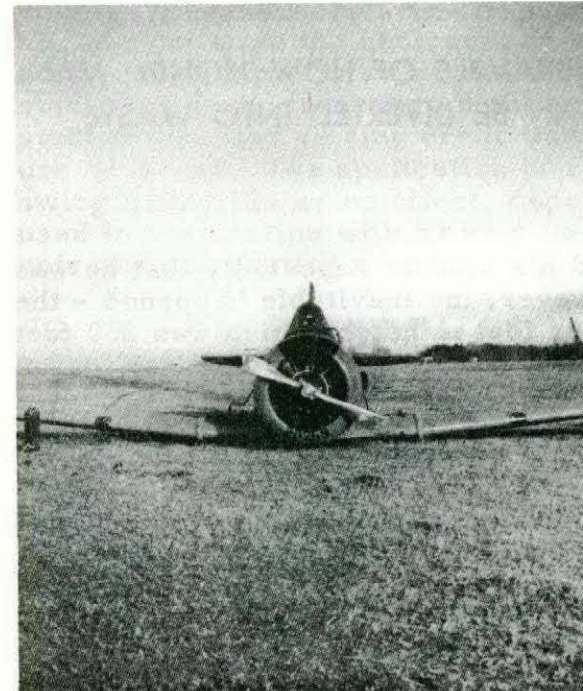
NO. 24 -- THIS IS UNBELIEVABLE

The student pilot was carrying out a solo day cross-country exercise. On return to his airfield by ADF homing, the engine failed one mile from the field at a height of 5,700 feet. From this point on, the student seems to have suffered from mental blackout because he did practically everything wrong. He made no thorough checks, he misjudged his glide approach, he selected undercarriage down for flaps and made his exit from the scene leaving the aircraft in the depicted ignominious position.

- (a) Failed to check fuel warning light on tarmac. This light incidentally was on "Dim" for day flying!!! and consequently did not show the lack of fuel pressure.
- (b) Knew he had insufficient fuel in his starboard tank at his second turning point to complete the trip, but did not change tanks.
- (c) Did not carry out a proper GMS check when engine failed.
- (d) Did not carry out a forced landing check while descending.

- (e) Did not plan his descent while he still had sufficient altitude to reach any runway on the field.
- (f) Showed poor judgement of his glide approach by undershooting considerably when he actually had sufficient altitude to make the runway.
- (g) Erred in his decision to select flaps down when obviously undershooting and in his haste inadvertently selected undercarriage down. Luckily he had insufficient height for the undercarriage to lock-down or a more serious accident would probably have resulted.
- (h) Failed to put his pitch lever in full course when undershooting which would have effectively increased his glide".

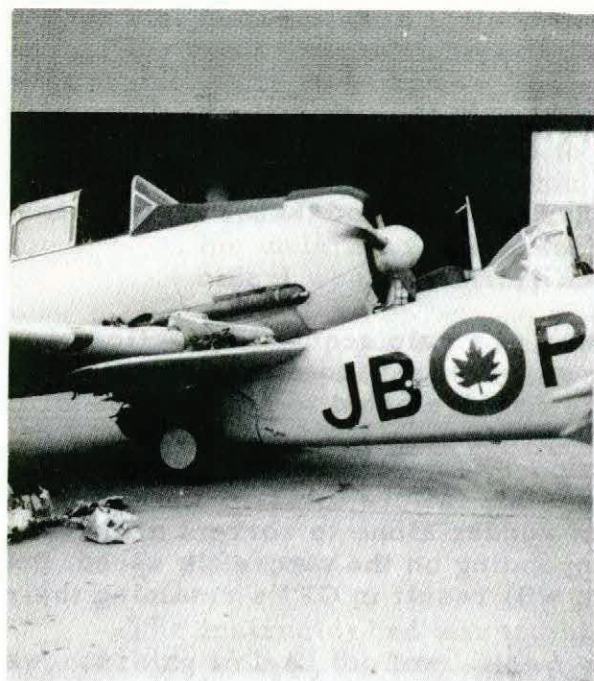
The post night-landing check had been completed by the student so the instructor decided to taxi the aircraft and at the same time brief his pupil on the faulty landing which had just been completed. He stated that at no time did he see another aircraft ahead of him while taxiing. However, on preparing to turn at the intersection of two runways, his aircraft ran into another which was holding with unserviceable identification lights.

The amount of damage caused to both aircraft can be judged by reference to the above picture.

- Cause: 1. Carelessness - insufficient lookout.
2. Diverted attention of instructor and student by carrying out briefing while taxiing.

Although this accident has been charged against the pilot of the aircraft which did the damage, it is considered that the pilot of the rammed aircraft should have notified the tower of his identification light unserviceabilities.

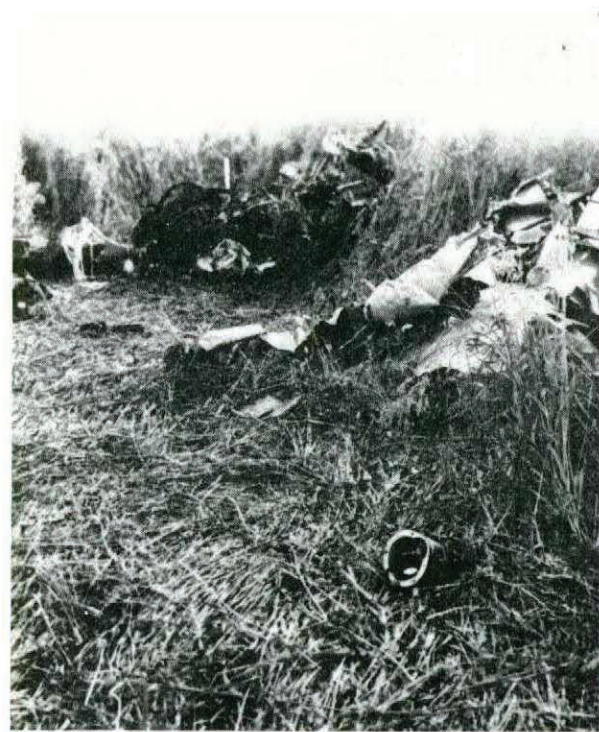
NO. 37 -- HIGH-SPEED SPIRAL DIVE

This training flight, involving dual instruction on instrument flying, ended in the tragic death of both instructor and student. The training exercise included instrument recovery from unusual positions. Eye witnesses saw the aircraft descending in a high speed spiral dive, striking the ground, and completely disintegrating. This accident has been assessed "Pilot Error" because the instructor failed to take control of the aircraft from the student in time to fully recover from the manoeuvre. Every emphasis must be placed on the importance of recovering from unusual positions at a safe altitude while flying on instruments.

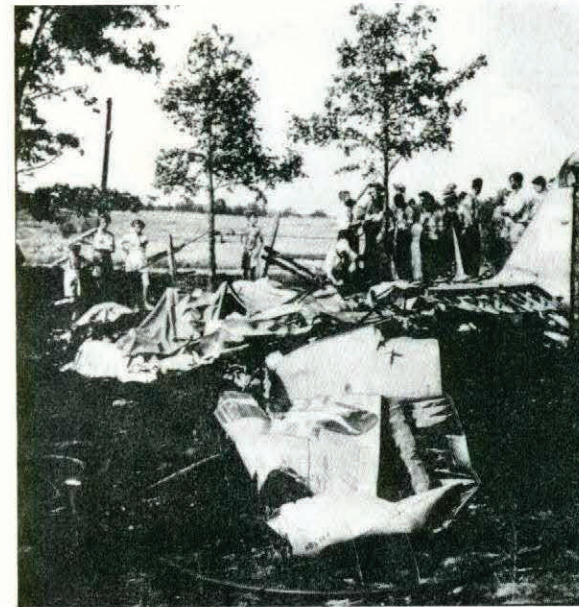
NO. 38 -- POOR RECOVERY TECHNIQUE

Witnesses first sighted the aircraft in a spin which continued until the pilot effected a recovery at approximately 400 feet above the ground. At this point, it was seen to assume a nose-up attitude and commenced a steep banked turn to port. During this turn, the nose dropped suddenly and the aircraft dove to the ground at an angle of 80 degrees. The aircraft was almost completely destroyed by impact and the ensuing fire. The pilot, who had been authorized to carry out an exercise consisting of climbing turns, stalls and spins, was killed instantly.

The direct cause of the accident is considered to be loss of control through over-controlling, after recovery from a spin at low altitude.

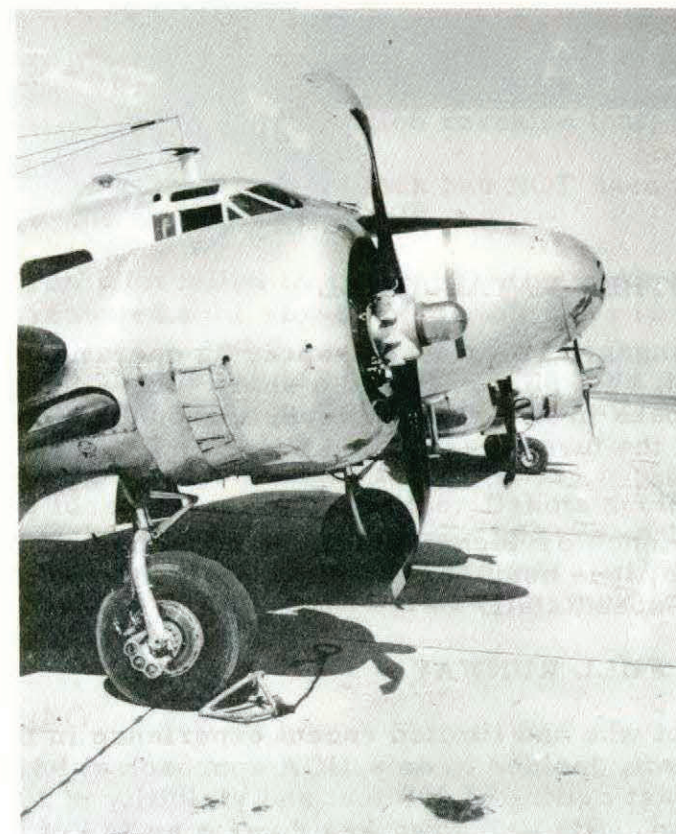
NO. 43 -- THERE ARE OLD PILOTS AND BOLD PILOTS

The two accidents listed below occurred during low level navigation exercises:

- * 1 The pilot flew so low that the aircraft struck a power line causing failure of the port rudder and damage to the starboard portion of the empennage. The pilot managed to land the aircraft at an aerodrome away from base.
- * 2 The pilot flew so low that both propellers struck the ground. The tips of all propeller blades were bent but the pilot was able to return to base.

In both of the above instances the pilots had been briefed to descend not lower than 250 feet above the ground.

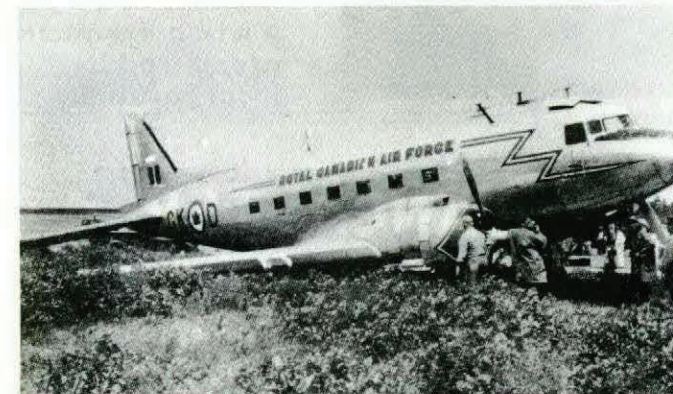
NO. 47 -- SWING

After landing, the aircraft commenced a swing to port which the pilot failed to check correctly. The result - another aircraft damaged extensively and categorized as "B".

The board of inquiry found that the pilot landed with the tail-wheel "unlocked".

Assessment of Cause - "Pilot Error".

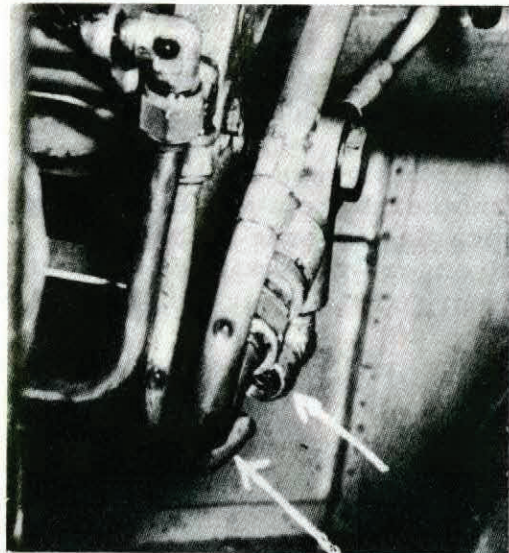
NO. 48 -- MODIFICATION MISS

When a down selection was made, the undercarriage failed to lower because of a fracture in the hydraulic line to the up-latch release. Thus, the hydraulic fluid was allowed to vent to the atmosphere. The emergency system was operated without results, so a wheels-up landing was carried out on the aerodrome.

Investigation into this accident disclosed that a modification, to replace the line which fractured with a high pressure line, had not been incorporated.

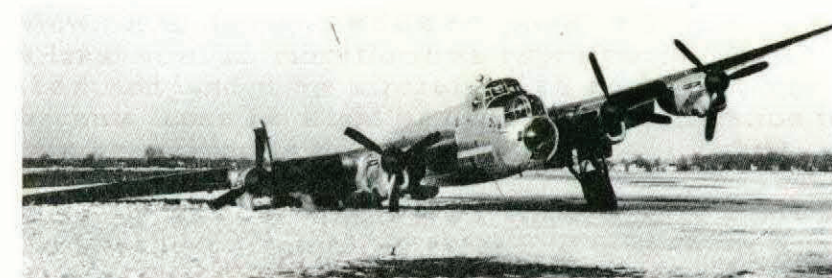
NO. 50 -- THIRD TIME UNLUCKY

Prior to being detailed to ferry a Lancaster aircraft, the pilot had ten hours dual and one hour solo on type. On the final approach, upon completion of the ferry trip, the pilot used full flap, despite the fact that the wind velocity at the time was 25 mph with strong gusts. The pilot was late in rounding out, and upon touching down, the aircraft bounced. The throttles were opened in an attempt to ease the aircraft back on the runway but on touching down the second time the control column was held forward instead of fully back and the craft bounced again, even higher than the first time. After the third bounce, the starboard tire blew out and the starboard undercarriage collapsed. The aircraft groundlooped and ended up facing in the opposite direction. Result -

A "B" category crash.
