CRASH COMMENT

SECOND QUARTER, 1953

ISSUED BY
DIRECTORATE OF FLIGHT SAFETY
R. C. A. F. HEADQUARTERS, OTTAWA, ONT.

ACCIDENT RESUMÉ

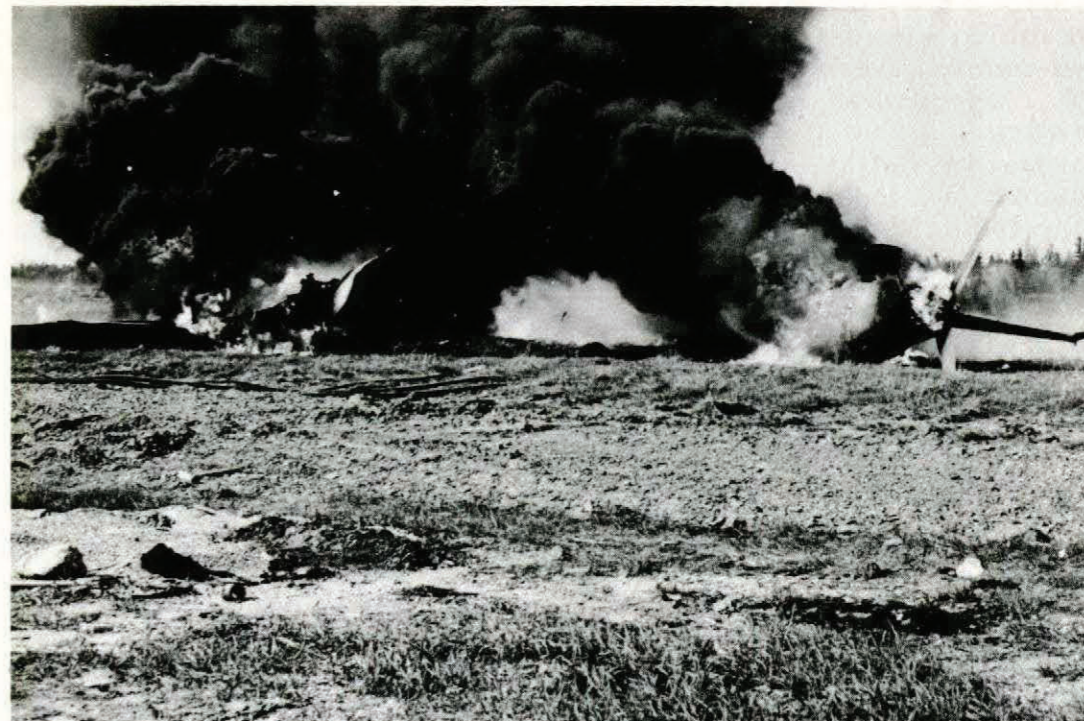
5 -- A VERY HOT LANDING

Immediately after take-off the number four pilot in a four plane Sabre formation noted his engine surging with a drop in RPM. He switched to emergency fuel system but the engine continued to surge and lose power. The pilot dropped his external tanks and made a 180 degree turn to get back onto the field. In his confusion from making a 180 degree turn at 200 feet with a failing engine, the pilot forgot to close the throttle, open dive brakes, and lower his flaps. He touched down at approximately 180 knots about one-third down the runway. On touchdown he opened the dive brakes and applied brake. The tires were stripped immediately and it appeared as if power was resumed. When the pilot realized he would overrun the runway he selected undercarriage up but could not press the "panic button" before the Sabre ran off the end of the runway into a dangerous overshoot area. The nosewheel collapsed when the Sabre struck a manhole. The fuselage separated from the wings and the entire aircraft burst into flames. The pilot is uncertain how he escaped from the aircraft. He suffered severe shock and burns about the face, arms and shoulders. The aircraft was burned beyond repair. This accident is still under investigation but a tentative primary cause for the accident appears to be "Pilot Error" because of the poor airmanship displayed by the pilot during his forced landing. It is believed the engine failed because of water in the fuel.

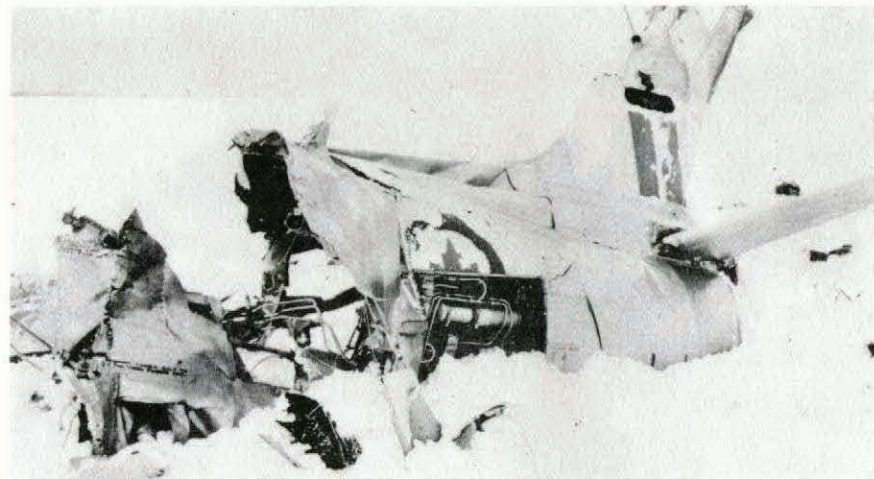
6 -- FATAL HORIZON

This fatal formation accident occurred in the first quarter 1953 but the lesson to be learned warrants inclusion of the accident in this issue of Crash Comment. A two plane Sabre formation was making a pipeline descent to base. During the descent number one's radio compass became unreliable so he asked number two to take the lead. The leader reported over the inner beacon at 4,000 feet and stated they were intermittently visual. Instead of continuing the descent to the field the leader requested permission to make a single beacon approach from 4,000 feet. During this procedure both Sabres crashed and disintegrated on the ice of a bay and both pilots were killed. There were no reports from the pilots after the leader's request for a single beacon approach and there were no eye witnesses to the crash. Investigations have determined the following course of events to be most probable. It is believed the formation became visual before the let down procedure was completed so the leader decided to continue to base at low altitude under visual conditions. In a turn to starboard the pilots apparently suffered "white-out" and flew into the snow covered surface. "White-out" is a winter phenomenon whose characteristics must be recognized or the consequences may be fatal. When the atmosphere is "milky" with low thin cloud and haze, there is no contrasting features on the snow covered surface, and the pilot can easily lose his sense of depth perception as the sky and land seem to merge into one. When this condition is even suspected go onto instruments immediately as it is impossible to accurately judge your height above ground. The cause of this accident has been assessed as "Pilot Error" because the leader of the formation deviated from the standard pipeline descent, and then failed to recognize the hazardous condition of poor depth perception due to "white-out".

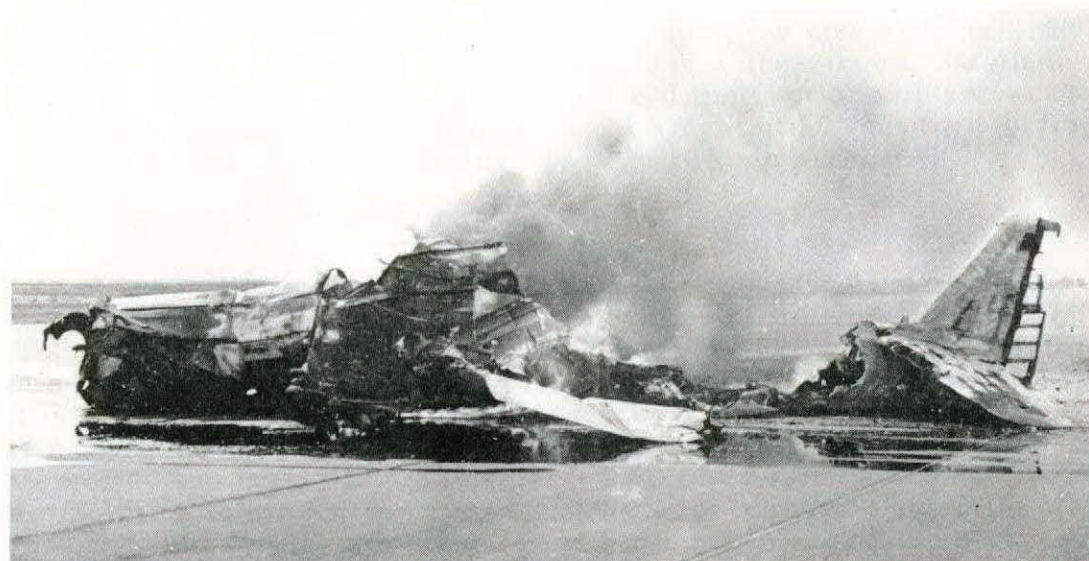
17 -- THIS WAS A MUSTANG!

The pilot allowed his airspeed to drop dangerously low on the approach. The Mustang stalled and crashed on the beginning of the runway. The port wing struck the runway and folded upwards as it split. The undercarriage was sheared off, followed by fire which completely destroyed the aircraft. The pilot escaped without injuries. The cause of this accident was "Pilot Error". The pilot displayed extremely careless airmanship, in that he could not recall whether he used flap during the approach, and he failed to check his airspeed on final.

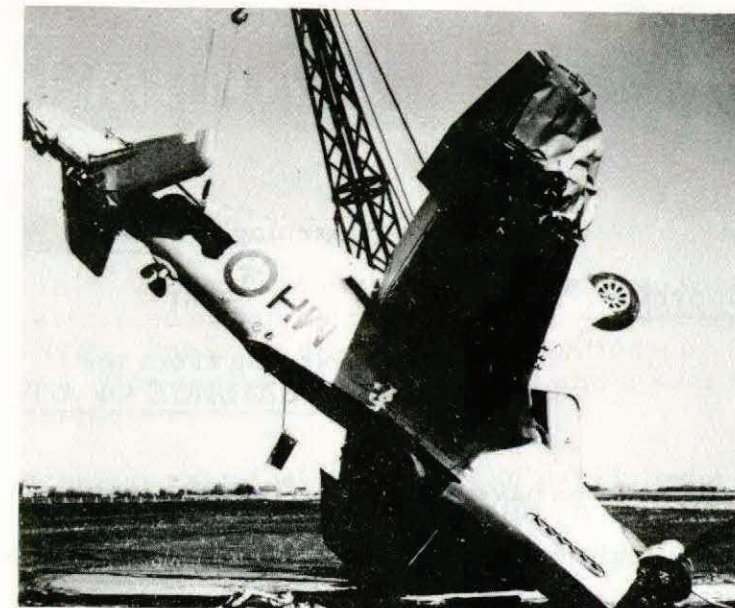
18 -- DISASTROUS TECHNIQUE

The pilot was inexperienced on the Mustang so when informed by the tower of a strong crosswind he made a "touch and go" to determine the aircraft's reaction. On the downwind leg the tower informed him the wind was 90 degrees to the runway and gusting to 35 mph. The pilot lowered full flap and made a three point landing. The inevitable ground loop followed only this swing had a serious ending. The port wheel dug into the soft shoulder of the runway causing the Mustang to cartwheel and crash in the inverted position. The aircraft was a complete "write-off". The pilot received only minor injuries.

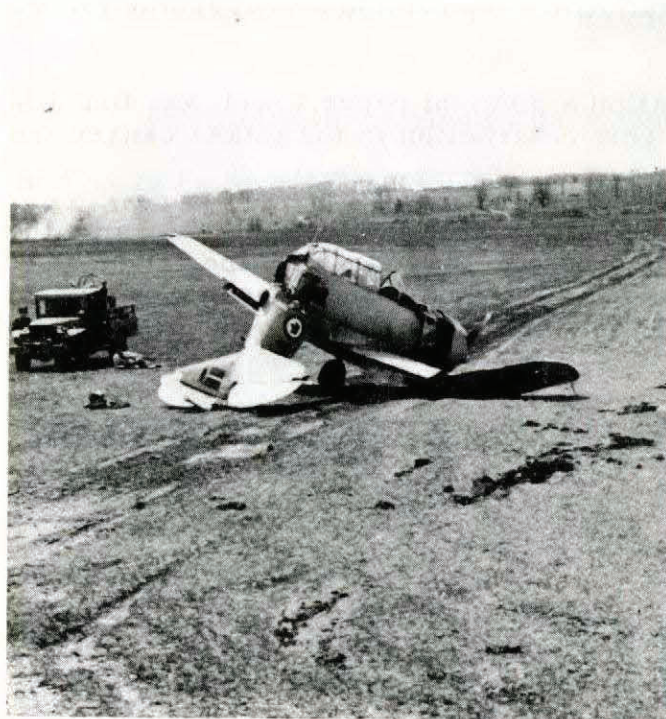
20 -- AN UNUSUAL LANDING!

The student pilot was attempting a three point landing. The Harvard ballooned badly with a very nose high attitude. The aircraft reached a height of about 30 feet and then stalled. The right wing struck the ground first and the resulting crash split the fuselage behind the rear cockpit. The aircraft was a "write-off". The pilot escaped injuries. The primary cause of this accident was "Pilot Error" because the pilot should have overshoot after the bad bounce rather than try to correct the landing. The secondary cause has

been assessed as "Briefing" because the student pilot was authorized to go solo when he had flown beyond the permissible solo time before having a dual check.

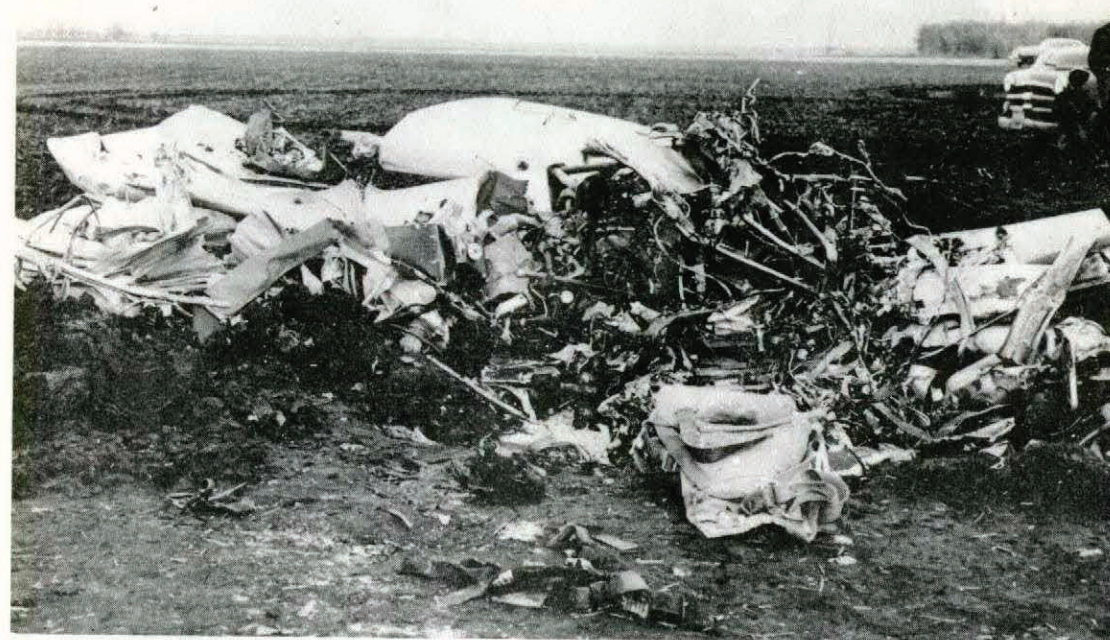
22 -- FATAL VIOLATION OF ORDERS

Two trainee pilots were authorized to practise mutual instrument flying. A half hour later both men were dead. Eye witnesses saw their Harvard do a series of consecutive loops. After one of these loops the Harvard descended out of control in either a spin or a spiral dive. The aircraft struck the ground at a very steep angle, instantly killing both pilots and completely destroying the aircraft. The pilots violated three separate orders by performing mutual aerobatics; the F17, a Command Instruction and CAP100 Chapter II, Section 35, subpara 3. For reasons which are obscure, the pilot was unable to regain control of the aircraft after an aerobatic manoeuvre.

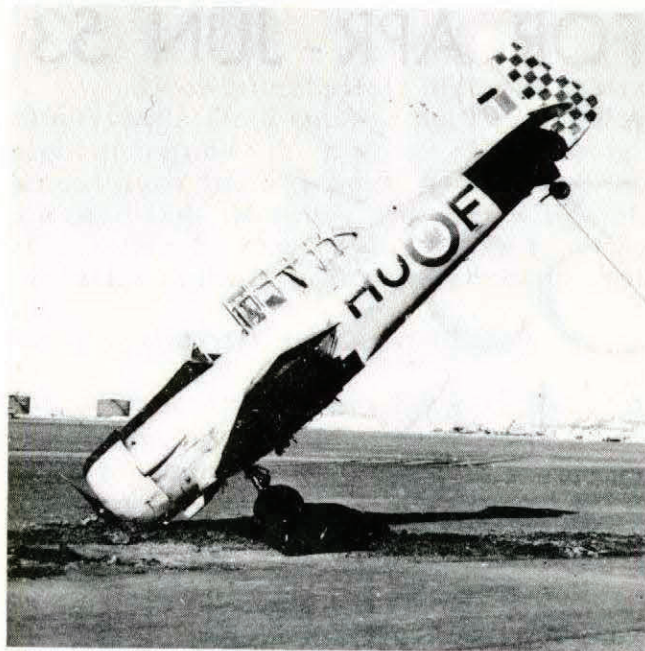
28 -- OUT OF CONTROL

The pilot made a flapless wheel landing under crosswind conditions. As the tail of the Harvard lowered it swung to the right. The pilot overcorrected and then appeared to lose control. The aircraft zigzagged down the runway until it eventually ran off the side into the soft infield and flipped upon its nose. The cause of this accident has been assessed "Pilot Error".

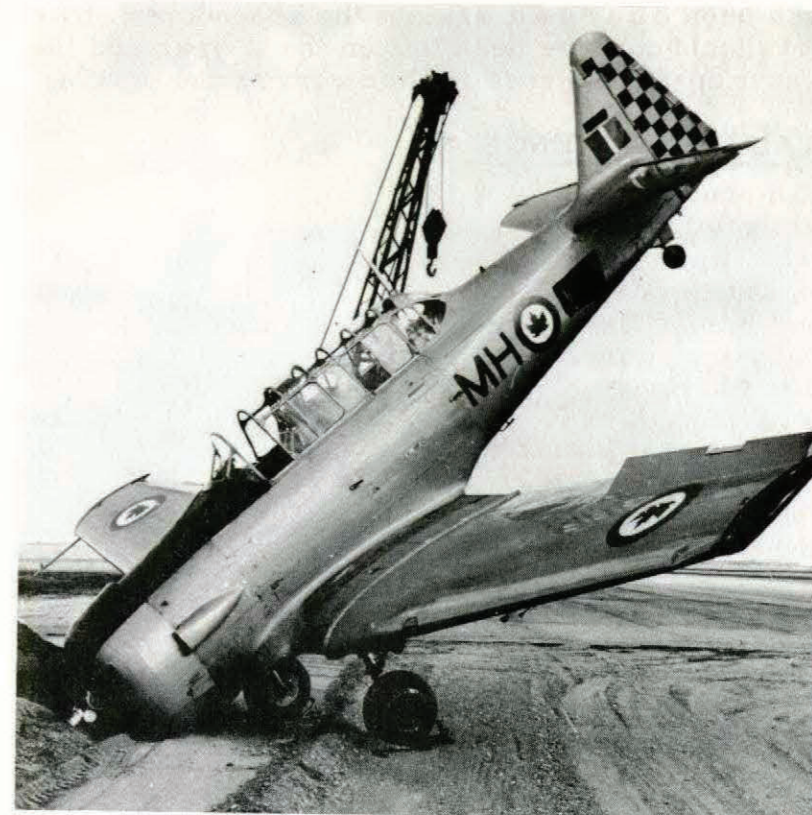
This pilot had 4,000 feet of runway in which to land a Harvard, but the accompanying photo shows his aircraft imitating an ostrich at the end of the runway. The pilot made a wheel landing with no flaps about a third of the way down the runway. He ran off the end of the runway onto the extension which was under construction. The starboard wheel struck a pile of gravel and the Harvard went up on its nose. The port wing and propeller were damaged beyond repair. The accident was caused by "Pilot Error".

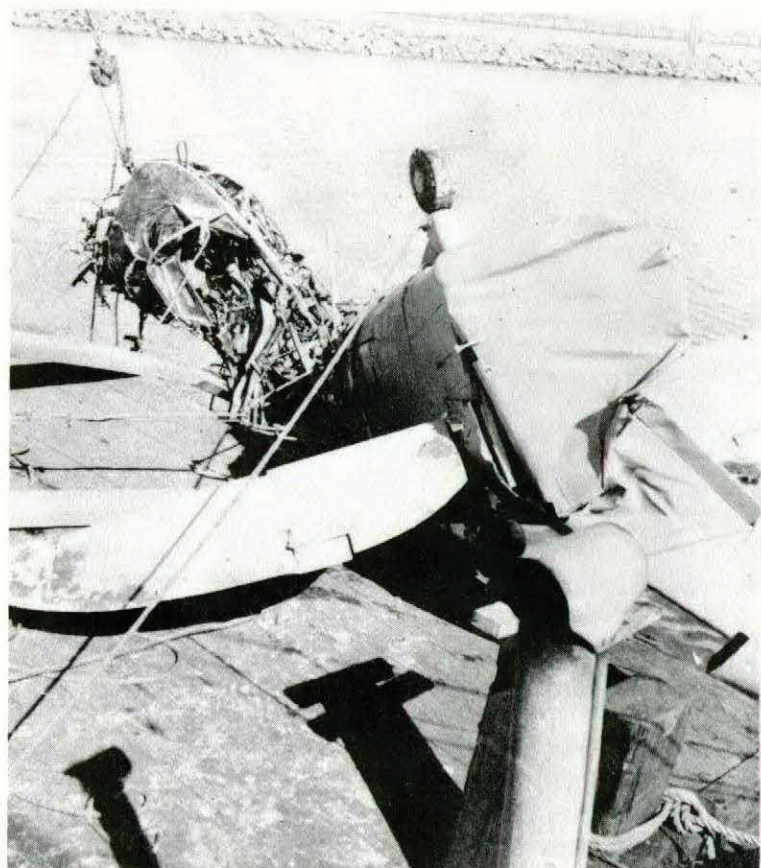
37 -- FATAL DISOBEDIENCE

The pilot was authorized to practise circuits, and forced landing procedures. He deliberately disobeyed these instructions and proceeded to make quarter attacks on another Harvard flying at 2500 feet. After one pass the pilot rolled out of a dive and flicked to the right into a spin. The pilot flicked into the spin at approximately 1500 feet. The Harvard spun or spiral dived into 12 feet of water. The pilot was instantly killed. The cause of this accident was "Pilot Error" in that the pilot lost control of his aircraft at a low altitude and crashed. Contributing factors were his disobedience of flying orders, his relative inexperience as a pilot, and lack of airmanship in indulging in fighter tactics at such a low attitude.

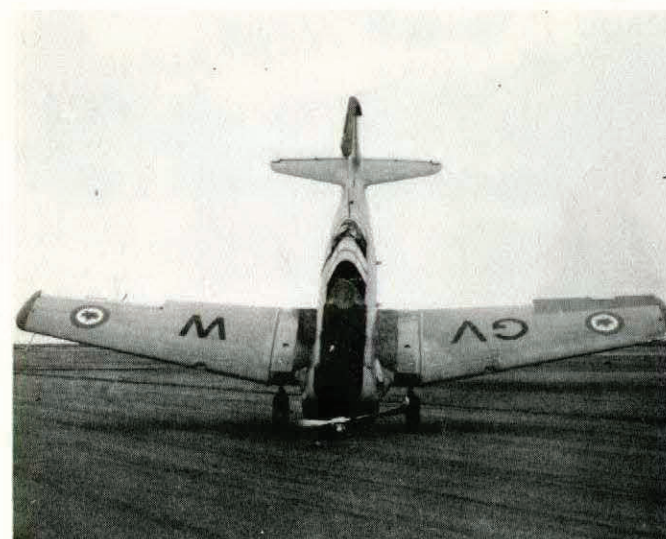
38 -- TOO MANY COOKS, ETC --

A student pilot was being given a circuit check. After touchdown the Harvard swung to port. The student took corrective action but the instructor overrode his control, without informing the student, and applied harsh starboard brake. The aircraft then developed a swing to starboard and it seems both pilots applied harsh port brake which caused the Harvard to flip up on its nose. This is the old story of neither pilot knowing who had control.

When either pilot takes control he should state the fact and receive confirmation from the other pilot.

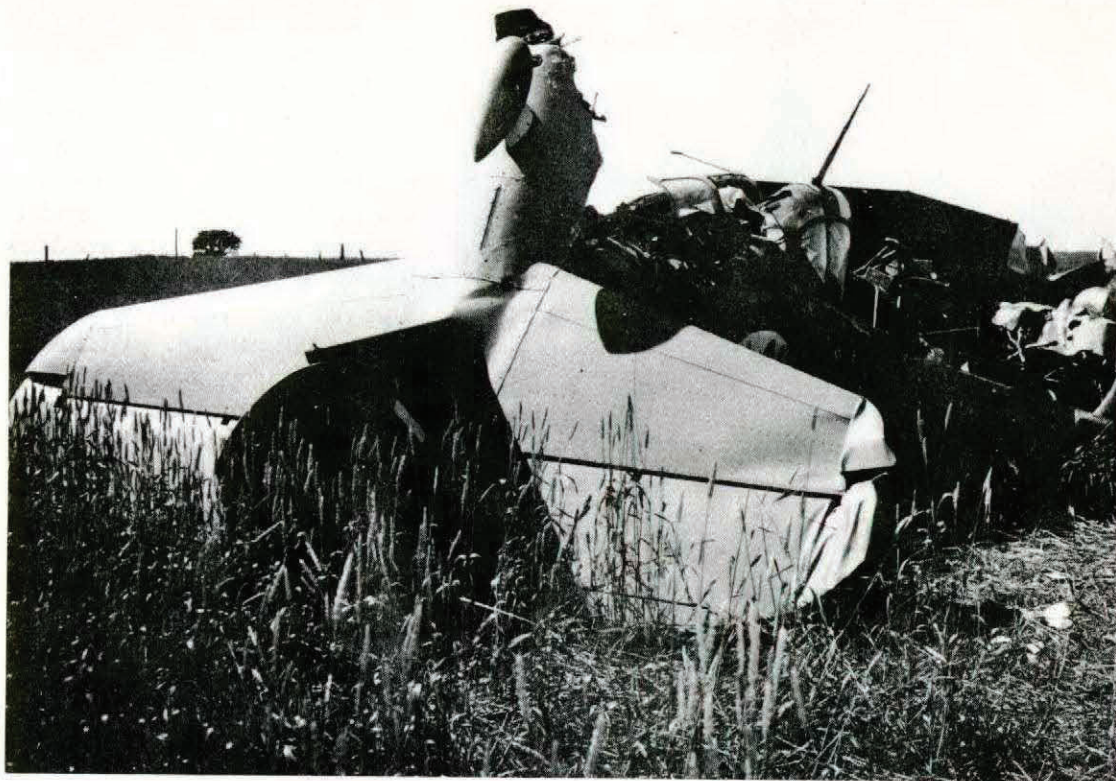
The pilot of the above heap of scrap metal, which before the crash was a serviceable Harvard, violated flying orders. He is now convalescing from serious injuries. Two pilots pre-arranged to carry out unauthorized flying in Harvards. At about 5000 feet the two pilots engaged in a dog fight which gradually lowered to an estimated 50 to 100 feet above ground level. One pilot made an overhead pass at the other and made a descending left turn to about 50 feet above the ground and then climbed away. The second pilot followed the first down in the turn and then one of two things happened (a) he encountered the slipstream of the first Harvard and lost control or (b) he levelled off too close to the ground and the aircraft mushed. The Harvard struck the ground and was totally destroyed. The pilot was seriously injured. The ripe wheat about the wreckage bears mute testimony to the passage in the Bible-----"AS YE SOW, SO SHALL YE REAP".

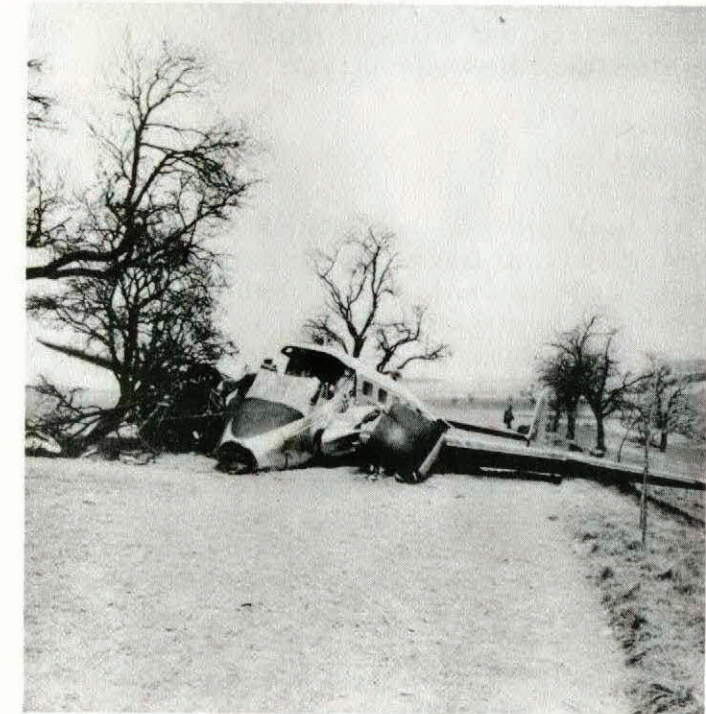
43 -- WATER IN THE FUEL

A Communications Flight Expeditor took-off with one pilot, a navigator, and four passengers. Five minutes after take-off at approximately 1500 feet the port engine failed. Thirty seconds later the starboard engine failed. The pilot had very little time to prepare for a forced landing in hilly terrain. The pilot stalled the Expeditor into a pancake landing on the top of a hill. The aircraft bounced and the starboard engine struck a tree. All passenger seats were broken loose on impact. The occupants were all in-

jured, three of them seriously. The aircraft was extensively damaged. The cause of the double engine failure was determined to be water in the fuel. An investigation is now under way to determine the source of the water found in the fuel. It has been recommended that all RCAF refuelling tenders have water strippers installed.

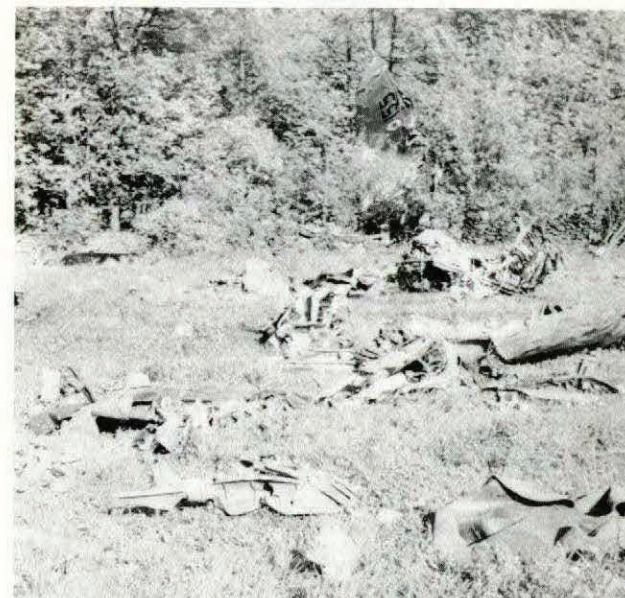
49 -- FATAL ERROR

With a crew of three and five passengers, a Mitchell pilot filed an IFR flight plan. Enroute at night he revised his flight plan and gave his new destination as a closer airfield than his former destination. The pilot reported over his revised destination and received clearance for a standard range approach. On his first attempt at landing the pilot made an overshoot and was cleared for another SRA with the alternative of remaining visual

if he wished. The aircraft was next seen heading across the field on what was assumed to be a runway procedure. The Mitchell crashed a few minutes later about two miles from the aerodrome while apparently turning to the left onto the final approach leg. The eight occupants were killed and the aircraft almost completely destroyed.

The subsequent investigations proved there was no indication of fire or structural failure prior to the crash. Although this accident is still under consideration the cause has tentatively been assessed as "Pilot Error". The crewman made an incorrect fuel entry in the L.14, showing the aircraft as having 120 gallons more than it actually carried. The port tanks contained 49 gallons less than the starboard tanks. The pilot grossly under-estimated his fuel consumption and was therefore compelled to revise his flight plan and land at the nearest aerodrome for the purpose of refuelling. It is believed the pilot lost control of his aircraft for one, or a combination of the following reasons: (a) failure of the port engine through fuel starvation; (b) the pilot encountered cloud at 400 feet while turning to port and while attempting to remain below the cloud he allowed the port wing to strike trees.

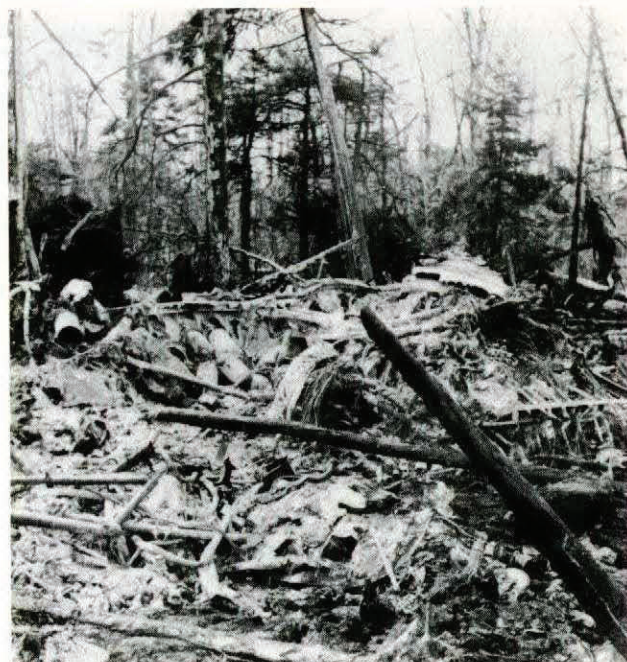
51 -- FATAL NAVIGATION ERROR

reasons unknown the captain disobeyed his orders and climbed to 4000 feet. Again, for unknown reasons the navigator permitted the aircraft to drift some 40 miles off track to the port. The Lancaster drifted over mountainous territory with the pilot flying in cloud. The aircraft flew into a 4100 foot mountain while flying at an estimated speed of 175 knots. The ten occupants were instantly killed and the Lancaster disintegrated. This accident is still under investigation but a provisional assessment resulting from available evidence as to the cause of the crash indicates both pilot and navigational error. The pilot disobeyed his briefing orders in not remaining VFR and in climbing beyond the prescribed height. The first navigator appears to have been lax in his duties in permitting the aircraft to drift so far off track. Possibly all navigational aids were not used because the crew apparently did not realize they were over land.
