CANADIAN
CONSERVATION
INSTITUTE

INSTITUT
CANADIEN DE
CONSERVATION

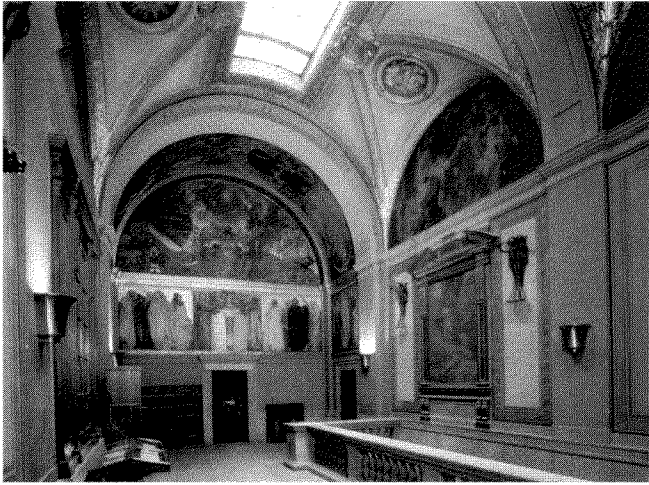
Figure 1. Sargent Hall looking north, 1999.

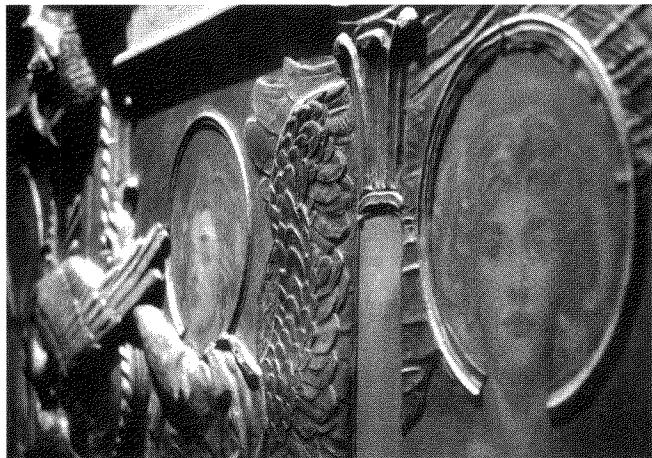
Figure 3. Detail of Frieze of Angels on the south wall. Papier-mâché relief elements applied over painted canvas.

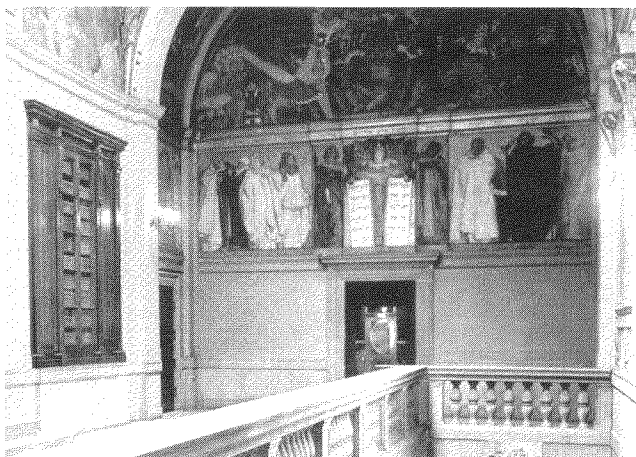
Figure 5. Sargent Hall looking north, after 1919. Original commercial lamp dating from 1895 at left, and brass sconces designed by Sargent in 1916 at right. Photo: Trustees of the Boston Public Library.

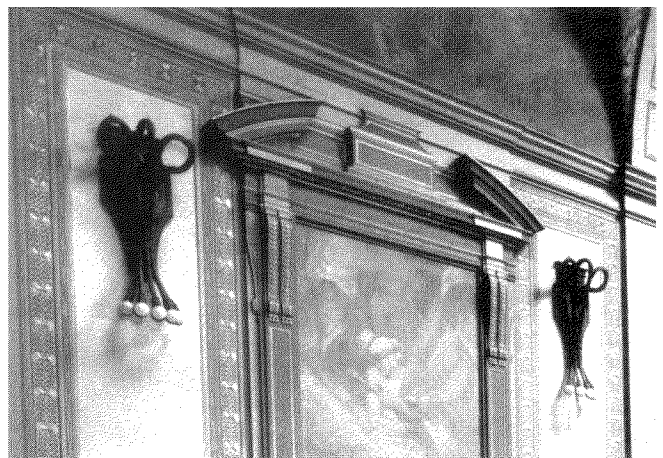
Figure 6. Pair of Sargent brass sconces on either side of Synagogue mural, circa 1919. Note glass bulbs on sconces that were subsequently removed in 1953 and replaced with non-functioning brass ball replicas. Photo: Trustees of the Boston Public Library.

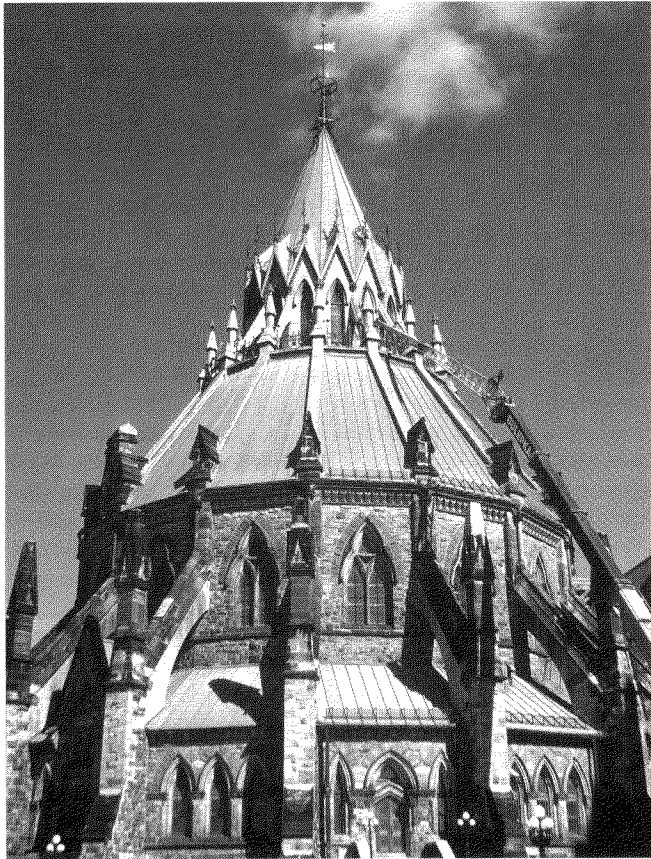
Figure 1. Exterior of the Library of Parliament, Ottawa.

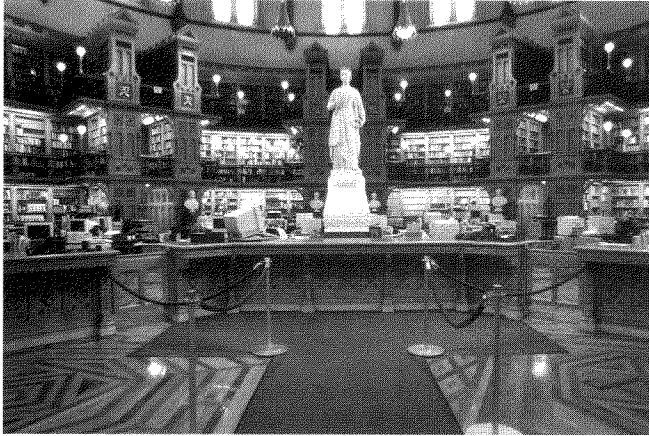
Figure 2. Overall interior view of the Library of Parliament.

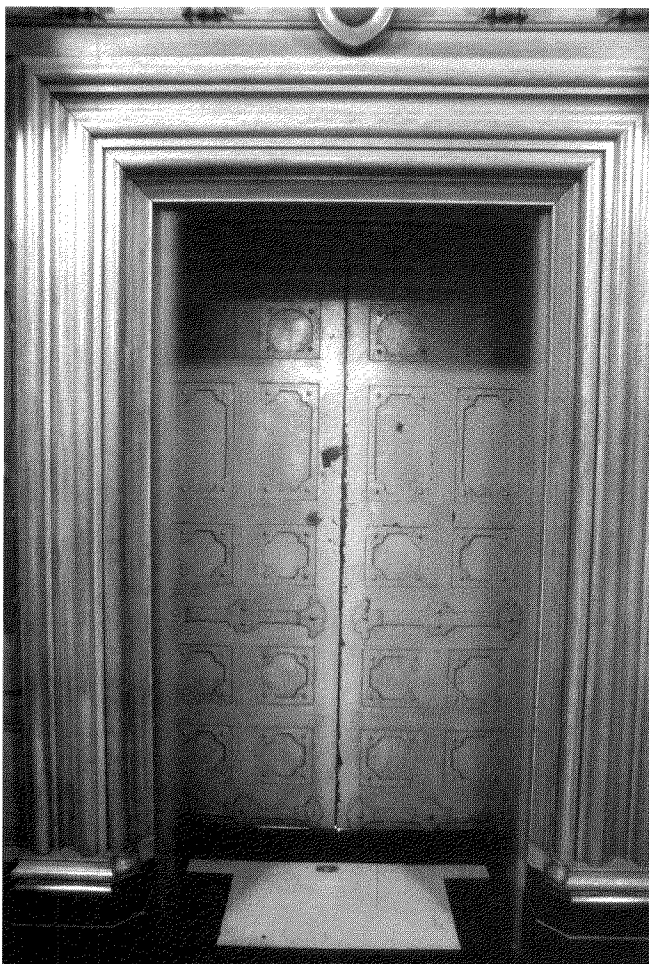
Figure 3. Fire doors to the Library of Parliament which date prior to 1916.

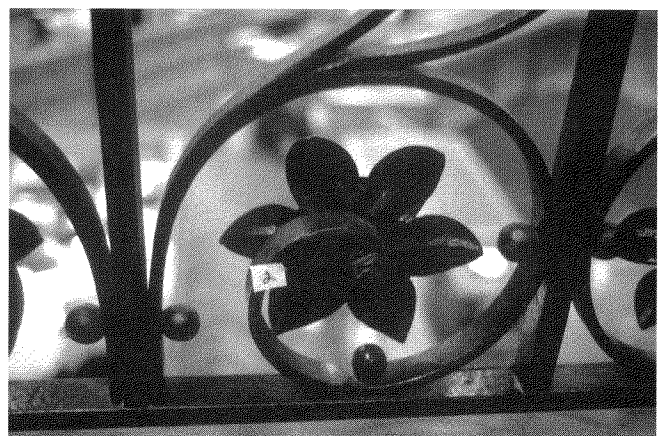
Figure 4. Close-up of the interior railings of the Library of Parliament.

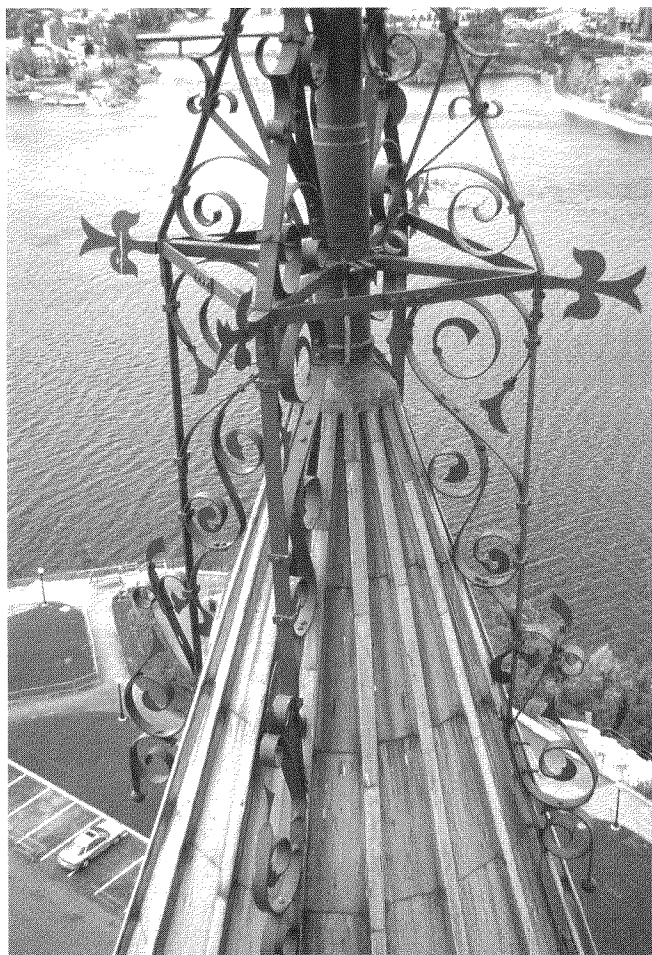
Figure 5. The roof and ornamental ironwork on the exterior of the Library of Parliament.

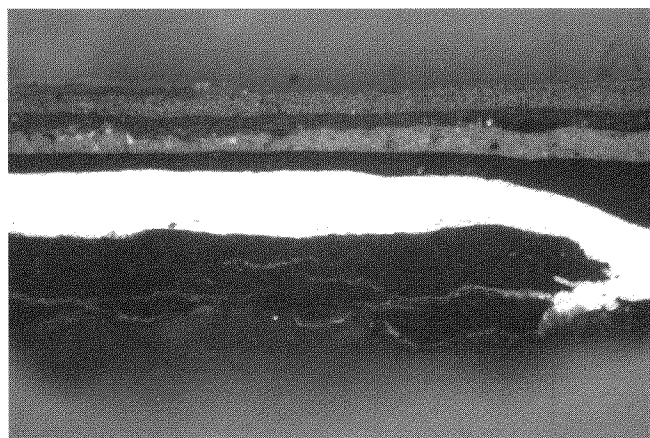
Figure 6. Cross section of the remaining paint layers from the weathervane of the Library of Parliament.

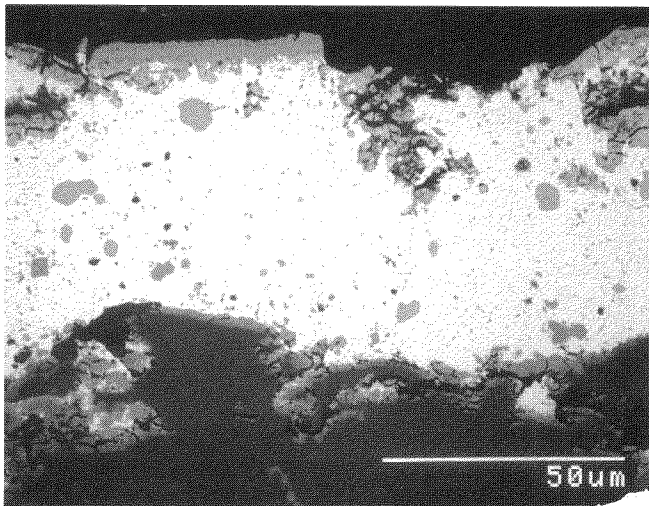
Figure 7. Backscattered electron micrograph of a cross section of the terne-coated copper sheet used on the roof of the Library of Parliament.

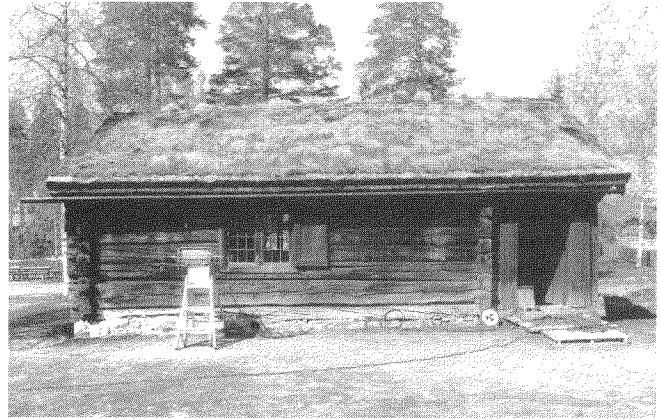
Figure 1. Synvisstua seen from the south, with the X-ray unit ready for exposure. Photo: Brænne.

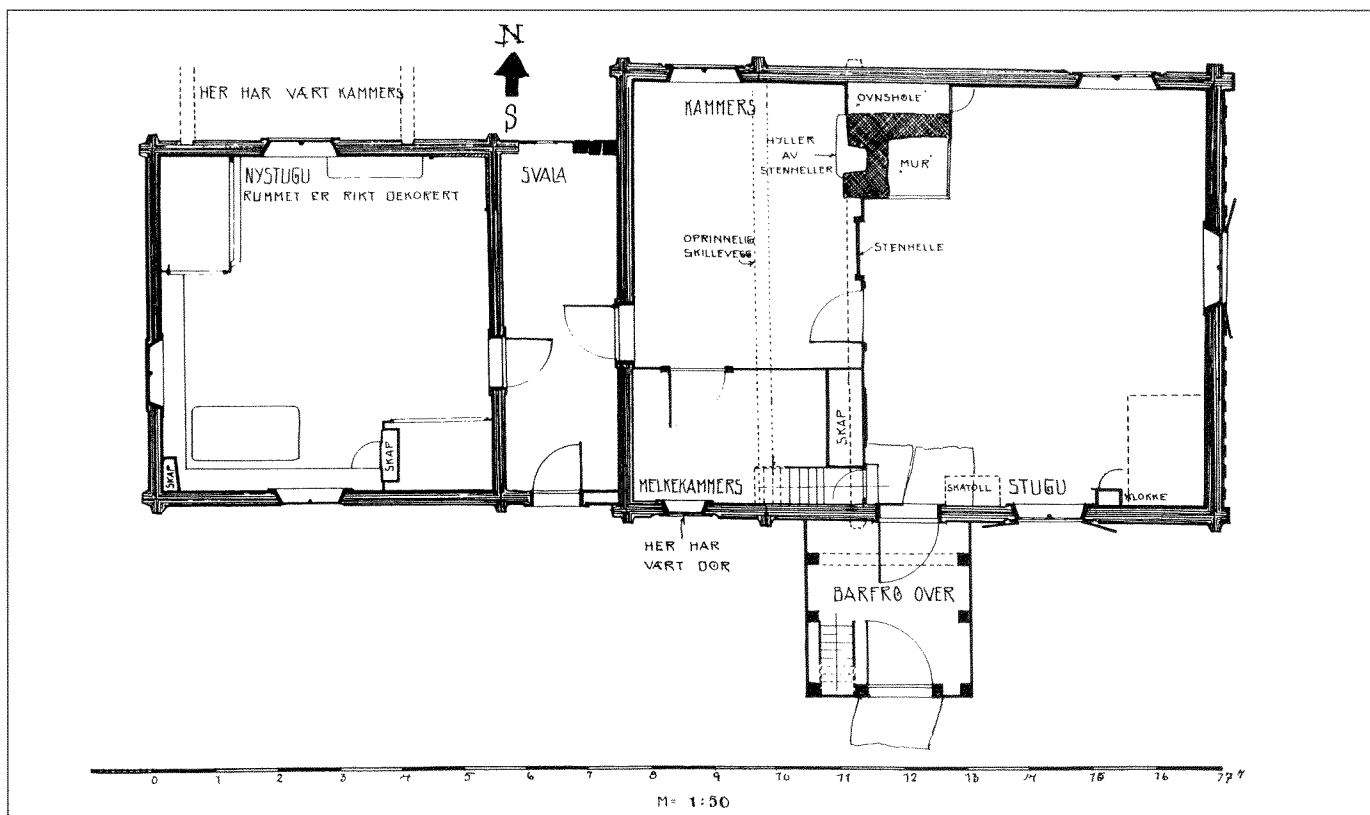
Figure 2. Ground plan from 1933, when the buildings still occupied their original sites on the farm. To the left is Synvisstua, with the entrance room to the right. The log-built dwelling to the right was left on the farm. When Synvisstua was dismantled, the log wall in the dwelling that formed Synvisstua's outer wall was replaced with pine and spruce deals.

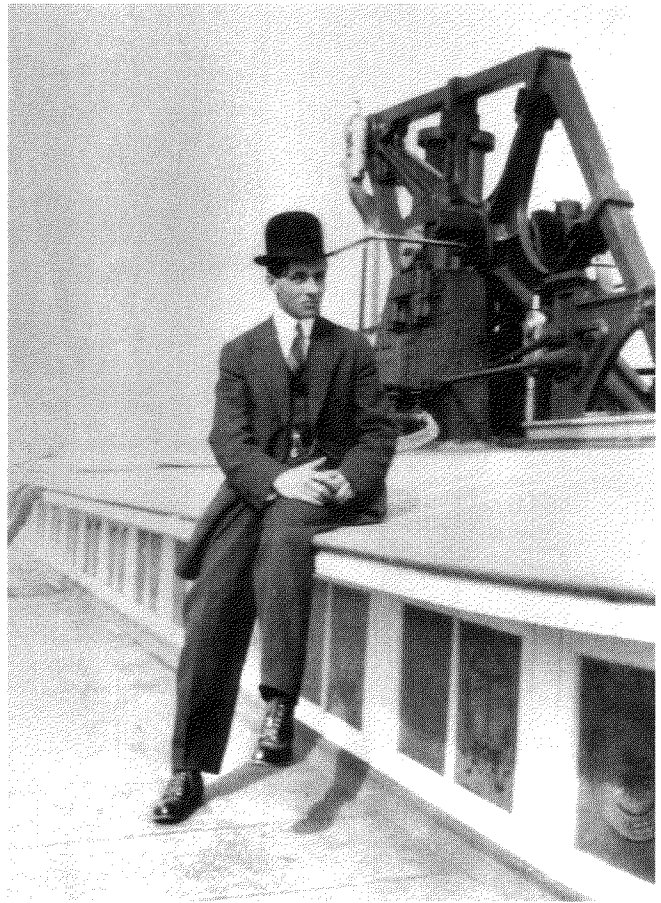
Figure 2. Charles Cole seated on the turtle dome on the hurricane deck during his honeymoon, September 1909 (4.20.4-636).

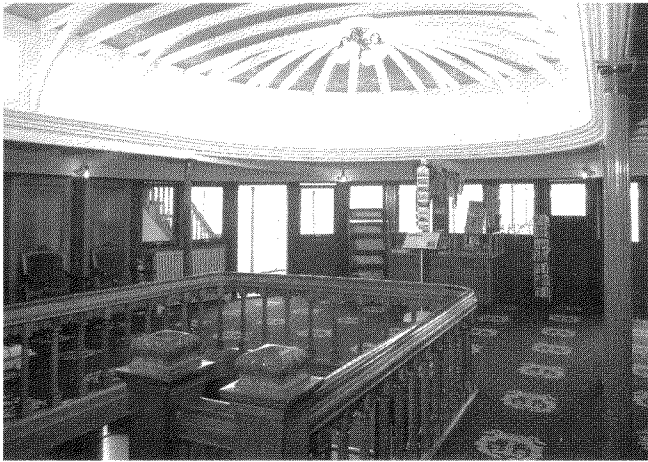
Figure 3. Restored stateroom hallway, and interior turtle dome, September 1998.

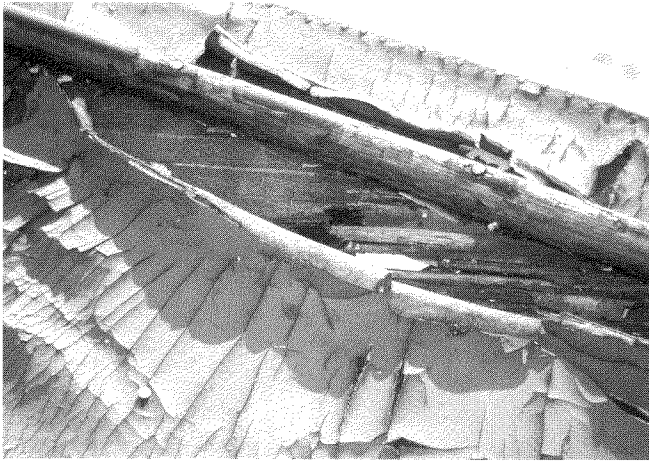
Figure 4. Deteriorated deck canvas/hurricane deck, 1993.

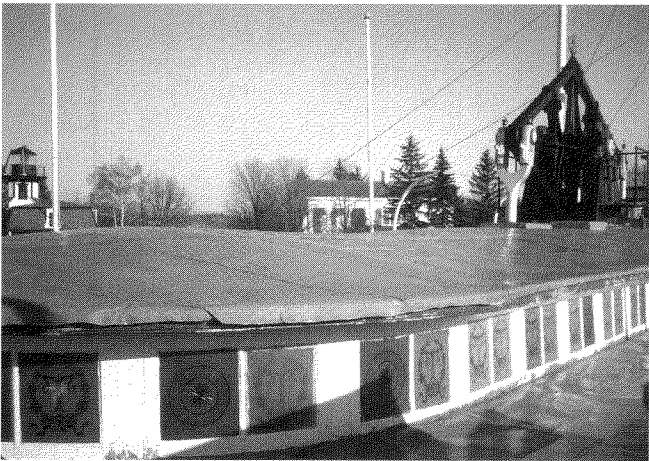
Figure 5. Turtle dome windows and deck with aluminum roofing flashing, 1993.

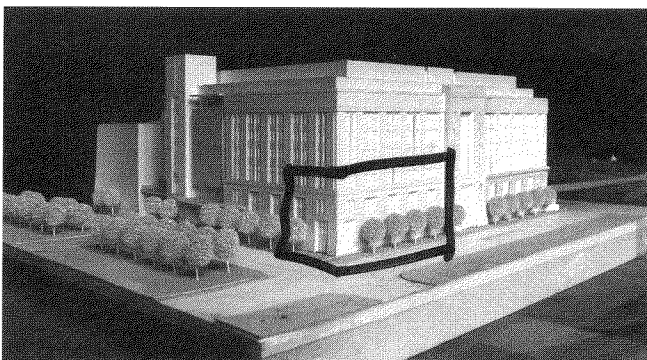
Figure 1. Architects' Model DPB 1935. Subject room marked.

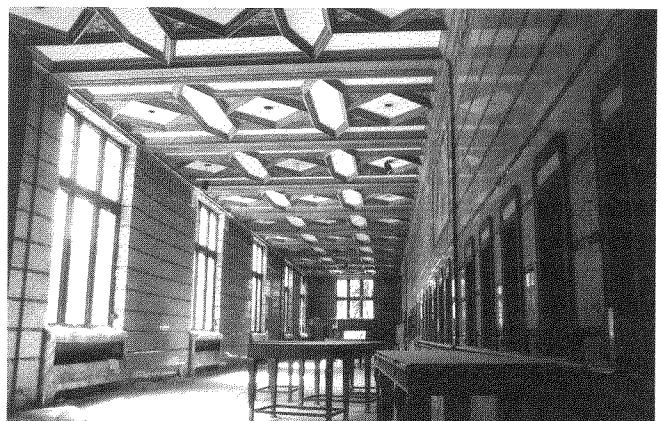
Figure 2. Postal hall of the Dominion Public Building is clad floor-to-ceiling in marble.

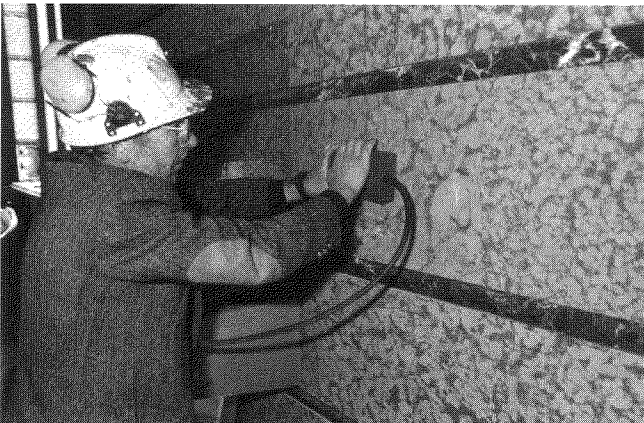
Figure 3. Technician passes 1-GHz antenna across the wall surface.

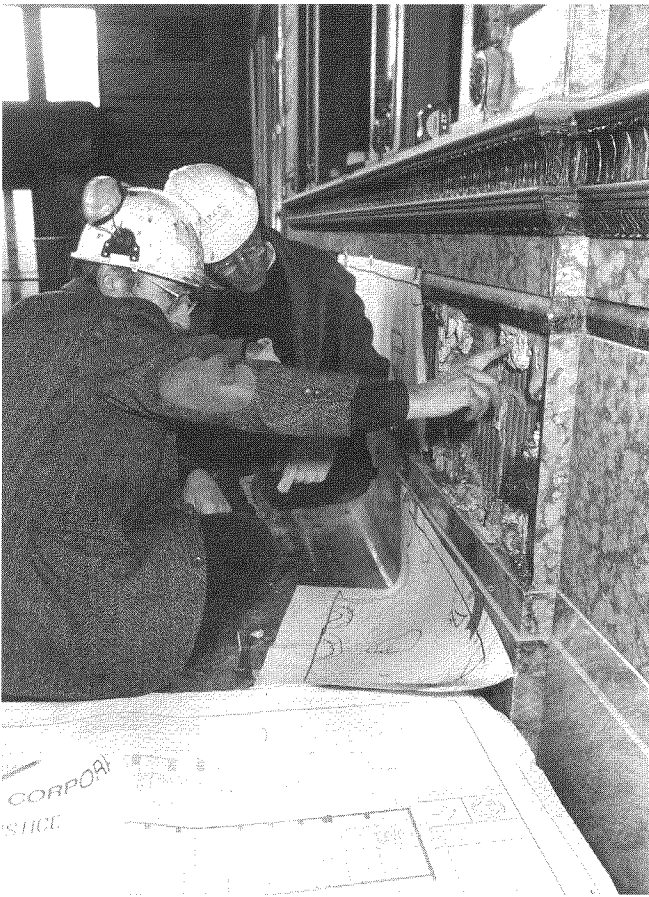
Figure 6. Once the test indicated that the procedure located the plaster adhesive patches with 90% accuracy, the survey continued.

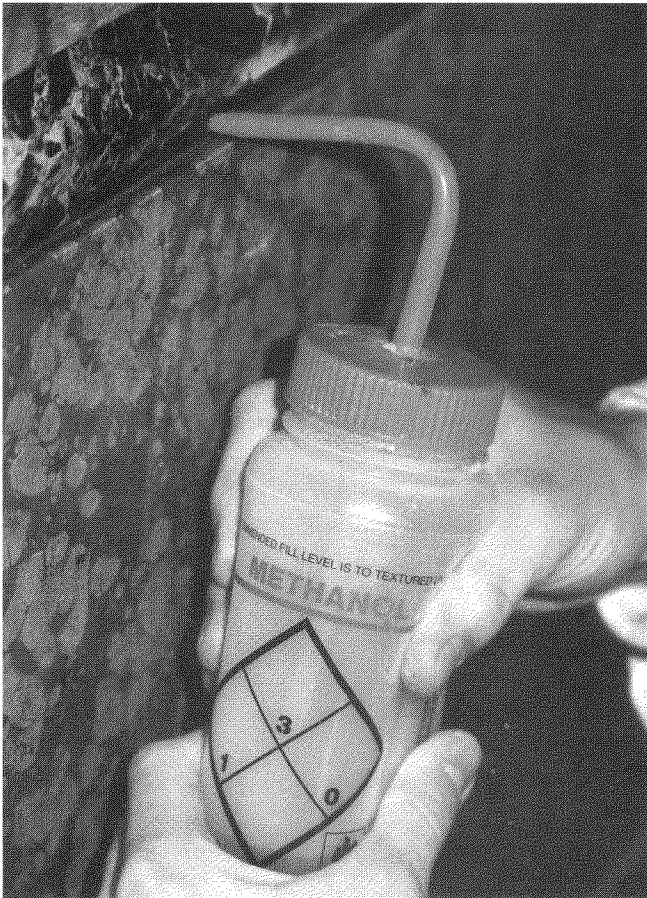
Figure 7. Methanol rinse being applied.

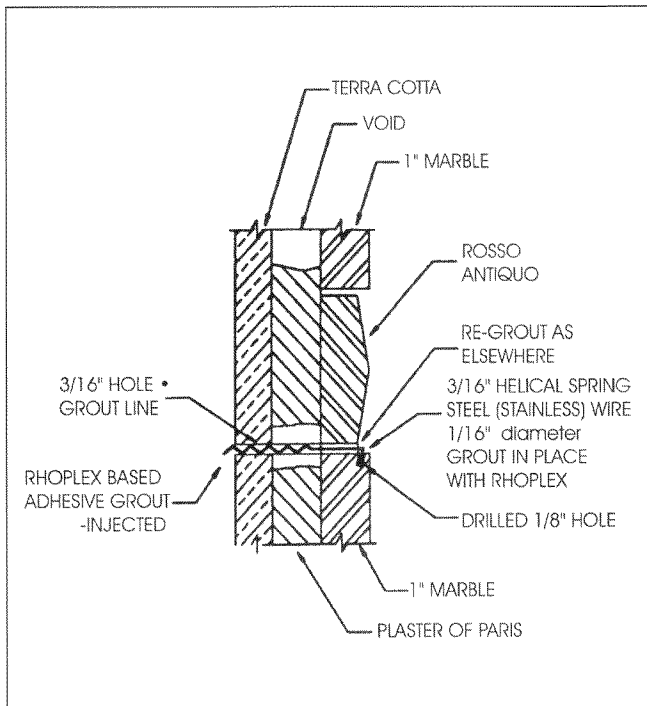
Figure 8. Cross section of marble cladding and wall showing mechanical connection.

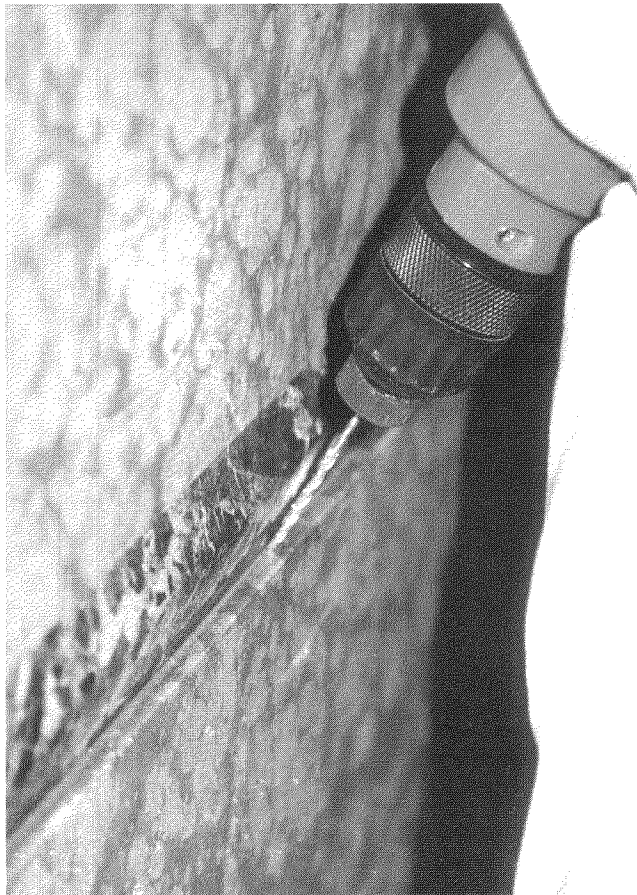
Figure 9. A 0.08-cm ($1/32$ -in.) hole drilled at 45° to accept the tail of the mechanical fastener.

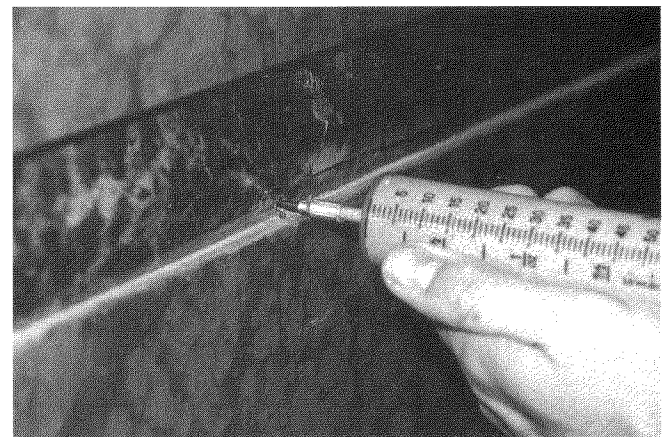
Figure 10. A filled adhesive is applied by injection through the centre of the helix to bond the stainless to the terra cotta. Once set, the straight end is fitted into the angle hole and a drop of Rhoplex placed to hold it.

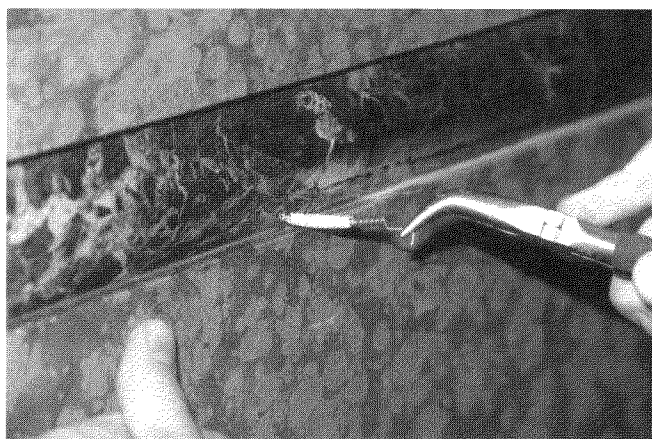
Figure 11. Stainless helical spring is inserted. Note the tail is formed to fit the hole being drilled in Figure 9.

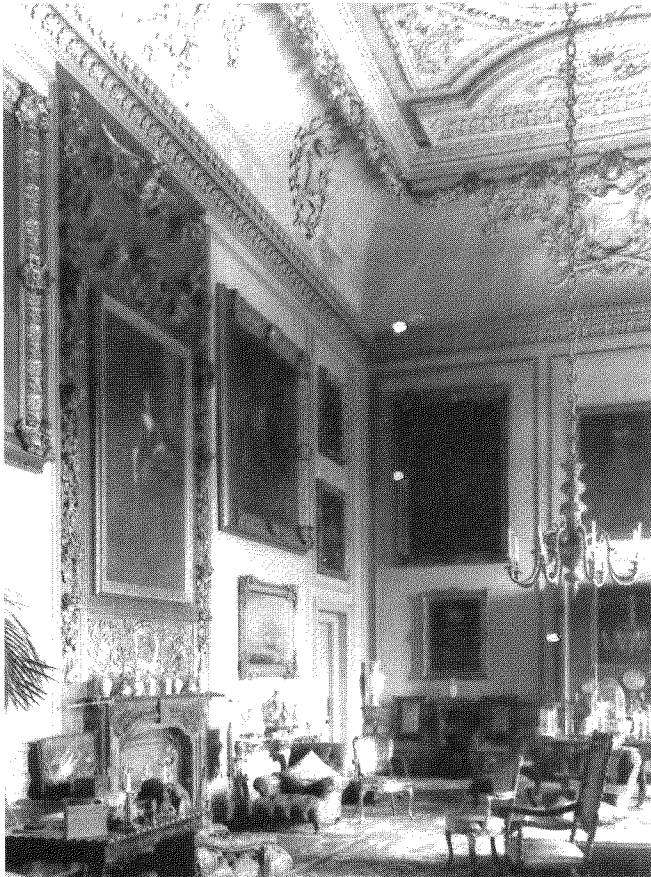
Figure 1. Blue Room, circa 1900. Note the Grinling Gibbons overmantle and ornate plaster festoons, which are now missing. Photo: Country Life.

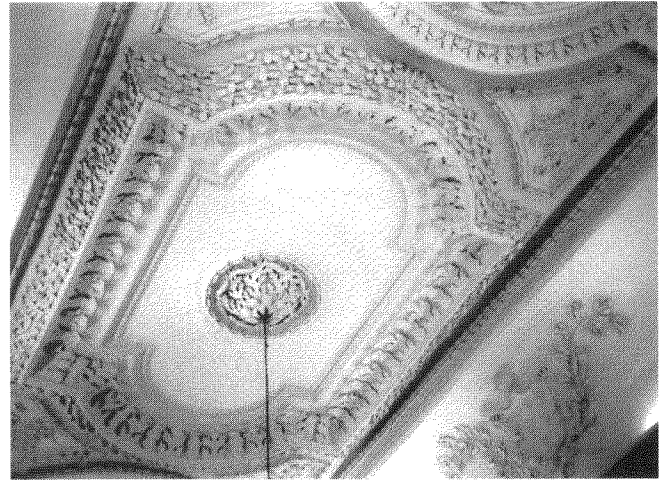
Figure 2. Ceiling of Blue Room, taken after completion of repair work. Photo: Chris Daniels.

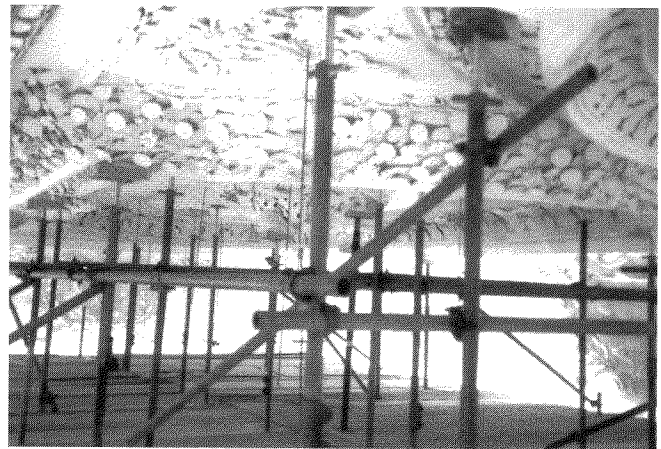
Figure 3. Propping system in place prior to work commencing. Photo: Chris Daniels.

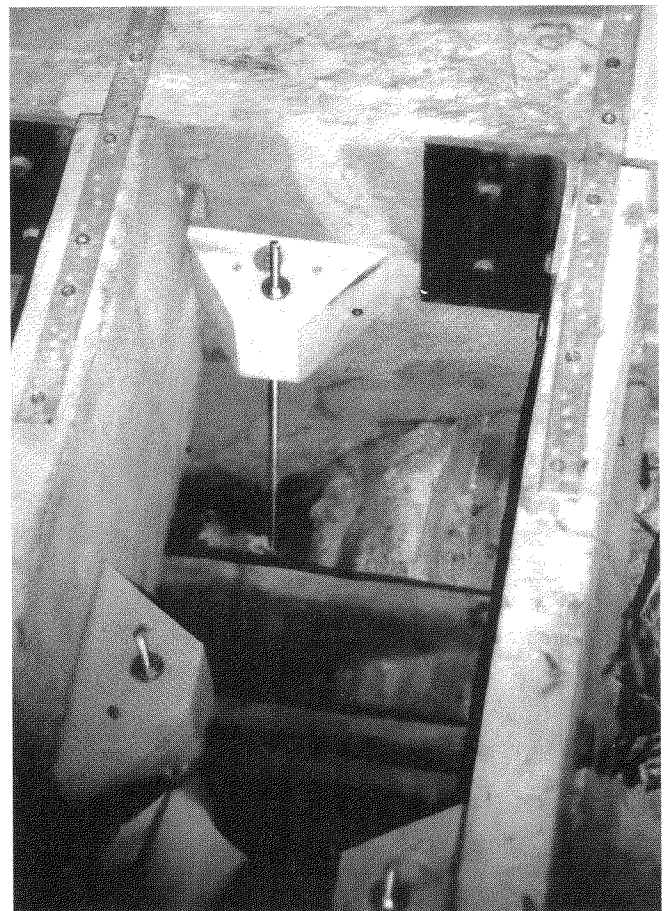
Figure 7. Junction of joists to tie beam showing straps and cleats added for extra rigidity. Also shown are the lugs through which structural ties, holding up plasterwork substructure, are secured and adjusted. Photo: Chris Daniels.

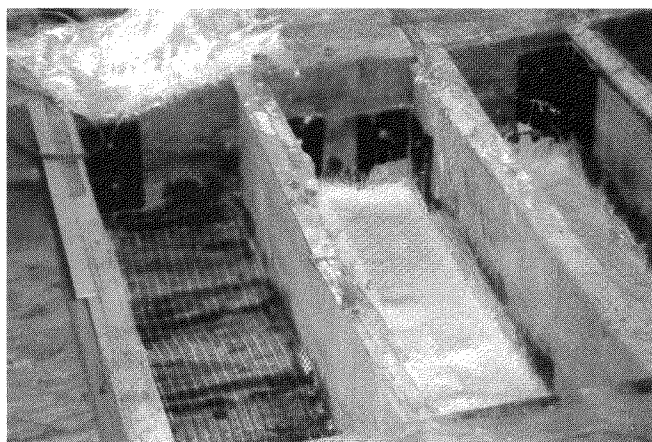
Figure 9. Re-attaching plaster to structure. Expamet shown in left bay, poured plaster in other bays. Note fibreglass mat on tie beam. Photo: Chris Daniels.

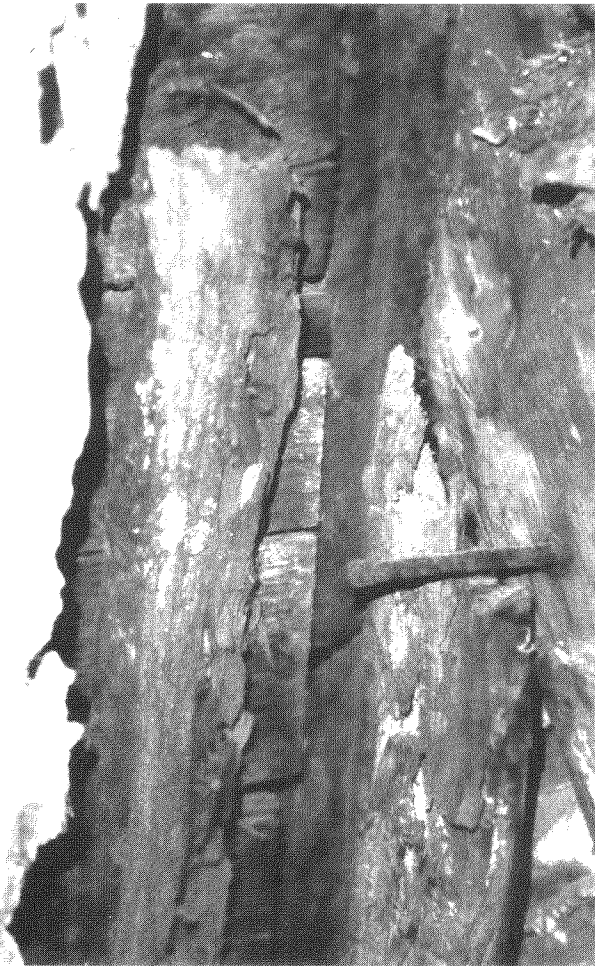
Figure 10. Extent of missing wood from rafter. Remnant of rafter resting against roof boarding. Note nail at right is 150 mm long and was used to attach joist to rafter. Photo: Chris Daniels.

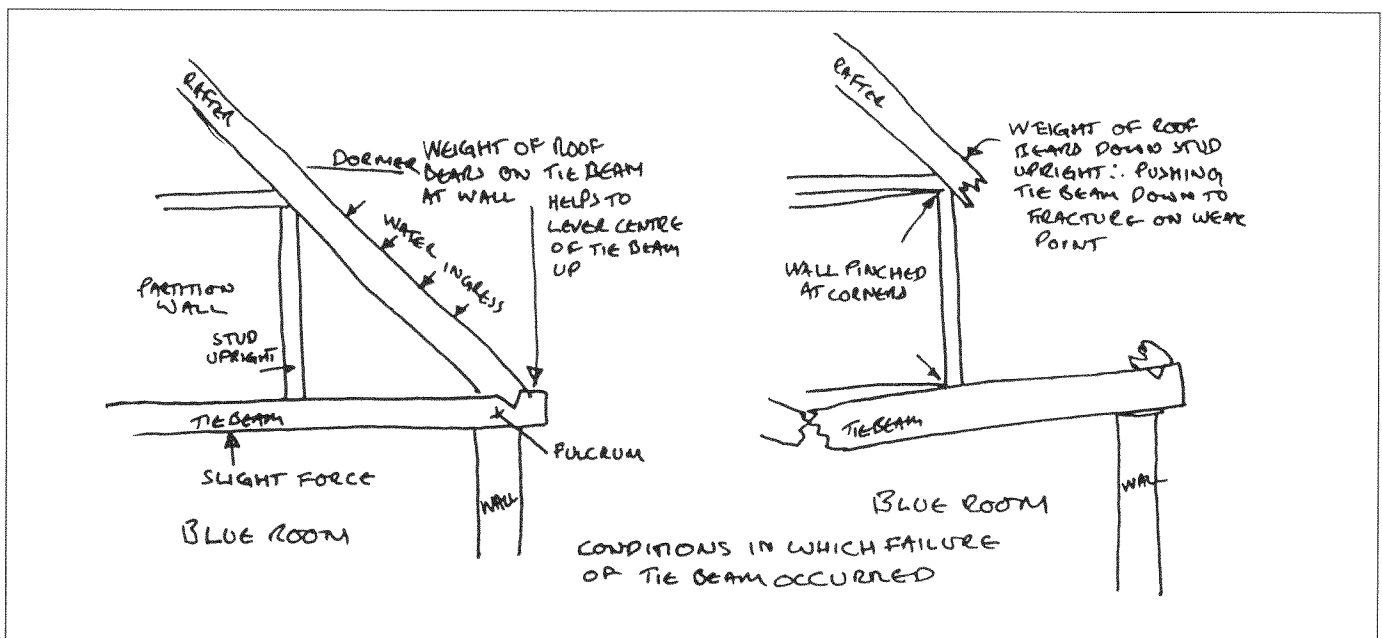
Figure 11. Factors causing fracture of tie beam.

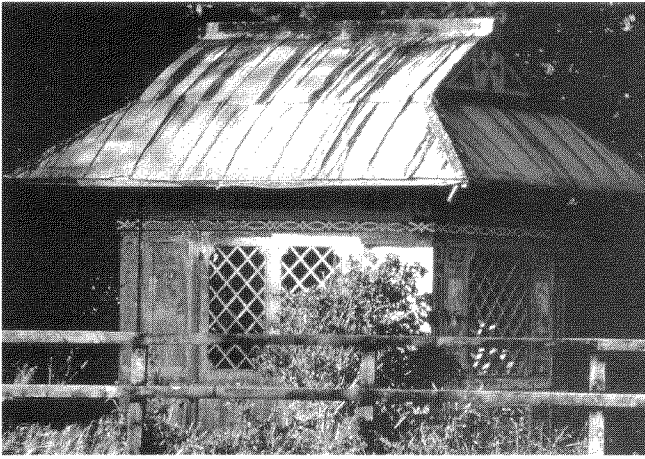
Figure 1. The Chinese House in Ireland.
Photo: the National Trust.

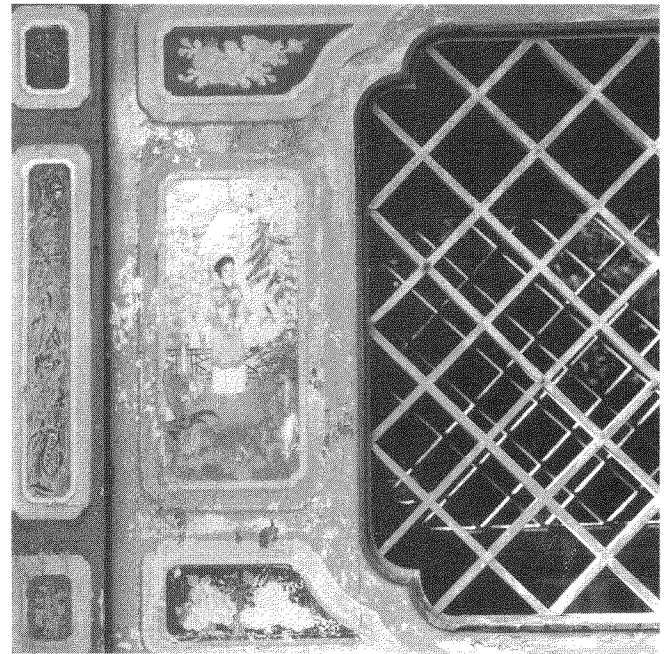
Figure 2. Exterior figurative panel. Photo: the National Trust.

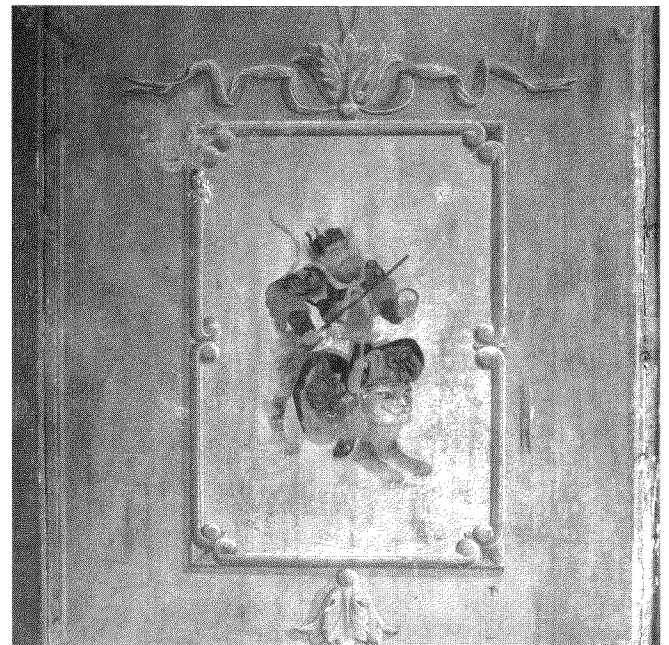
Figure 3. Decorative panel on the interior. Photo: the National Trust.

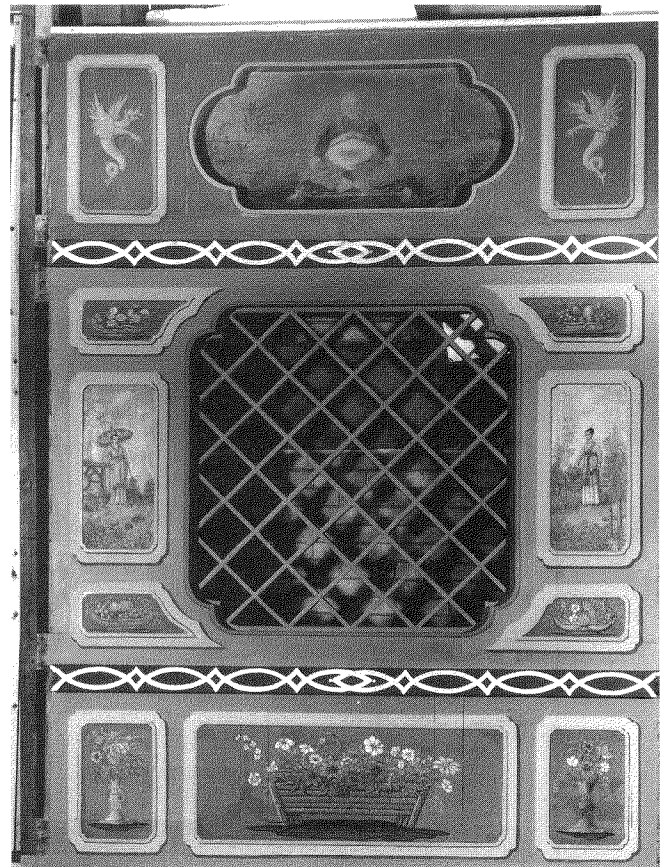
Figure 4. Conserved figurative and floral panels after removal of overpaints and retouching of losses. Photo: the National Trust, Ian Blatern photographer.

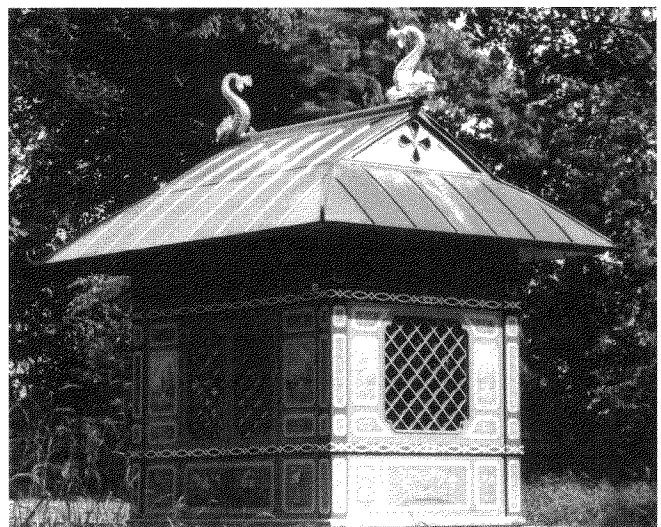
Figure 6. The Chinese House after conservation and restoration. Photo: the National Trust.

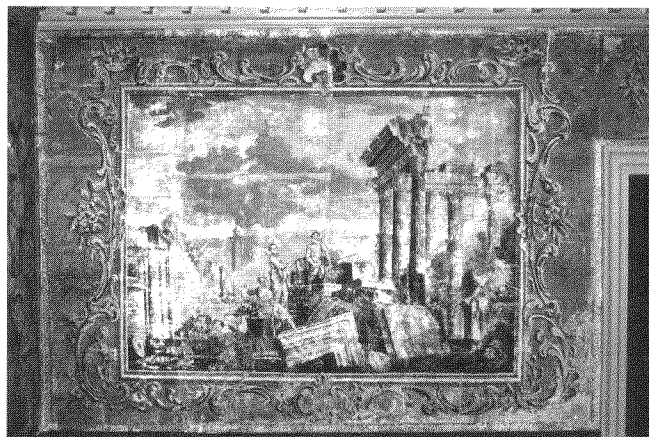
Figure 1. Hand-painted grisaille scene after Giovanni Paolo Panini, English, circa 1765, before treatment.

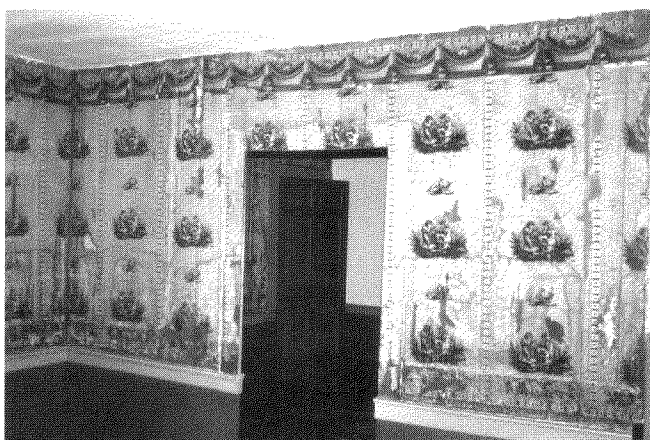
Figure 3. ‘Landscape Figures’ pattern wallpaper, French, circa 1815, Rosedale, before treatment.

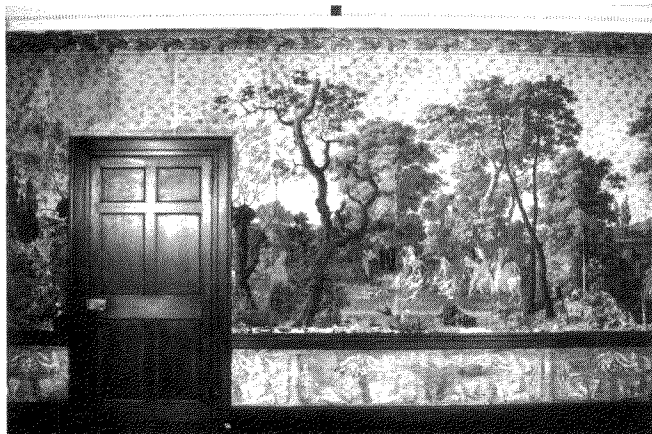
Figure 7. Scenic wallpaper, *Chasse de Compiègne* by Jacquemart, French, 1812, before treatment.

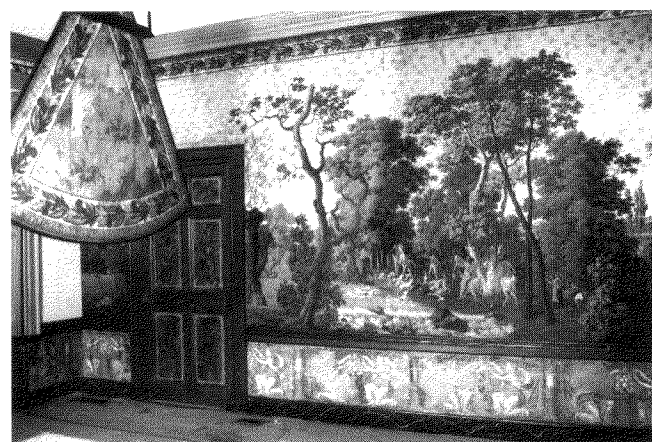
Figure 8. *Chasse de Compiègne*, after treatment.

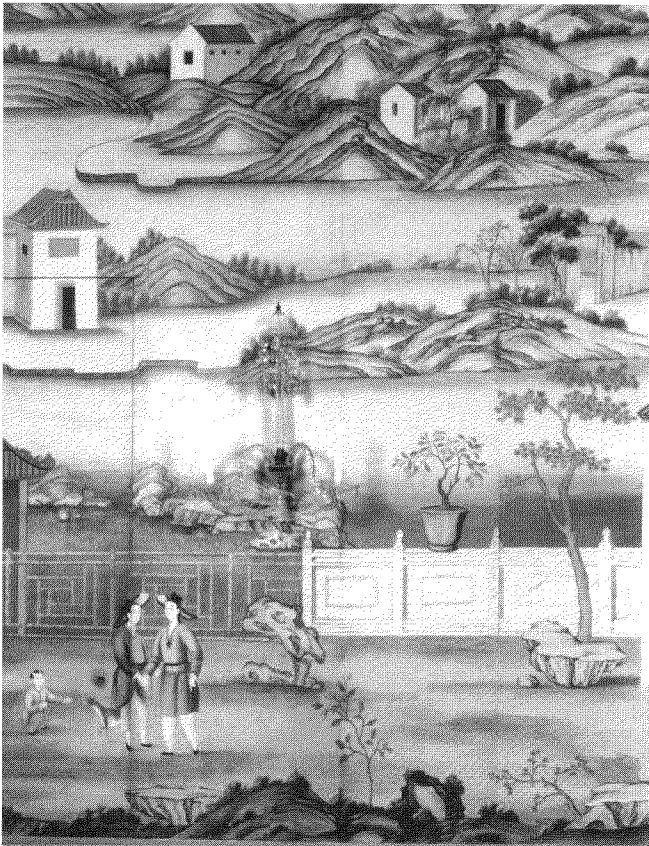
Figure 9. Hand-painted export wallpaper, Chinese, circa 1790, after treatment (the top left quadrant is the simulation from 1931).

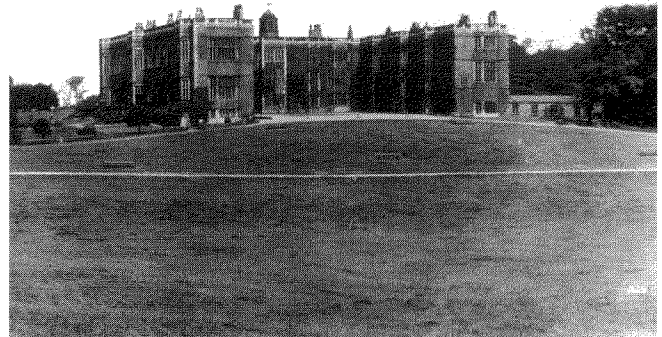
Figure 1. Temple Newsam seen from the southeast. The Picture Gallery is in the north wing on the first floor.

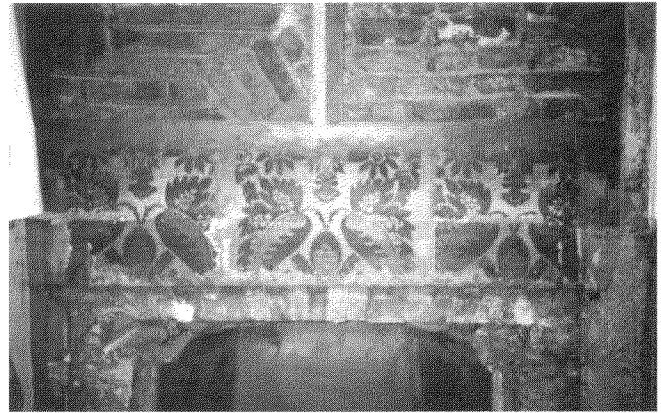
Figure 3. Pieces of the Picture Gallery's green flock wallpaper, discovered in 1992, on re-used timber lining during excavation of a room in the west wing. A William Morris paper, called "Indian" circa 1880, can be seen on the right of the picture.

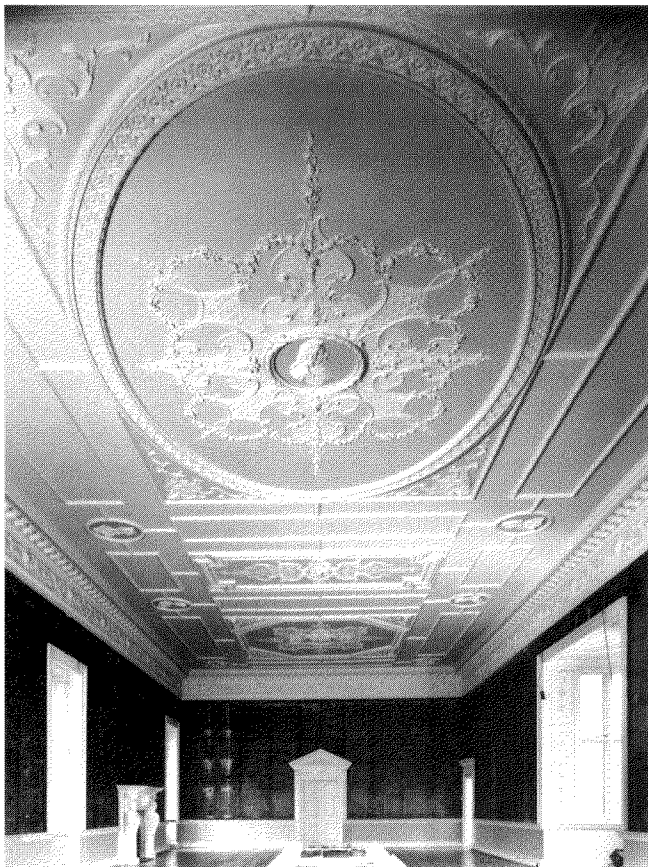
Figure 4. General view from the west of the plaster ceiling and the Tudor and Jacobean brickwork after removal of intrusive elements.

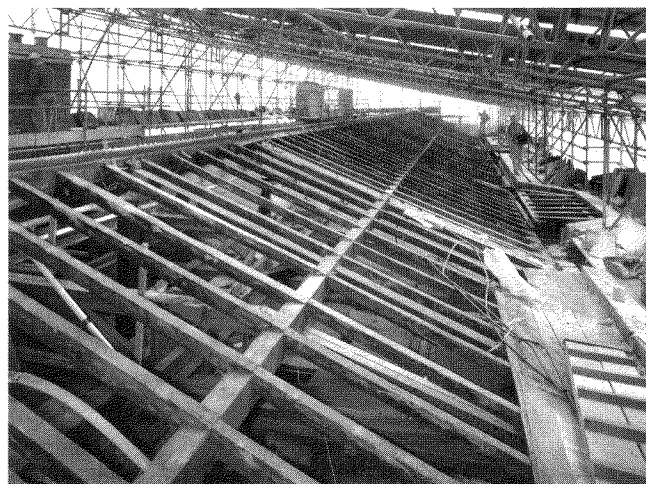
Figure 12. Re-roofing of the north wing.

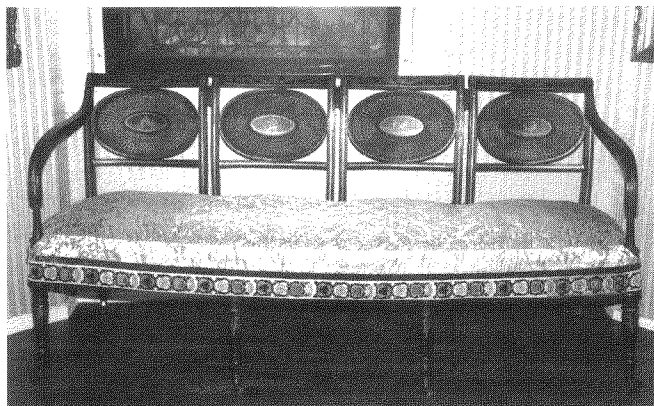
Figure 1. Late-18th-century English chairback settee, after re-upholstery in 1996. A hand-silk-screened velvet replacement trim decorates the bottom edge of the seat cushion. A section of Gardner's original figured velvet trim can be seen in the right corner.

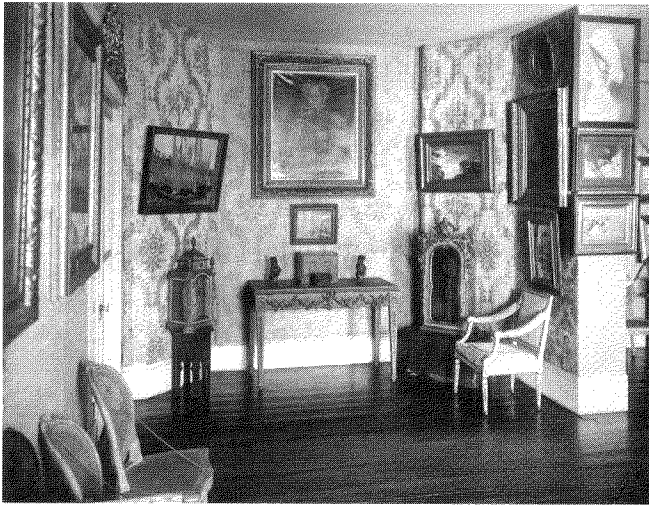
Figure 2. Isabella's Gardner's Blue Room installation, as photographed in 1926 (southwest corner). Some fabrics were stretched taut, others draped, and several hung sideways. One of the wall fabrics, an 18th-century lampas with a feather and floral design, may originally have been bed curtains as suggested by the size of the panels and placement of the trim. This fabric is seen on the diagonal walls in the photograph.

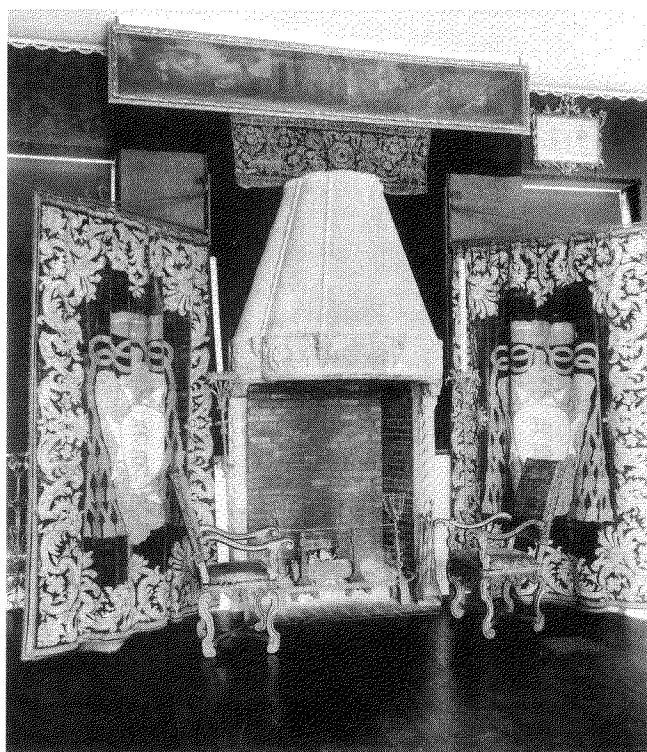
Figure 4. This pair of 18th-century Italian armorial hangings, photographed in 1926, had a commanding presence in the Raphael Room before they were deinstalled in 1994. The museum is currently evaluating the option of replacing them with an historically accurate reproduction.

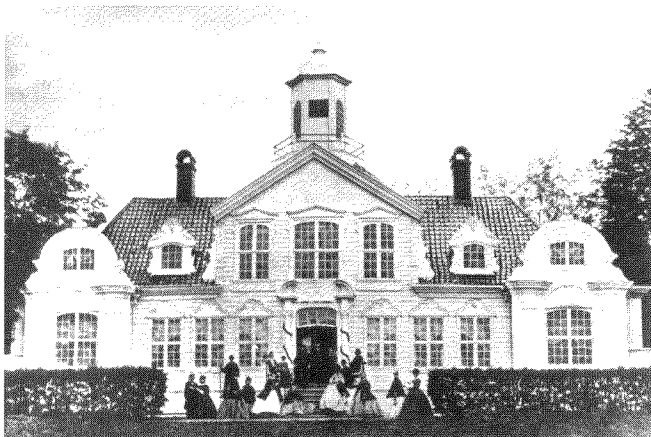
Figure 1. *Damsgård*, dated 1770, main facade.
Photo from the 1860's.

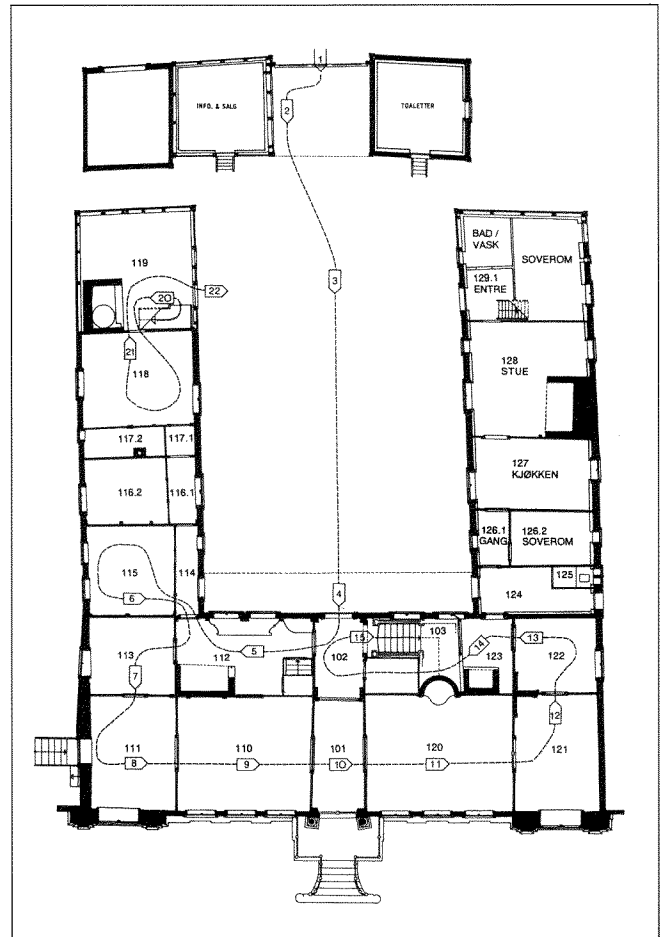
Figure 3. Plan. Ground floor. The main part comprises the museum. Rooms 124–129, in the west wing, built within the existing building, are an apartment for the keeper/gardener. The attic is used as the museum's storage room and for temporary exhibitions. Room 116.2 is a small kitchen and room 118, a cafe. The direction of the guided tours is marked on the plan. Photo: Arkitektene Hansteen A/S.
