CANADIAN
CONSERVATION
INSTITUTE

INSTITUT
CANADIEN DE
CONSERVATION

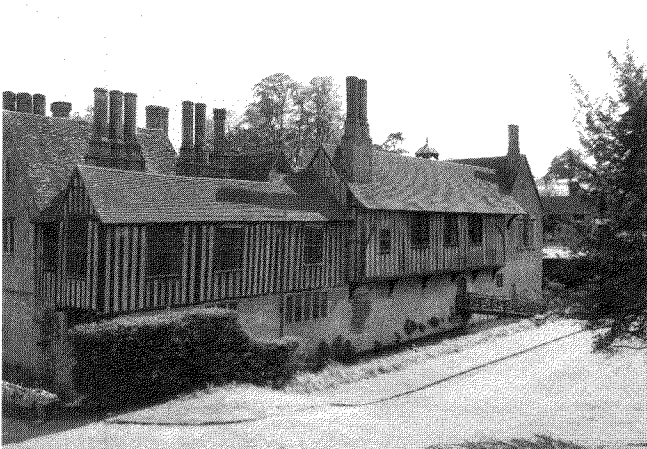
Figure 1. The north range of Ightham Mote which shows the Tudor Chapel above the wooden bridge. Photo: the National Trust.

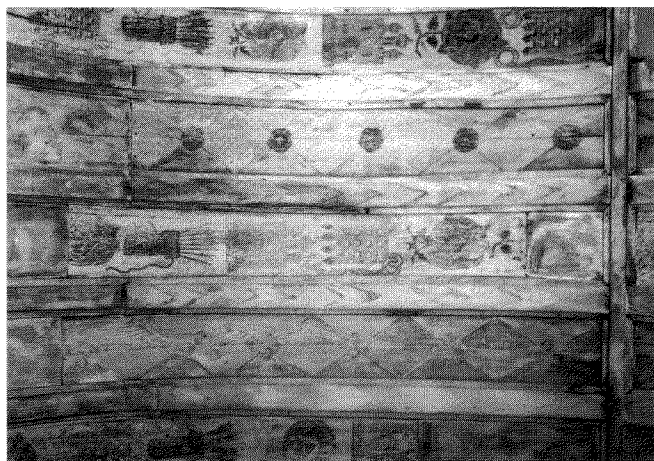
Figure 3. The painted ceiling panels and ribs before conservation treatment. Photo: the National Trust.

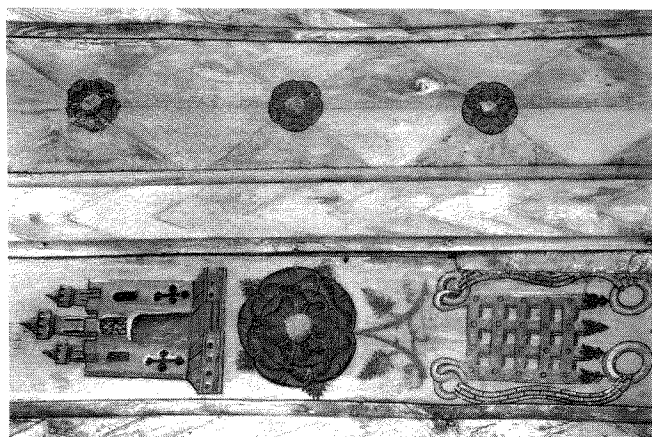
Figure 4. The painted ceiling panels and ribs after conservation treatment. Photo: the National Trust.

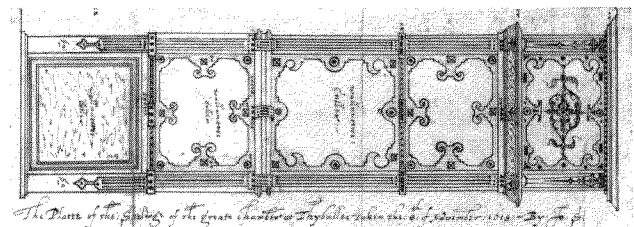
Figure 3. Panelling at Theobalds, Hertfordshire. RIBA, Smythson III/13.

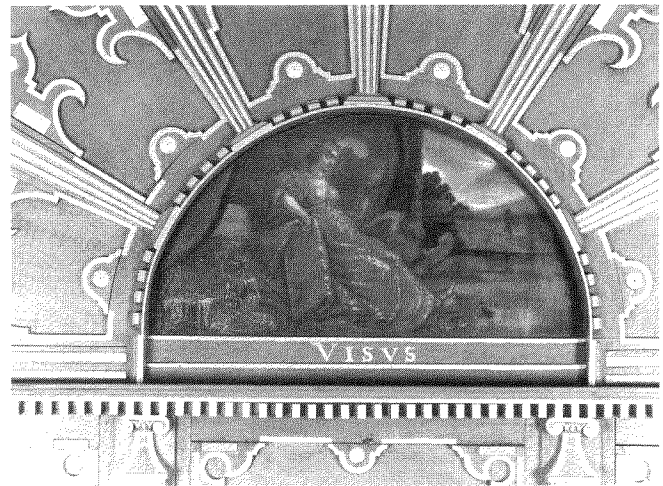
Figure 7. *Visus* (circa 1619). Photograph taken in 1994.

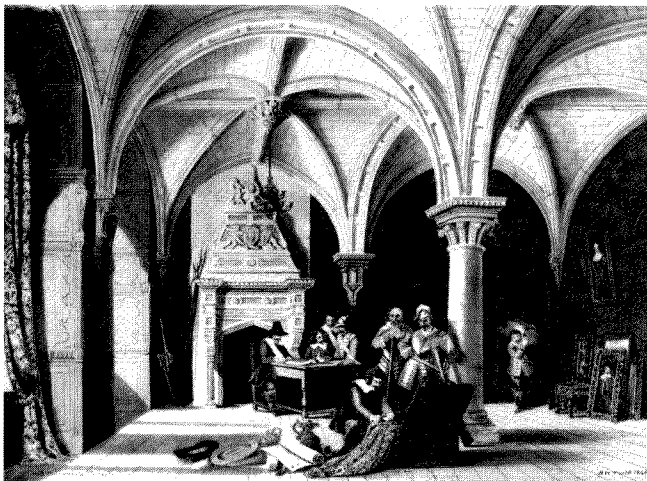
Figure 8. Parliamentarian Troops in Pillar Parlour. Watercolour by H.W. Todd, 1846.

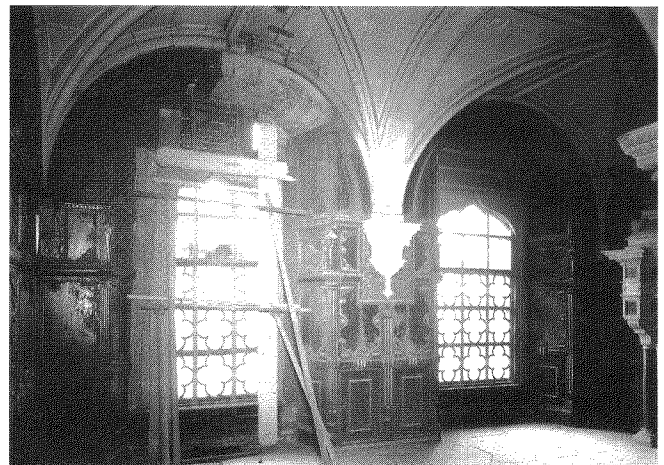
Figure 9. North wall (Gothic windows added circa 1750). Repairs carried out in 1953 revealed small upper window openings that had been blocked.

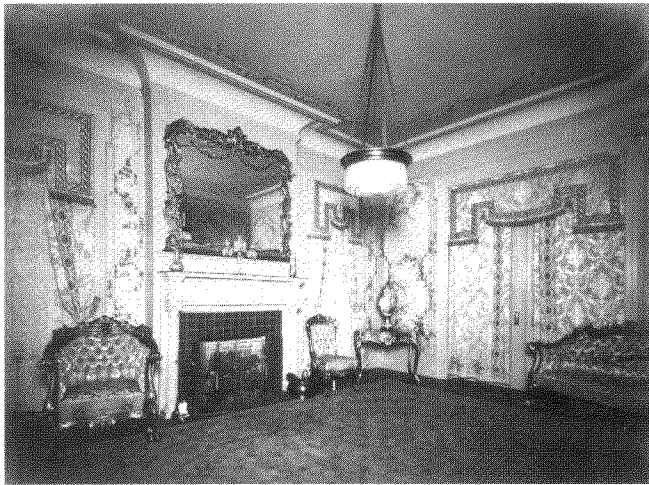
Figure 2. Pink Parlor of the McFaddin-Ward house in 1907; note the painted wall decoration. Photo: McFaddin-Ward House Museum.

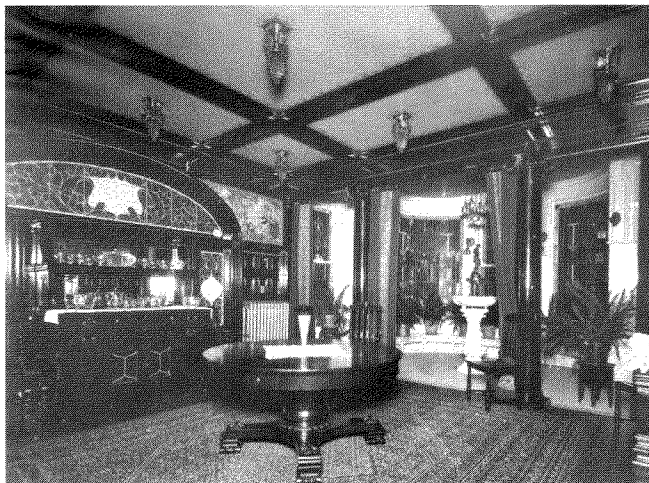
Figure 3. Breakfast Room and Conservatory of the McFaddin-Ward house in 1907. Photo: McFaddin-Ward House Museum.

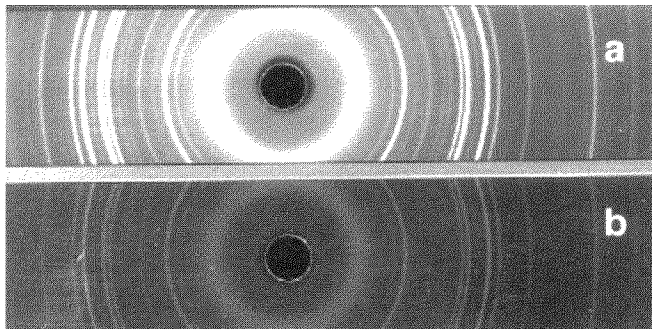
Figure 2. X-ray diffraction powder patterns for (a) thenardite, as identified in efflorescence on mortar joint (sample no. 4), and (b) standard sodium sulphate dry powder (Anachemia) shown for comparison.

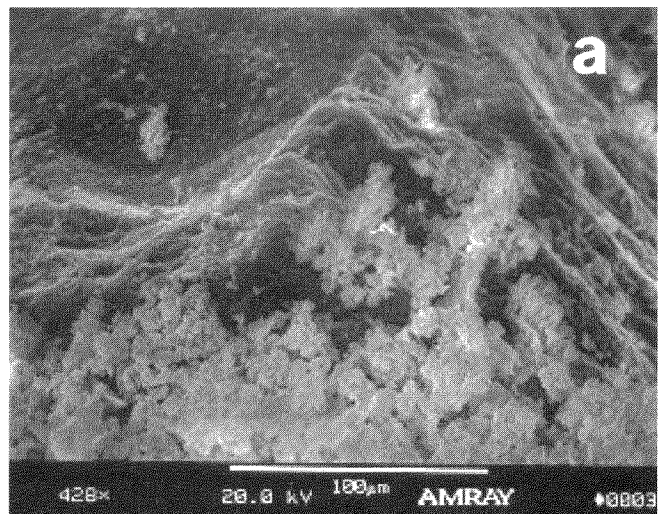
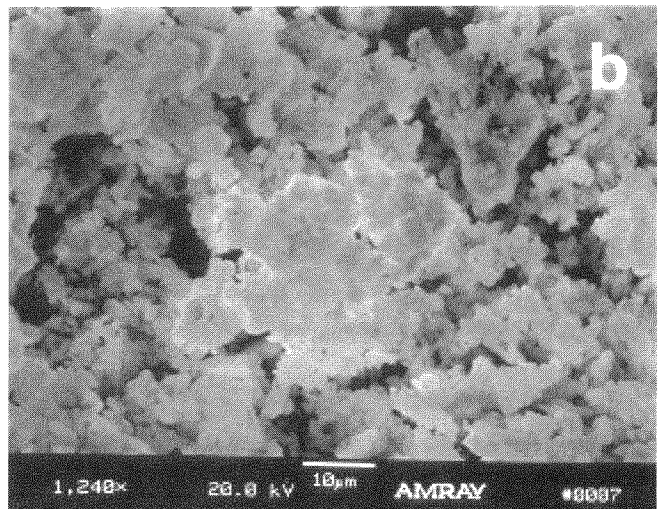
Figure 3. Efflorescence on mortar, identified as sodium sulphate (sample no. 4), at magnifications of (a) 428x and (b) 1240x.

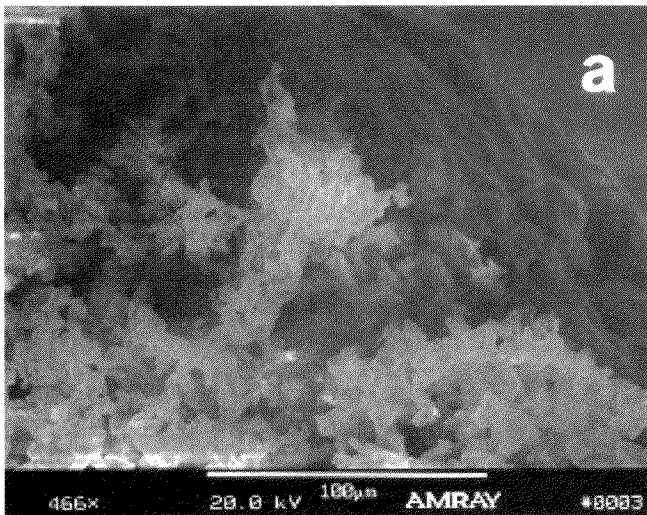
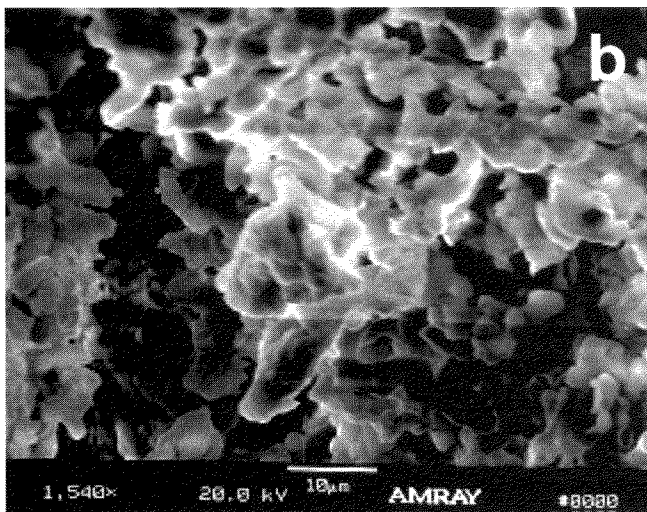
Figure 4. Efflorescence on brick, identified as sodium sulphate; scattered through the mass of the deposit are the crystals of a minor component identified as magnesium sulphate (sample no. 36), at magnifications of (a) 466x and (b) 1540x.

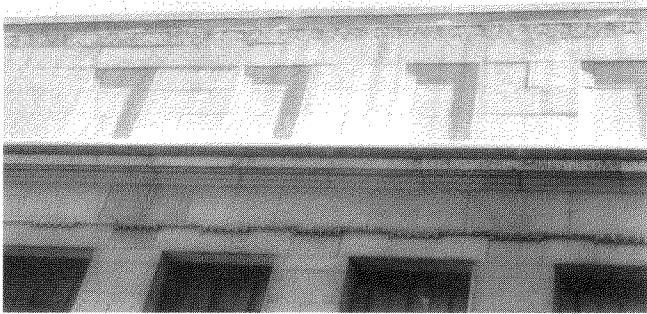
Figure A4. West facade. Typical conditions at the top of the upper parapet walls: heaved stone blocks, empty mortar joints, and pronounced surface deterioration. Photo: Anna Kozłowski.

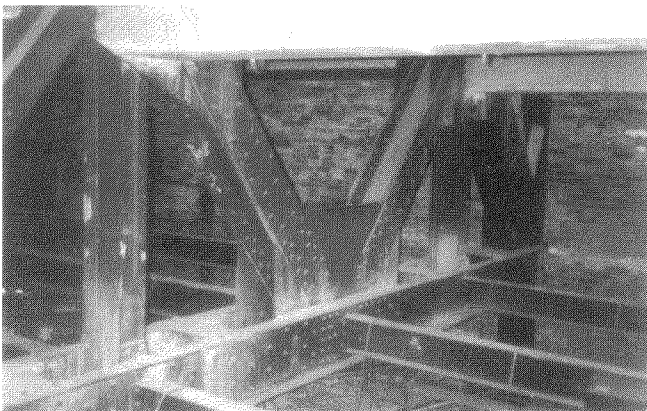
Figure A5. Detail of steel roof truss. The brick casing of the parapet walls, covered in efflorescence, appears in the background. Photo: Khaled Ibrahim.

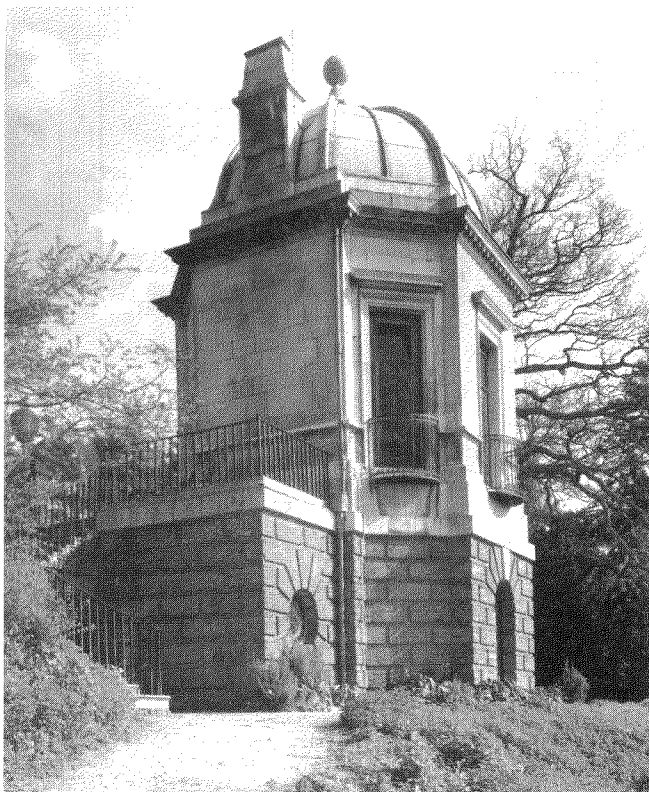
Figure 1. An exterior view of the Chapel at Cliveden looking up from the bank on which the building stands. One of the two side chapels can be seen with its roof formed by the parterre.

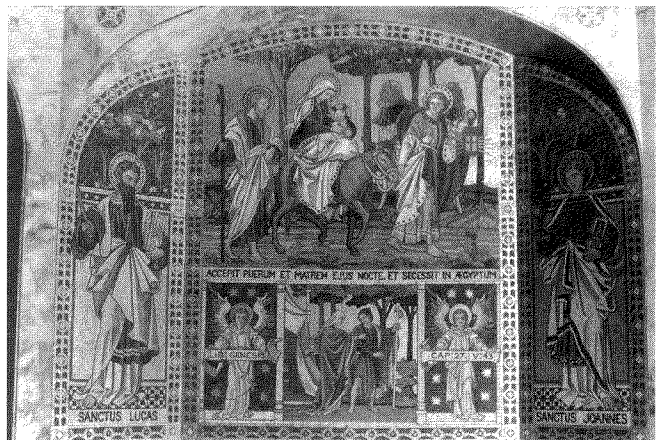
Figure 2. An interior view of one of the mosaic panels, Flight into Egypt.

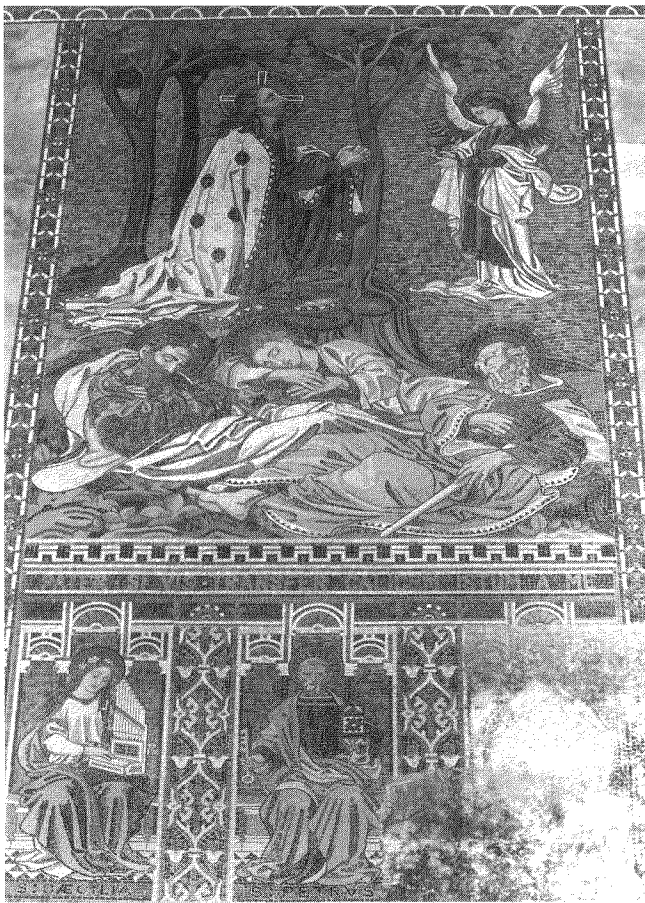
Figure 3. The mosaic panel of Garden of Gethsemane showing significant damage from salt efflorescence at the lower right.

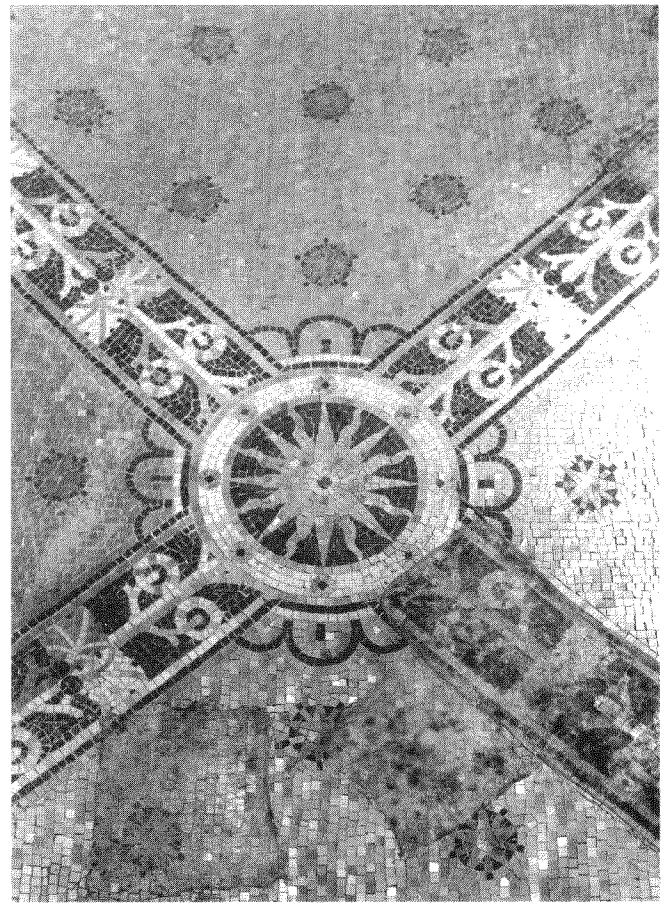
Figure 4. The ceiling showing facing to secure loose tesserae.

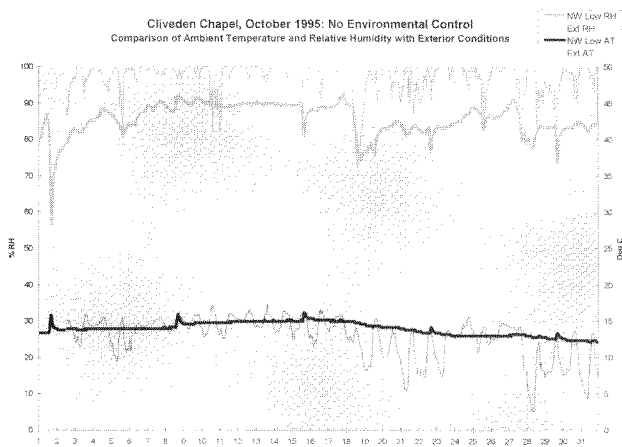
Figure 5a. The Chapel at Cliveden, October 1995, no environmental control. Comparison of ambient temperature and RH with exterior conditions.

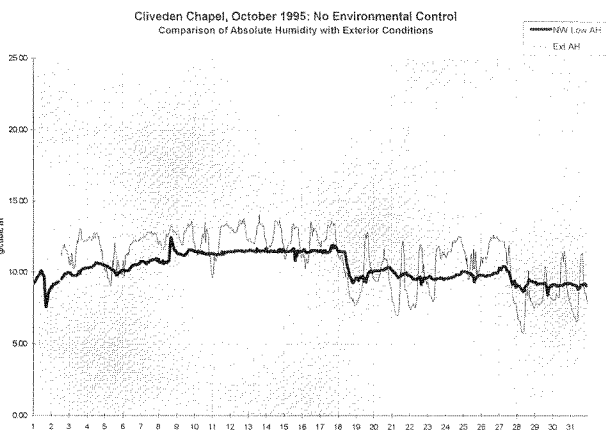
Figure 5b. The Chapel at Cliveden, October 1995, no environmental control. Comparison of absolute humidity with exterior conditions.

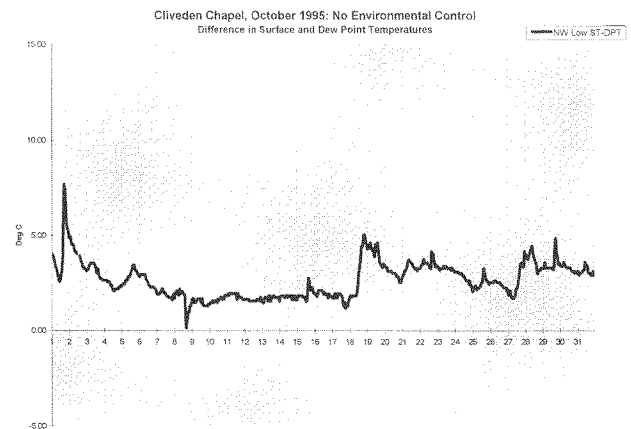
Figure 5c. The Chapel at Cliveden, October 1995, no environmental control. Difference in surface and dew point temperatures.

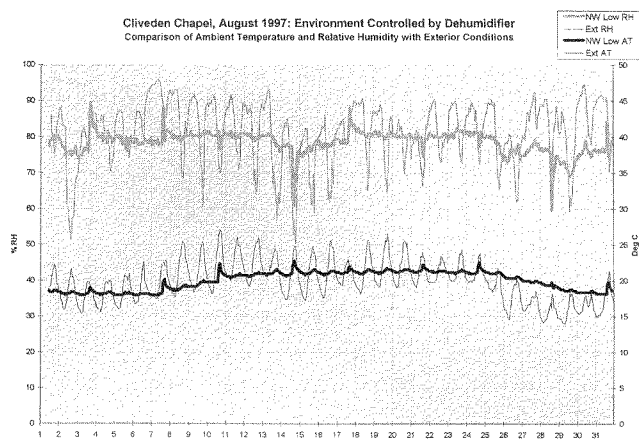
Figure 6a. The Chapel at Cliveden, August 1997, environment controlled by dehumidifier. Comparison of ambient temperature and RH with exterior conditions.

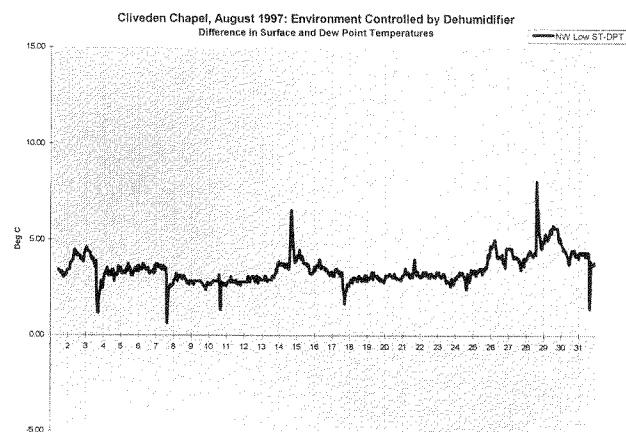
Figure 6c. The Chapel at Cliveden, August 1997, environment controlled by dehumidifier. Difference in surface and dew point temperatures.

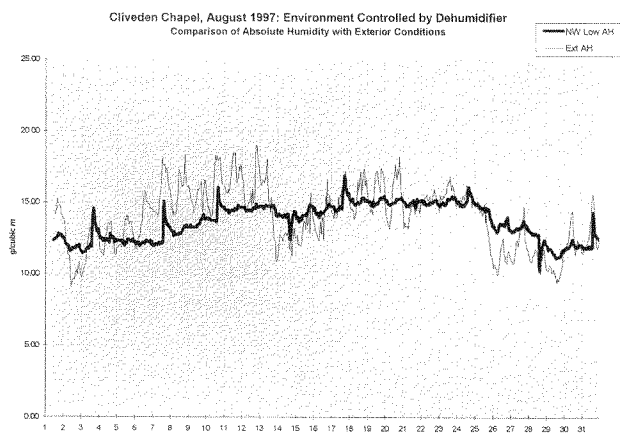
Figure 6b. The Chapel at Cliveden, August 1997, environment controlled by dehumidifier. Comparison of absolute humidity and exterior conditions.

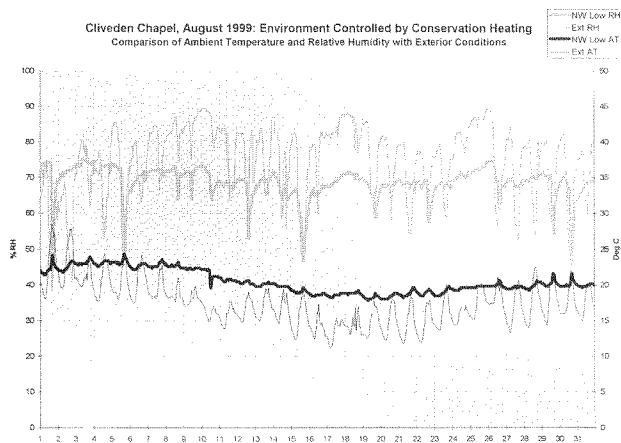
Figure 7a. The Chapel at Cliveden, August 1999, environment controlled by conservation heating. Comparison of ambient temperature and RH with exterior conditions.

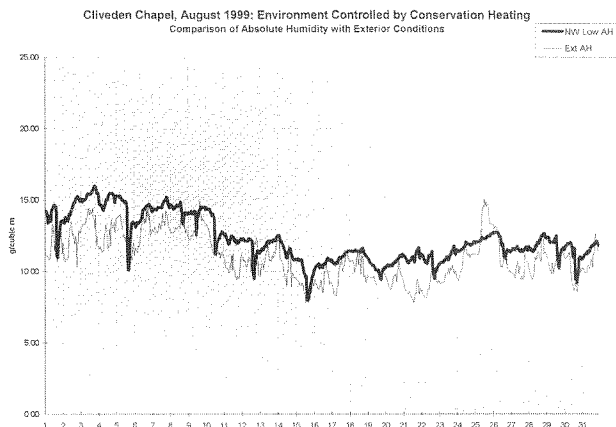
Figure 7b. The Chapel at Cliveden, August 1999, environment controlled by conservation heating. Comparison of absolute humidity with exterior conditions.

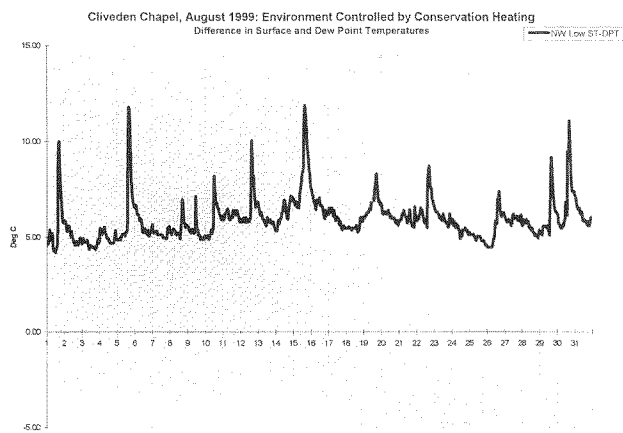
Figure 7c. The Chapel at Cliveden, August 1999, environment controlled by conservation heating. Difference in surface and dew point temperatures.
