RESIDENTIAL COMBUSTION VENTING FAILURE

A SYSTEMS APPROACH

FINAL TECHNICAL REPORT

COUNTRY-WIDE SURVEY RESULTS

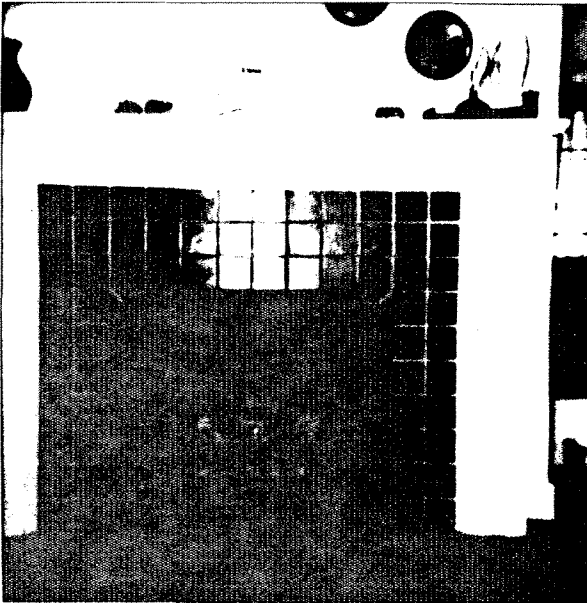
HOUSE NO. 1

Chimney Height: 4 m

Number of spillage events: 2

Duration of spillage: 44 seconds

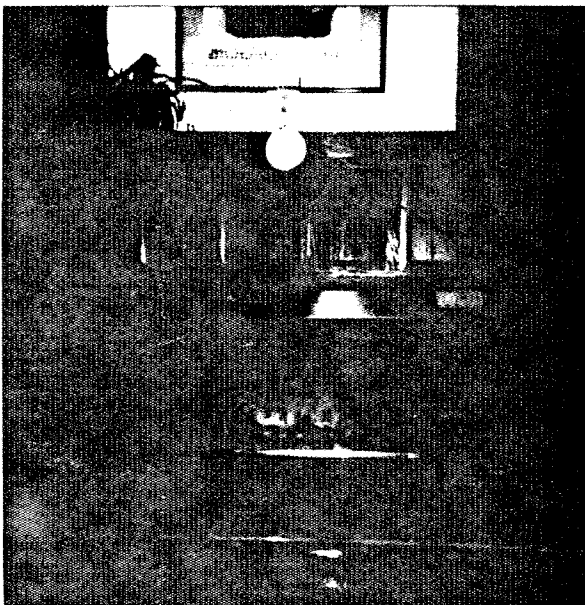
HOUSE NO. 2

Chimney Height: 4 m

Duration of spillage: 81 seconds

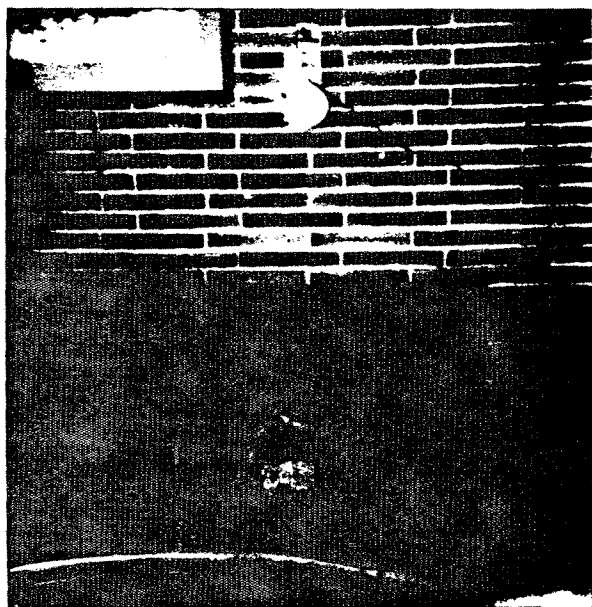
HOUSE NO. 3

Chimney Height: 6 m

Number of spillage events: 6

Duration of spillage: 42 seconds
