Residential Combustion Venting Failure - A Systems Approach

**Remedial Measures for Wood-burning Fireplaces:
Airtight Doors with Direct Air Supply**

FINAL TECHNICAL REPORT

January, 1987

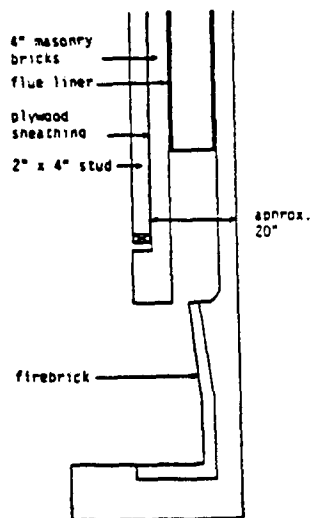
← Figure 1

That prompted inspections of about 10 fireplaces under construction in various locations. The general construction was very similar in most of them. They were all fireplaces on an external wall and the typical construction was as shown in Figure 1.

Compare Figure 1 with Figure 2 which is taken from "Fireplace Report", an industry guide for the design and construction of fireplaces and chimneys published by the Alberta Masonry Institute. Note the differences between Figures 1 and 2. The major shortcomings in Figure 1 are:

- (1) Plywood sheathing which forms part of the outside wall, is in direct contact with the chimney's masonry blocks. Building code requires a minimum of 1/2" clearance.
- (2) The thickness of masonry in the smoke chamber (the portion above the throat up to the beginning of the tile liner) is only 4". The building code requires 7-1/2" of solid masonry.

- (1) Building inspectors inspect new masonry fireplace installations very closely to ensure they comply with the building code.
- (2) Masons and bricklayers who build fireplaces should be informed of these problems by local building or fire officials, so that they can improve their work. For a nominal extra expense a person is better off eliminating combustibles for the full width of the fireplace. The combustible framing will then be as shown in Figure 4 as opposed to the more traditional Figure 5 where the firebox backs through the wall.

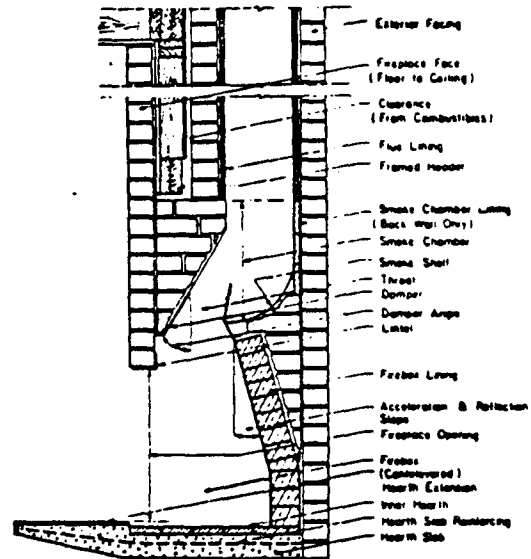
Photo 1 This incident took place in Richmond on December 7, 1983. The fireplace insert had been installed approximately 4 years ago. The unit was purchased second hand and therefore no installation instructions were available to the present owner. The unit was listed by ULI (American) and required 33 inches clearance between the top of the insert and any combustibles - visible or concealed. This clearance apparently was not met. In addition, the unit was modified by the addition of a baffle plate which according to the owner brought the heat forward. The unit did not use a flue connector but the ULI standard did not require one anyway. The Underwriters' Laboratories of Canada standard for fireplace inserts presently requires a flue connector to direct flue gases into the chimney.

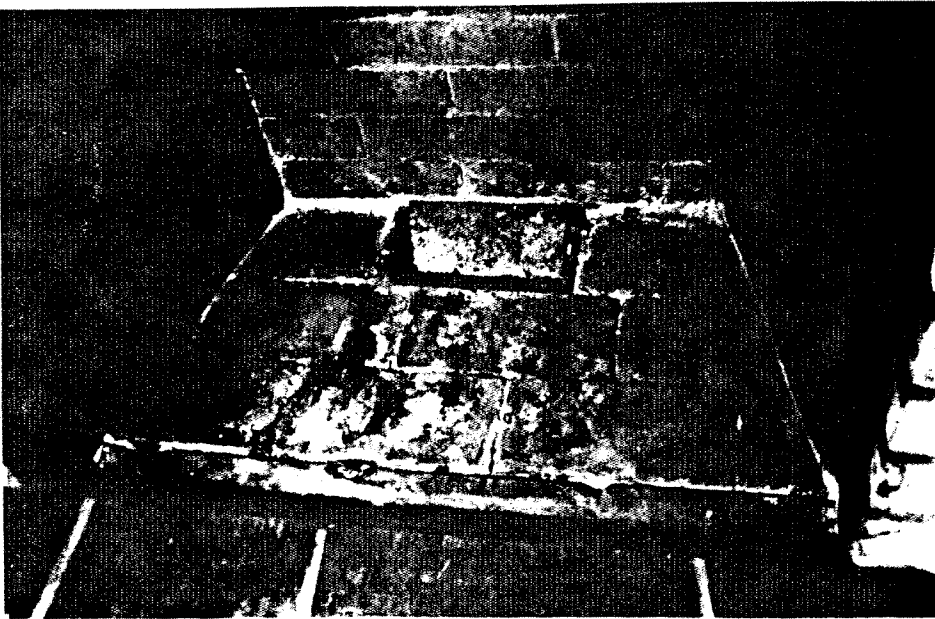
4. Ash clean-out and masonry inspected for damage or fire hazards.

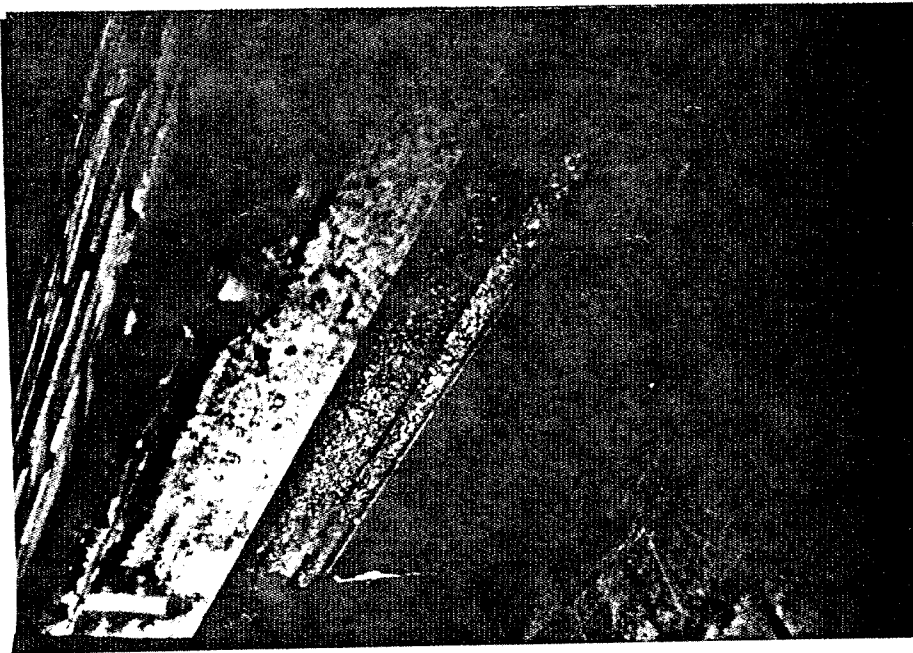
5. Observations made to determine condition of flue, location of flue liner, and construction of smoke chamber.

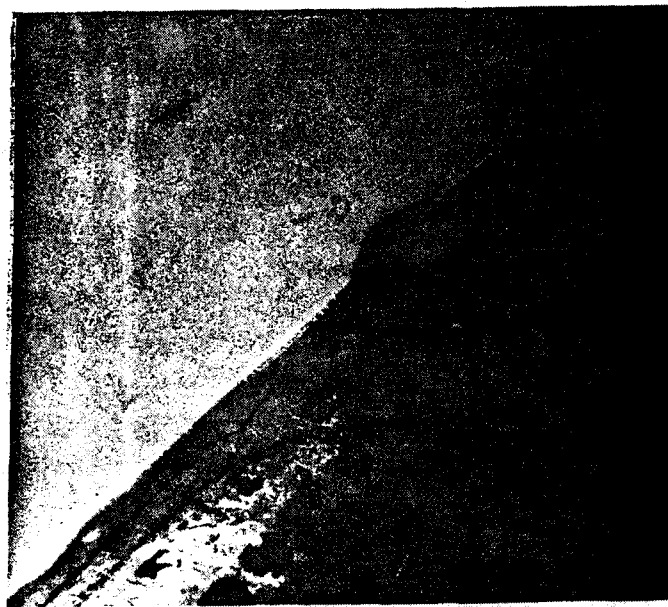
8. Examining bore debris to identify wooden components.
