CAM-F (SARCPA LAKE) DEW LINE STATION
CONDITION REPORT
SEPTEMBER 1980

Report No. EA-HQ-80-110

CAM-F (SARCPA LAKE) DEW LINE STATION
CONDITION REPORT

September 1980

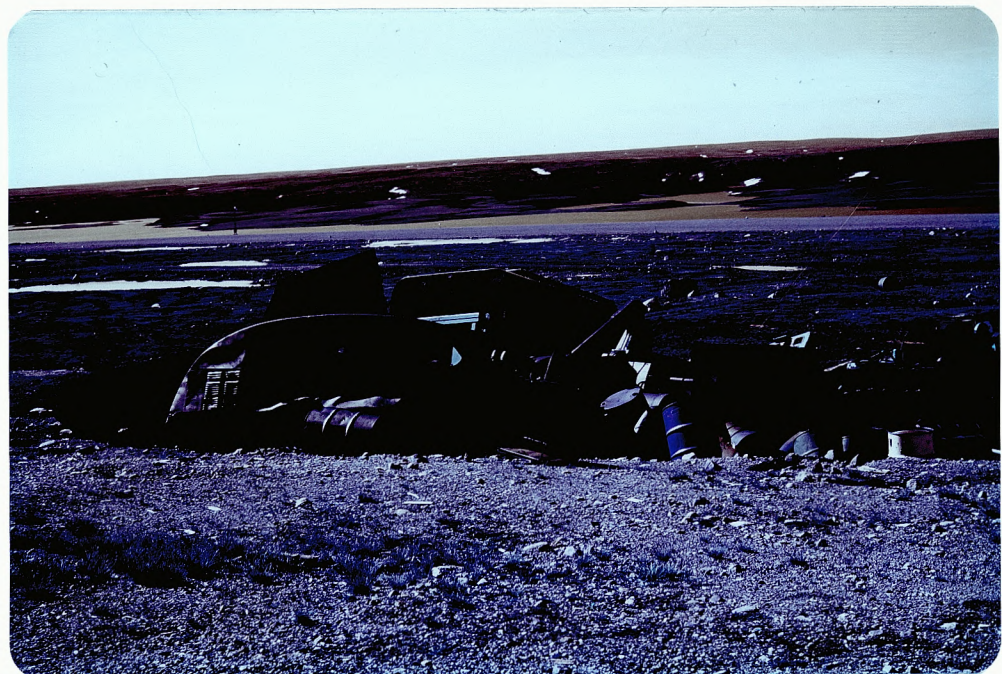
Photo 4 - Vehicle Pile near Warehouse

The two vehicle piles represent extravagant waste. Someone, presumably DEW Line personnel closing the station, has bulldozed the

vehicles into piles and set fire to them. Some means of storage may have been preferable as some of the vehicles appear not to have had many hours of use on them.

The pile to the south of the warehouse included (Photo 4):

- 2 bulldozers
- earth mover
- fuel truck
- dump truck
- bombardier
- trailor

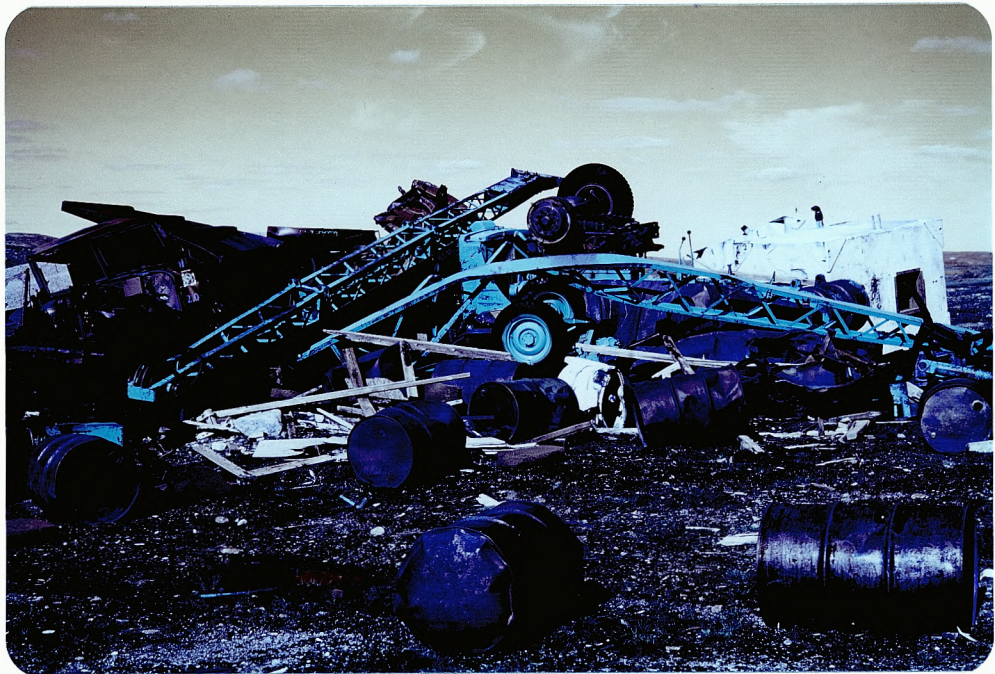
Photo 5 - Vehicle Pile near Construction Camp

The pile near the construction camp (see LAP-2 insert) included (Photo 5):

- bombardier
- dump truck
- jeep
- trailor
- misc. equipment unidentifiable

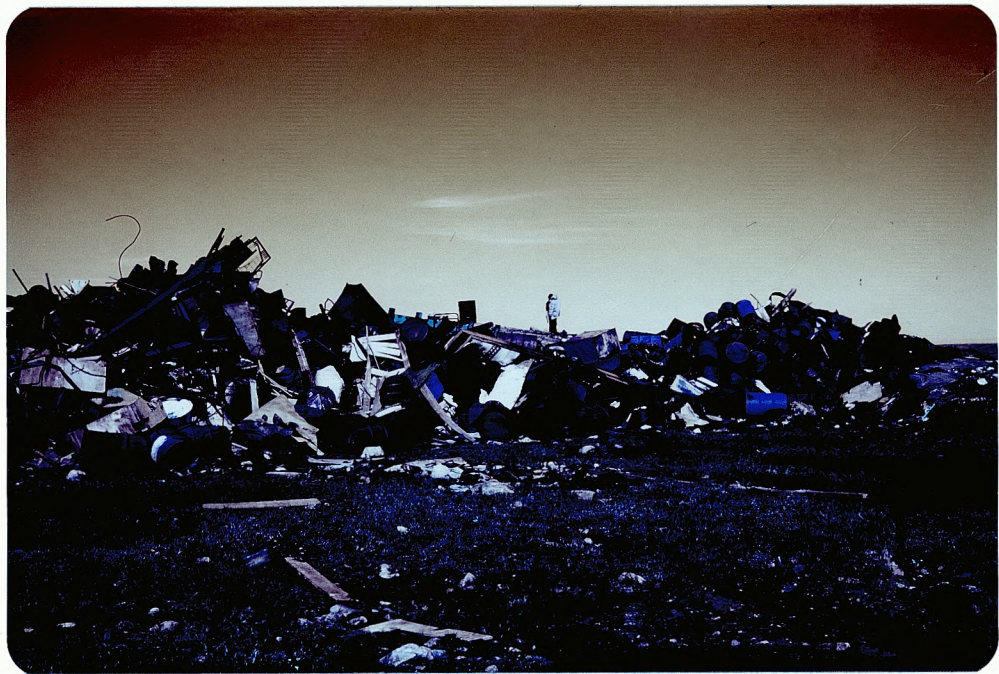
Photo 6 - Garbage Dump

The garbage dump contained an enormous quantity of material including fuel drums, scrap steel, lumber, wrecked equipment, furniture, etc. (Photo 6). It is suspected that much of this would have been useable prior to disposal although there is very little salvageable now. The dump has been piled together but not compacted or covered. A smaller dump, also messy, is located down a slope north-east of the POL tanks.

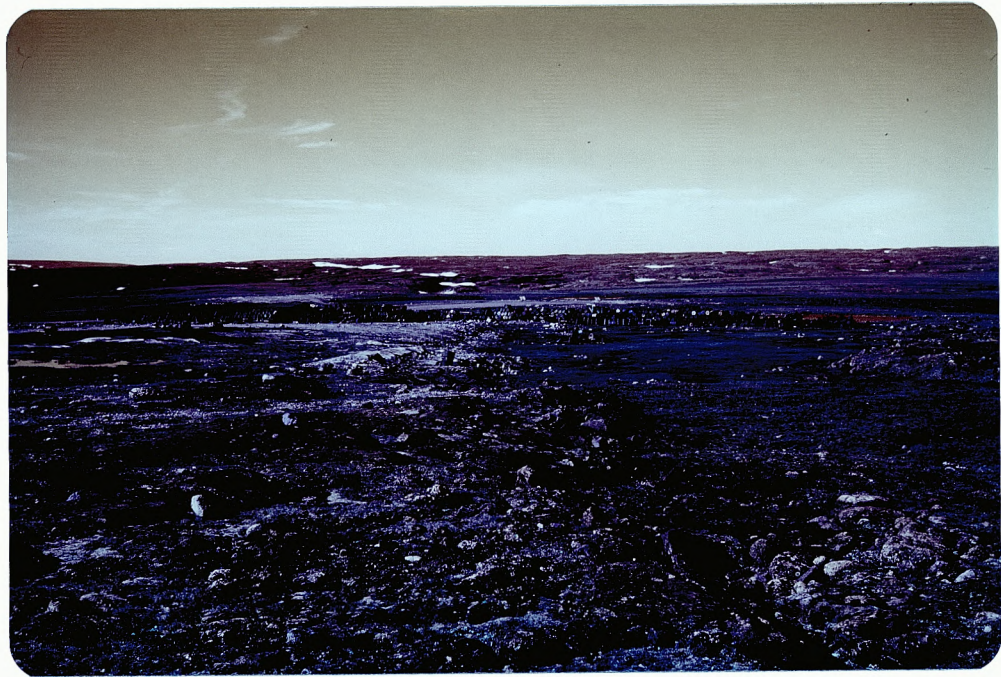
Photo 7 - Oil drums near airstrip

Fuel drums are stacked or left in a number of locations. A long pile of approximately 350 drums is located north of the north end of the airstrip (Photo 7). Another large pile of approximately 700 drums is piled at the construction camp (Photo 8). Other small piles are dispersed around the area.

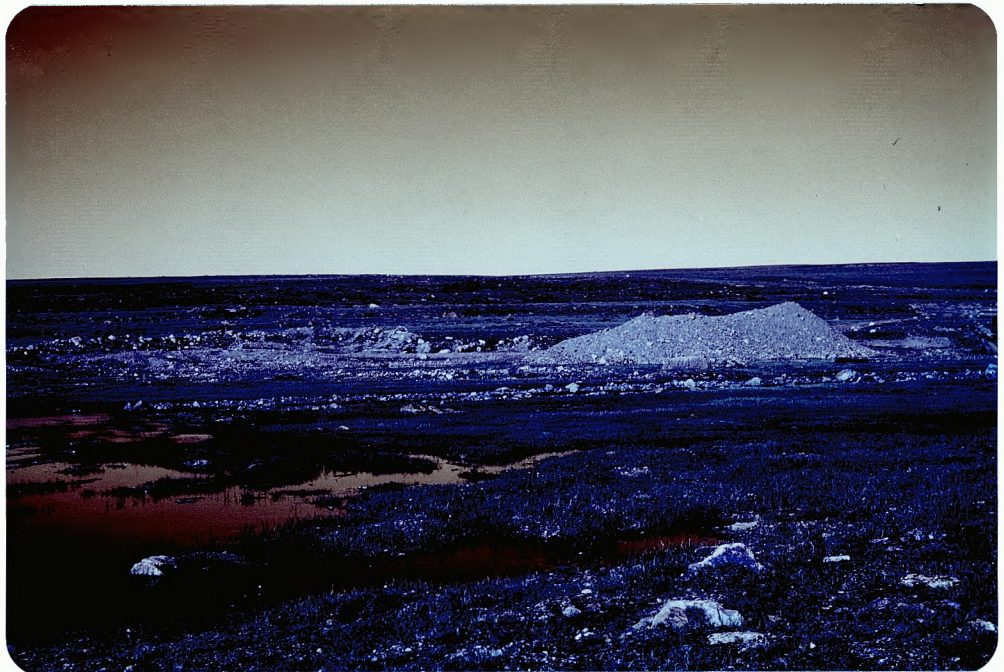
Photo 9 - Gravel Pit near Sarcpa Lake

Two sources of gravel were noted: one along the west arm of Sarcpa Lake (Photo 9) and one at the construction camp (Photo 10). See LAP-1 "insert". The former pile contained an estimated 500 m³ of stone, while the latter contained an estimated 200 m³. Each gravel source would have limited further supplies of gravel in the ground.

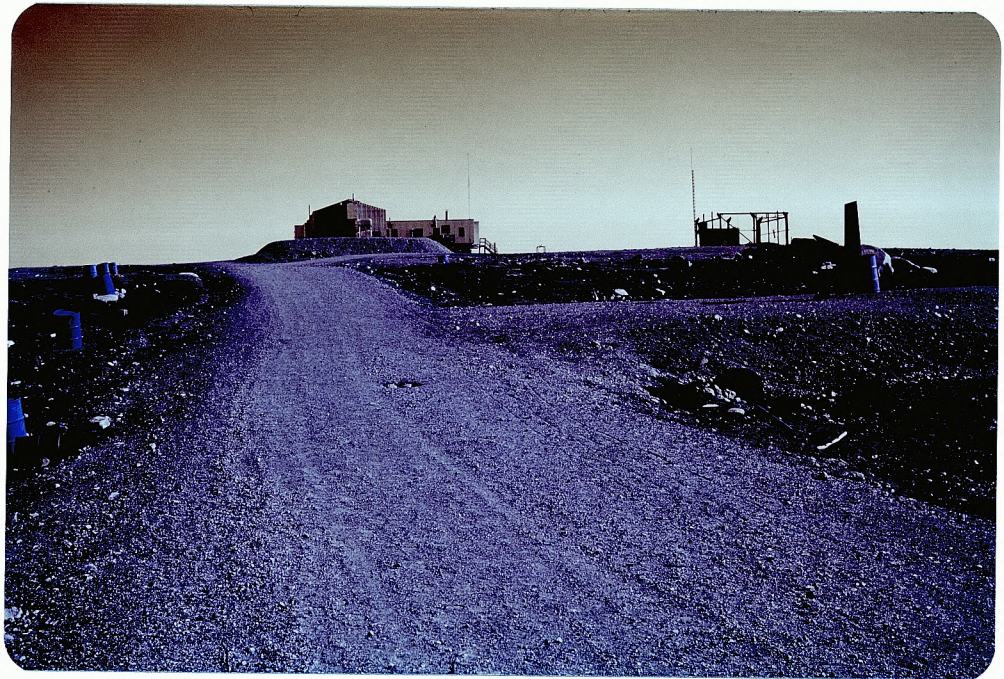
Photo 11 - Road to airstrip

The gravel road from the building site to the airstrip was in very good condition with one pothole over a culvert (Photo 11). The pothole would require a shovel and wheelbarrow or bucket to repair. Drainage along the road was very good and the culverts were clear. The gravel road from the building site to the construction camp was in good condition and, though somewhat bumpy, required no immediate repairs. Neither road required re-gravelling, shoulder and side

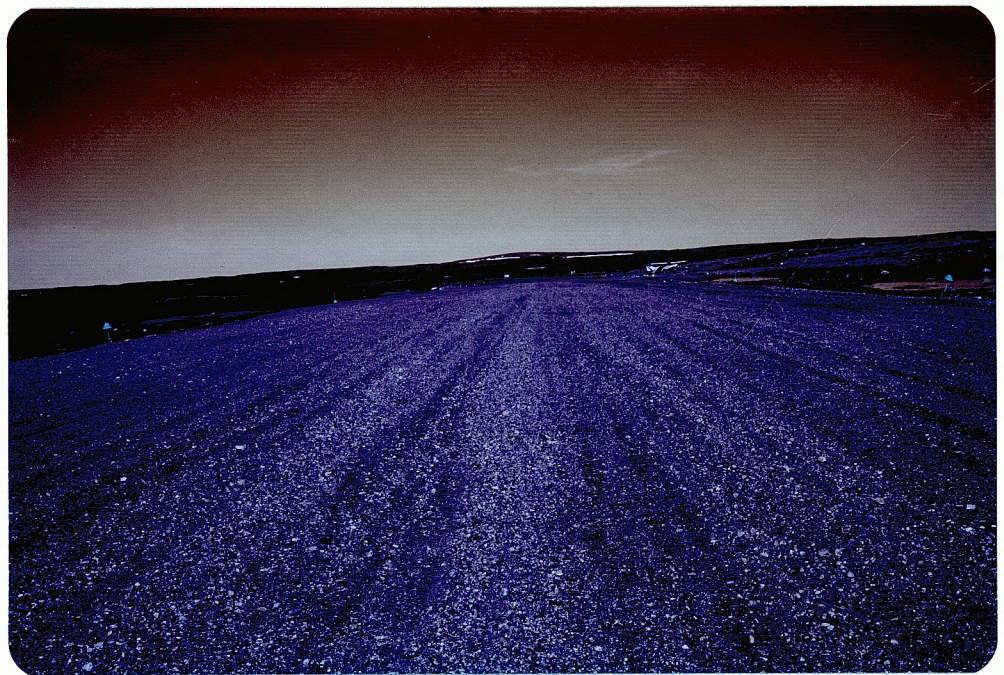
Photo 12 - Airstrip

While no technical investigation of the airstrip (100' x 3600') was carried out, visual inspection indicated the runway to be in very good condition (Photo 12). The Twin Otter had no difficulty landing. There was very little rutting of the gravel surface by aircraft tires indicating that the surface and sub-grade were still in very good condition. Minor erosion was occurring along the south edge of the north-east end of the runway. The extreme north-east end was somewhat wet and there was poorly drained standing water along the north side of the north-east end of the runway. Rehabilitation of the drainage ditch would be necessary to remove this water.

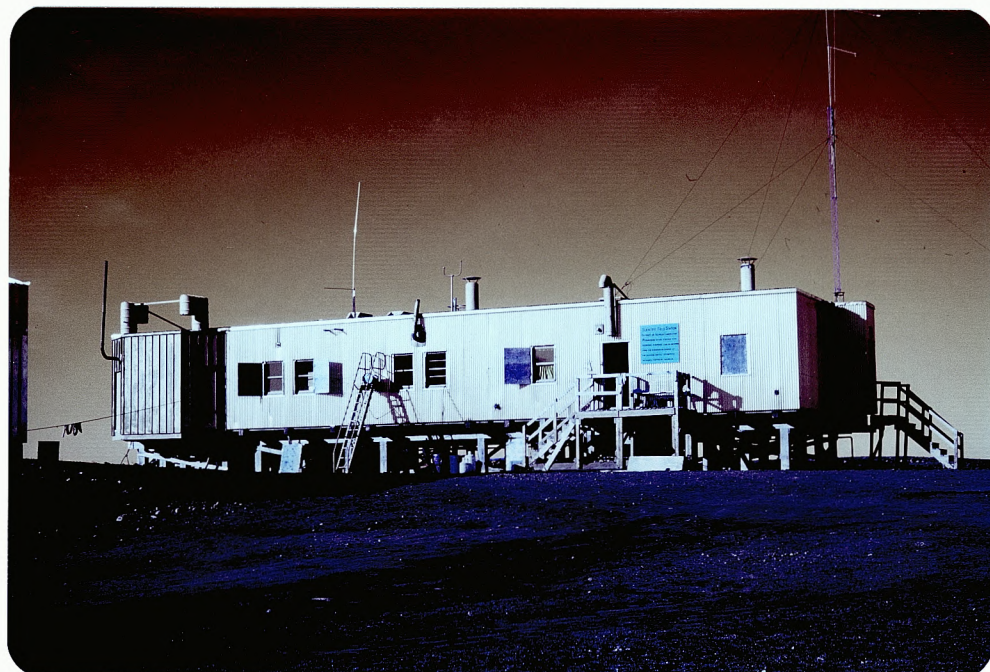
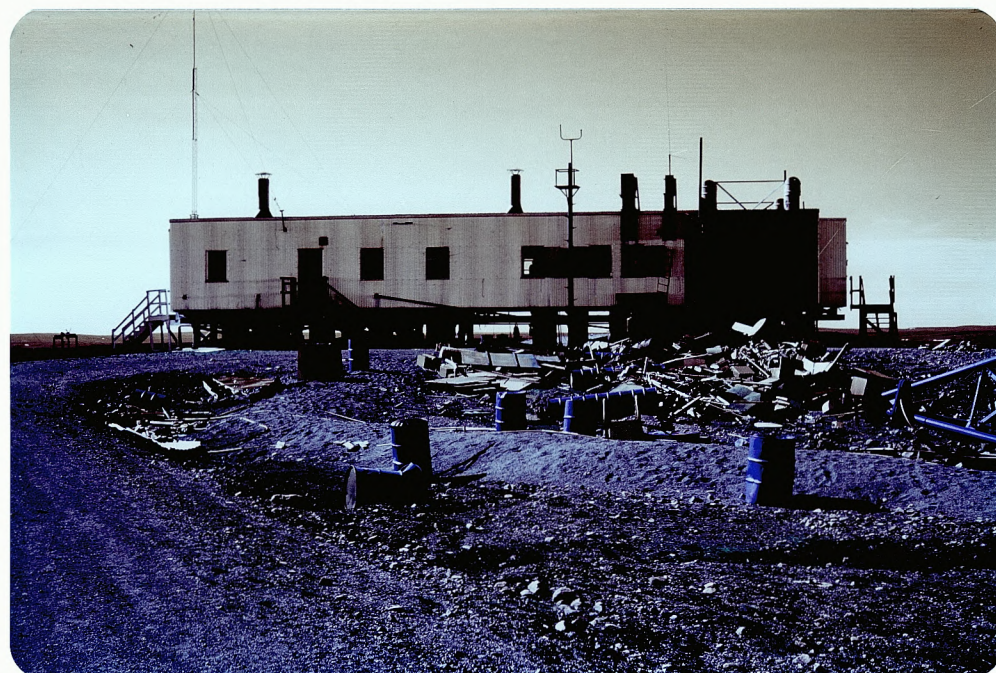
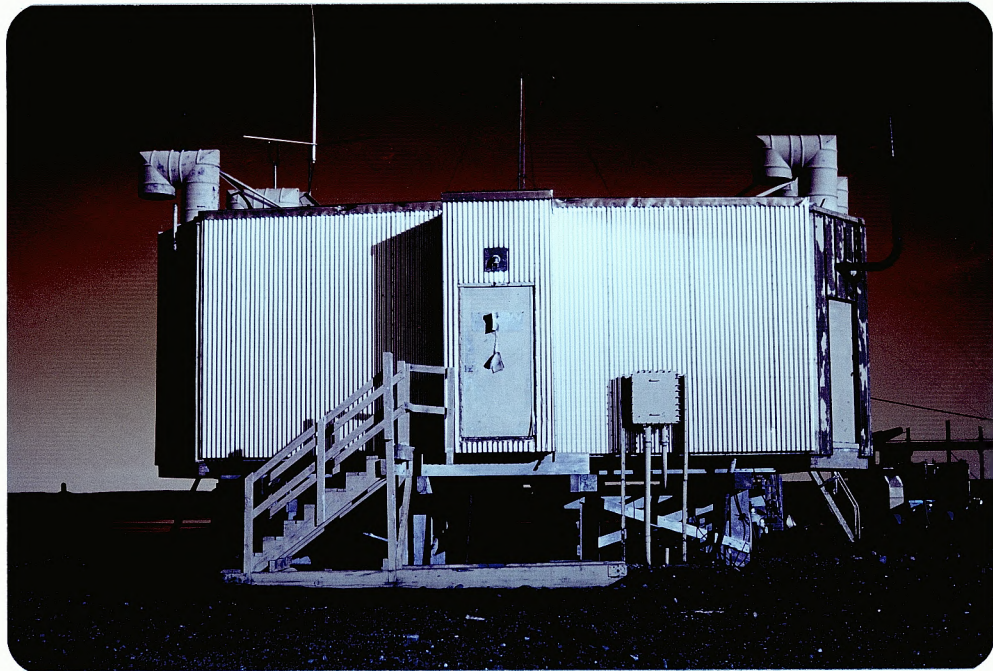
Reference should be made to the attached drawing 1-1A "Typical Building Train". In general, the building was in good condition (Photos 13, 14, 15). The foundation pad of compacted granular material on bedrock was still sound with no indication of settlement or erosion. A wood post to bedrock foundation structure transfers the building load to ground. The 12" x 12" Douglas fir members were in durable condition though there was pervasive paint flaking. No sign of rot was noted.

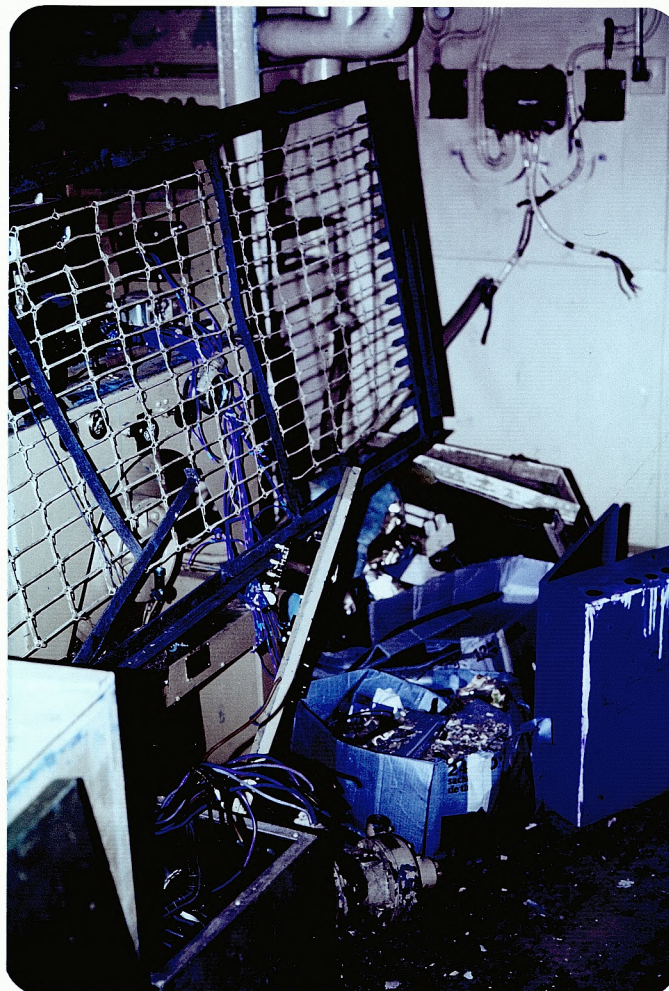
Generally, the interior of the building was in good condition though substantial alterations from the original design had been made. Floors were all structurally sound and flat with no sign of sagging or unevenness due to excessive floor loading or foundation failure. The tile floor finish, however, has deteriorated with some rooms having some tiles loose or missing. Except for the Power and Heat Room where there was a lot of debris on the floor (Photo 16), floors were being kept clean by the York University summer school.

- in use as women's toilet room
- some equipment removed, much debris on the floor. Requires cleaning.

Photo 16 - Power and Heat Room debris

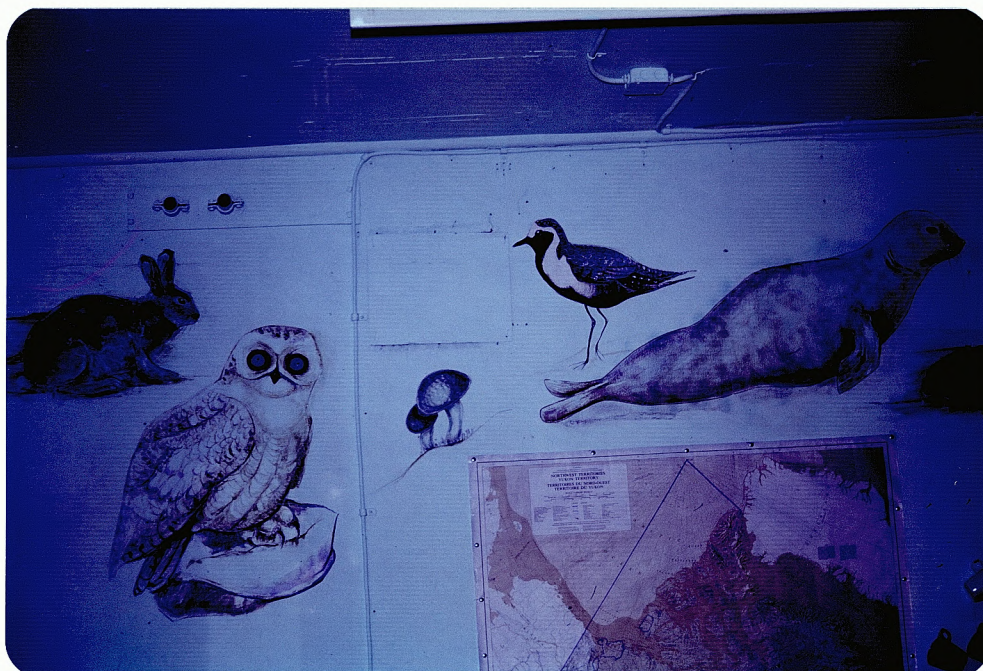
Photo 17 - Artwork on kitchen wall

Interior walls were structurally sound and free of cracking, bulging or other indications that they could not support the design load. All wall sections, consisting of painted plywood sheeting, were tightly in place. There was no sign of weather penetration. Interior paint was in good condition, the York University group having painted the kitchen and hall, recently and some other rooms previously. Notable are the wildlife paintings on the kitchen walls which should be preserved (Photo 17).

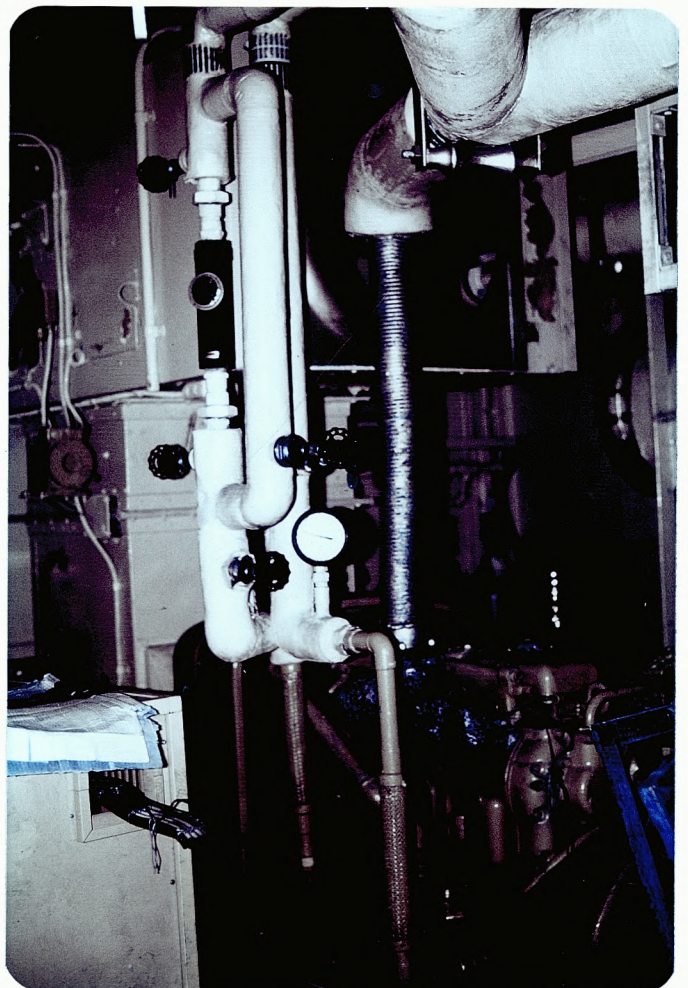
While electrical wiring and lighting were largely in tact, the original generating equipment was non-operational. Restricted power service was supplied to the building from a three kilowatt Onan electrical generator rated at 220/240 volts located in the Warehouse with power carried to the Train Building by an overhead power line. This generator was bought for CAM-F by Environment Canada. The original generators and other equipment in the Power and Heat Room have been rendered unserviceable (Photo 19). While some parts were damaged or missing, the remainder of the generators were in good condition and probably could be repaired. Much of the wiring in the Power and Heat Room has been cut (Photo 20).

Photo 20 - Power and Heat

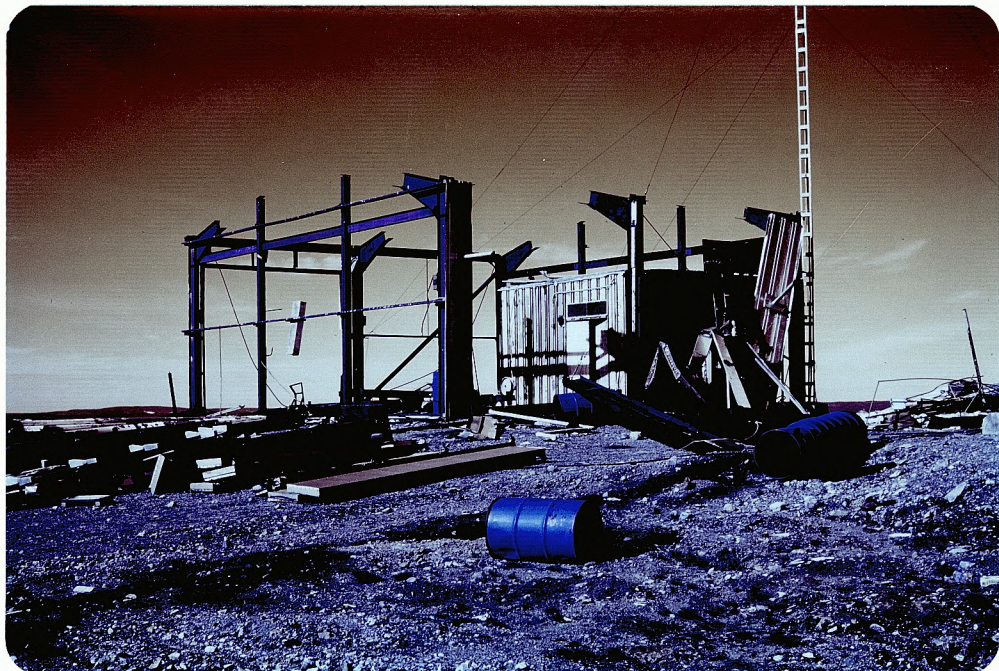
Photo 26 - Garage

Refer to attached drawing 1G-1 "Garage Plan and Sections". The garage has been almost totally demolished by persons unknown (Photo 26). Only steel beams, part of the Generator Room and the concrete floor remain in tact. Much of the building material has been left on the ground while some has been used in building the Quonset-type hut. Some of the remaining garage material would be salvageable for building purposes.

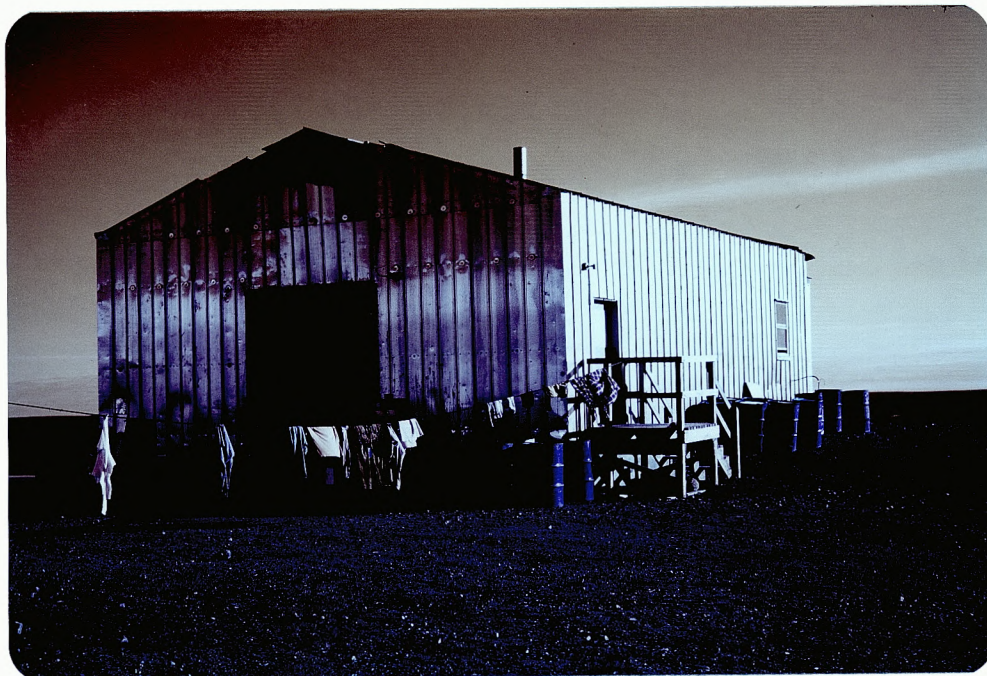
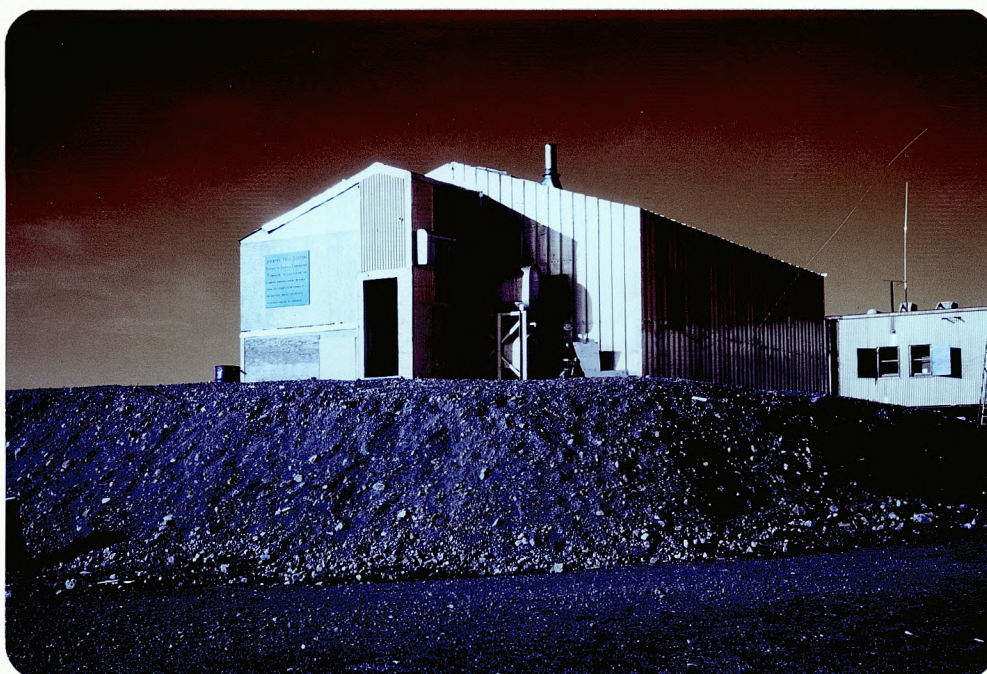
The exterior of the warehouse was in very good condition with corrugated aluminum walls and roof (Photos 27 and 28). A portion of the aluminum siding at the peak on the north side had been removed and more siding was missing from the walls of the addition on the south side. The pieces removed may have been used in the construction of the Quonset-type hut. The resultant exposed plywood should be painted or covered. Otherwise the aluminum walls only had minor dents.

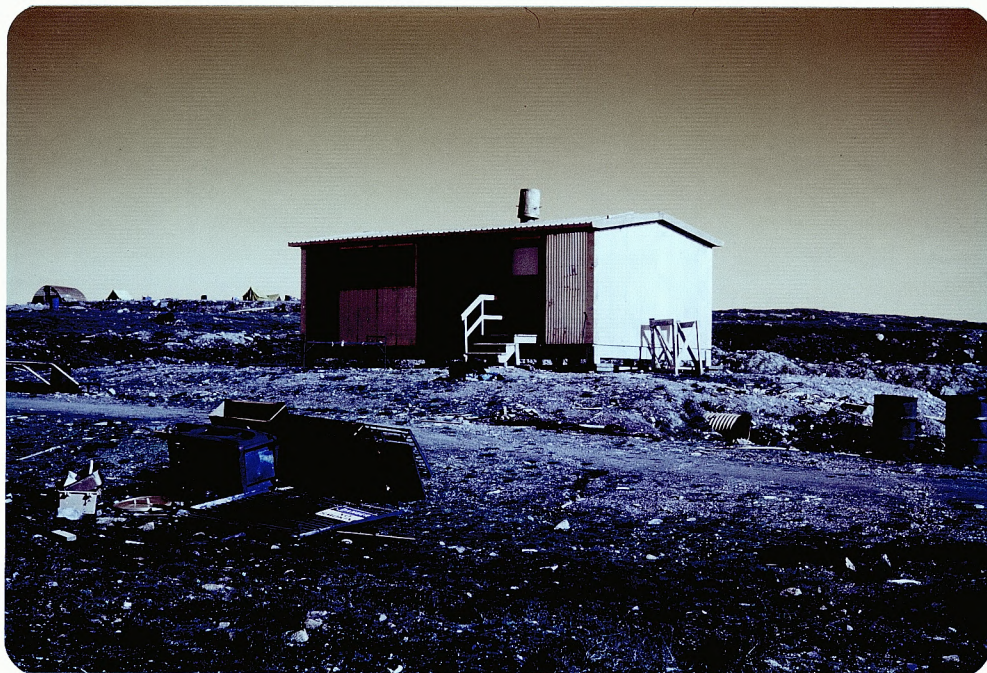
Photo 29 - NANR House

The NANR House was in generally good condition (Photo 29). The gravel foundation pad was stable and well-drained. The wood post on sill foundation structure was good with no sign of rot or settlement. The aluminum walls and roof were in good condition. There was a small tear on the lower south-west corner exposing plywood and insulation, a small tear on the front wall and numerous minor dents. The exterior fuel tank was not in place. The grounds around the house were messy with fuel drums, scrap steel and furnishings removed from the house.

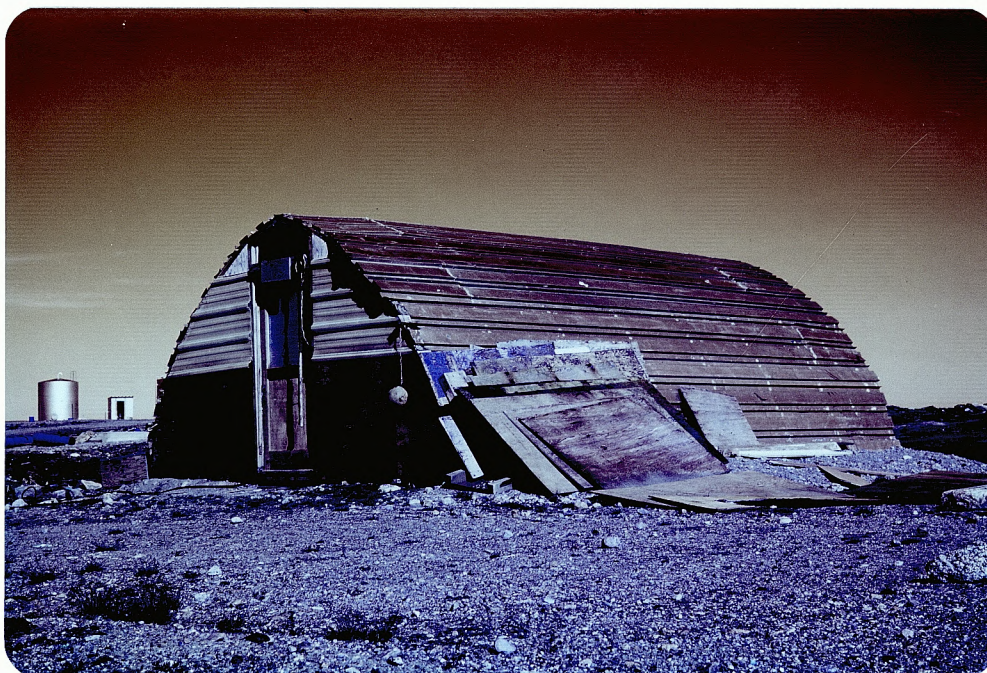
Photo 30 - Quonset-type Hut

A Quonset-type hut has been constructed on the main building site out of materials available from the garage (Photo 30). This appeared to be a solid, weatherproof structure in use for storage.

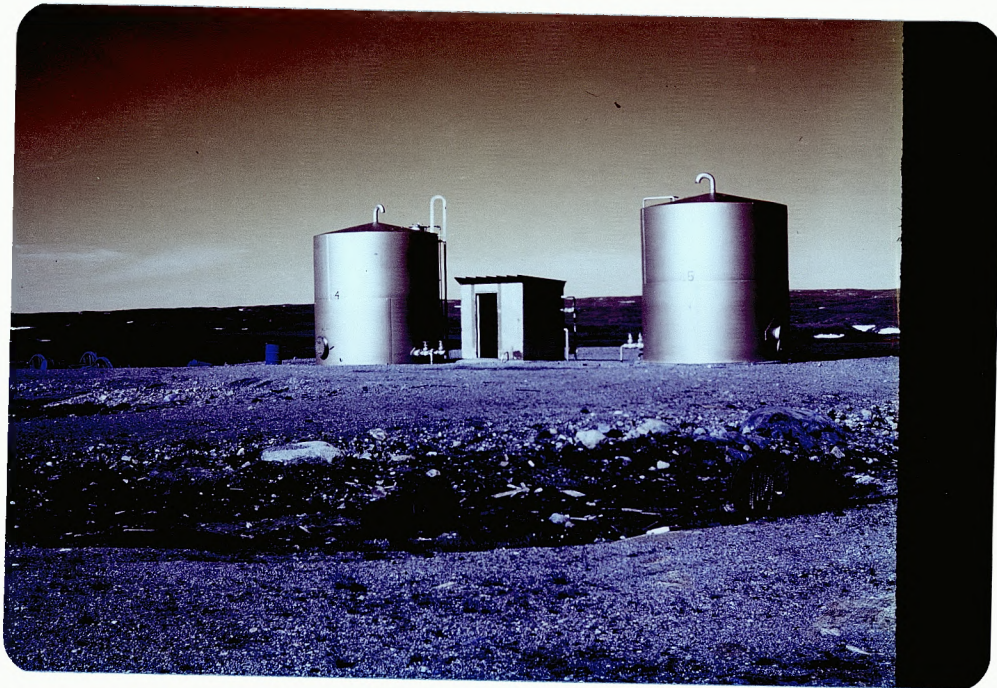
Photo 31 - POL Tanks and Pump House

The two POL tanks and pump house on the main building site were in good condition though the access ports on both tanks have been left open allowing water to enter (Photo 31).

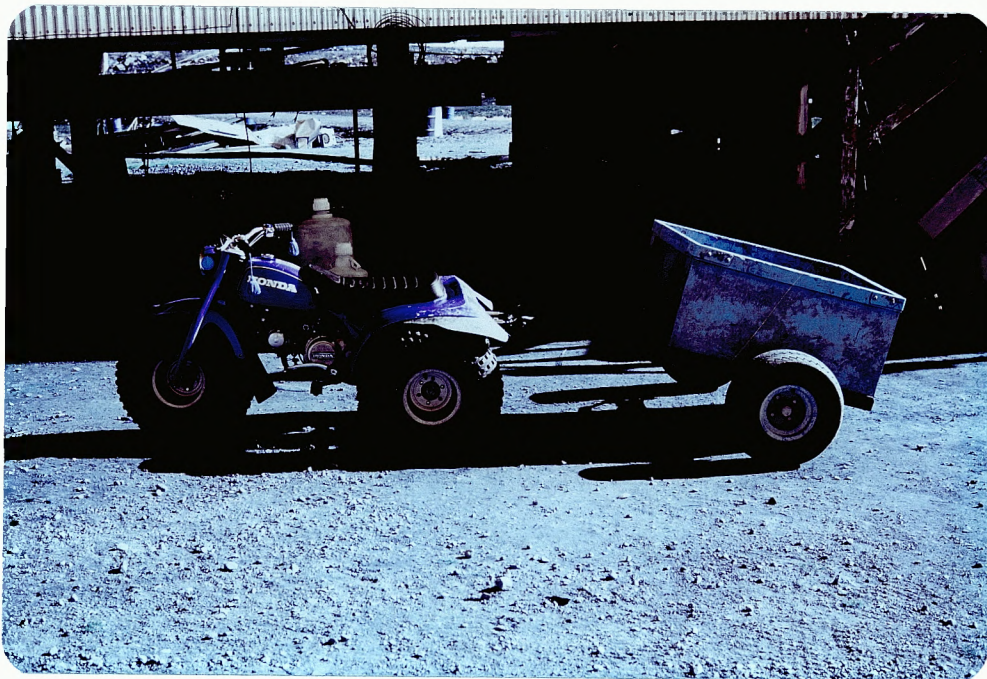
Photo 32 - Honda ATC 90 with trailor

Two Honda ATC 90 three wheel trail vehicles were operational, one with a trailer used for hauling water and other supplies (Photo 32). These were being maintained by the York University group. The 1975 vehicle was in good condition while the 1976 vehicle was in fair condition with a torn seat and broken fiberglass body.
