FOX-B (MID-BAFFIN) DEW LINE STATION  
CONDITION REPORT  
SEPTEMBER 1980

Report No. EA-HQ-80-109

FOX-B (MID-BAFFIN) DEW LINE STATION  
CONDITION REPORT

by D.E. Rodger  
Municipal Services Divison  
Technical Services and Contracts Branch

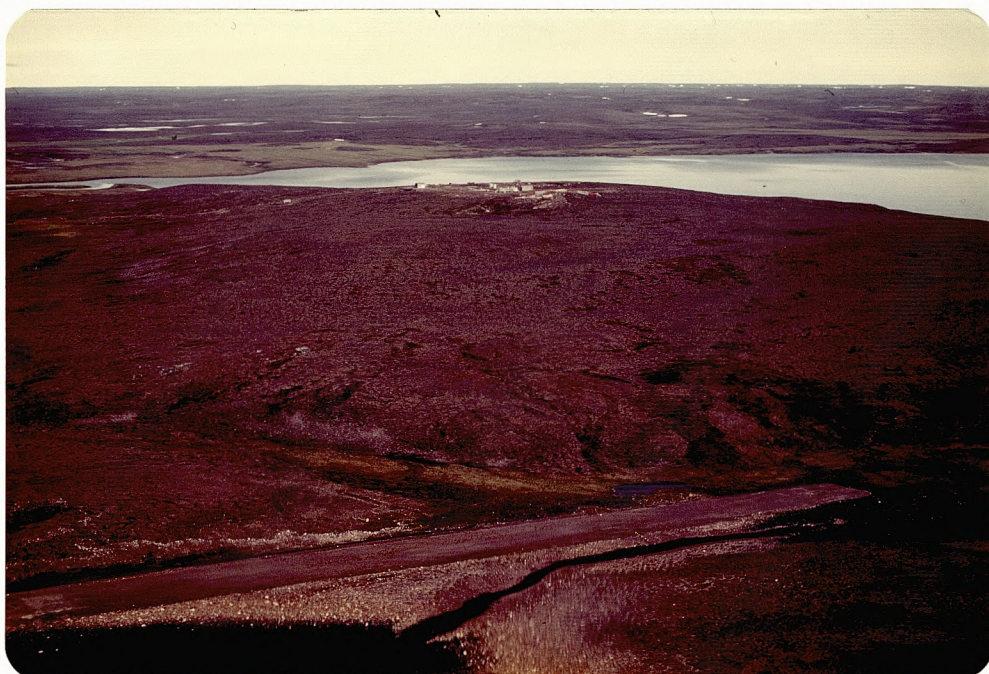
Photo 1 - FOX-B Intermediate Station

FOX-B is situated on a very impressive location atop a hill (153 m ASL) from which a 360° view is available including Nadluardjuk Lake 1.2 km to the east (Photo 1). The surrounding country is a beautiful composite of gently rolling rocky hills, broad grassy valleys, wetlands and lakes (Photo 2). Numerous caribou were sighted from the air.

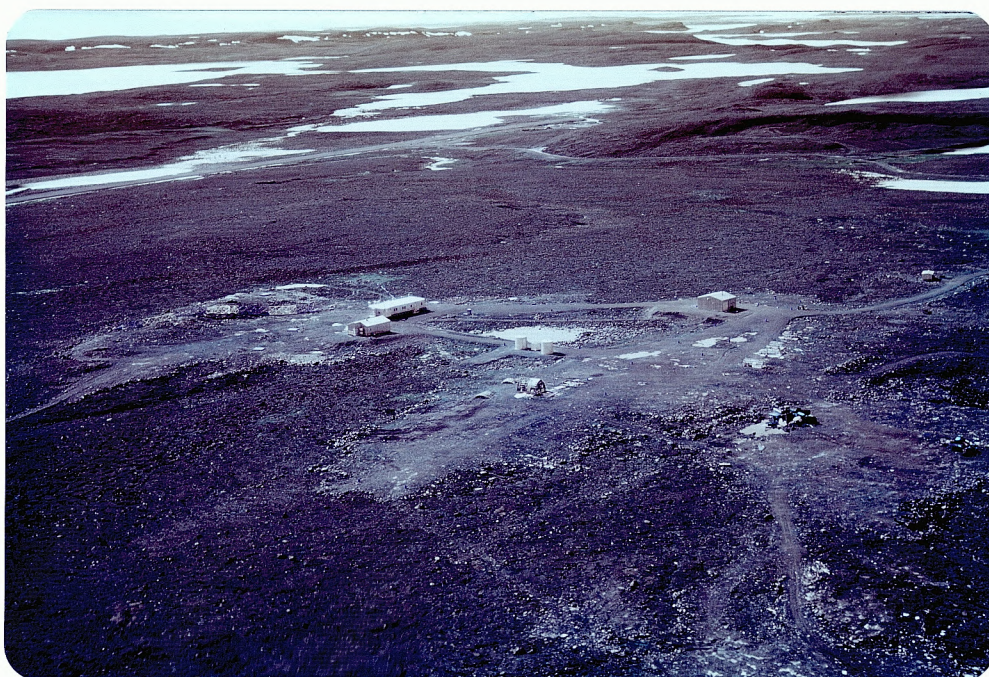
Photo 3 - Layout of Station

As-built drawing LAP-1 "FOX-B Site Development" (attached) shows the lay-out of the station (Photo 3). The train building, warehouse, garage and POL tanks are located on top of the hill. The NANR House is approximately 400 m down the road to the west. The 300 ft. AA antenna has been felled along a south-west alignment away from its base resulting in an unsightly wreck of twisted silver and orange metal and cable (Photo 4).

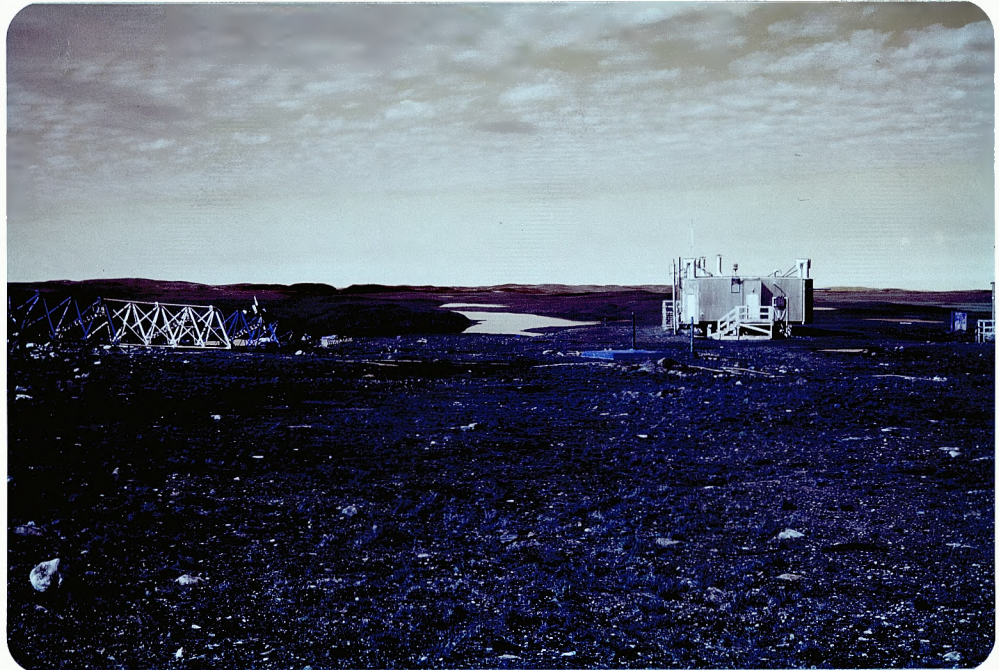
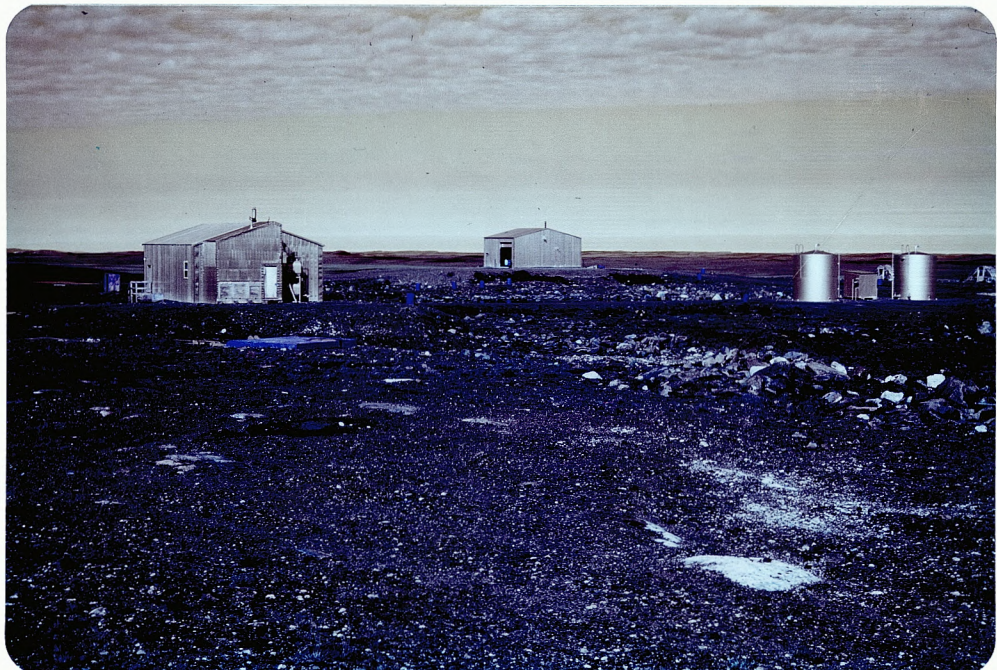
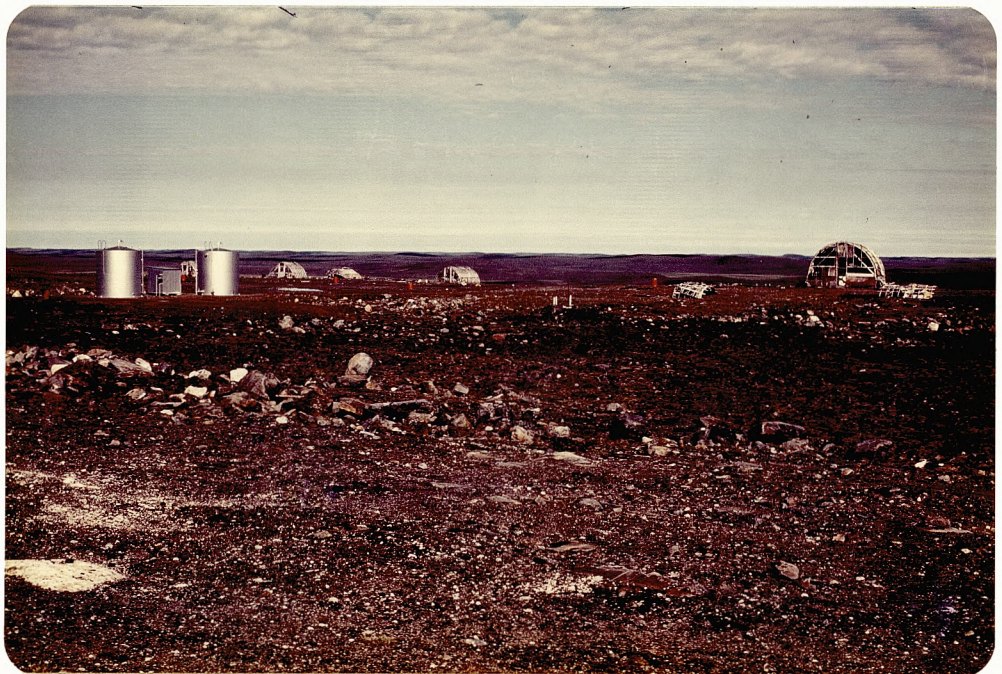
As-built drawing LAP-2 "FOX-B Building Site" (attached) provides site development details of the main building site (Photos 5, 6 and 7). Physically the site was in very good condition. Building foundation

pads and roads were of compacted gravel and were in tact with no significant erosion, gullyng or slumping. The garage, however, had poorly designed drainage reportedly resulting in spring run-off flowing over the garage floor to an unknown extent. Minor gullyng was occurring along the road between the warehouse and the POL tanks. The road between the garage and the POL tanks has been extended by the Elliotts as a make-shift airstrip. It was marked by oil drums but, with a length of approximately 270 m and a depressed center, its use cannot be recommended.

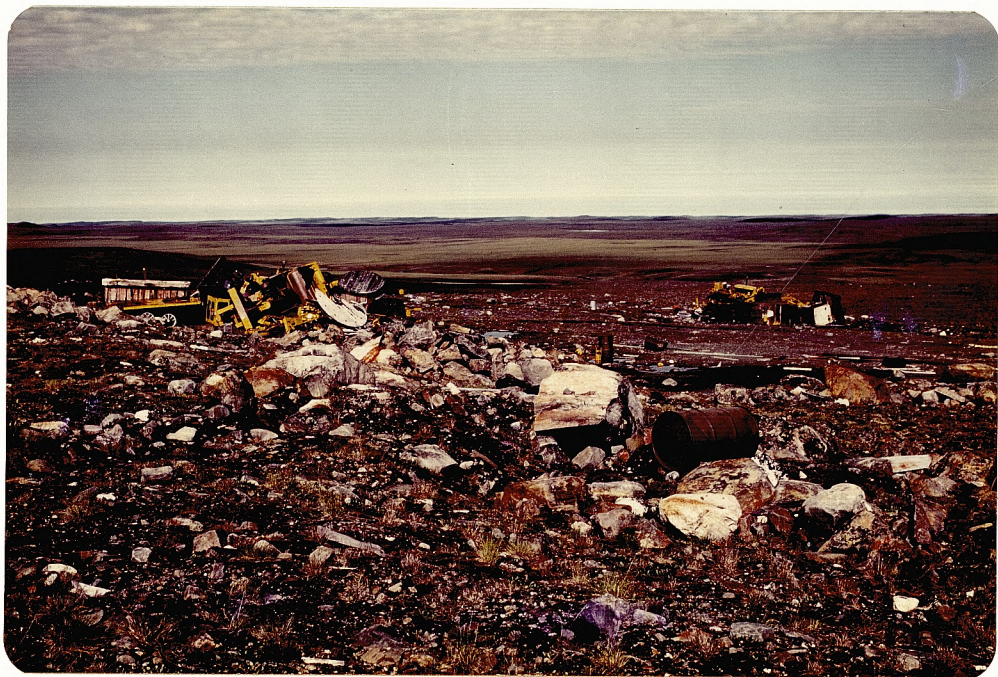
Photo 12 - Vehicle pile near building site

The three vehicle piles represent extravagant waste. Someone, presumably DEW Line personnel closing the station, has bulldozed the vehicles into piles (two at the main site and one at the airstrip) and set fire to them. Some means of storage may have been preferable as some of the vehicles appear not to have had many hours of use on them.

The pile north of the building site (Photo 12) included:

- grader
- earth mover
- bulldozer (D8)
- fuel truck
- dump truck
- flatbed trailor
- crane
- misc. items (inc. Nicad batteries)

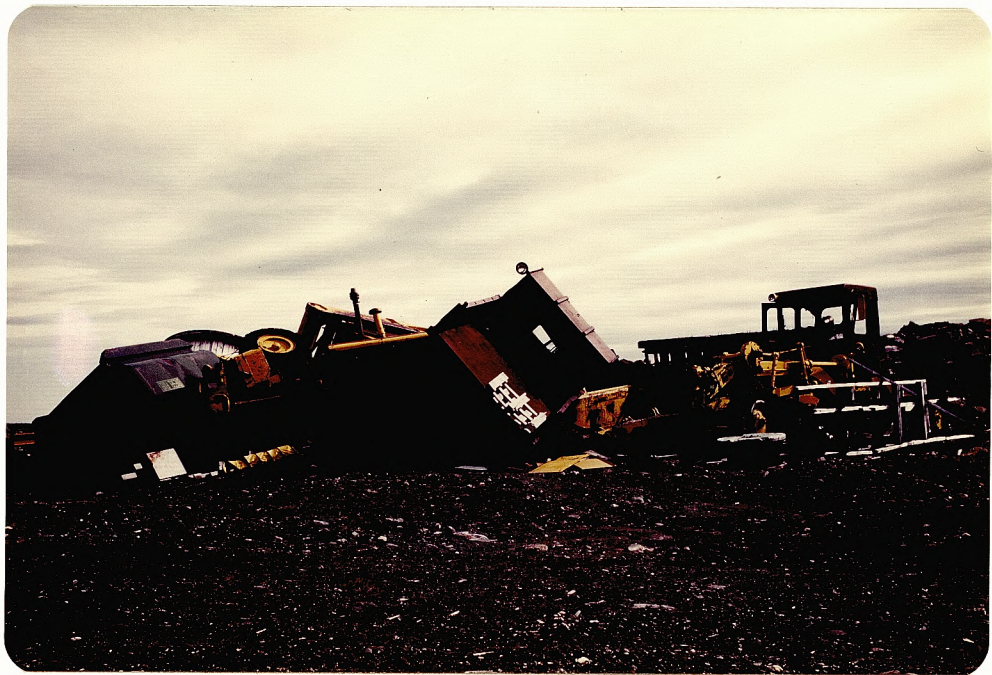
Photo 13 - Vehicle pile close-up

The adjacent pile north of the building site (Photo 13) included:

- bulldozer (D8)
- bulldozer (small)
- water trailor
- jeep
- misc. items

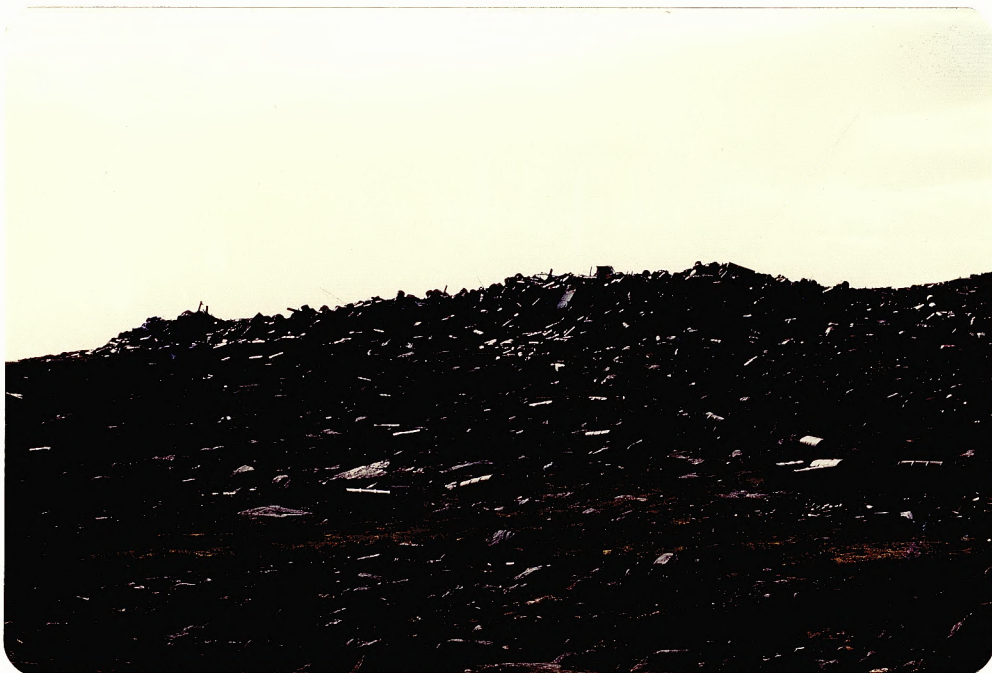
Photo 14 - Landfill

The landfill (Photo 14) contained an enormous quantity of material including fuel drums, scrap steel, lumber, wrecked equipment, furniture, etc. bulldozed into a pile with some compaction and no earth cover. It is suspected that much of this would have been useable prior to disposal and some is still salvageable (e.g. new copper wire coils). Some of the landfilled material, especially fuel drums, has rolled down the slope below the dump and spread out on the tundra.

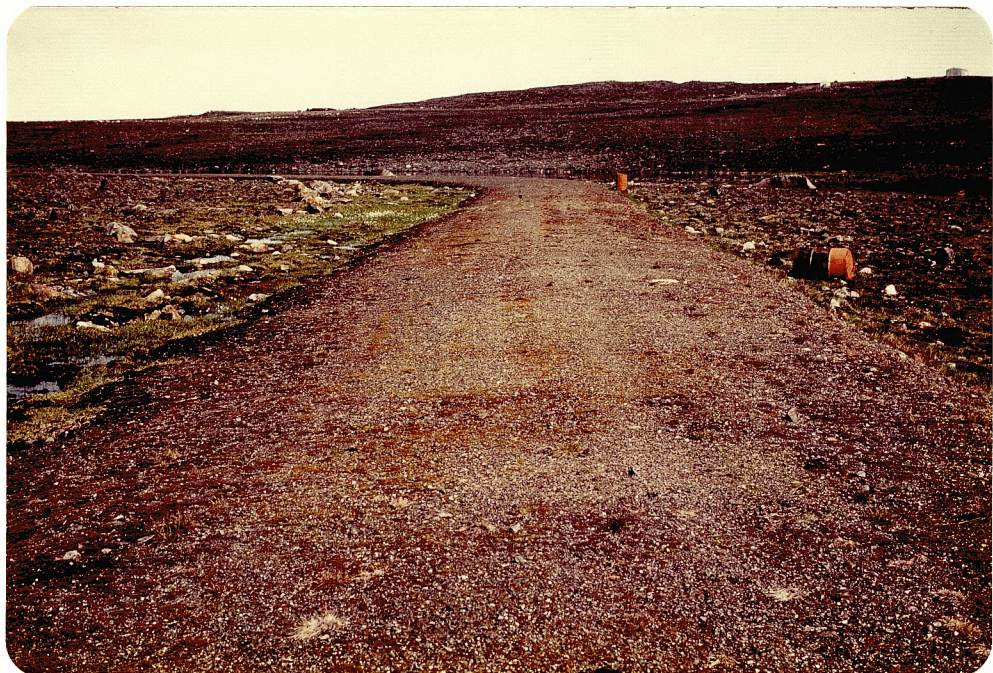
Photo 15 - Road to airstrip

The main road from the building site to the water point and to the airstrip, (Photo 15) was generally in very good condition. Minor wash-outs were located at a distance of from 200-400 m east of the junction of the water point road and airstrip road. These wash-outs are small and could be repaired with wheel barrel and shovel. Midway along the airstrip road, there would be some spring run-off over the road from the adjacent slope. The road into the western gravel source was in poor condition due to the wetness and softness of the terrain. Some re-construction would be necessary if the gravel pit were to be re-activated. All culverts were clear.

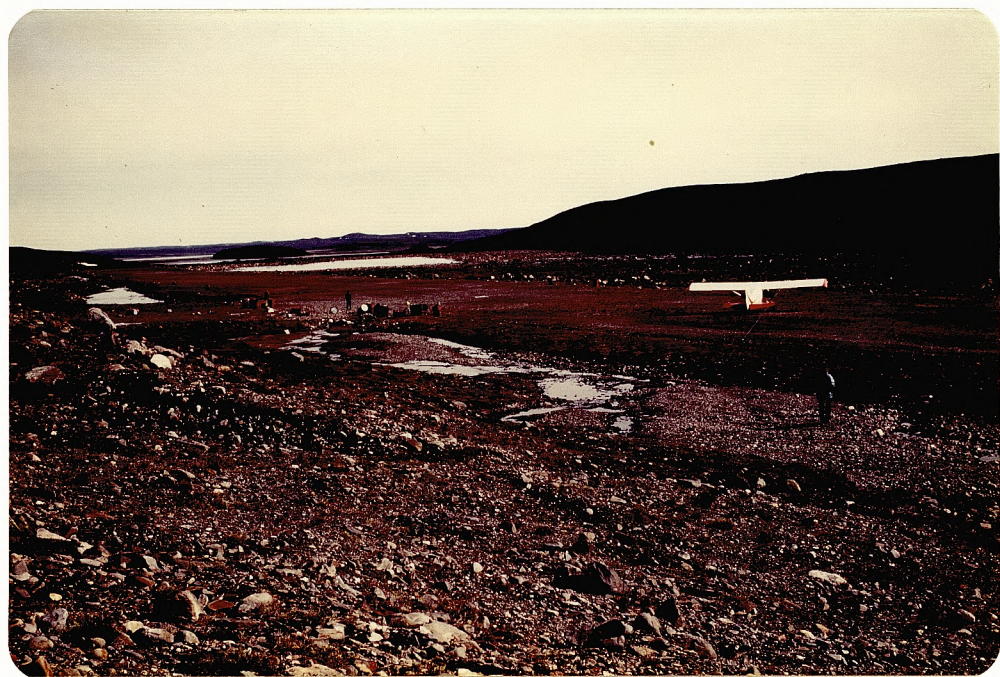
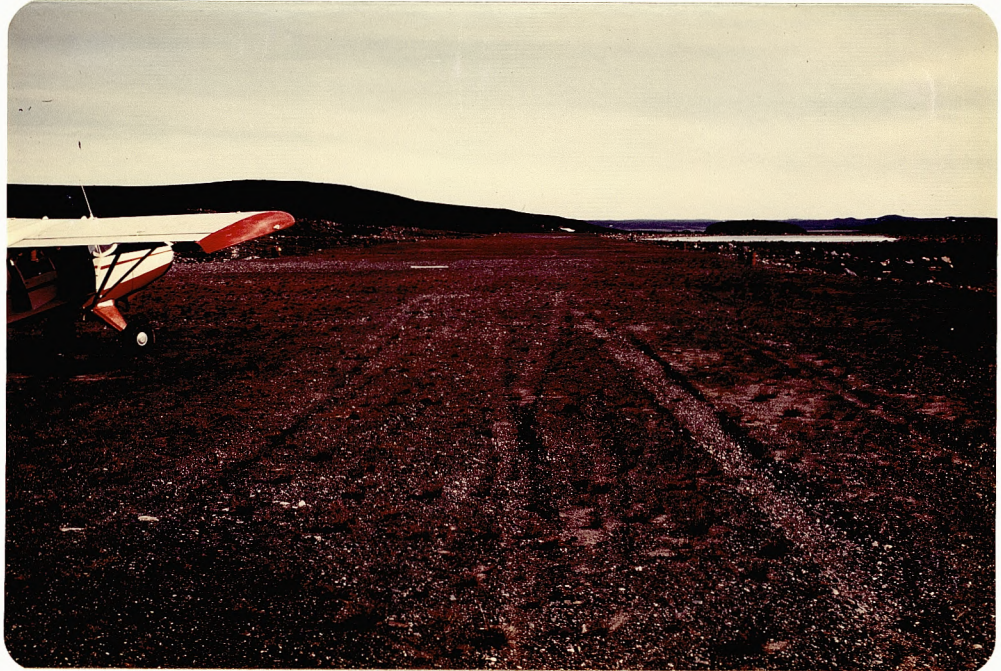
While no technical investigation of the airstrip (124' x 3990') was carried out, visual inspection indicated the runway to be in good condition (Photos 16 and 17). The Maule aircraft landed with no difficulty and there should be little problem for a Twin Otter. It is not known if the airstrip could support heavier aircraft. There was minor rutting in the surface from aircraft tires. A few slump lines existed on the south edge of airstrip. Ditching is required

along the north side of the east end of the airstrip to divert spring run-off. The runway lights were unserviceable as many of the wires had been cut and the fixtures damaged. The wind sock was missing but replaced temporarily with reinforced plastic strips. There was a moderate quantity of scrap wood around which could be used for fire.

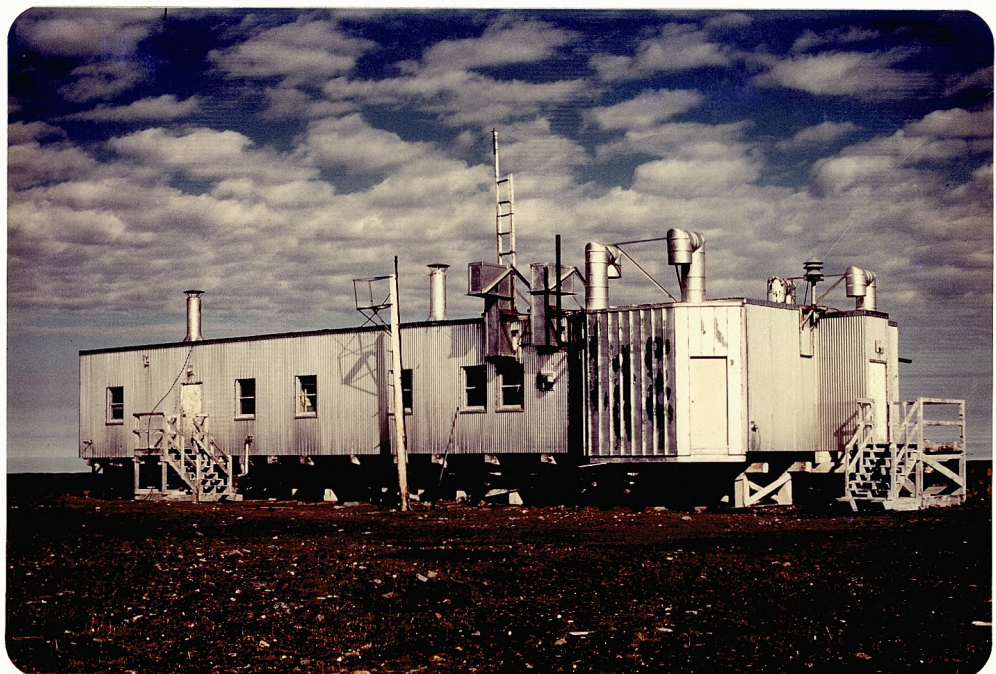
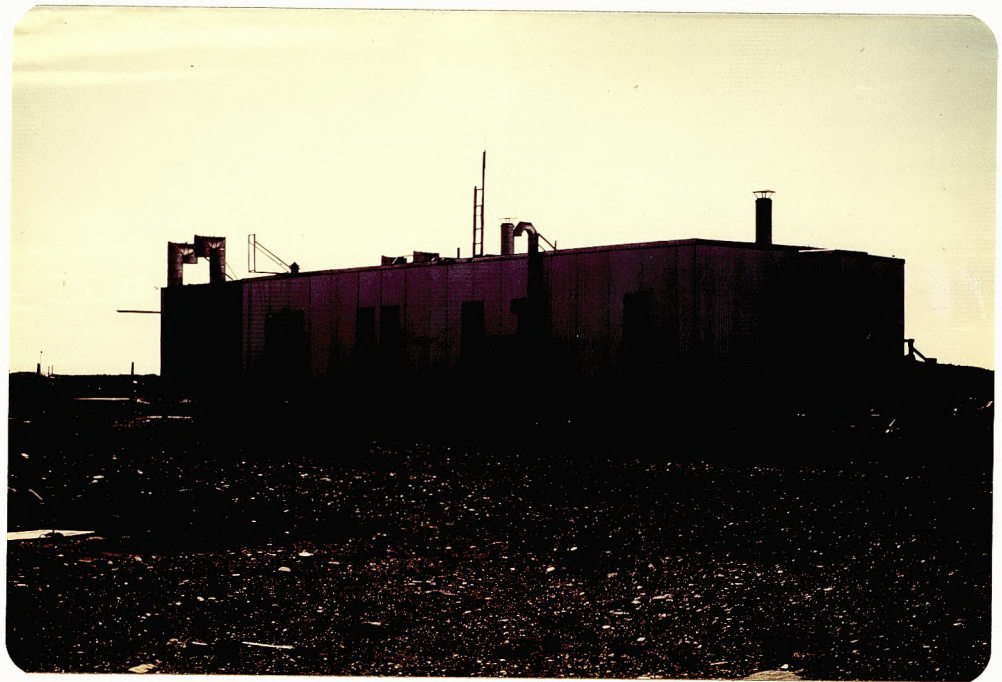
Reference should be made to the attached drawing 1-1A "Typical Building Train". In general, the building was in very good condition (Photos 18 and 19). The foundation pad of compacted granular material on bedrock was sound with no indication of settlement or erosion. A wood post on mudsill foundation structure transfers the building load to the ground. The 12" x 12" Douglas fir members were in durable condition although there was minor rot in some areas where the mudsills meet the ground. The members do not appear to have been treated with wood preservative. No building settlement was noted; the building floors were flat and the joints were flush. Some of the gray paint on the wood members was flaking or weathered off.

Exterior walls were of heavy gauge corrugated aluminum except for the plenum walls which were of gray painted galvanized steel. Except for a few minor dents, the aluminum siding was in excellent condition. There was some paint flaking on the galvanized steel. No holes, cracks or leaks were apparent. Aluminum windows and flashings were all in excellent condition. Minor re-caulking is required. On the south exterior wall the fire ladder and waste outfall pipe were in place and serviceable. Wires from the Equipment Room were cut from an outside conduit. Similarly on the north side, wires from the Equipment Room were cut though the ground wire from the Water Storage and Snow Melting Room was in place.

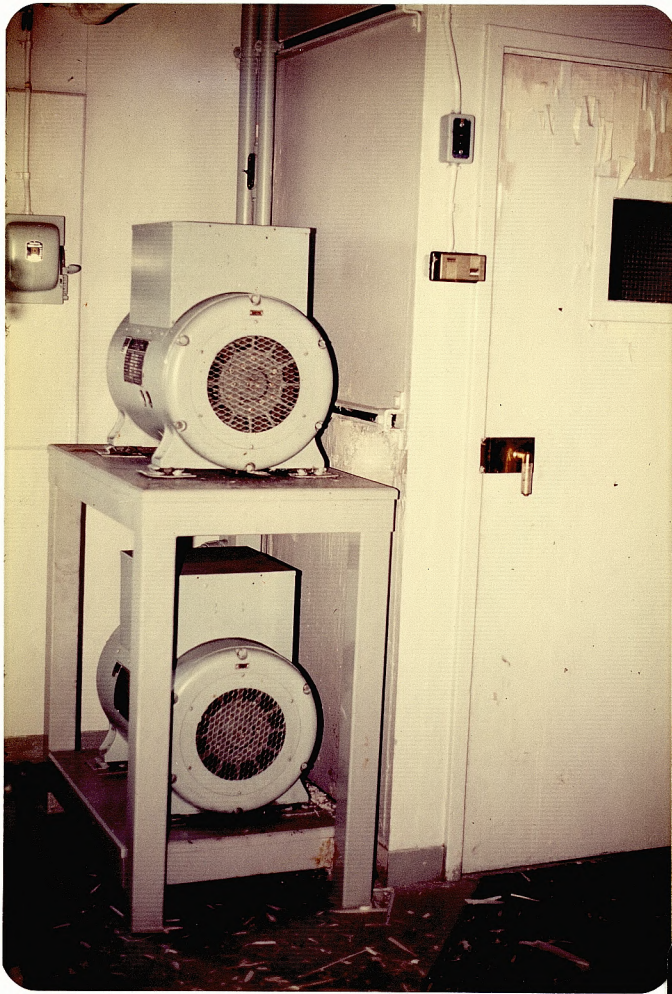
Photo 21 - Tank Room

Plumbing systems were non-operational but all installed equipment appeared to be in place and in tact. It is suspected that sewer and water systems were drained when closing down the facility, but not altered or damaged. In brief, the Water Storage and Snow Melting Room contained two 2500 gal. water storage tanks and one 2500 gal. snow melting tank, all with water meters and an alarm system, a chlorinator, a 30 gal. make-up tank, pumps, water boiler, and two 275 gal. fuel tanks (Photo 20). The room also contained four CO<sub>2</sub> cylinders for the fire protection system. It was estimated that one of these was full, one half full, and two empty. A clothes dryer was missing. The Tank Room contained a sewage tank, a waste water tank, sewage ejector, three 10 hp. motor/5 kw. generators, and other associated equipment (Photo 21).

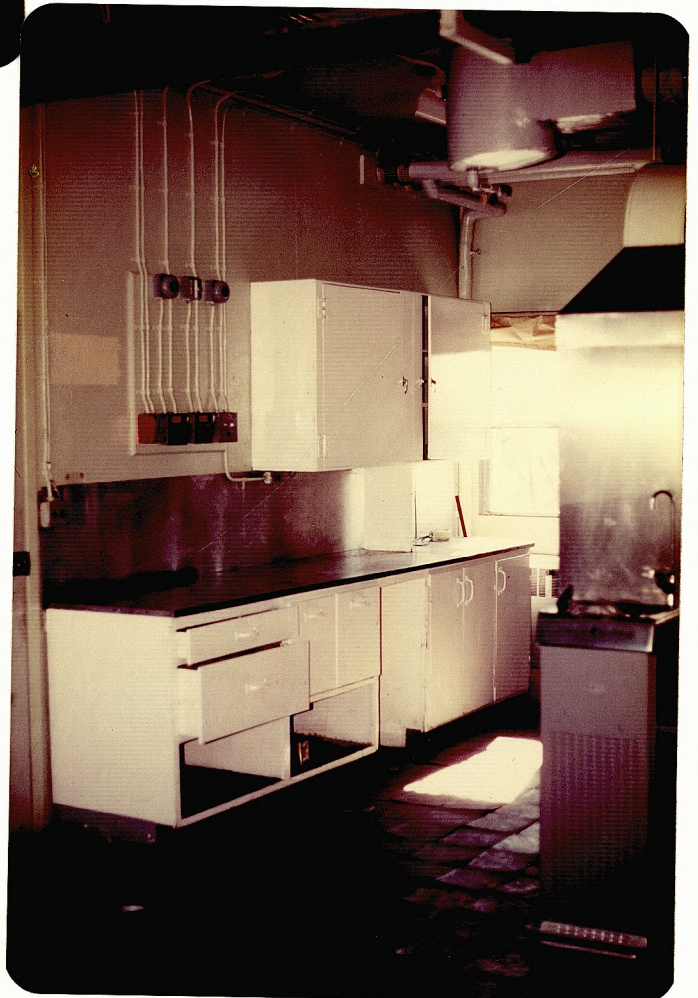
Photo 22 - Kitchen

The Kitchen water system was in tact including a 100 gal./1500 w. hot water tank and one stainless steel sink (Photo 22). Bathroom fixtures were also in place including a porcelain sink and toilet and a stainless steel shower stall (Photo 23). To the extent that pipes were accessible, there was no indication of leaking or corroded pipes or of inadequate bracing or support.

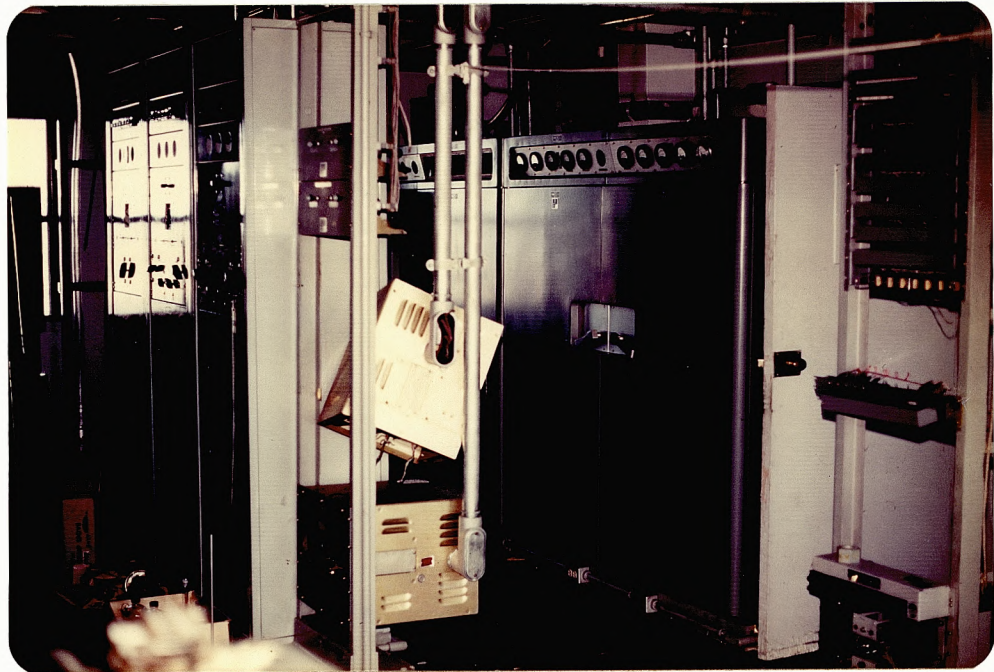
Photo 25 - Equipment Room

The communications equipment in the Equipment Room has been deliberately rendered unserviceable either by removal or destruction. High quality steel cabinets and some electrical components remained from the original transmitter/receivers, dehydrator, alarm system and controls (Photo 25).

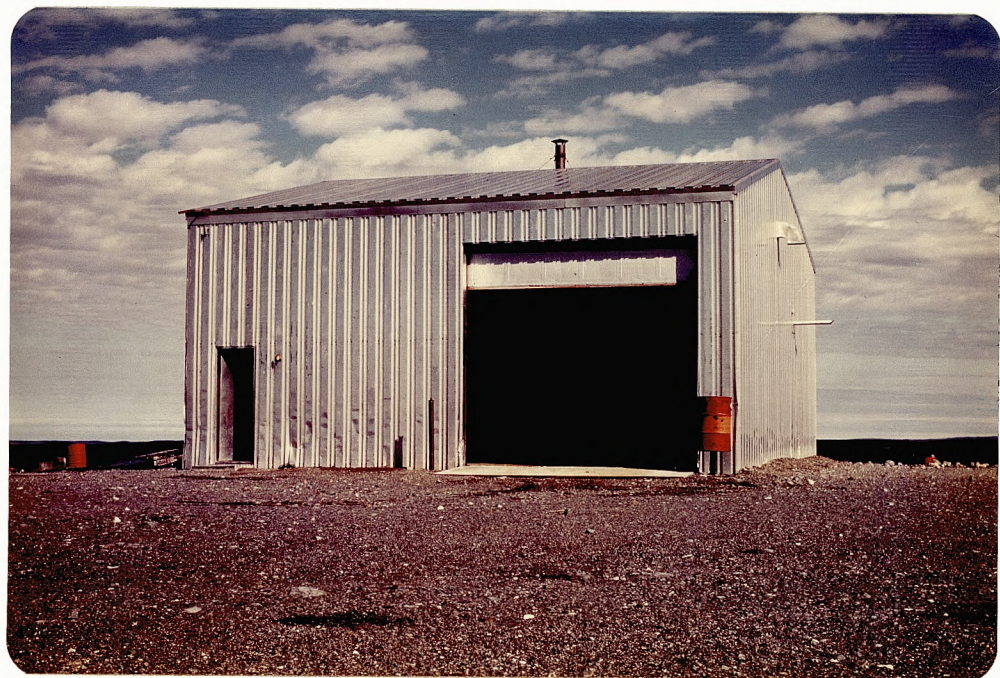
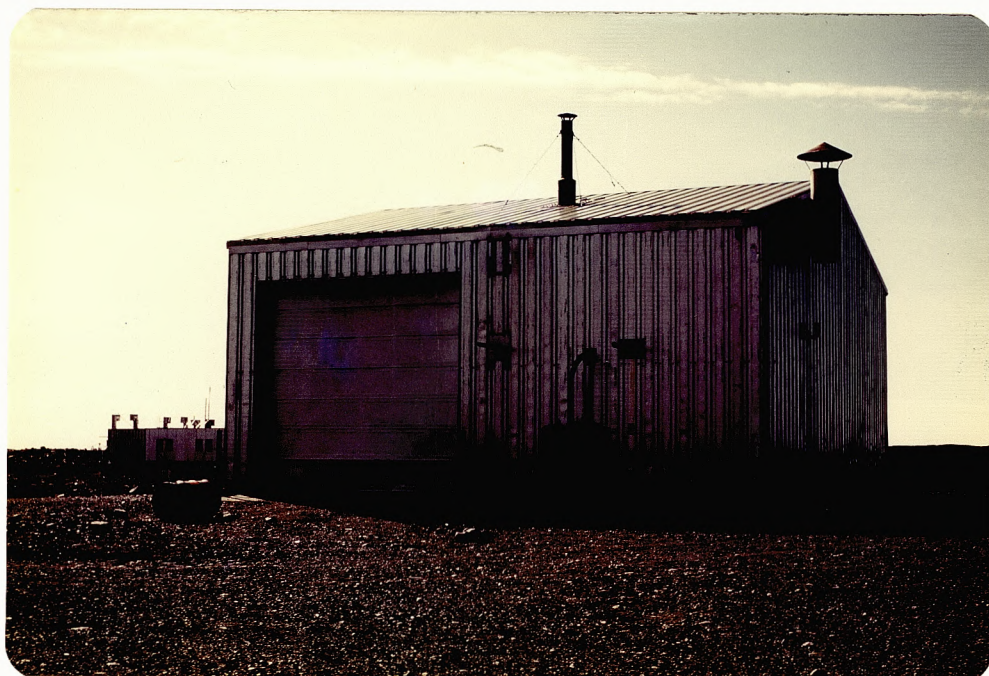
Refer to attached drawing 1G-1 "Garage Plan and Sections". The exterior and interior of the garage were in very good condition (Photos 26 and 27). The foundation pad was solid but drained poorly causing melt water to enter the garage floor area in spring. The exterior walls and roof were of corrugated aluminum in good condition except for minor dents. All ventilation and exhaust stacks were in tact. The two vehicle doors and the man door all operated well. Structurally the building was very sturdy with no sign of any deterioration or weakness.

The internal structure and walls were also sound with minor dents on the walls. The concrete floor was free of cracks. In the generator room, a Hercules 50 kw. diesel generator was in place. It appeared fully serviceable but lacked a push-pull throttle. There was also a 4-cycle portable gas generator (12 volt, 20 amp.).

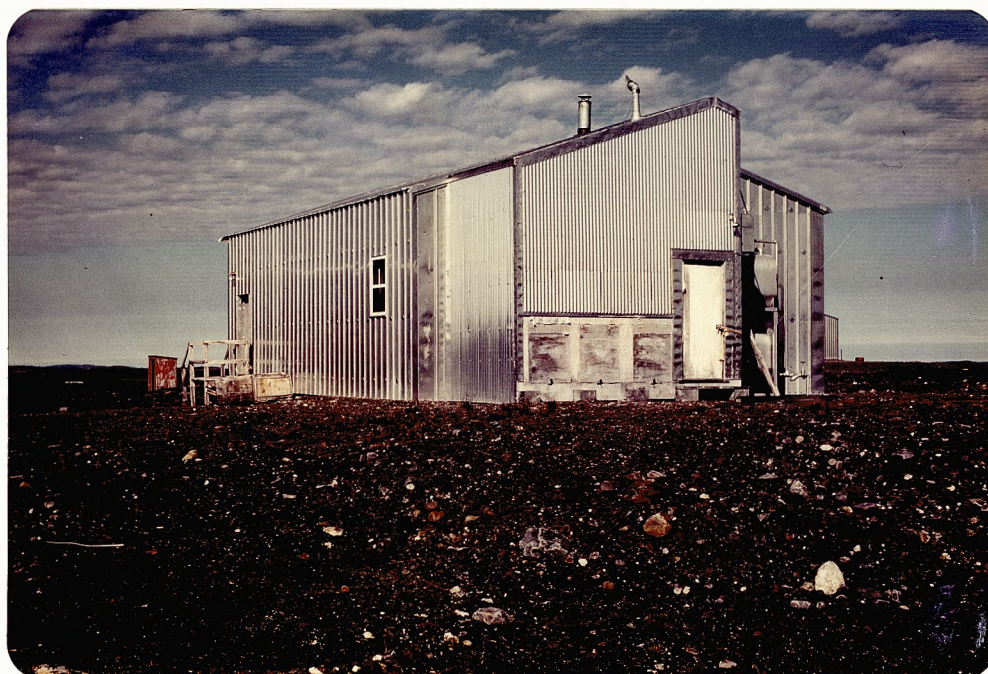
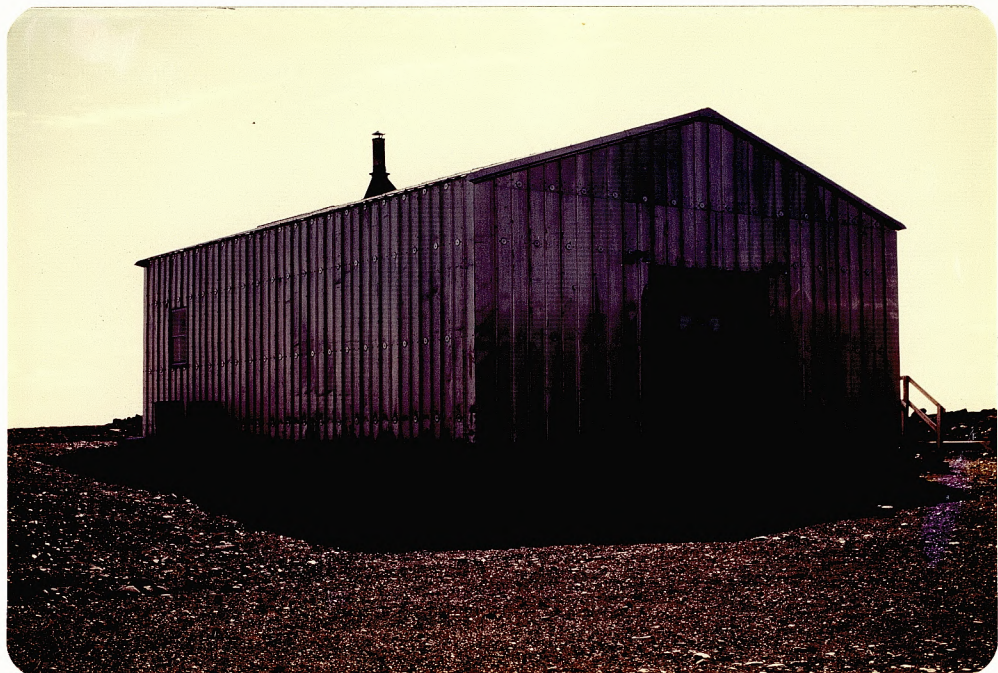
The exterior of the warehouse was in very good condition with corrugated aluminum walls and roof (Photos 28 and 29). There were some minor dents around the unloading door. The concrete foundation, where exposed, appeared sound with minor cracking only. The window on the south side required re-caulking and the wooden doors needed

re-painting. Both doors are tied shut as the handles are not serviceable. The stairs are sturdy but listing. Two 250 gal. fuel tanks were located at the east side of the building; one empty and one with 32 gal. according to the gauges.

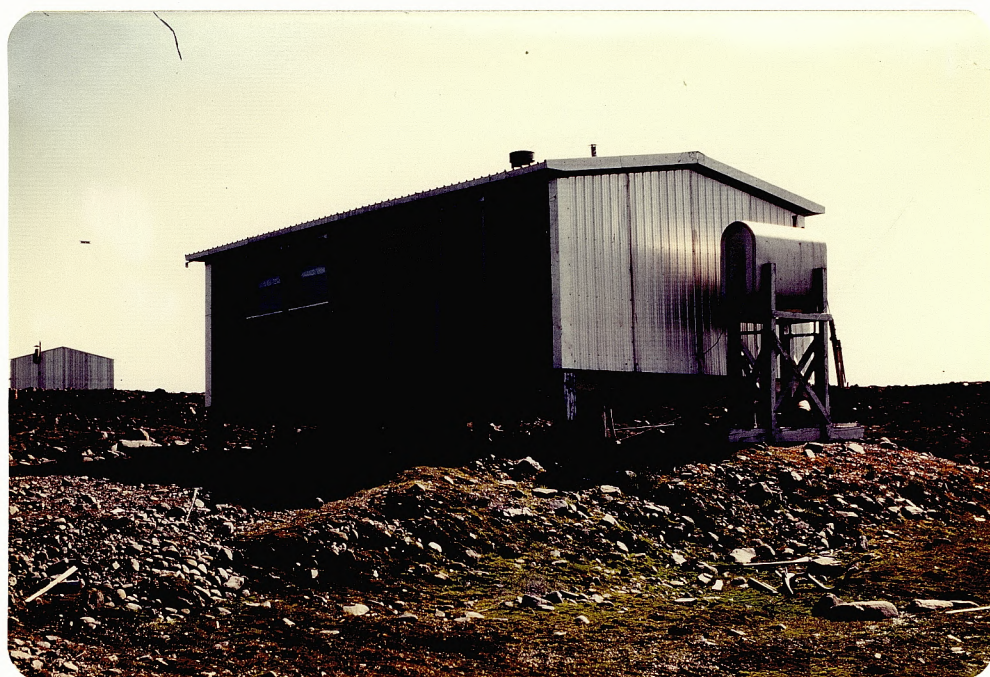
Photo 30 - NANR House

This house was in generally good condition (Photo 30). The wood post on sill foundation and gravel pad were satisfactory. There was no sign of instability or unevenness of floor. The ground however was quite messy with lumber and other debris. The painted aluminum siding and aluminum roof were all in tact.

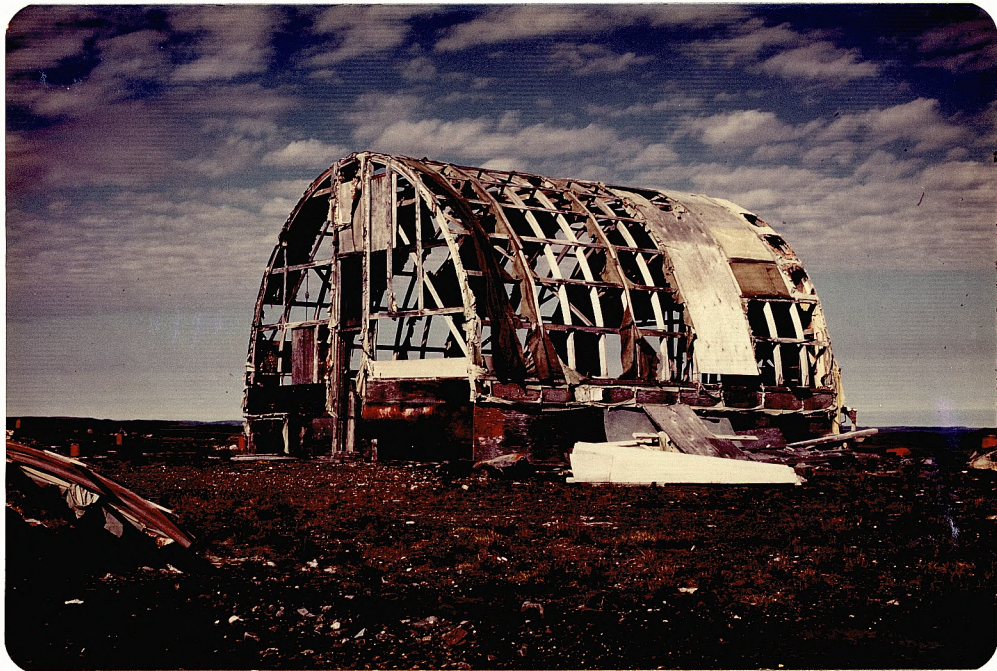
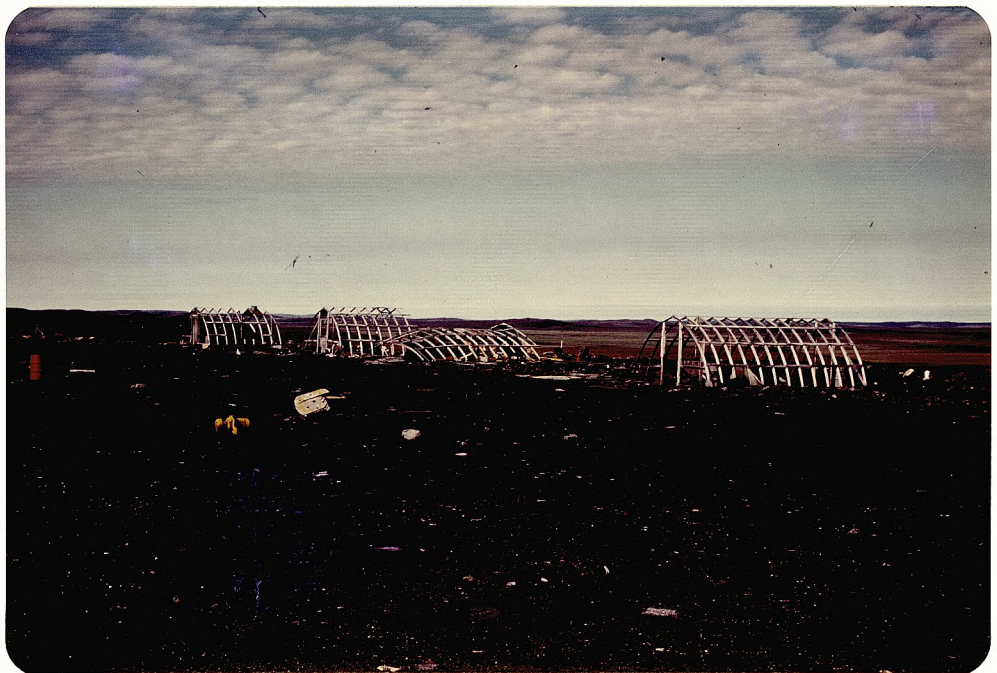
The one large and four small Atwell buildings have been largely demolished (Photos 31 and 32). They can provide salvageable plywood and lumber. The canvas cover was largely rotten.

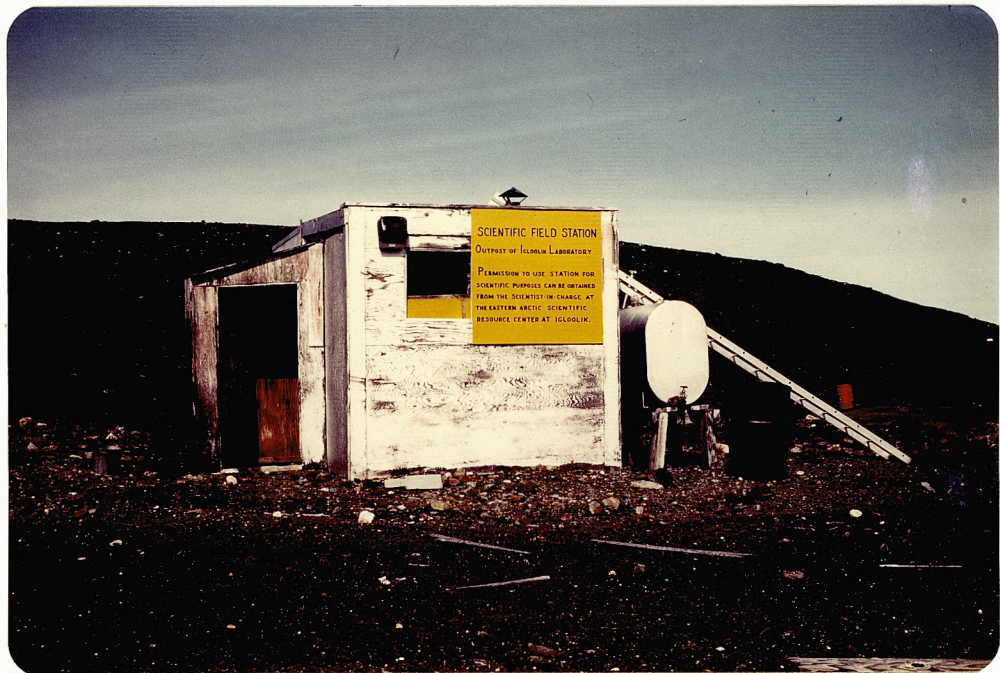
Photo 33 - Airstrip Emergency Shelter

The airstrip emergency shelter was in somewhat derelict condition (Photo 33). It was uninsulated but with windows could provide rudimentary shelter. The electric heater inside was unserviceable. Re-wiring for interior lights and the runway light switch is necessary. The outside fuel tank contained approximately 60 gal. of diesel fuel.

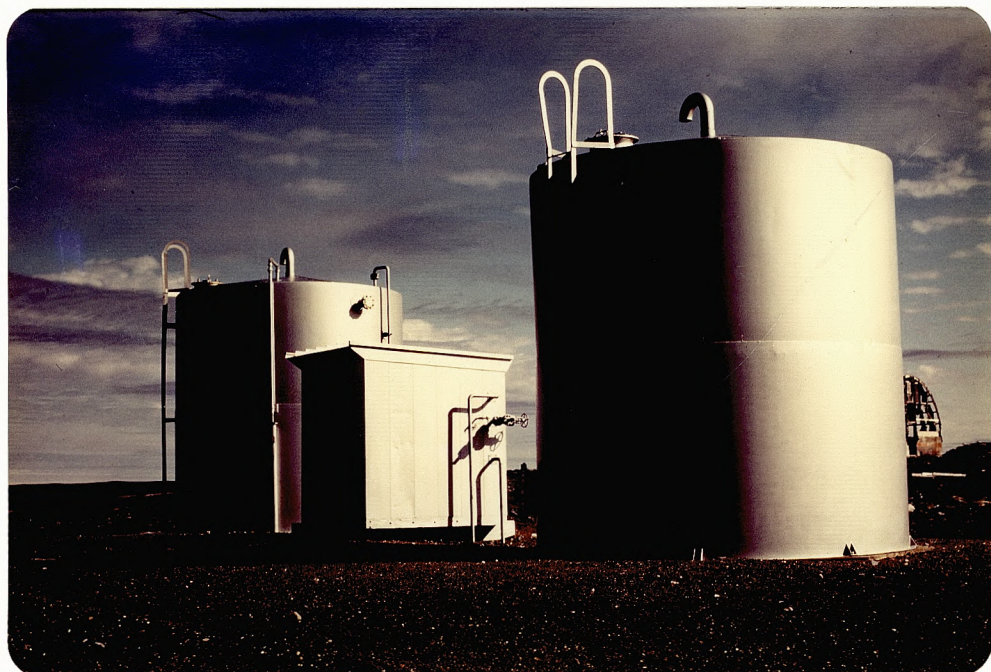
Photo 34 - POL Tanks and Pump House

The two POL tanks at the main building site were in excellent condition (Photo 34). Each has a 20,000 gal. capacity. It was estimated that combined they contained approximately 300 gal. at the time of the visit. The pump house between the tanks including the interior equipment was in tact.
