# AVIATION INVESTIGATION REPORT A15H0002

## **Collision with terrain**

Airbus Industrie A320-211, C-FTJP

Halifax/Stanfield International Airport

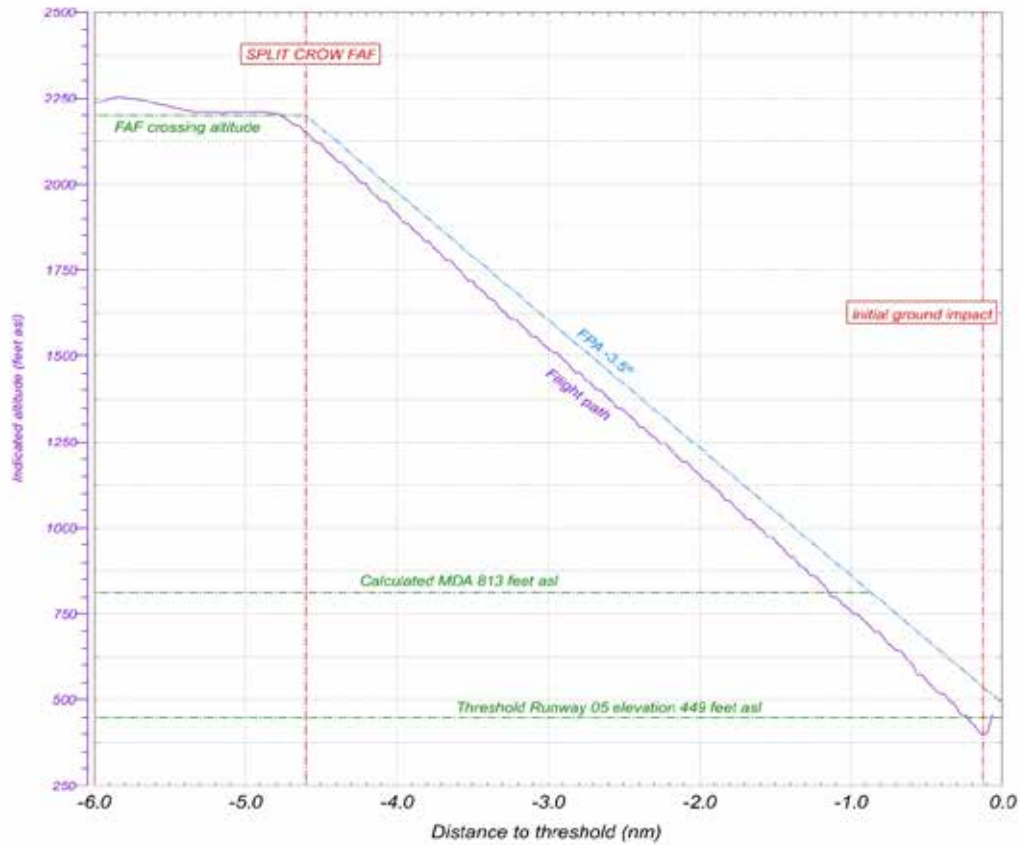
Figure 1. Flight path angle (FPA) versus aircraft flight path

The aircraft started to descend about 0.2 nm from the FAF. The aircraft crossed the FAF at 2170 feet indicated altitude (Figure 1).

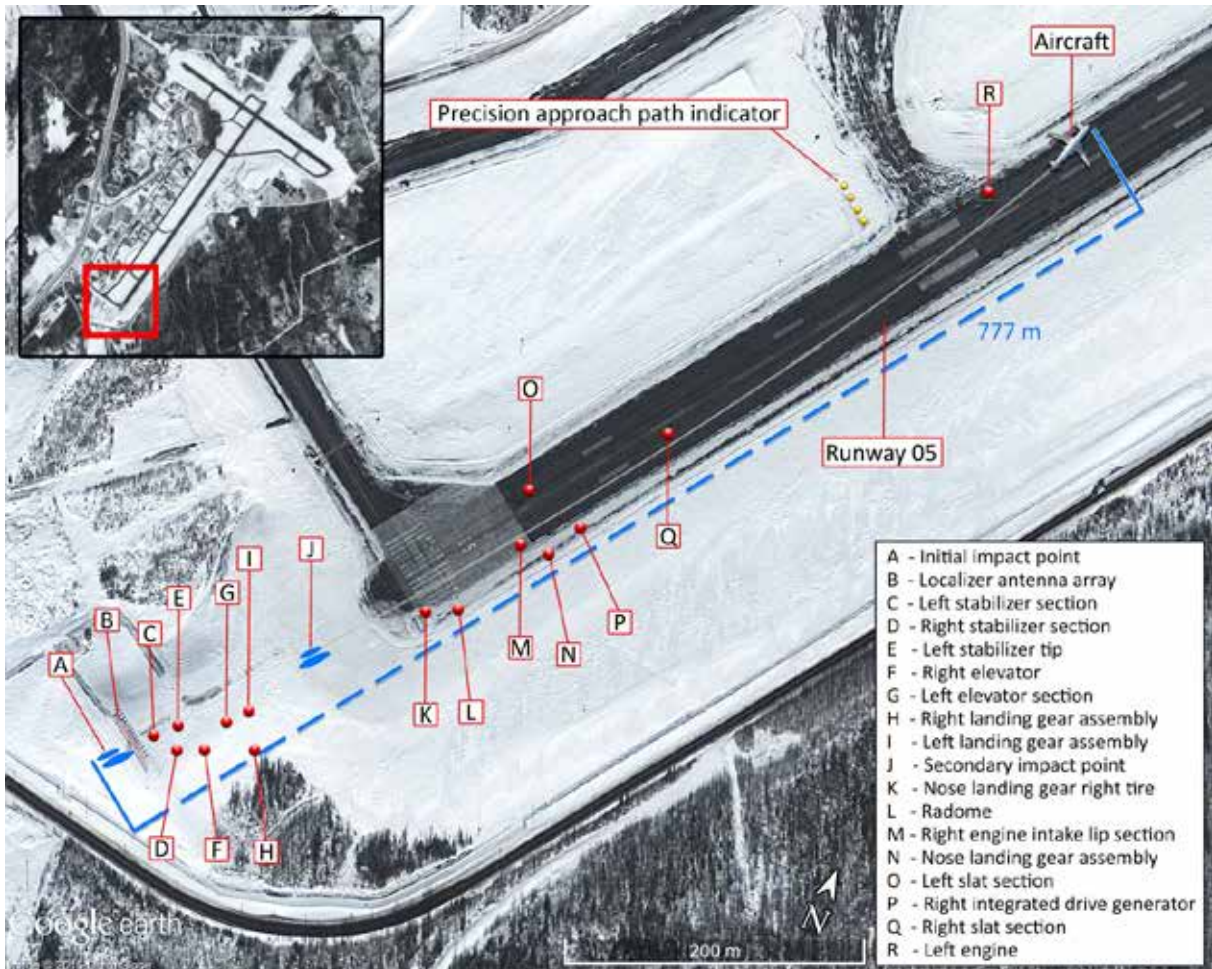
Figure 7. Site survey and wreckage distribution on Runway 05 (Source: Google Earth, with TSB annotations)

The aircraft then bounced before contacting the runway. The left engine completely detached from the wing and came to rest on the left side of the runway. The aircraft stopped on the left side of the runway in a slight nose-up and left-bank attitude, on an approximate heading of 025°M (Figure 7).

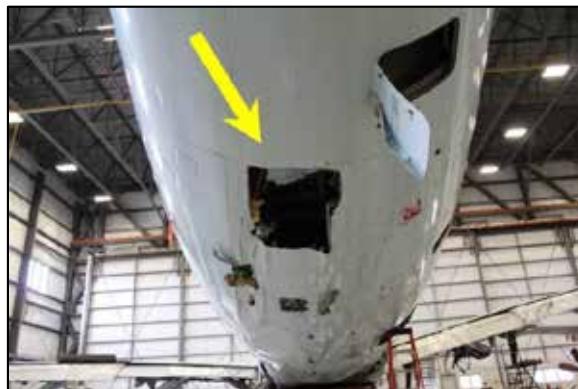
Figure 8. Fuselage damage

The nose wheel well area was forced upward and rearward, buckling and fracturing many of the internal structural components. The fuselage sustained multiple dents, tears, and punctures, including a large hole located just forward of the aft pressure bulkhead, where the fuselage skin and internal structure had fractured when forced up and aft (Figure 8).

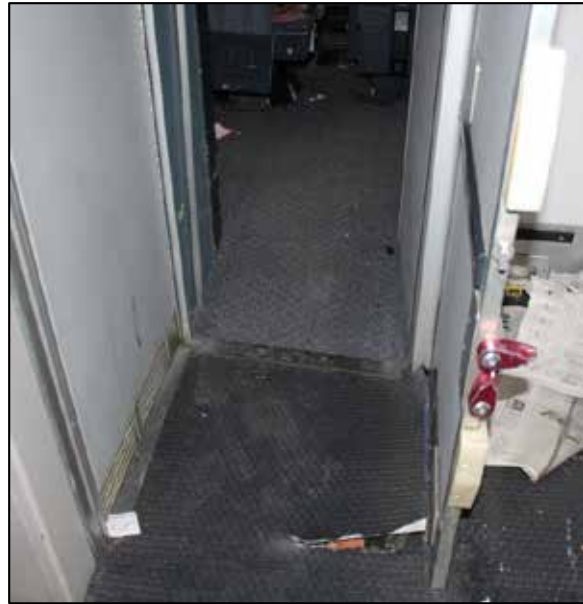
Figure 9. Floor damage aft of cockpit door

The entire nose landing gear bay had extensive damage that caused the structure to be forced rearward and upward. The floor aft of the cockpit door was forced upward by displacement of a pulley resulting from this structural damage. The cockpit door frame was also buckled as a result of the floor having been pushed upward, thereby restricting the movement of the cockpit door (Figure 9).

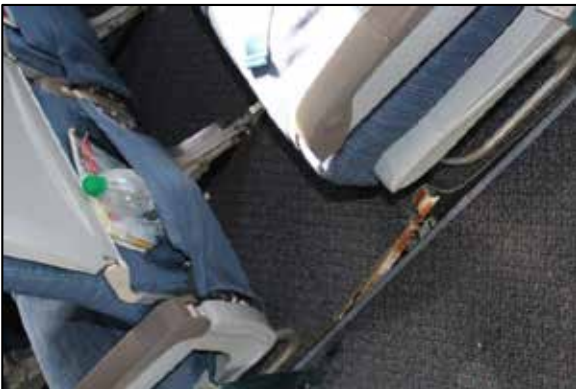
Figure 10. Floor damage forward of passenger seat 31D

Striking the snow-covered ground caused some of the aft lower fuselage stringers and formers to fracture and break, and caused the floor of the bulk cargo compartment to buckle and to be forced upward. The cabin floor was punctured forward of seats 31D and 33D when the stanchions of the forward and aft nets of the bulk cargo door were forced upward (figures 10 and 11).

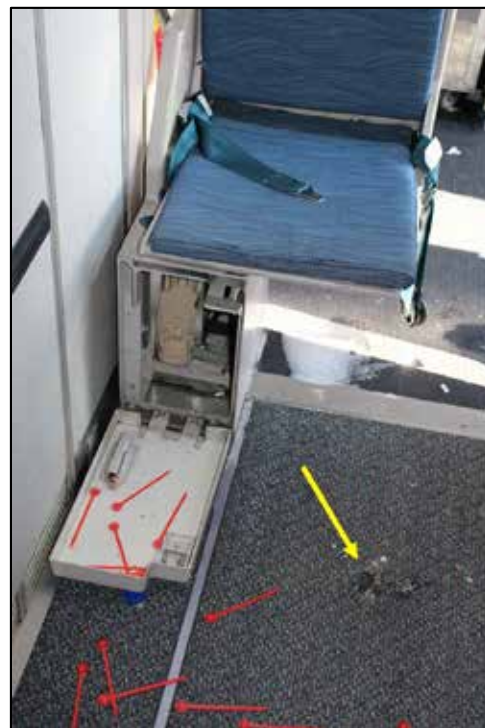
Figure 12. Floor damage above FR65

The cabin floor was also punctured adjacent to the flight attendant’s bulkhead-mounted, forward-facing jump seat when the FR65 vertical beam was forced upward (Figure 12).

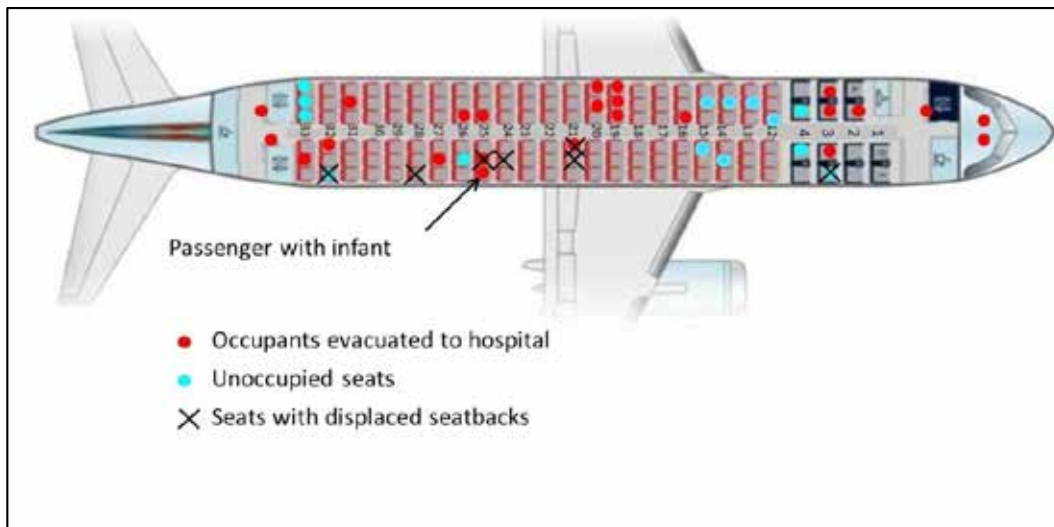
Figure 13. Passenger seating on the occurrence aircraft (Source: Air Canada with TSB annotations)

The examination noted that 7 seatbacks had been displaced forward beyond the upright position and were free to pivot about their hinge point. The seats were located on the right side of the aircraft in rows 3, 21, 24, 25, 28, and 32 (Figure 13).

All 7 seats involved had sheared shear pins. No damage or deformation of the seat frames was observed.
