# AVIATION INVESTIGATION REPORT

## A15P0217

### **Loss of control during night approach and near collision with terrain**

Sikorsky S-76C+ (helicopter), C-GHHJ

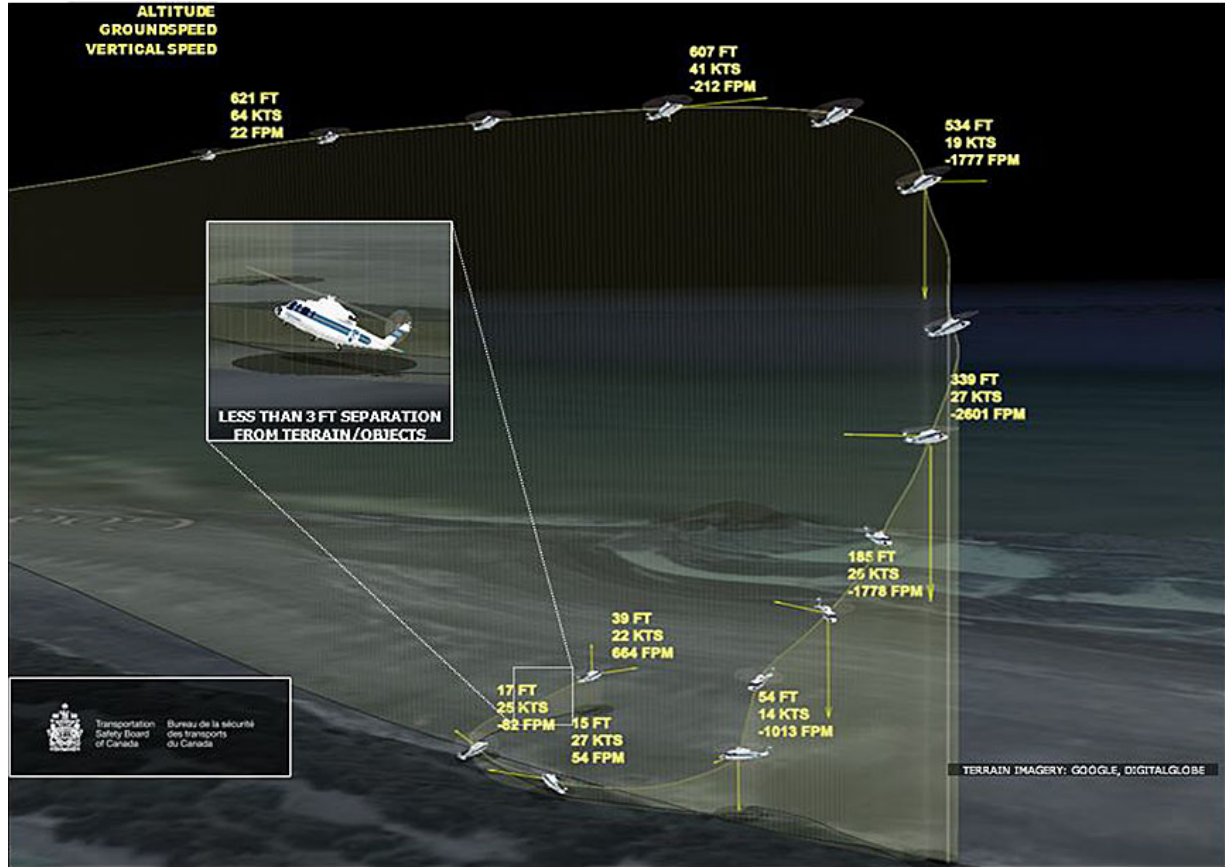
Figure 3. The occurrence flight's approach path to CYAZ, showing altitude, ground speed, rate of descent, and direction of flight (Terrain imagery source: Google Earth)

rotated to the direction in which the helicopter was moving, the airspeed began to increase, and the helicopter continued to descend through 50 feet AGL.

The PF increased the collective to the full-up position, and the engine torques reached 134% while the  $N_R$  dropped to 77%. The helicopter passed along the foreshore at approximately 15 to 25 knots while at nearly 0 radar altitude (approximately 65 feet below the airfield elevation of 80 feet ASL). The terrain below the helicopter at this point consisted of bushes at the edge of the foreshore and large logs washed up against the beach embankment.

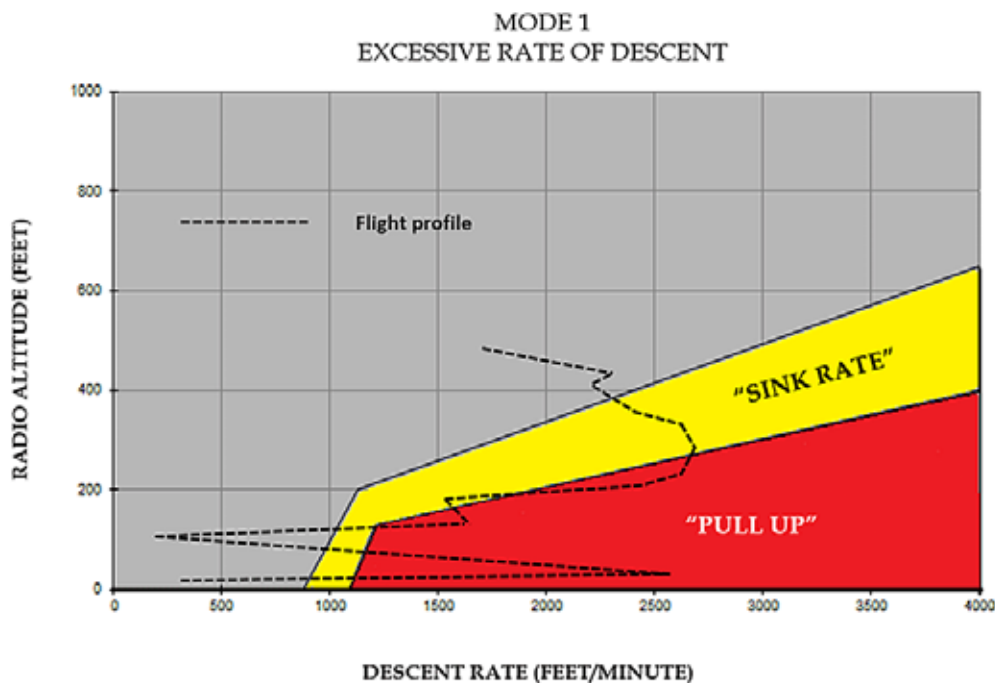
Figure 6. Enhanced ground proximity warning system mode 1: Alerting of excessive rate of descent (Source: Honeywell International Inc., 060-4314-200, *MKXXII Helicopter EGPWS Pilot Guide*, Rev. C [March 2004], with TSB annotations showing flight profile)

During the occurrence, no “SINK RATE” or “PULL UP” warnings were activated on the first approach to CYAZ due to the autorotation<sup>25</sup> inhibit function<sup>26</sup> that was configured when the EGPWS was initially set up. When engine torque values fall below 7.5% torque, Mode 1 of the EGPWS is inhibited until engine torque values increase above 7.5% and the helicopter is out of the autorotation. The EGPWS then takes 20 seconds to reset before additional “SINK RATE” and “PULL UP” alerts can be activated.

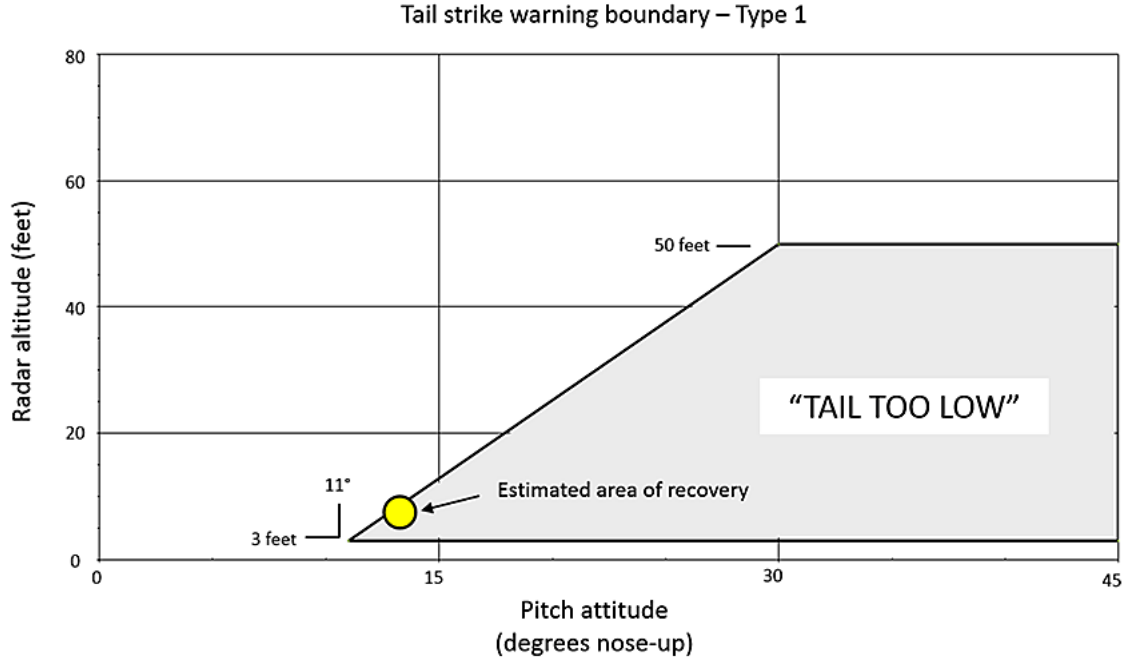
Figure 7. Mode 6: Tail-strike warning boundary (Source: Honeywell International Inc., 060-4314-200, *MK XXII Helicopter EGPWS Pilot Guide*, Rev. C (March 2004), with TSB annotations indicating estimated area of recovery of this flight)

The boundary set for the occurrence helicopter is depicted in Figure 7.
