AVIATION INVESTIGATION REPORT

A16O0016

Runway incursion and risk of collision

Air Canada, Embraer 190-100IGW, C-FNAW
and

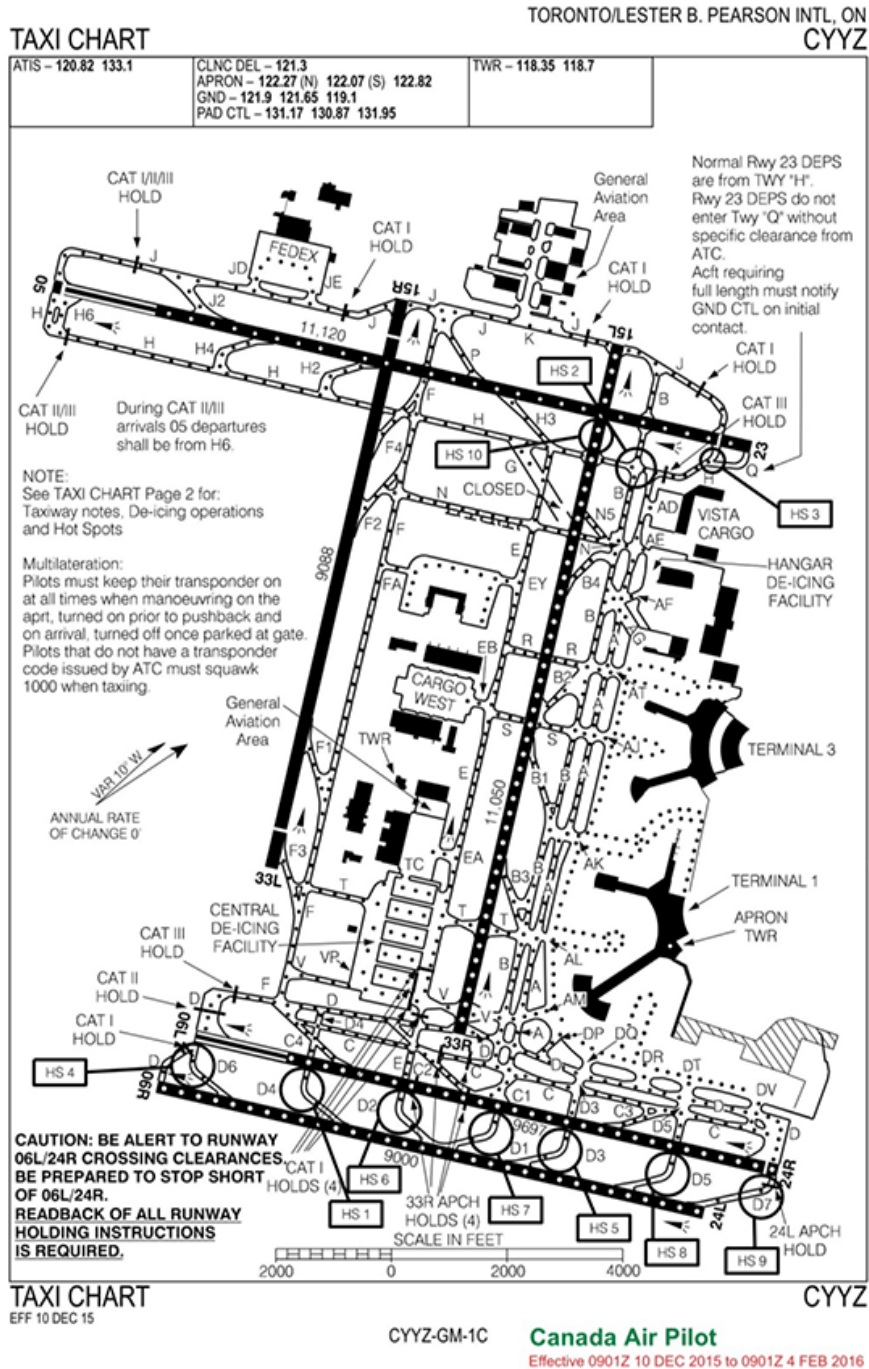
Appendix A – Toronto/Lester B. Pearson International Airport taxi chart

The CYYZ airport has 5 runways: 05/23, 15L/33R, 15R/33L, 06L/24R and 06R/24L. Runways 24L and 24R are parallel and their centrelines are separated by approximately 1000 feet (Appendix A).
