AVIATION INVESTIGATION REPORT

A16A0041

Nose landing gear failure on landing

Beechcraft 1900D, C-FEVA

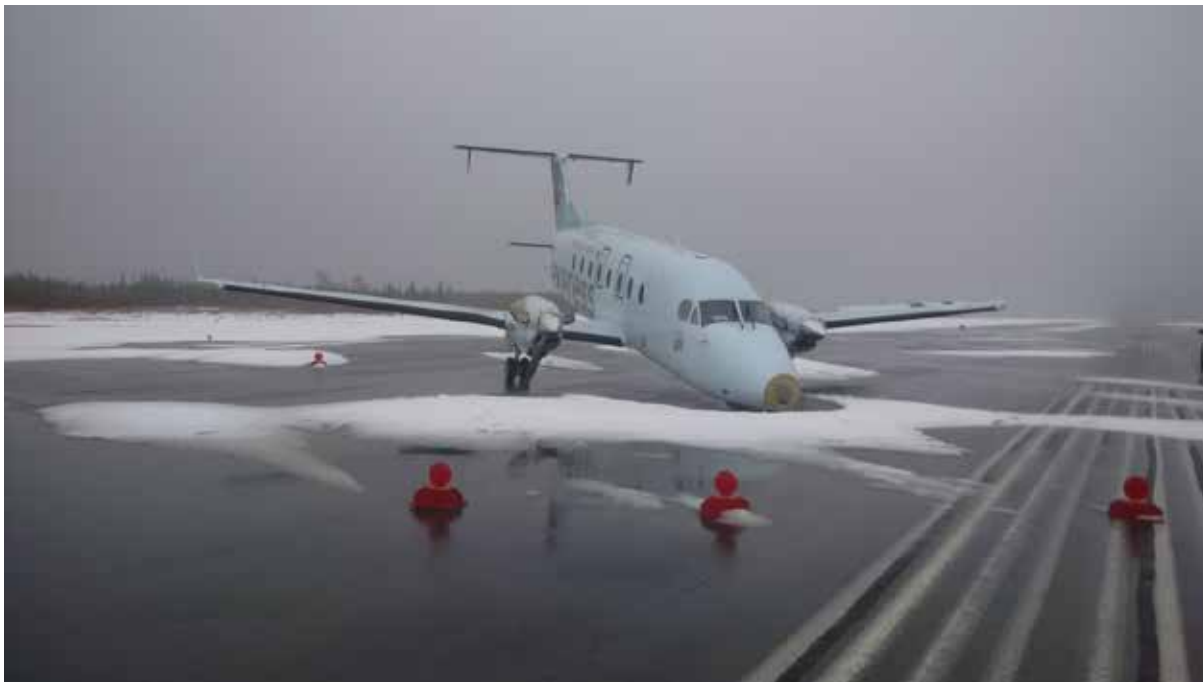
Figure 2. C-FEVA on the day after the occurrence showing the nose landing gear collapse

When the NLG collapsed (Figure 2), the aircraft's nose struck the snow-covered portion of the runway. The force of the impact caused crush damage to the lower part of the forward fuselage. Abrasion damage due to the aircraft sliding along the runway was also noted on the lower nose area.

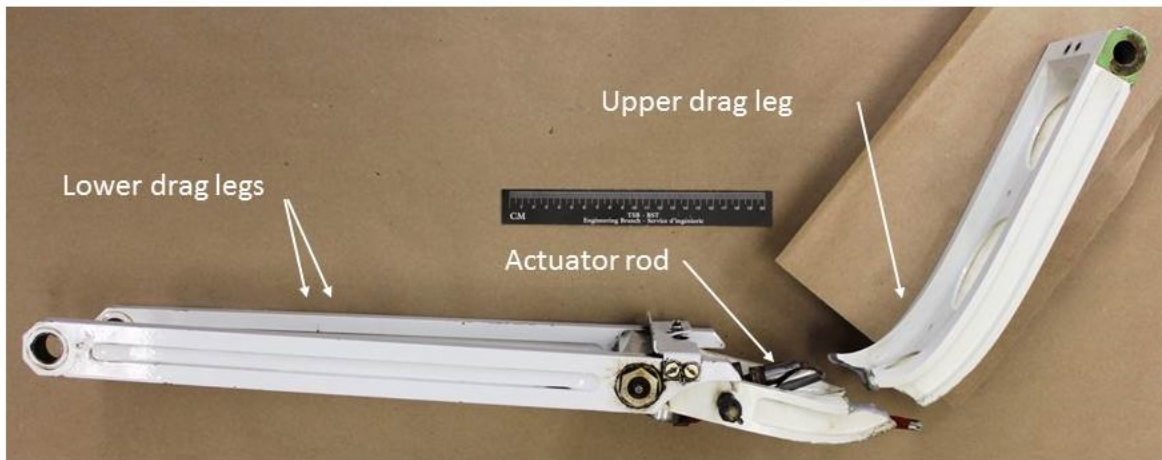
Figure 3. Upper drag leg failure

The nosewheel assembly struck the compacted-snow windrow with sufficient force to cause the upper drag leg to fail in compressive overload (Figure 3). The hydraulic actuator rod also failed in overload. Other NLG components were damaged when the NLG assembly collapsed rearward.

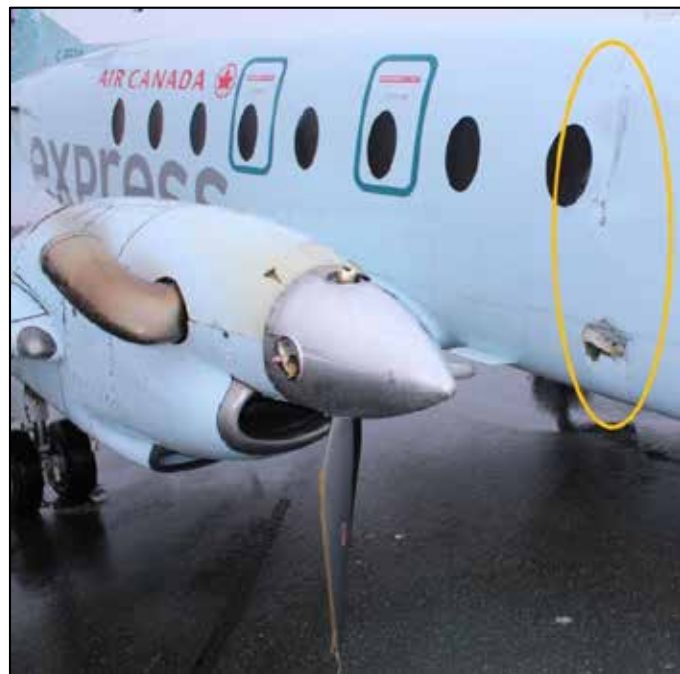
Figure 4. Fuselage with damage caused by propeller blade (circled)

The upper dent caused the window interior trim and cabin interior to fracture and come loose inside the cabin. A portion of blade penetrated the cabin wall just above the floor level between seats 1B and 2B. About 19 inches of the blade tip remained embedded (Figure 4).
