AVIATION INVESTIGATION REPORT

A16P0069

Loss of tail-rotor effectiveness

Bell 206B Jet Ranger-III (Helicopter), C-GOPK

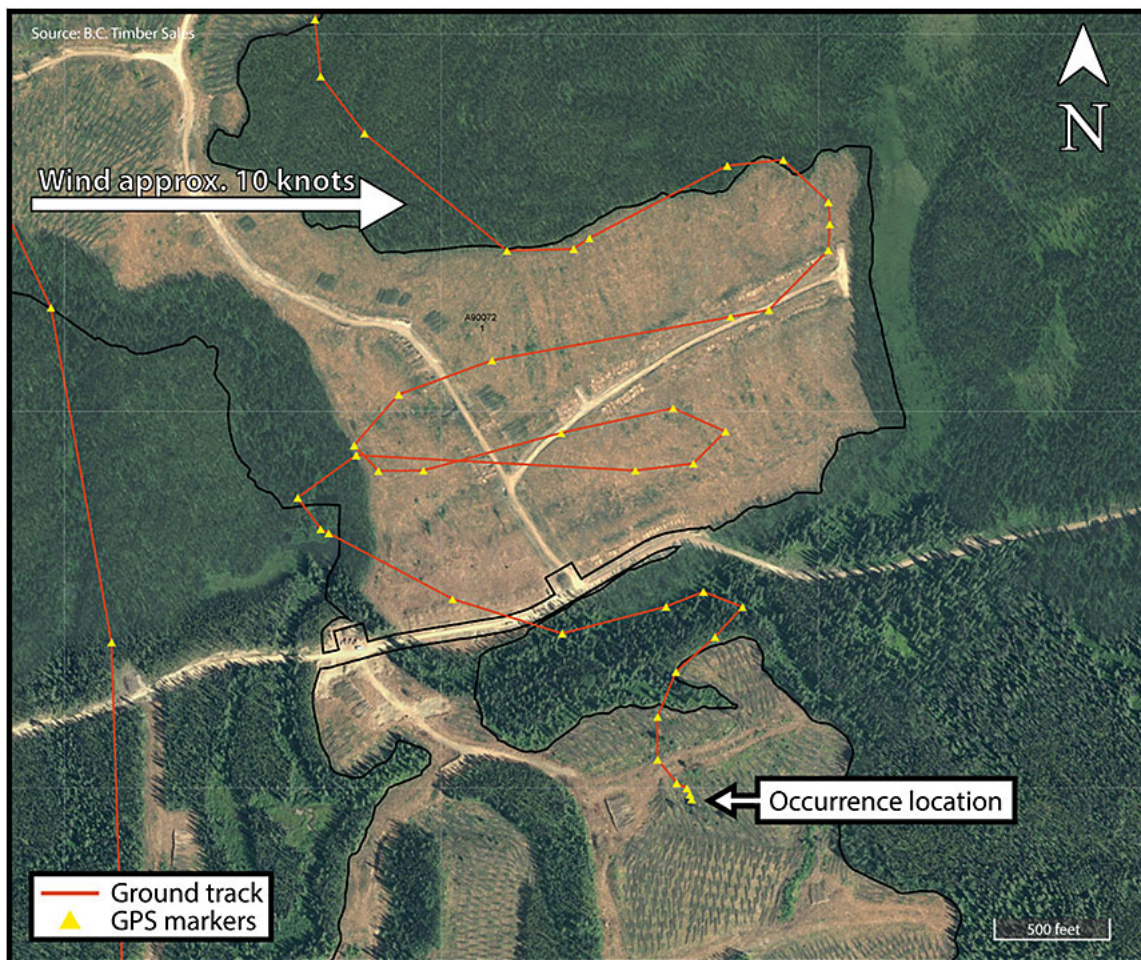
Figure 1. Flight path of C-GOPK (Source: BC Timber Sales, with TSB annotations)

Global positioning system (GPS) data (Figure 1) showed that the helicopter's average ground speed during scanning of the first area was about 41 knots. Its average ground speed in the second area was about 34 knots. The helicopter entered the last area at about 27 knots ground speed, and the ground speed decreased steadily thereafter, averaging about 19 knots over the 22 seconds prior to the loss of yaw control.

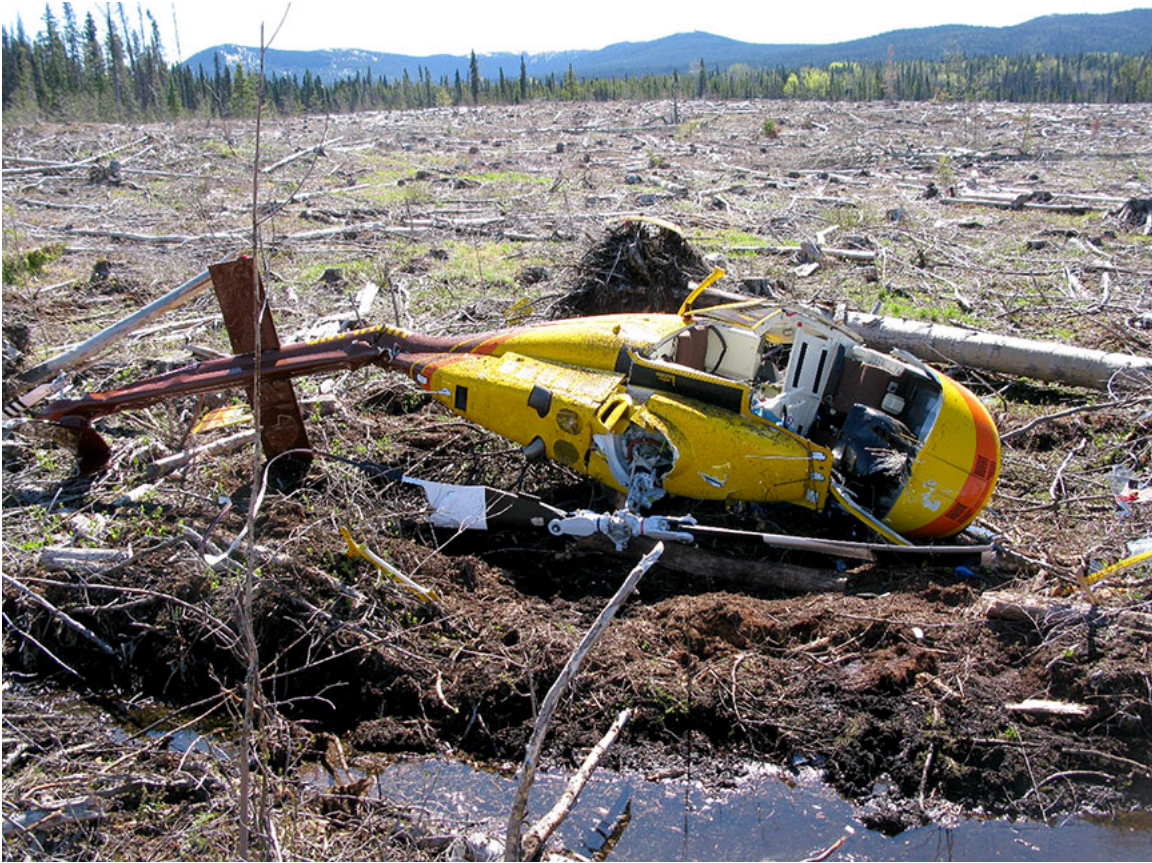
Figure 2. Wreckage and accident site

The helicopter was destroyed on impact with the ground (Figure 2). Both main-rotor blades broke several feet outboard of their root ends. The main-rotor gearbox had broken its mounts, and the aft coupling on the driveshaft between the engine and the main-rotor gearbox had pulled apart. The tail boom remained attached to the fuselage, but was severely bent upward and to the right, about 6 inches aft of the tail-boom-to-fuselage attachment point. The vertical stabilizer (fin) remained attached to the tail boom, but the lower 10 inches of the fin were bent about 90° to the right, and the remaining fin had rotated several degrees counterclockwise as viewed from aft of the helicopter, twisting the tail boom immediately forward of the fin. The upper portion of the fin had been struck by a main-rotor blade.
