## AVIATION INVESTIGATION REPORT A16W0126

### **Loss of power and collision with trees**

Bell 206B (Helicopter), C-GHHU

Fox Creek Airport, Alberta, 12 nm SW

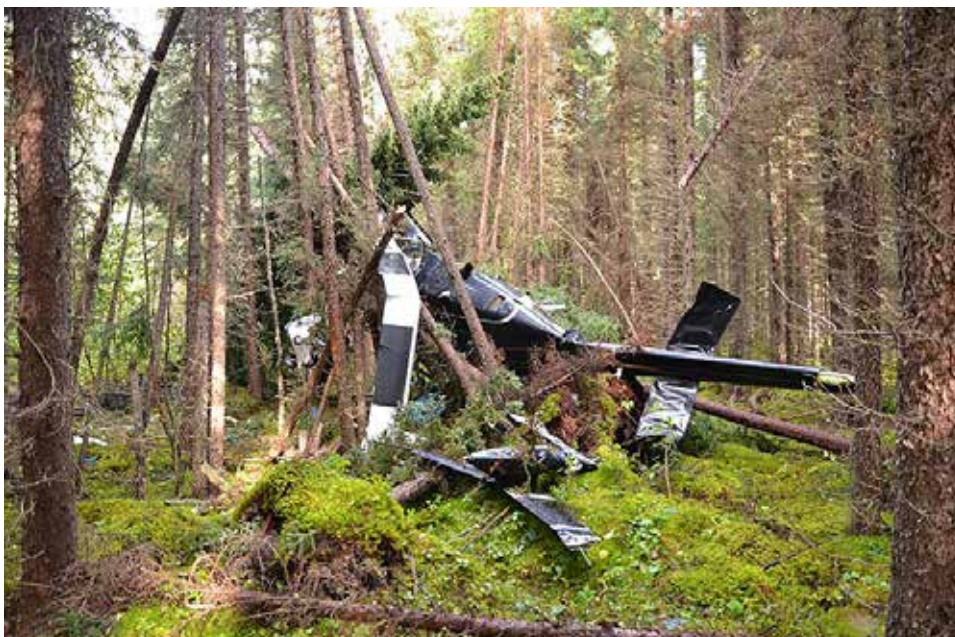
All of the helicopter's components were located and identified within a 50-foot radius of the aircraft (Figures 3 and 4). The helicopter's forward section and cockpit were destroyed. The cabin sustained substantial impact damage, particularly on the left side of the fuselage. The fuel cell was punctured during the impact sequence and was leaking. The main-rotor head was intact, with its 2 rotor blades still attached. Both main-rotor blades sustained minor damage consistent with low  $N_R$ , indicating that no power was being produced at the time of impact.

The tail-rotor was intact. One blade was straight with no damage to its skin. The other blade had sustained impact damage and was bent in 2 locations. The damage observed on both tail-rotor blades was consistent with low tail-rotor rpm, indicating that no power was being produced at the time of impact.

Figure 3. View of C-GHHU from aft left (severed vertical fin visible to the left of tail boom)

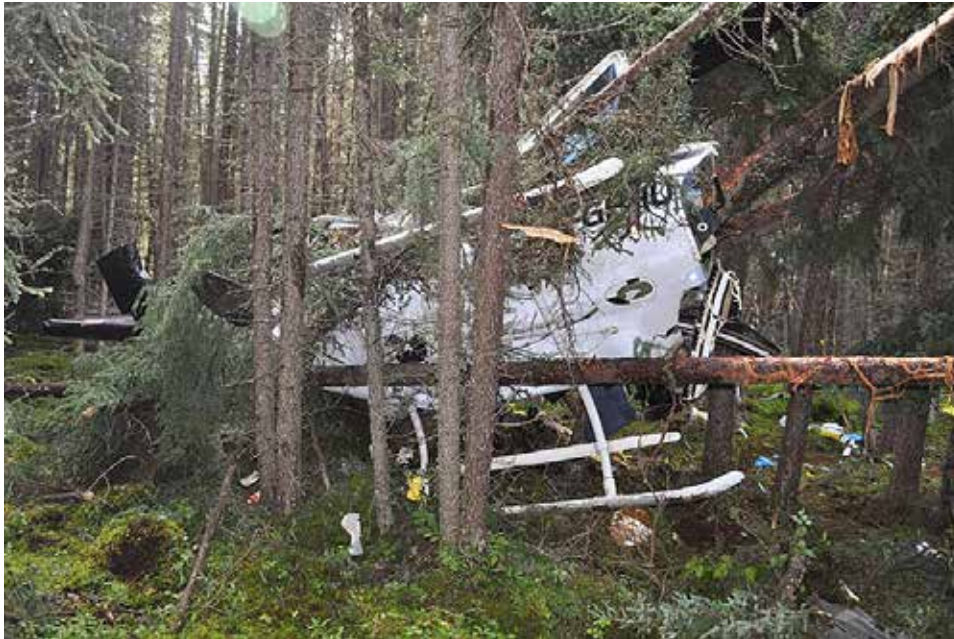
Figure 4. View of C-GHHU from front right (underside of helicopter visible)

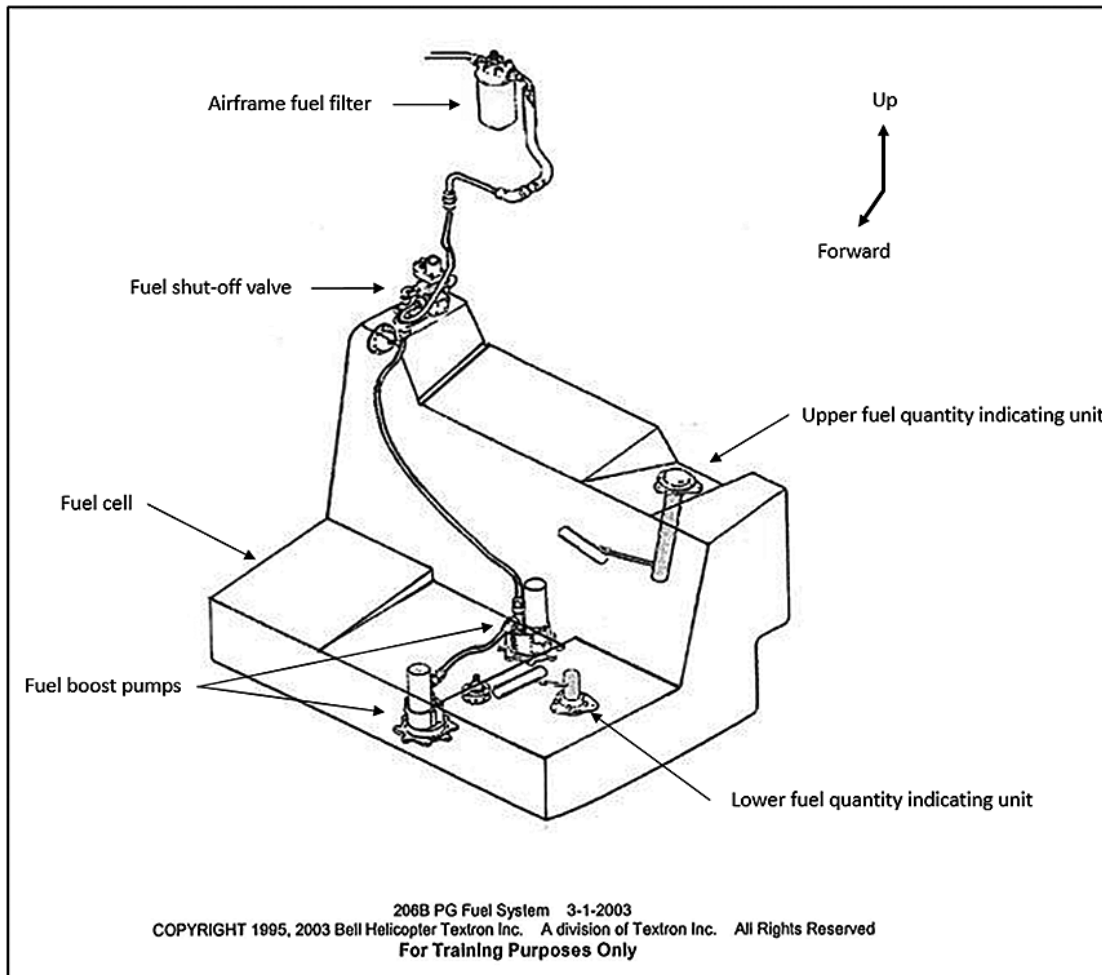
### Appendix A – Bell 206B helicopter fuel system

With 1 or both of the fuel boost pumps inoperative, the unusable<sup>14</sup> fuel is 10 USG.<sup>15</sup> With 10 USG, it is possible for the fuel to slosh. Sloshing can result from uncoordinated flight<sup>16</sup> or during aircraft acceleration and deceleration. Uncoordinated flight can result from exposure to atmospheric turbulence or pilot flight control inputs. The sloshing can momentarily expose, or unport, 1 or both of the boost pumps to the air. A resulting ingestion of air can cause an engine flame-out.

While the helicopter was making a left turn, it is likely that acceleration forces caused 1 or both of the boost pumps to unport. The introduction of air into the combustion chamber interrupted fuel flow, resulting in an engine flame-out.
