# RAILWAY INVESTIGATION REPORT

## R16D0073

### **Misaligned switch and derailment**

Acton Vale, Quebec

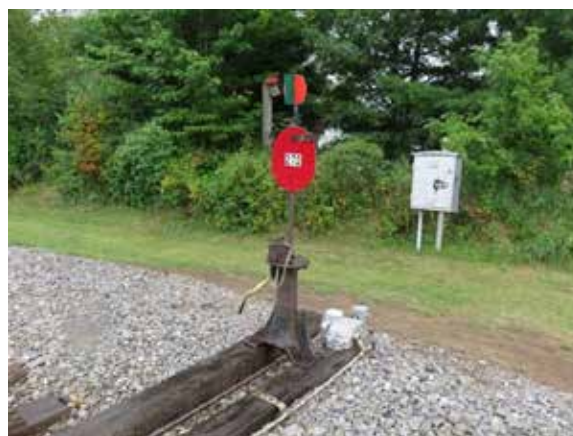
Figure 2. Red targets of switch 272 at Acton Vale

The reflective surface of the target was clean and in good condition. According to the video recording from the locomotive's forward-facing camera, the target was visible from the last level crossing, at a distance of approximately 1500 feet. Given the presence of several light sources and the fact that it was dark, the red reflection of the target did not stand out from its surroundings and was not easily perceptible.

The emergency brakes were not applied until approximately 200 feet from the switch, which indicates that the attention of the train crew was not focused far ahead of the train. Based on an estimated reaction time of 5 to 6 seconds for a complex, unexpected situation, it can be deduced that the crew members were not able to perceive the switch in the reverse position until the train was approximately 400 feet away. This distance corresponds to the best-lit zone in front of the locomotive, where the locomotive's ditch lights cross the centreline of the track. The train crew was not looking far enough ahead of the train to perceive the target of switch 272 in time.

In spite of its weaknesses as a visual alert system, the switch target can nevertheless be considered an additional line of defence. However, its effectiveness is limited: the visual stimulus is static, so the target may not consistently attract the attention of train crews. In addition, in some situations, sightlines may be restricted by track configuration, weather conditions, or vegetation.

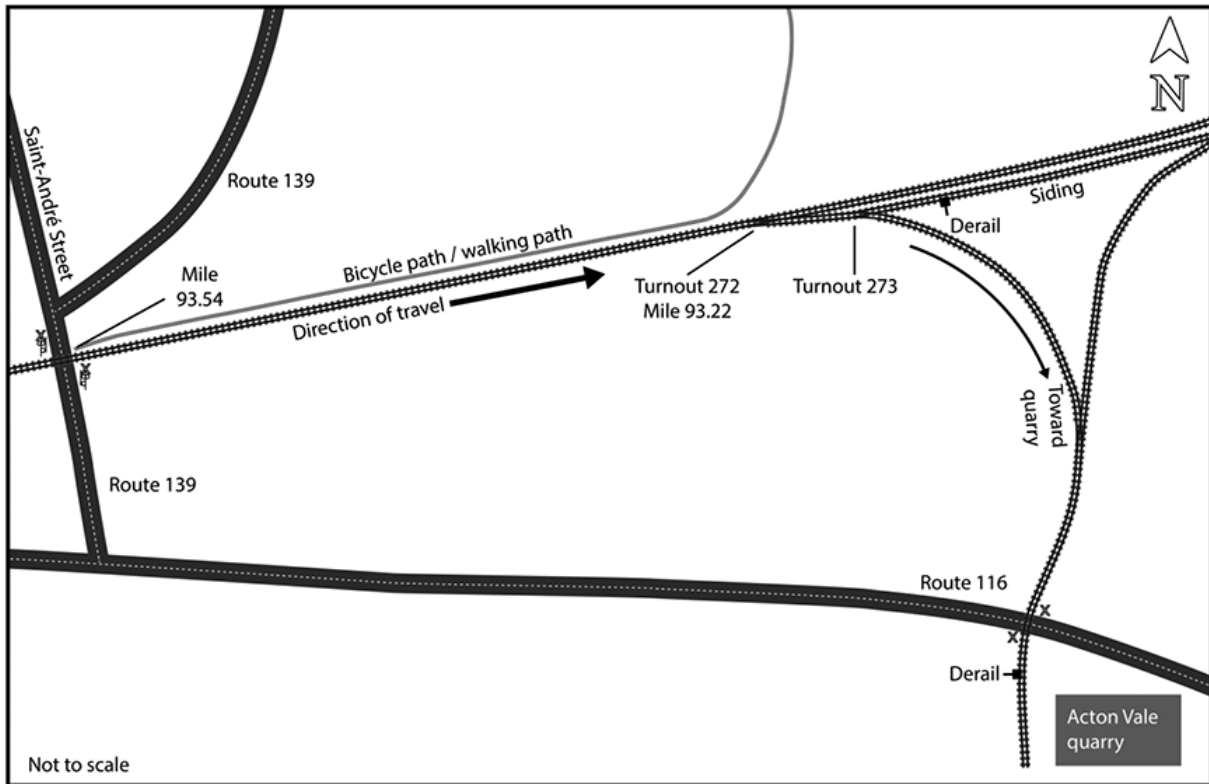
From the siding, the wye track and the Acton Vale quarry are accessible via turnout 273. Switch 273 was in the normal position and locked with a high-security lock.<sup>5</sup> A hinged derail was positioned on the track leading to the quarry (Figure 3).

Figure 3. Diagram of tracks at Acton Vale

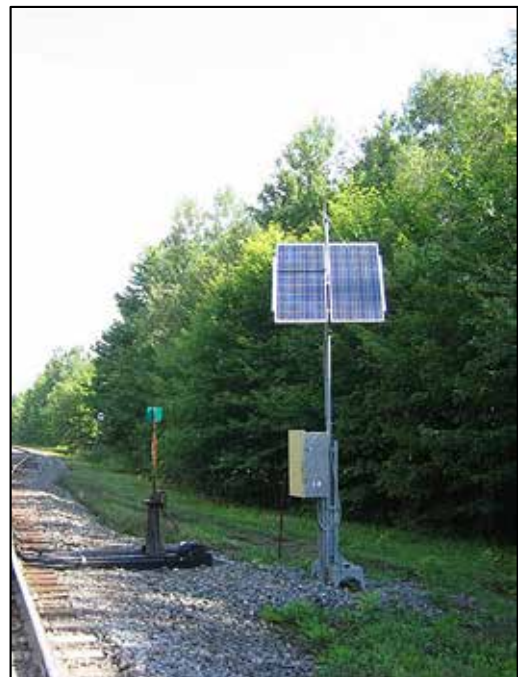
A duotone multi-frequency communication system can confirm turnout locations and the position of switches. This detector is used to determine the position of switches and can issue the information on demand through a talker message over the radio system (Figure 4).

Figure 4. Switch-position detector
