RAILWAY INVESTIGATION REPORT

R16D0092

Crossing collision

VIA Rail Canada Inc.

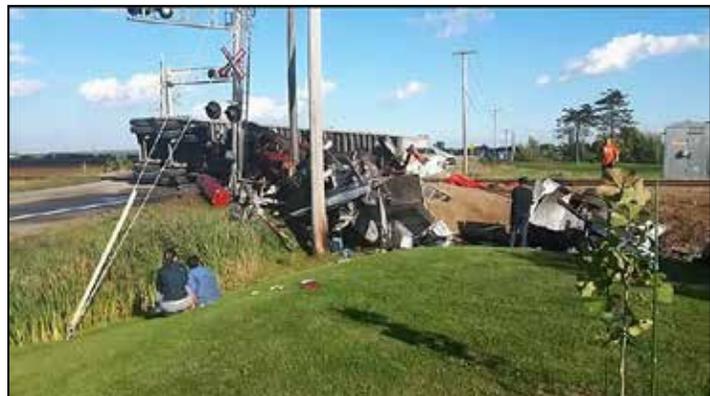
Figure 3. The tractor and the trailer after the collision (Source: Transport Canada)

The tractor-trailer was destroyed (Figure 3). The tractor cabin, the engine and the axles were ripped from the frame and thrown into the ditch along the railway track. The fuel tanks ruptured and spilled approximately 60 gallons of fuel. The trailer, which detached from the tractor, came to rest on its side, parallel to the track and blocking the road. The tarp that covered the trailer was ripped off and the load of sand spilled onto the track. The trailer frame was twisted and its upper lateral stiffeners were torn.

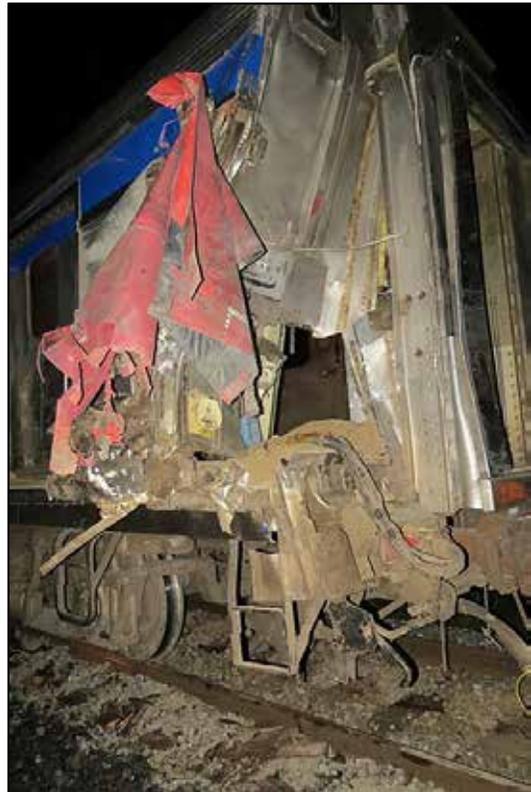
Figure 4. First baggage car

Both trucks of the first coach derailed; the rear truck was damaged and the right side of the car body was bent in the middle. The front right corner of the first baggage car was deformed and its vertical support was dented (Figure 4). The engine access panels on the second locomotive (VIA 6413) were torn off (Figure 5). The fuel tank of the second locomotive was ruptured, and braking system and suspension components were damaged (Figure 6). The second baggage car and the second coach were slightly damaged. Approximately 1800 gallons of fuel from the locomotives spilled along the track.

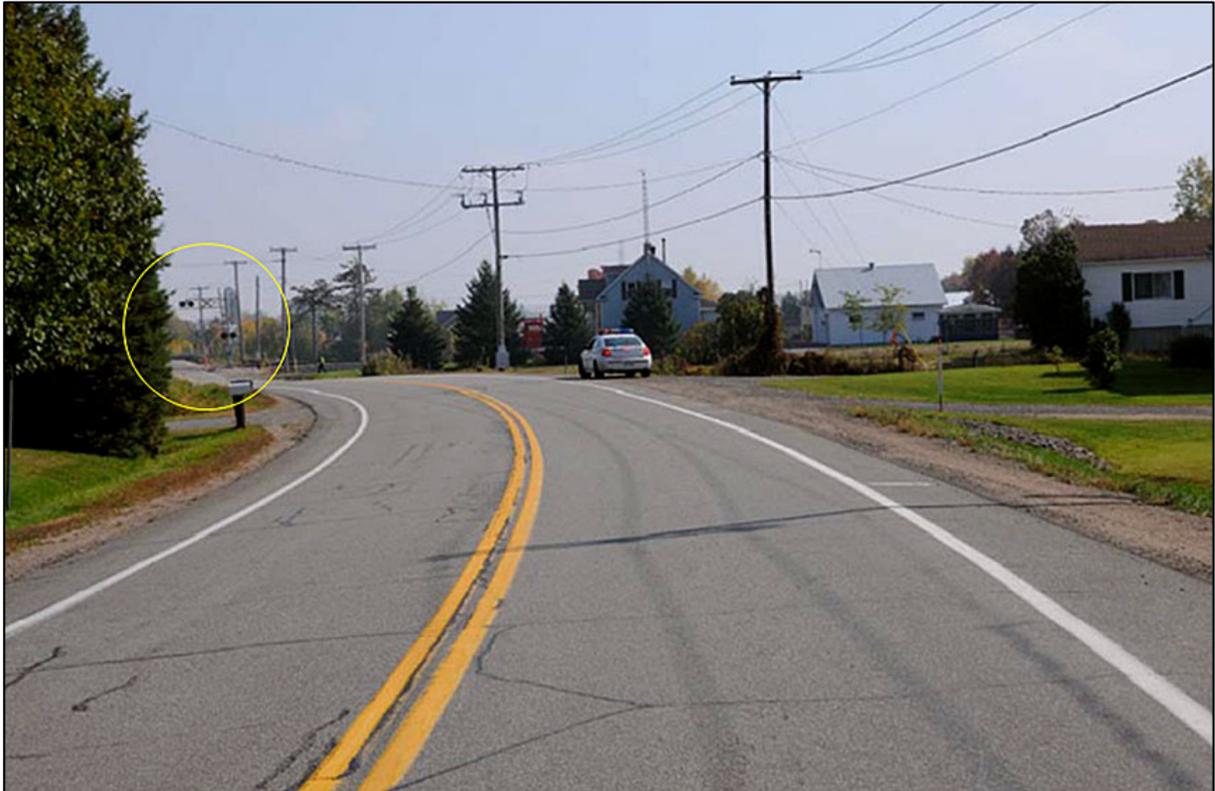
Figure 7. View from a distance of approximately 800 feet from the crossing (Source: Sûreté du Québec)

Vehicles coming from the west on Highway 348 must negotiate a left-hand curve before they reach the crossing. The trees along the road interfere with the visibility of the crossing warning system, which only becomes partially visible approximately 800 feet before the crossing (Figure 7).

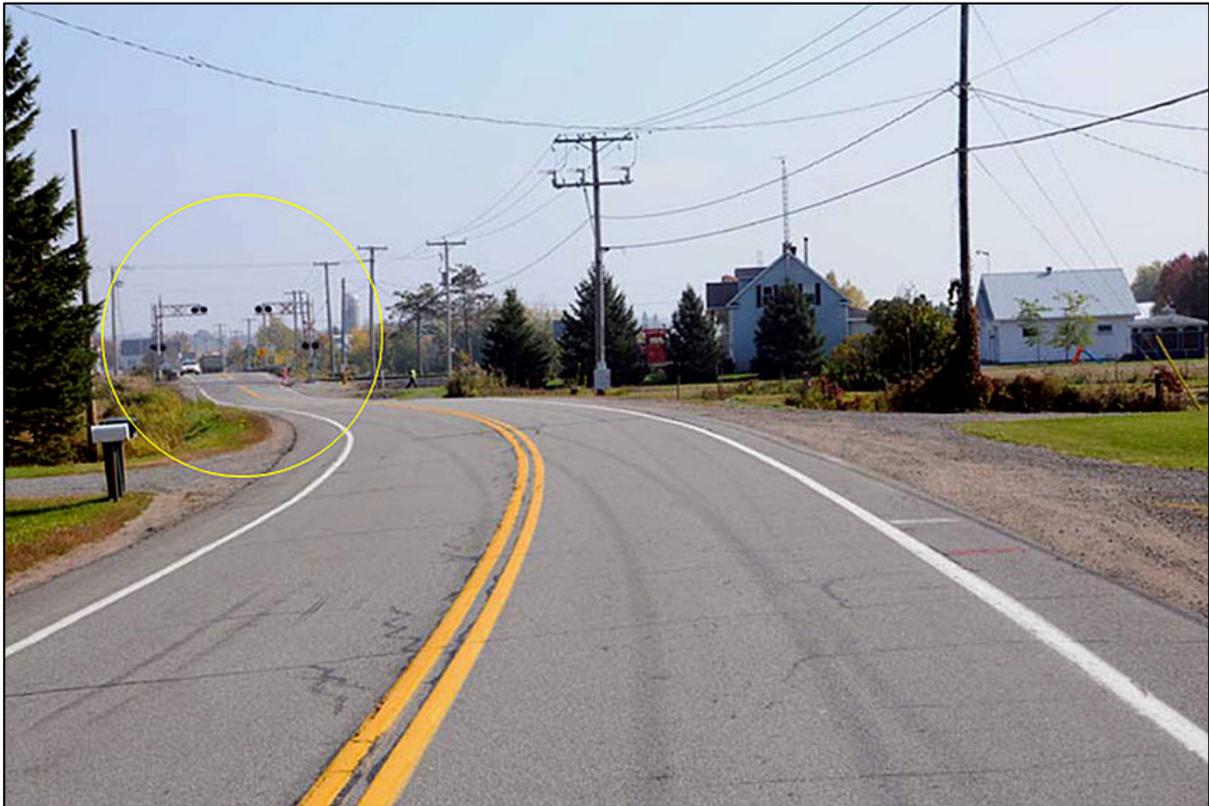
Figure 8. View from a distance of approximately 730 feet from the crossing (Source: Sûreté du Québec)

The warning system becomes completely visible at a distance of approximately 730 feet from the crossing (Figure 8). From that point on, the curve continues over a distance of approximately 230 feet, at which point the road becomes straight for 500 feet up to the crossing.

In this occurrence, the curve west of the crossing obstructed the visibility of the warning system, which only became completely visible at a distance of 730 feet. From that point, a tractor-trailer equipped with ABS and approaching at 90 km/h could theoretically stop before the crossing, whereas a similar vehicle with no ABS travelling on a damp roadway would require 909 feet (distance equal to the stopping sight distance [SSD]). Therefore, the visibility of the crossing warning system must enable the drivers of approaching vehicles to see the warning devices at a distance at least equal to the SSD. If the warning system cannot be perceived at a distance at least equal to the SSD, motor vehicle drivers may not be able to stop before the crossing, thereby increasing the risk of accidents.

The previous regulations did not specify any standard regarding SSD nor any condition where a "Prepare to Stop at Railway Crossing" sign had to be installed. However, Transport Canada's (TC's) new *Grade Crossings Regulations* requires that, by 2021, an active "Prepare to Stop" sign be installed when the crossing lights are not clearly visible within the limits of the SSD. The SSD for vehicles coming from the west on Highway 348 is 909 feet, whereas the crossing warning system is visible from 730 feet. Given that the visibility of the lights of the grade crossing warning system is less than the SSD, an active "Prepare to Stop at Railway Crossing" sign connected to the crossing warning system will be required at that location by 2021 in accordance with TC's new *Grade Crossings Regulations*.

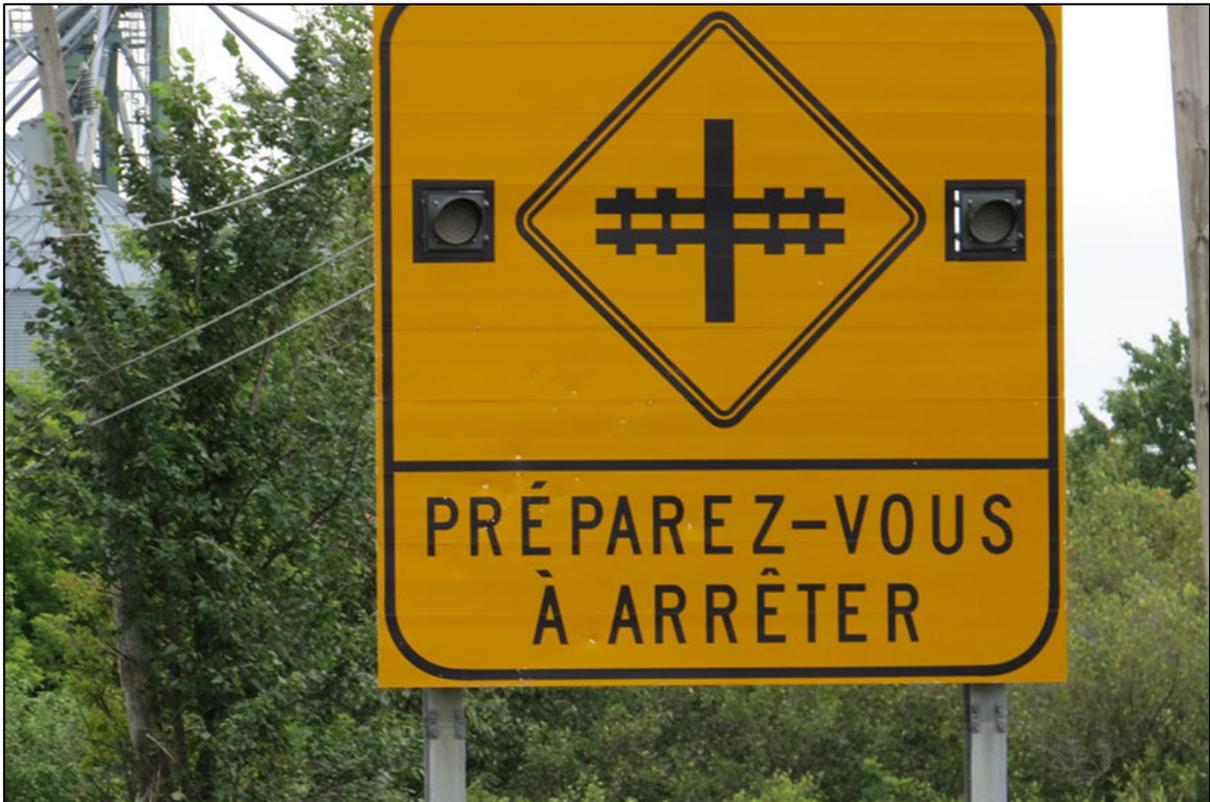
Figure 9. A “Prepare to Stop at Railway Crossing” sign” with flashing lights on Highway 347 in Saint-Norbert, Quebec

Research on advanced warning signs¹⁸ indicates that, in locations where yellow flashing lights were added to a slightly larger advanced warning sign and where the lights were activated by a train, drivers were much more likely to recognize the signals and slow down. These signs alert drivers to the presence of a train at the crossing approximately one quarter of a mile ahead of the crossing. There is such a sign at the Highway 347 crossing in Saint-Norbert, Quebec, at Mile 90.61 of the Joliette Subdivision (Figure 9).
