# MARINE INVESTIGATION REPORT

## M15P0286

### **Capsizing and loss of life**

Fishing vessel *Caledonian*

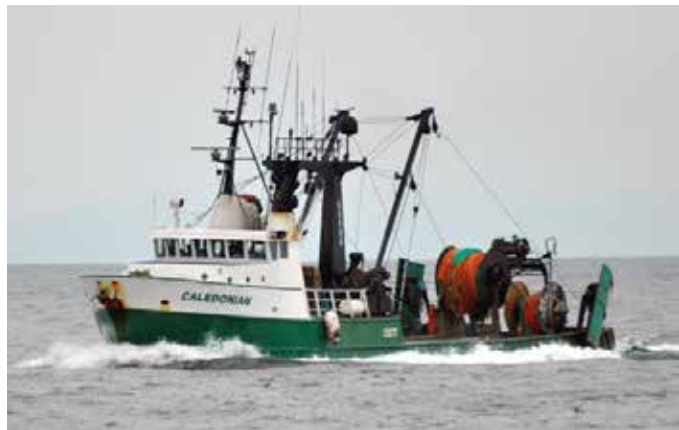
Photo 1. *Caledonian* (Source: Eric Sorenson)

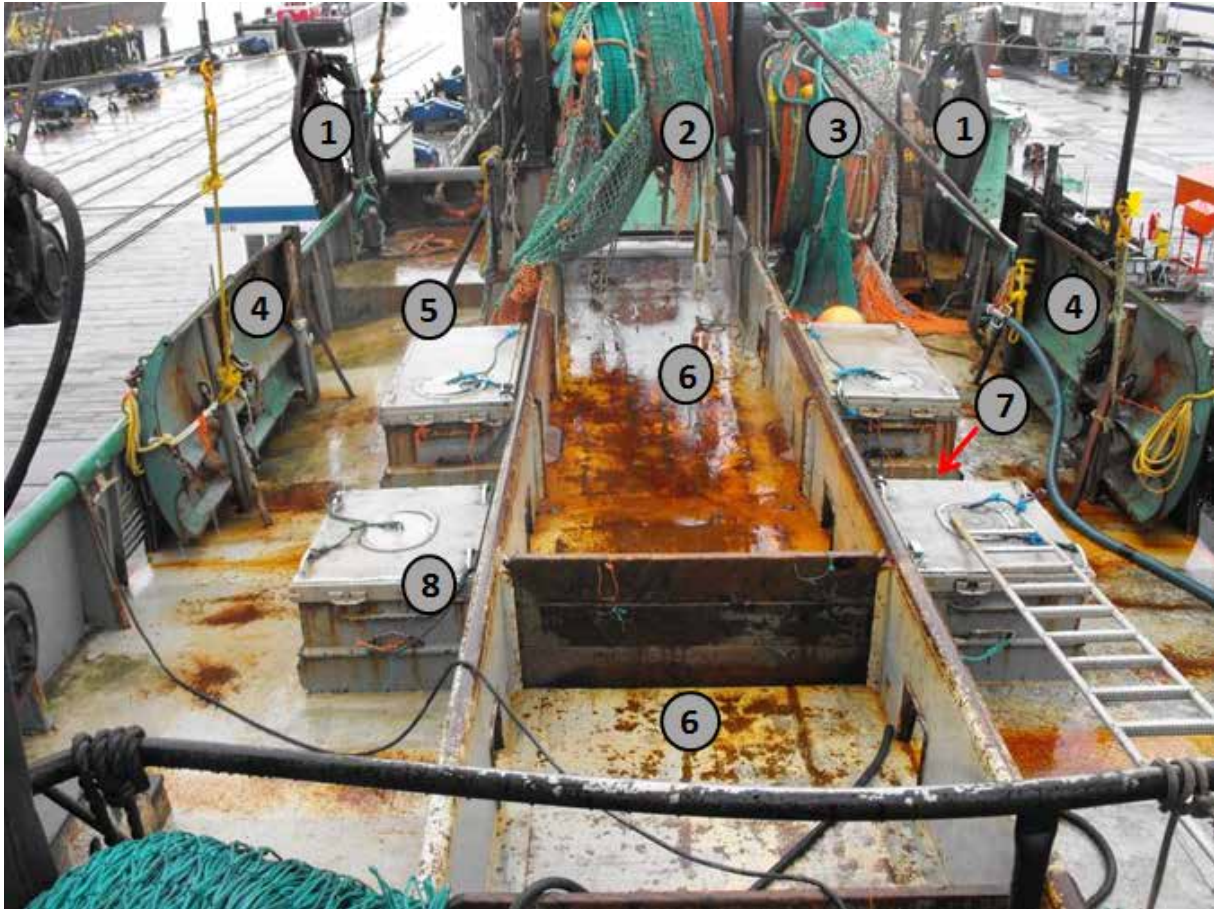
Photo 2. Working deck of the *Caledonian*, looking aft

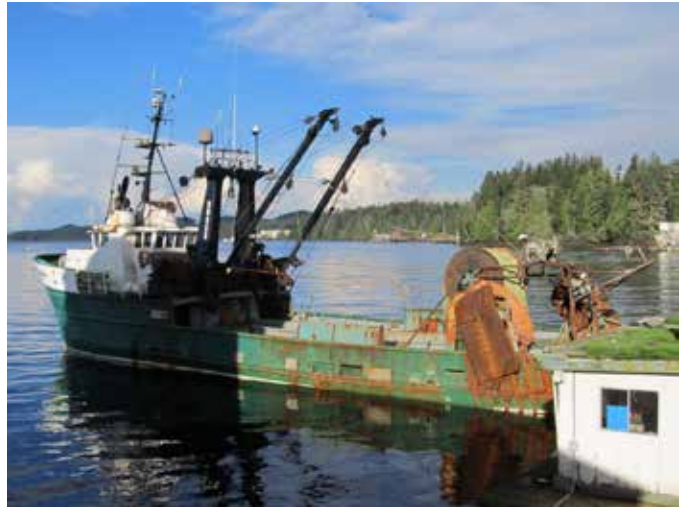
Photo 3. *Caledonian* moored in Port Hardy, April 2015

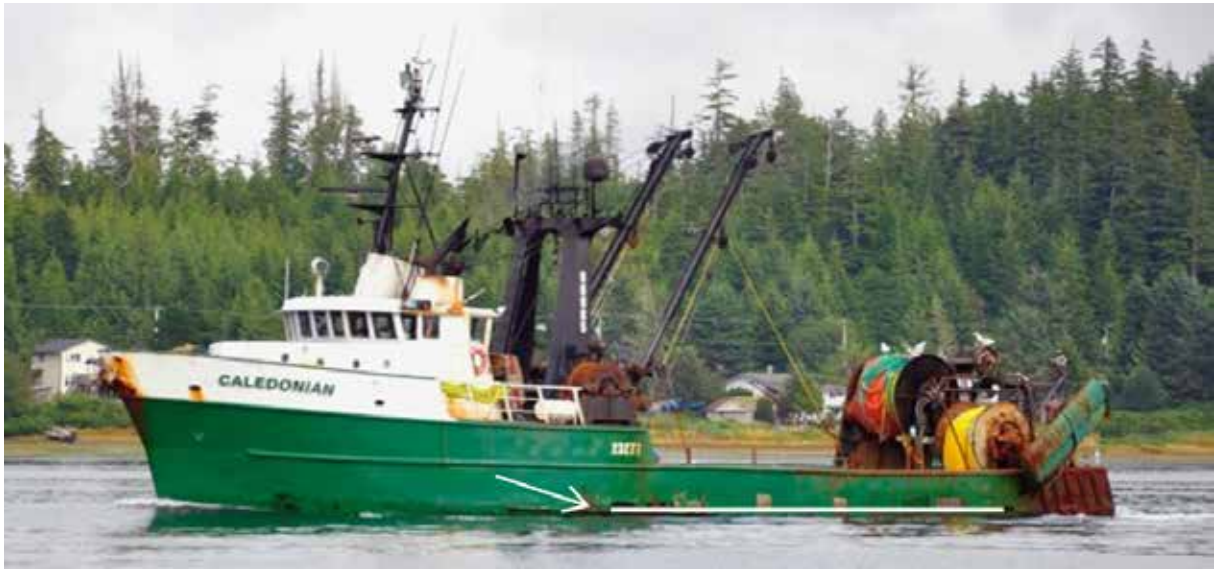
- The total weight of the vessel would have increased by over 9%.
- The minimum freeboard<sup>46</sup> would have been reduced to the extent that the waterline would have been level with the main deck, in contrast to a 1.4-foot minimum freeboard calculated in the stability booklet. This result is consistent with recent photos of the vessel in a loaded condition, showing almost no freeboard to the main deck (Photo 4).
- The vessel would not have fully met the stability criteria of TP 7301.

Photo 4. *Caledonian* in loaded condition. The white line on the hull indicates the estimated level of the vessel's working deck (Source: Eric Sorenson, with TSB annotations)
