MARINE INVESTIGATION REPORT M15A0348

Person overboard and subsequent loss of life

Small fishing vessel *Cock-a-Wit Lady*
23 nautical miles SSW of
Clark's Harbour, Nova Scotia
30 November 2015

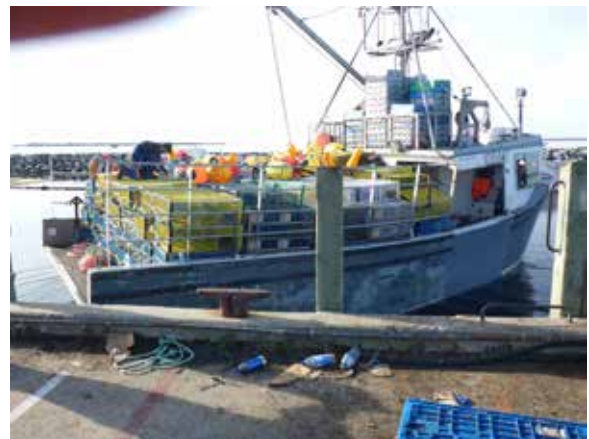
Photo 2. The *Cock-a-Wit Lady* in a partially loaded condition

The vessel has an open stern to facilitate the setting of lobster traps (Photo 2). A permanent aluminum rail is fitted on the starboard side. A temporary rail of equal scantlings¹ is fitted on the port side and is used only at the beginning and end of the lobster season, to provide stability for the traps on deck. A cargo boom with a small winch is mounted on top of the wheelhouse. There is a trap hauler on the starboard side with a block located above it that can be raised or lowered into position for use. The vessel is used primarily for fishing lobster and longlining.

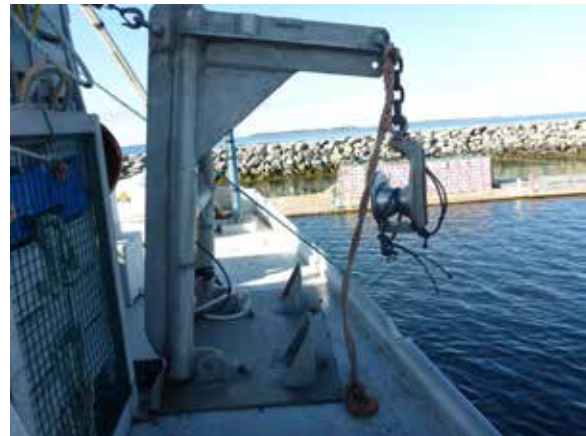
Photo 3. Overhead block in raised position

While they were under way, the crew lowered the overhead block that is mounted on top of the wheelhouse and above the trap hauler (Photo 3). They began hauling from this end and, after retrieving 3 traps, they brought up the deckhand who had fallen overboard. At approximately 0905, after being underwater for approximately 10 minutes, the deckhand was recovered and brought on board. As no pulse was detected, cardio-pulmonary resuscitation was administered immediately.

As the *Cock-a-Wit Lady* was intending only to set traps on the day of the occurrence, the overhead block was not lowered into the horizontal position; it was lowered only when it was intended to be used for hauling traps. Performing regular emergency drills would provide an opportunity for crew members to identify shortcomings in the retrieval of a person overboard, such as the fact that, in the vertical or raised position, the overhead block was not available for immediate use to haul a person overboard and that, when lowered, the block allowed for the most efficient angle for hauling the heavy traps and the weight of the person in the water.
