MARINE INVESTIGATION REPORT

M16C0005

Grounding

Container vessel *MSC Monica*

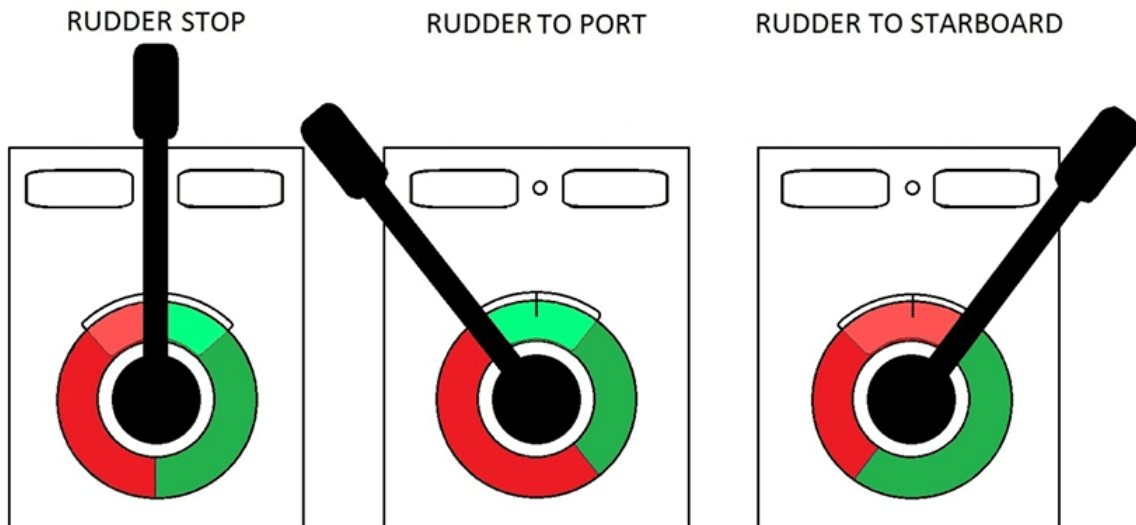
Figure 8. Schematic of the *MSC Monica's* non-follow-up tiller operation

By internationally recognized maritime standards, the colour red signifies the port side, while the colour green indicates the starboard side. On the *MSC Monica*, the NFU tiller was connected to the control system in an inverted manner; as a result, the red/green colour code operated in contradiction to the international standards. When the control lever of the NFU tiller switch was moved to the left, in a counterclockwise rotation, the green part of the indicating disc was brought over the illuminated section, and the steering gear moved the rudder to port. When the control lever of the NFU tiller was moved to the right, in a clockwise rotation, the red part of the indicating disc was brought over the illuminated section, and the steering gear moved the rudder to starboard (Figure 8).
