MARINE INVESTIGATION REPORT

M16C0016

Striking of ice and subsequent flooding

Fishing vessel *Saputi*
Davis Strait, Nunavut
21 February 2016

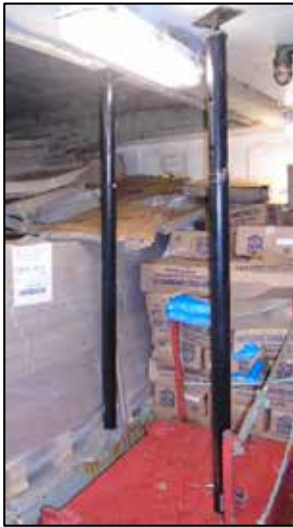
Figure 3. Jack posts used to secure hatches (Source: Nataaaqnaq Fisheries)

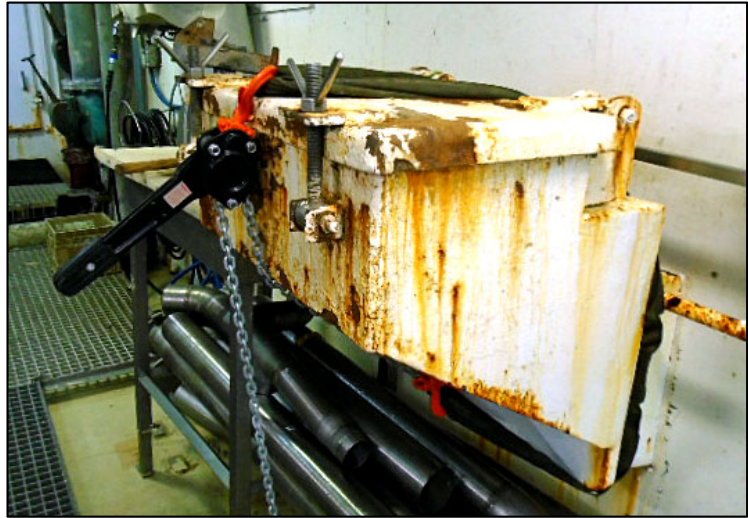
Figure 4. Chain hoist used to secure hatch (Source: Nataaaqnaq Fisheries)
