MARINE INVESTIGATION REPORT M16P0162

Collision and sinking

Tugs Albern and C.T. Titan

24 May 2016

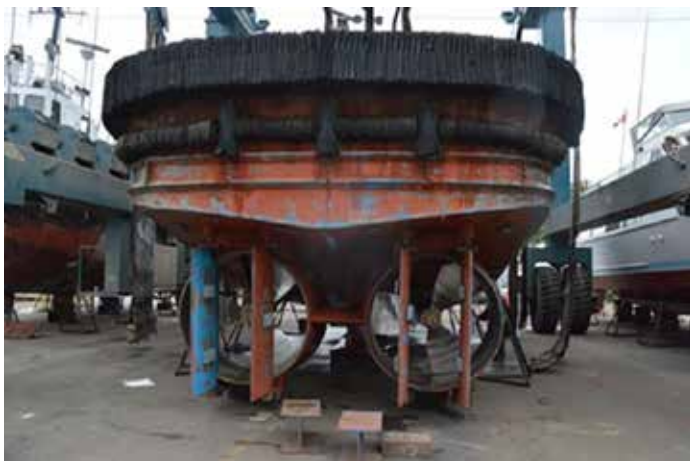
Figure 3. Rudders on the *C.T. Titan*

The steering gear system consists of 2 sets of rudders, which are located immediately aft of each propeller (Figure 3). All 4 rudders operate synchronously; for example, moving the steering control to port moves all 4 rudders to the port side.

Between 28 March and 04 April 2016, the *C.T. Titan* underwent routine maintenance at a commercial dry-dock. As part of this maintenance, all 4 rudders and rudder stocks were dismantled. The rudder stock bolt holes were repaired and realigned to fit the rudder flange holes, and maintenance to the steering gear was carried out. Following completion of the steering gear maintenance, the rudders were reinstalled. The maintenance records did not indicate whether the rudder alignment was checked following the reinstallation of the rudders. Also, there was no record indicating that the engine controls were tested.

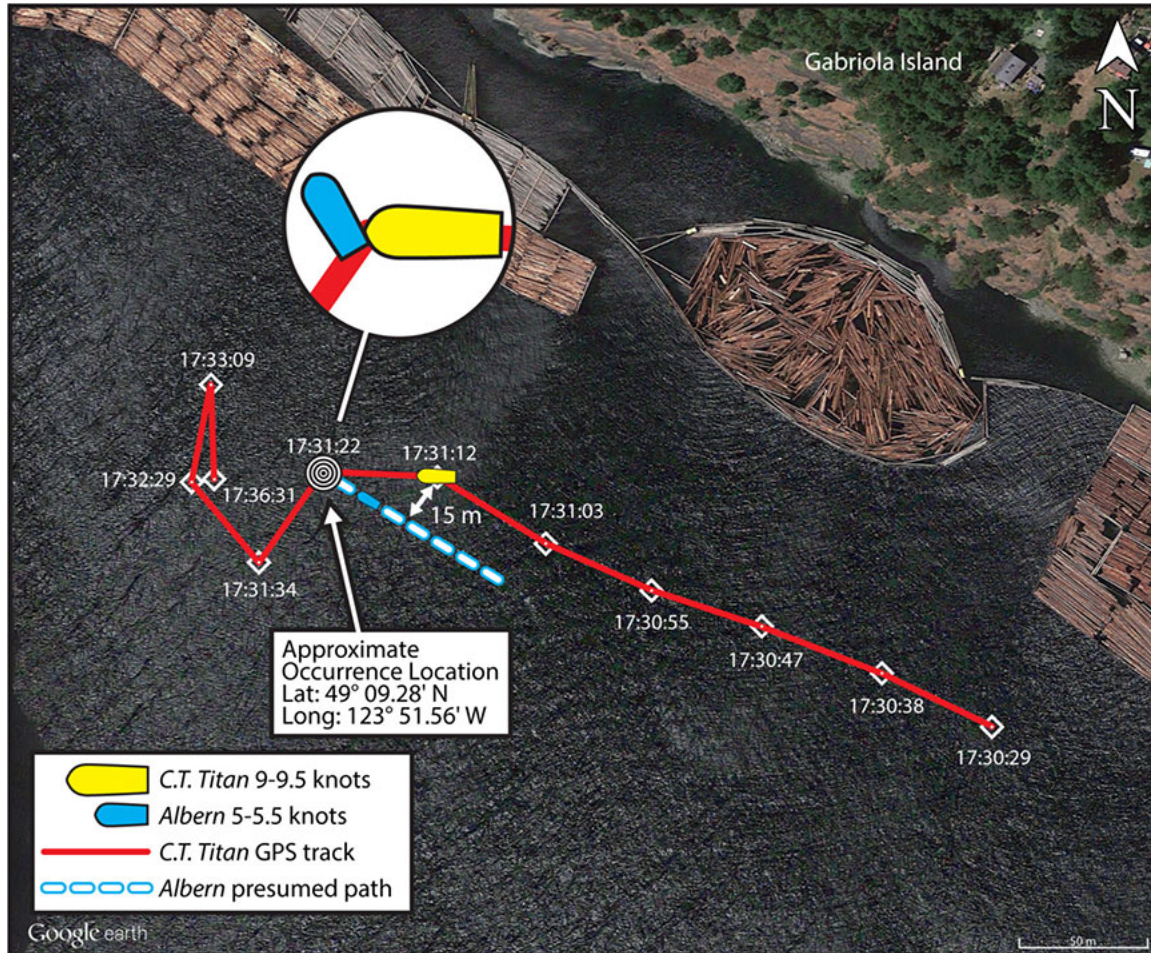
Figure 4. Satellite photo with overlay showing tracks and collision of the *C.T. Titan* (yellow) with the *Albern* (Source: Google Earth with TSB annotations)

Upon striking the *Albern*, the *C.T. Titan* veered approximately 90° to port (heading 215°T) and then ran up onto the hull of the capsized *Albern*. Soon after, the *C.T. Titan*'s master regained propulsion control and backed the vessel away from the *Albern*. The *C.T. Titan* sustained damage to its keel cooler.⁷

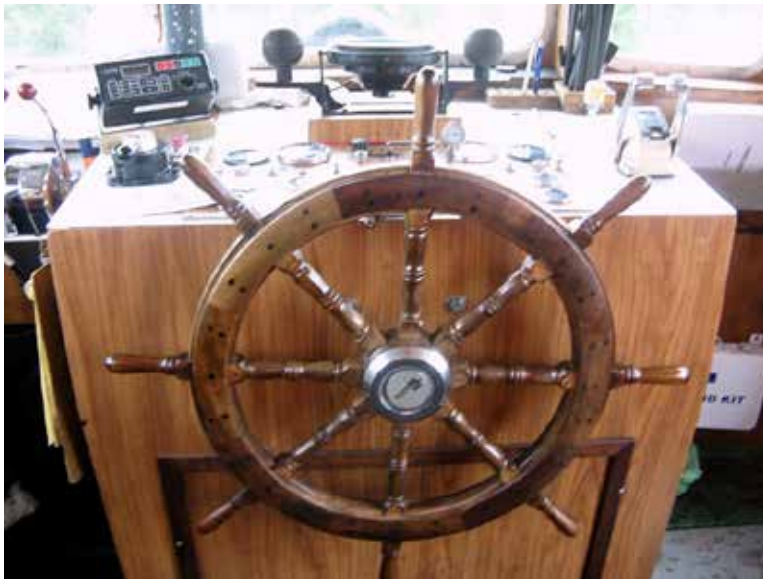
Figure 5. Wheelhouse control station on the *C.T. Titan*

The *C.T. Titan* has 3 identical propulsion control units, located in the wheelhouse (Figure 5), on the flying bridge, and near the towing winch. Each unit has a hand steering wheel and a jog, and 2 hand levers (Figure 6) that control the port and starboard main engines' revolutions and the propeller shafts' rotational direction individually.

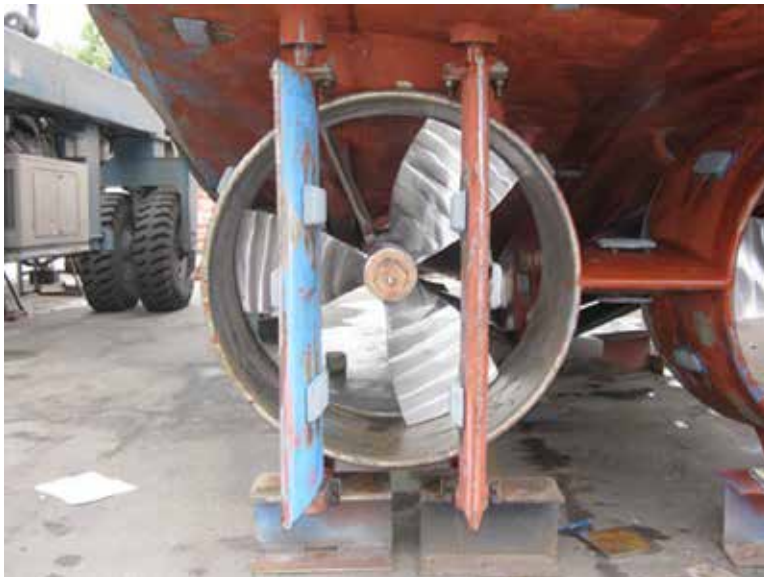
Figure 8. *C.T. Titan* port rudder alignment

- Both port and starboard rudders were undamaged, and the port outer (blue) rudder and the starboard inner rudder were misaligned towards the port side. These misalignments were visually estimated to be approximately 3° (Figure 8).
- The rudder angle indicators at the flying bridge and winch control stations were not consistent with the rudder angle indicator in the wheelhouse. There was a 1.5° to 2° error on the indicator at the flying bridge and about a 0.5° error on the indicator at the winch station.
