Cost and Design of Housing For Disabled Persons: Case Studies

**COST AND DESIGN OF HOUSING
FOR DISABLED PERSONS
CASE STUDIES**

Prepared for
Canada Mortgage and Housing Corporation
by
Associated Planning Consultants

CASE STUDY 1
Apartment
Module 3: Purpose-built - Upgrading
Recommended

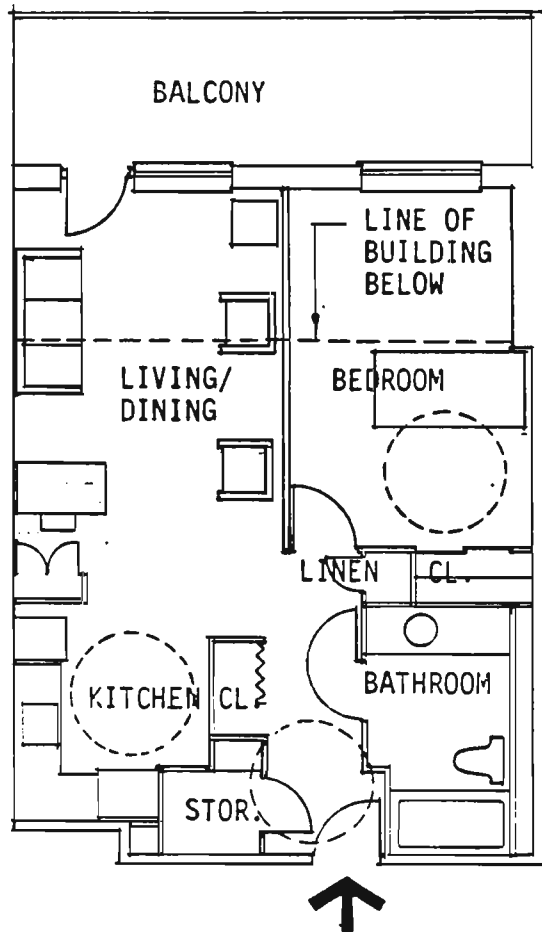
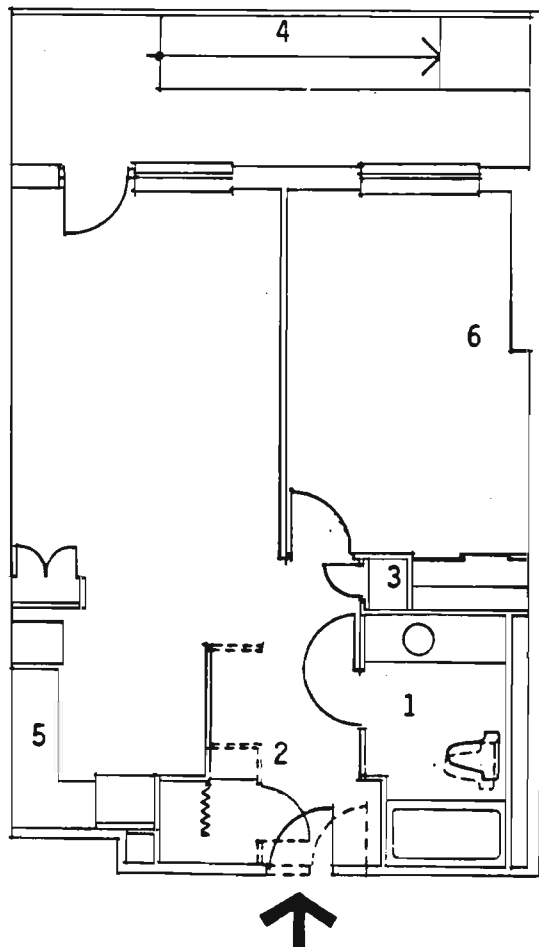
EXISTING APARTMENT

A number of problems were noted by the user and consultants. The sloped tunnel entrance to the main door is very windy, the doors are too heavy and the door handles and elevator buttons are too high.

Many of the available standards have not been followed in the design of the unit in this case study; this has resulted in the problems noted above.

Relocate the toilet to improve access to the bath; relocate the mirror, the electrical duplex outlet and accessories; replace the faucet to the bath with lever handles.

Provide a ramp and raised platform to the balcony to improve visibility. (During the course of the consultant's investigation, the user had a ramp added. It should be noted that the height of the balcony enclosure now contravenes building regulations requirements.)

UPGRADING RECOMMENDED

1. Bathroom: relocate toilet, mirror and accessories to provide access; replace dial faucet to bath.
2. Entrance Hall: relocate entrance door, remove storage cupboard and relocate coat closet to improve access.
3. Linen Closet: relocate shelves to provide side access.
4. Balcony: provide ramp with raised landing to permit vision over front of balcony.
5. Kitchen: minor changes to counter and cupboard.
6. Room configuration restricts bed position and circulation - no change possible.

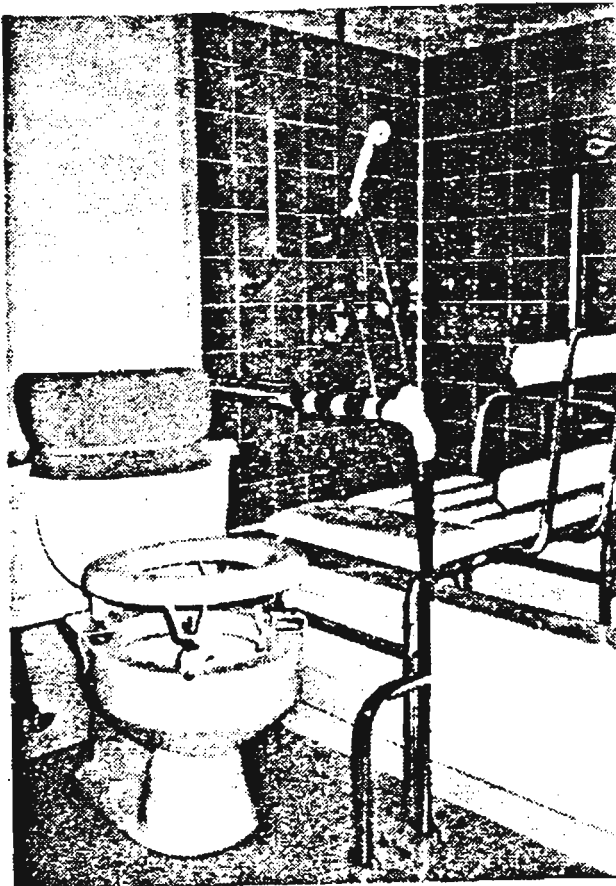
Bathroom with inappropriate placement of toilet and grab bars.

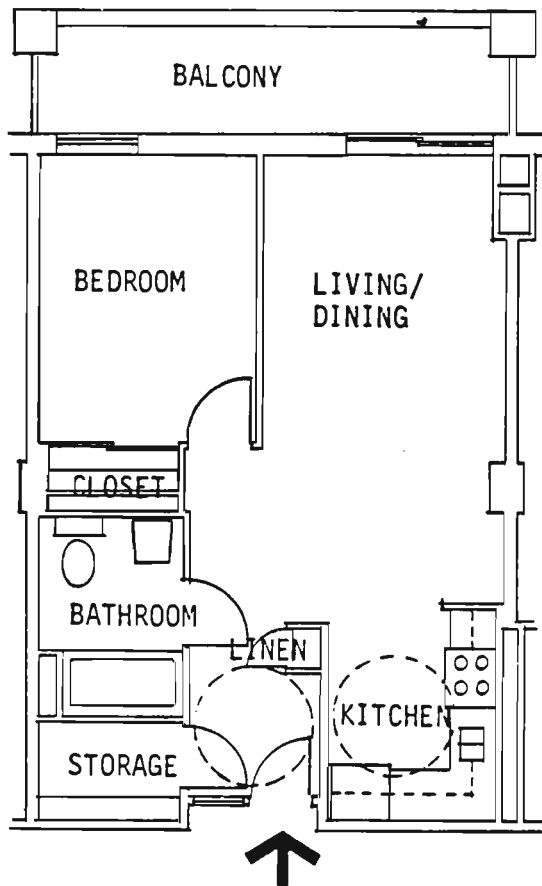
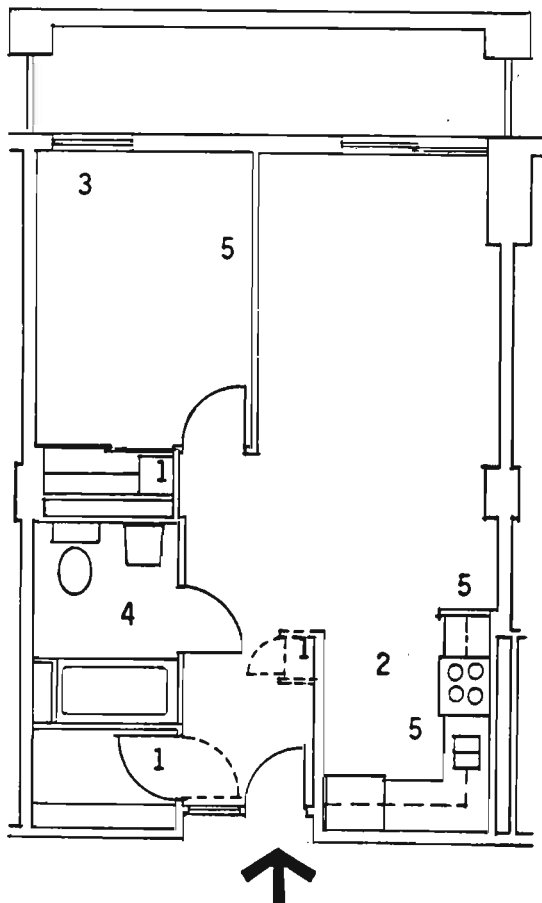
EXISTING APARTMENT

The exterior ramp leading to the building is too narrow and steep and has an inadequate lower and intermediate landing. The main doors are heavy to open, and the intercom, elevator buttons and mailboxes are too high. The user is unable to use the garbage chute because of the way the garbage chute enclosure is designed.

Many of the guidelines for adapted housing have not been adequately met, resulting in the problems noted above.

Remove the kitchen cupboards, counters, shelves and so on, and replace and relocate sink and range to provide improved accessibility.

Replace the sliding window with windows that can be operated by a disabled person.

UPGRADING RECOMMENDED

1. Relocate linen closet to bedroom closet, and rehang storage room door to improve circulation.
2. Remove kitchen cupboards and replace; relocate sink and improve accessibility.
3. Replace sliding bedroom window with suitable window for operation by disabled.
4. Make minor changes to bathroom.
5. Relocate manual controls for louvered heating grill, fuse box, electrical outlets and services to improve accessibility.

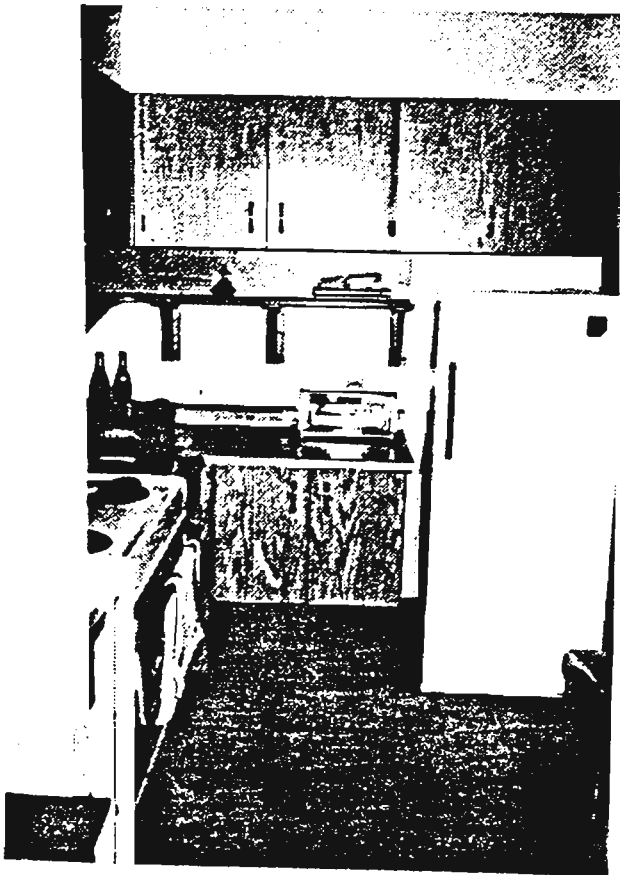
Location of sink is such that user cannot independently manoeuvre chair under sink. There is no counter area with knee clearance provided.

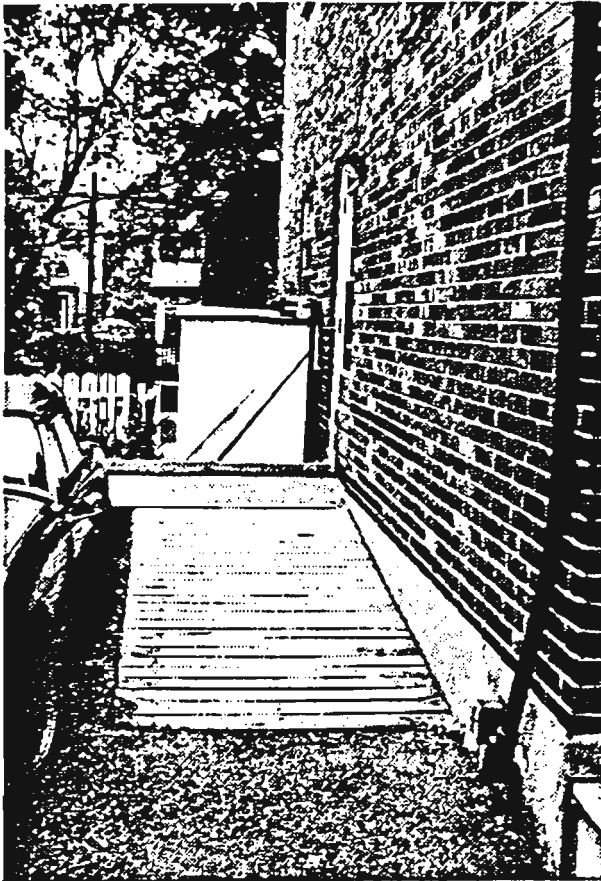
Side ramp and landing.
No handrails provided.

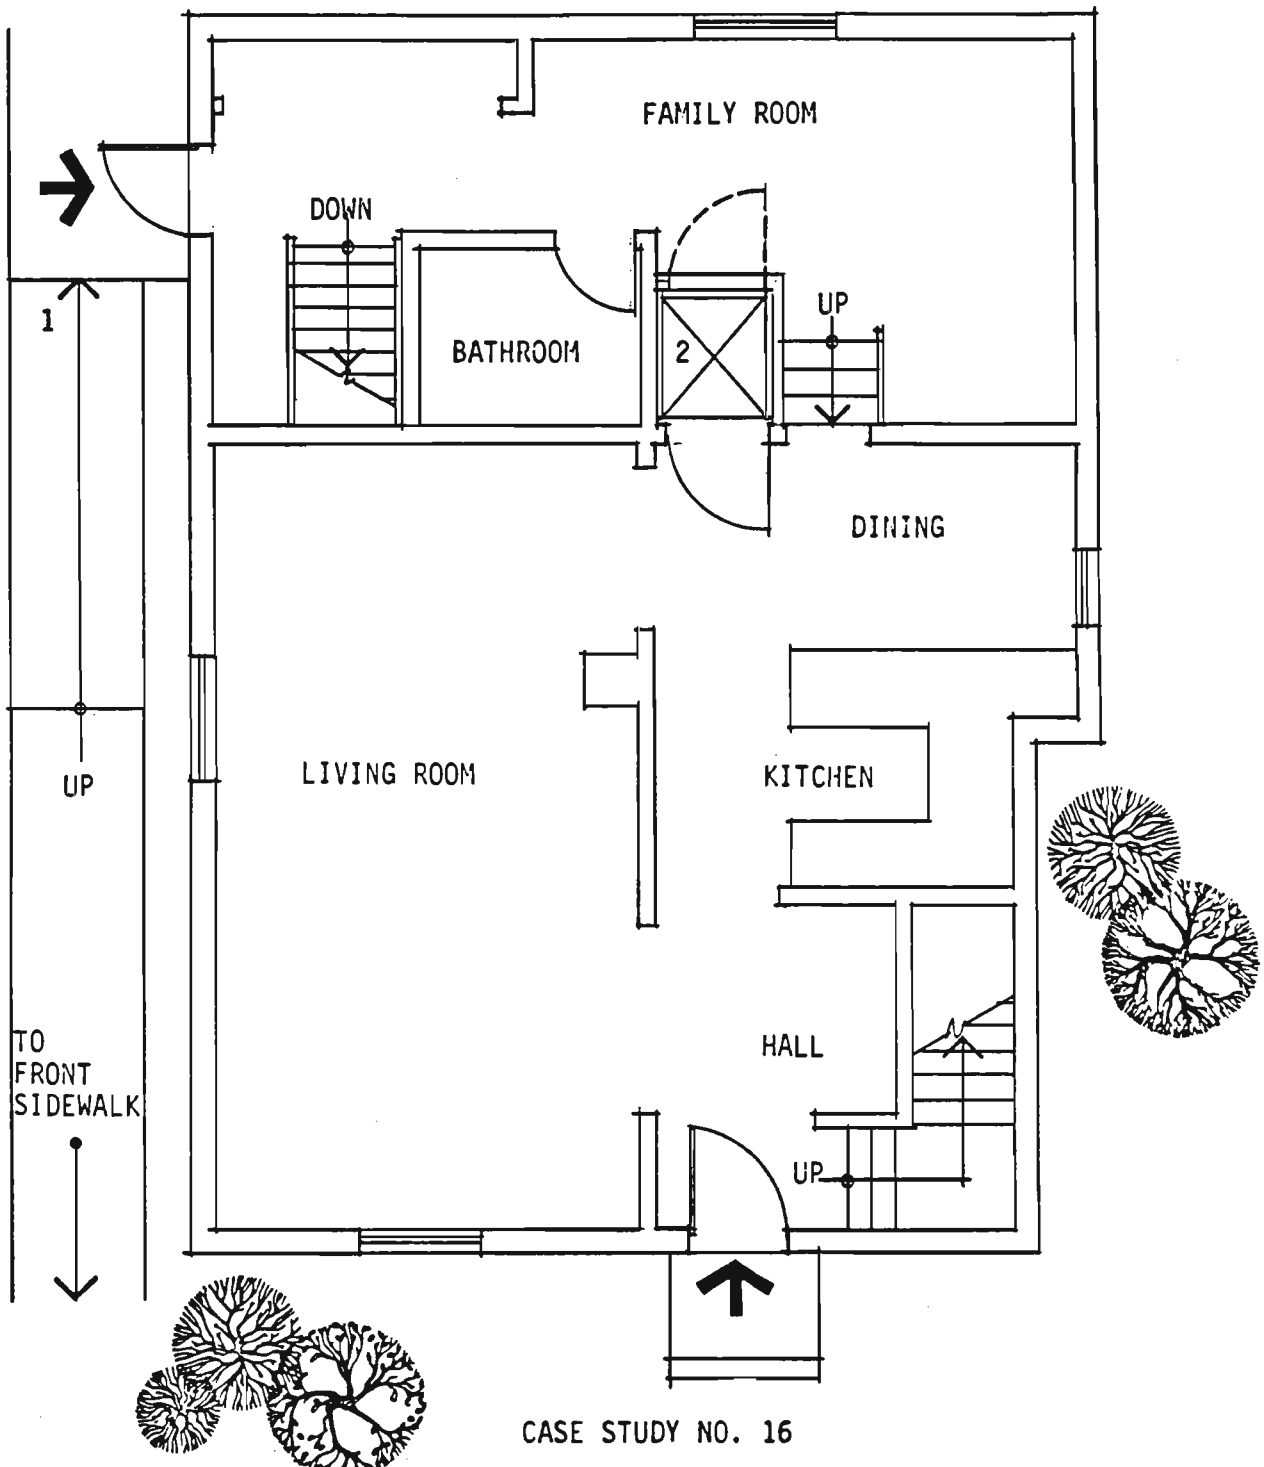
CASE STUDY NO. 16

1. New concrete landing and ramp at side entrance (requires handrails).
2. New vertical hoist with entrance at three levels.
