APPENDIX 3 TO MAIN REPORT

STUDY OF APPLE HILL
ENERGY EFFICIENT HOMES

TASK D - THERMOGRAPHIC SCANNING

FEBRUARY 1984

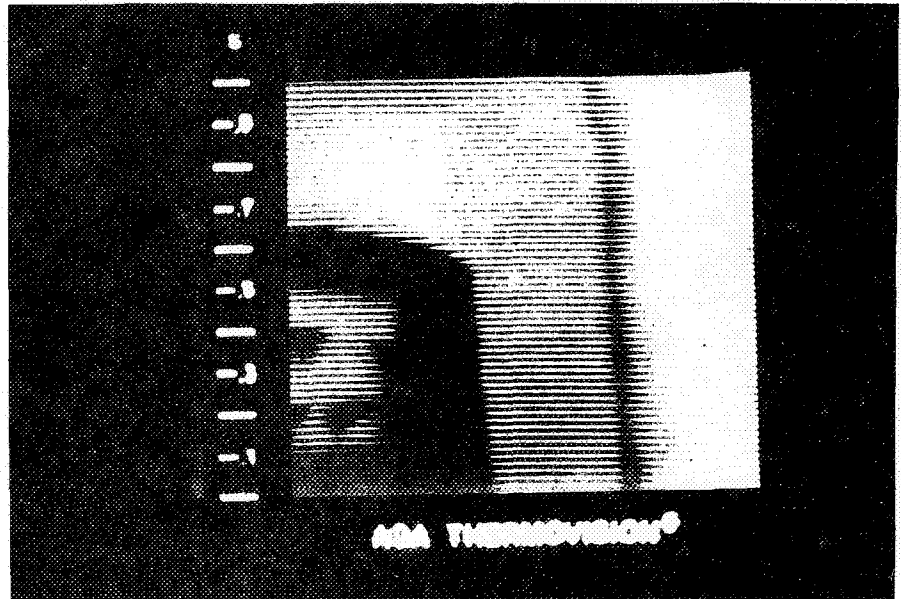
Air leakage at fireplace-wall joint, probably due to poor A/V barrier seal where wall meets fireplace

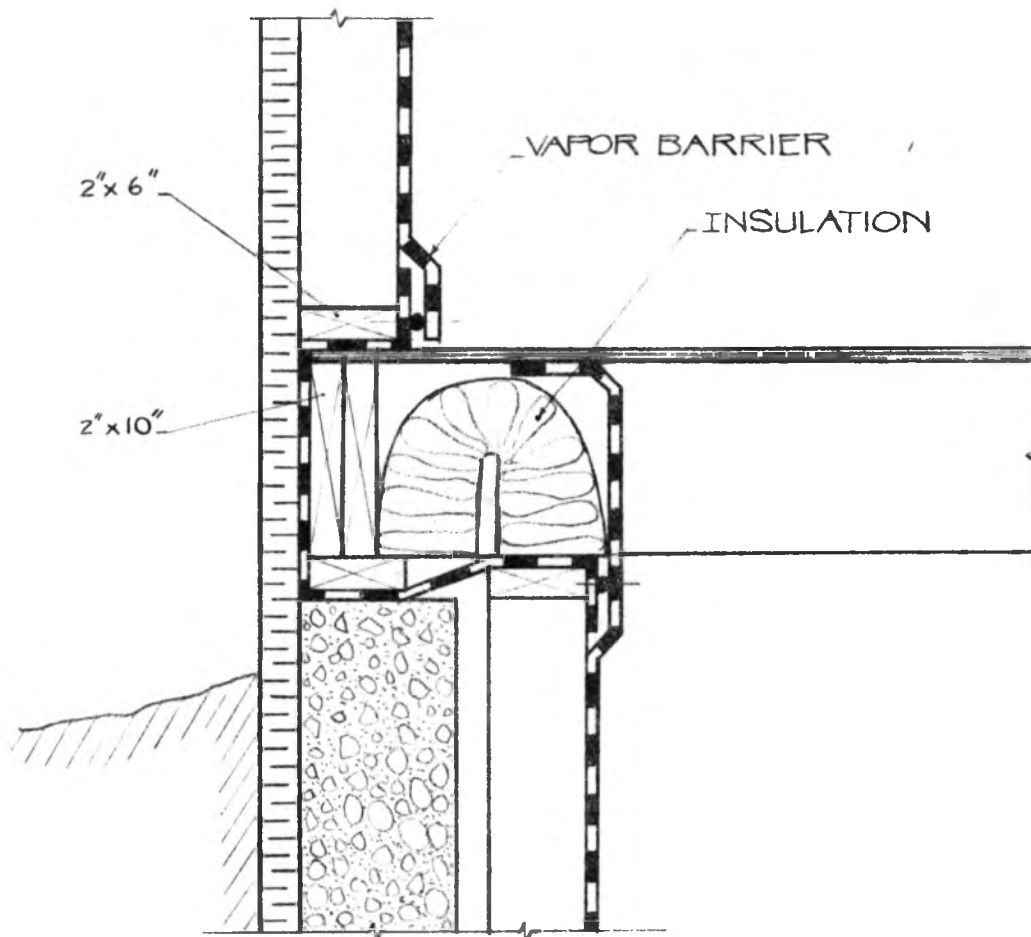
Figure 5.1
CROSS-SECTION OF HEADER JOIST AREA

4. A major trouble spot on all of the homes was the header/joist area at the top of the foundation wall. A foam gasket was used underneath the sill plate. This foam gasket does not seal adequately wherever there is rough concrete, window frames or plumbing, and ductwork and wiring penetrations. The amount of air leakage into the finished wall cavity is such that all basement wall outlets and trimwork are very leaky.

The difficulty of firmly attaching a polyethelene A/V barrier along the joist/sub-floor topography should not be underestimated. The evidence of condensation problems along the header joist (band joist) suggests that a considerable amount of vapour is diffusing into this area. Any moisture that does reach the band joist is likely condensing, and has accumulated for several reasons:

A. The band joist is inadequately insulated with 37 mm of Glasclad insulation sheathing;

C. The basement wall AV barrier is applied to the warm side of the header space fiberglass resulting in partial vapour lock. This last condition requires immediate corrective action to maintain the integrity of the header joist. This problem is illustrated in Figure 5.1.

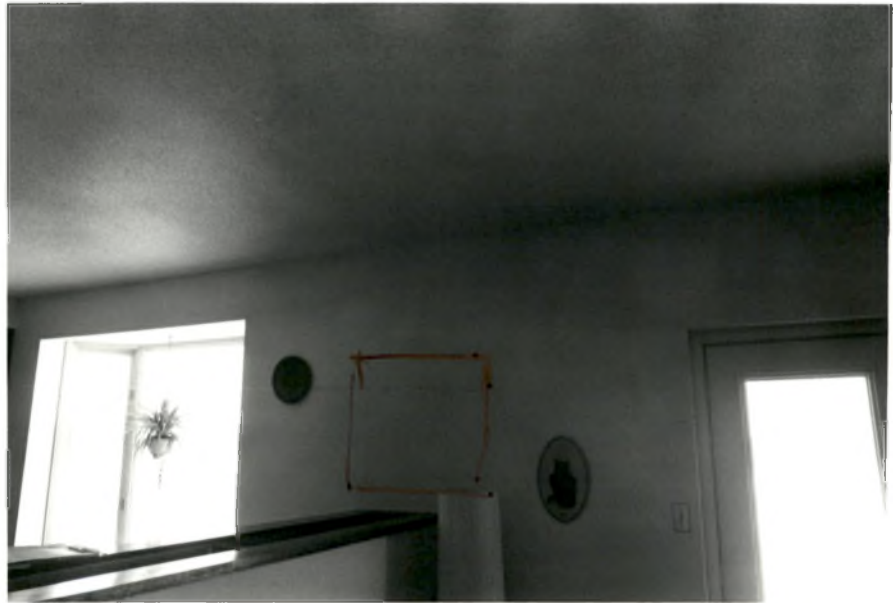
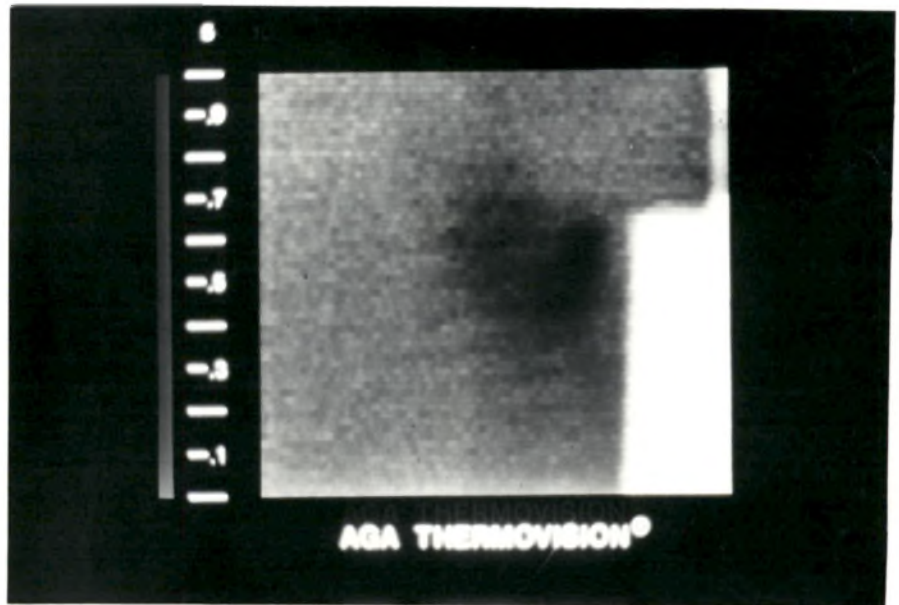
North wall -
Family Room

likely condensation
in walls due to
break in A/V
barrier.

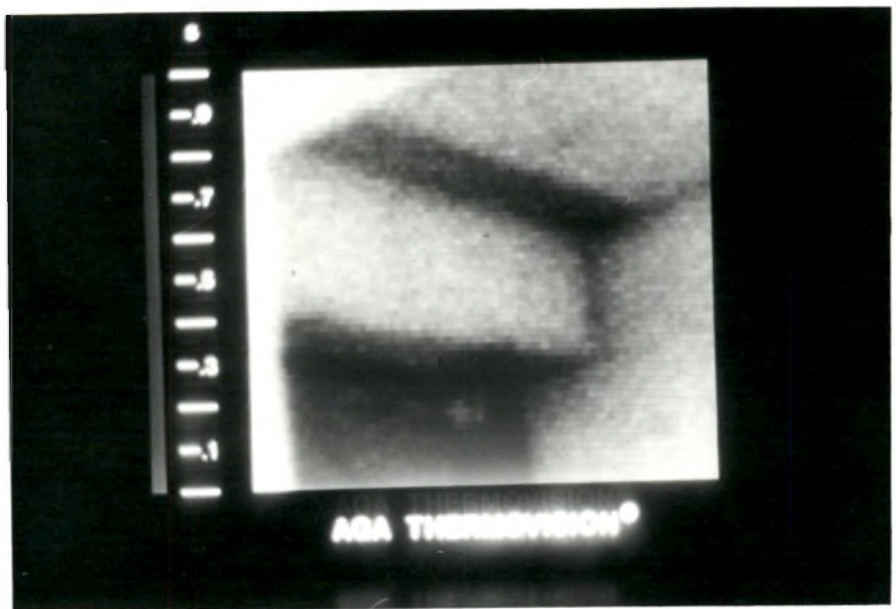
Front entrance -
South side

apparent void
in insulation.

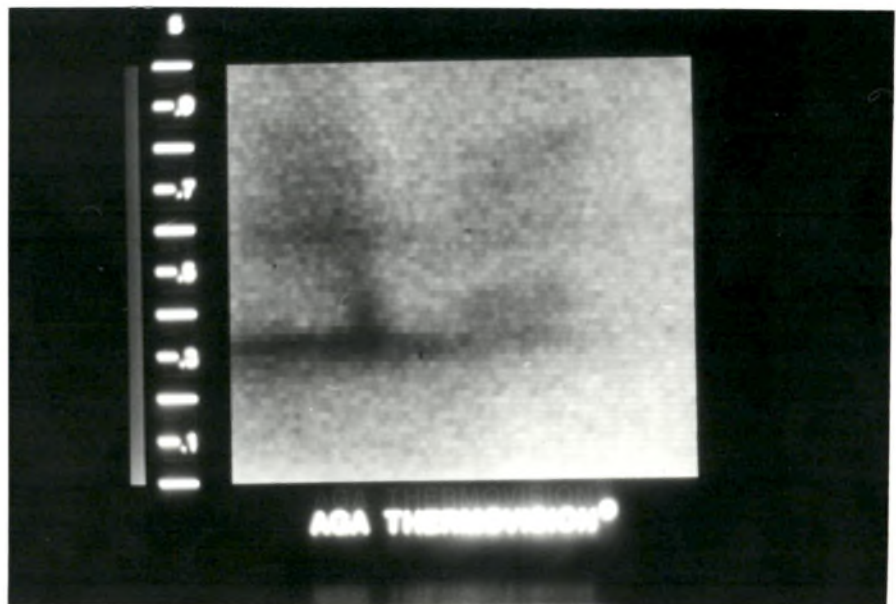
Master Bedroom -
west wall

possible condensation
problem resulting
from air leakage at
plate due to
insufficient A/V seal

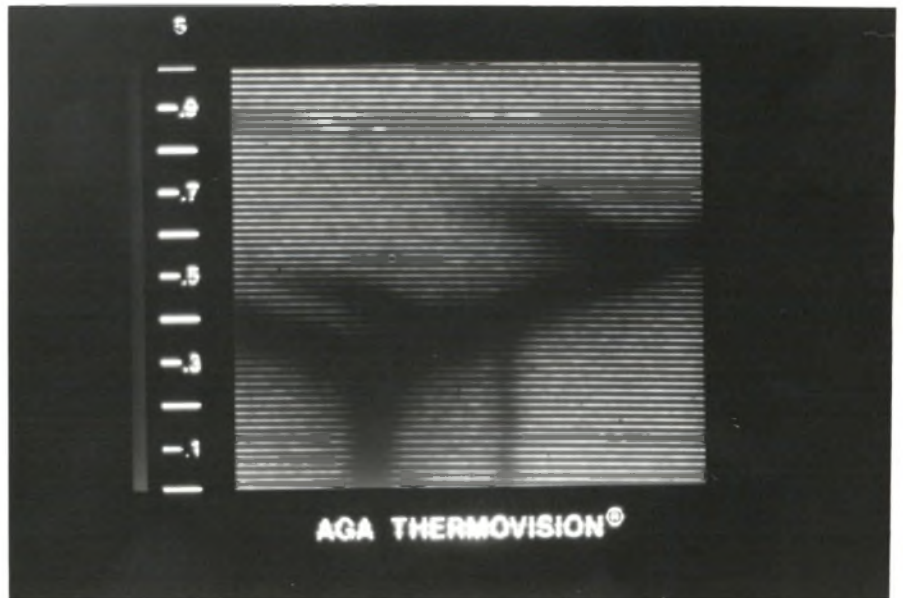
likely ineffective
A/U barrier causing
condensation

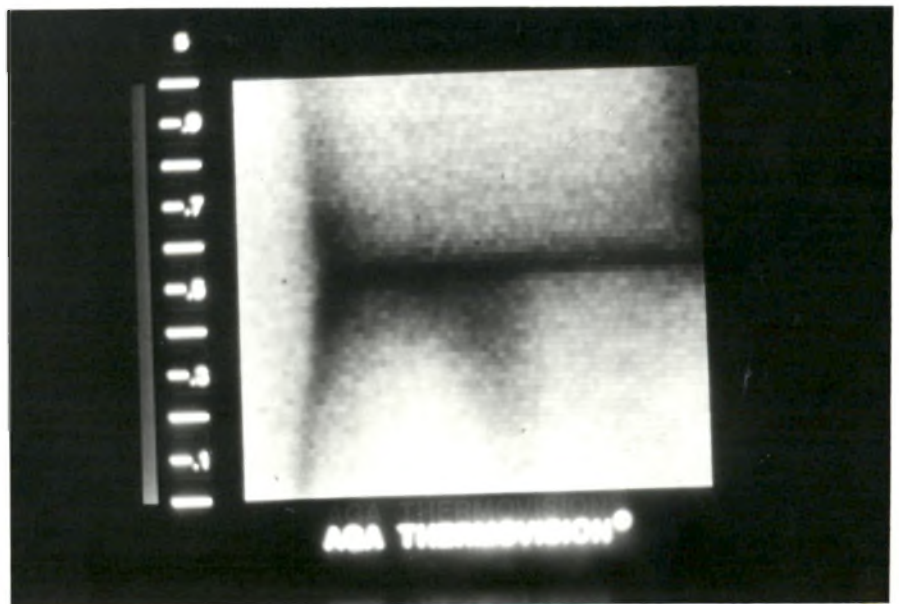
Air leakage at
baseboard

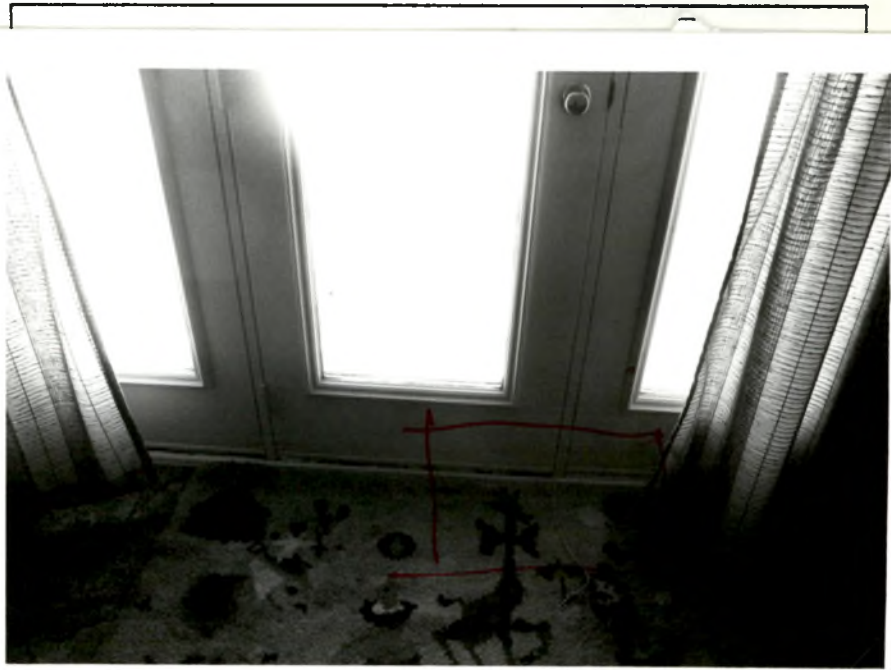
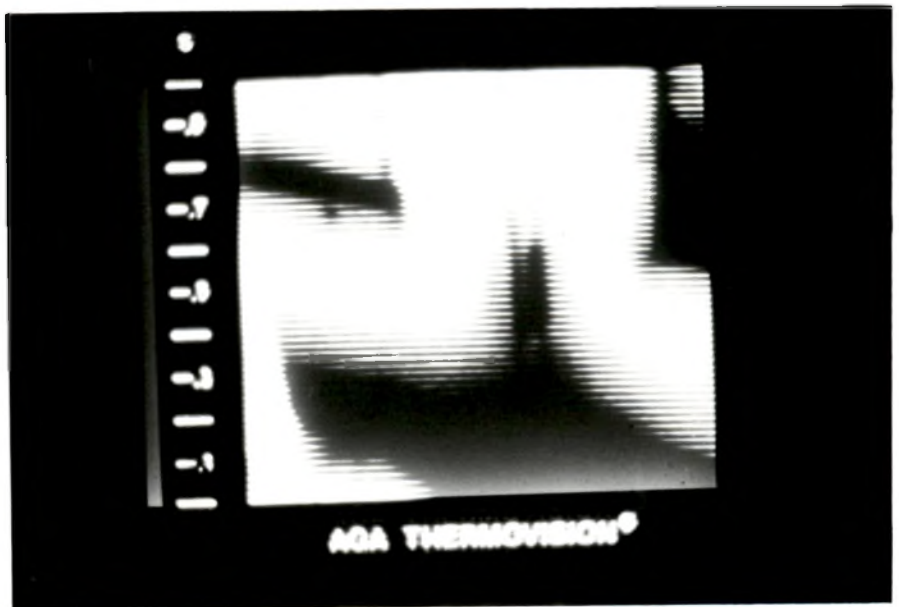
Family Room
door to exterior

air leakage @
threshold

ineffective weather
stripping

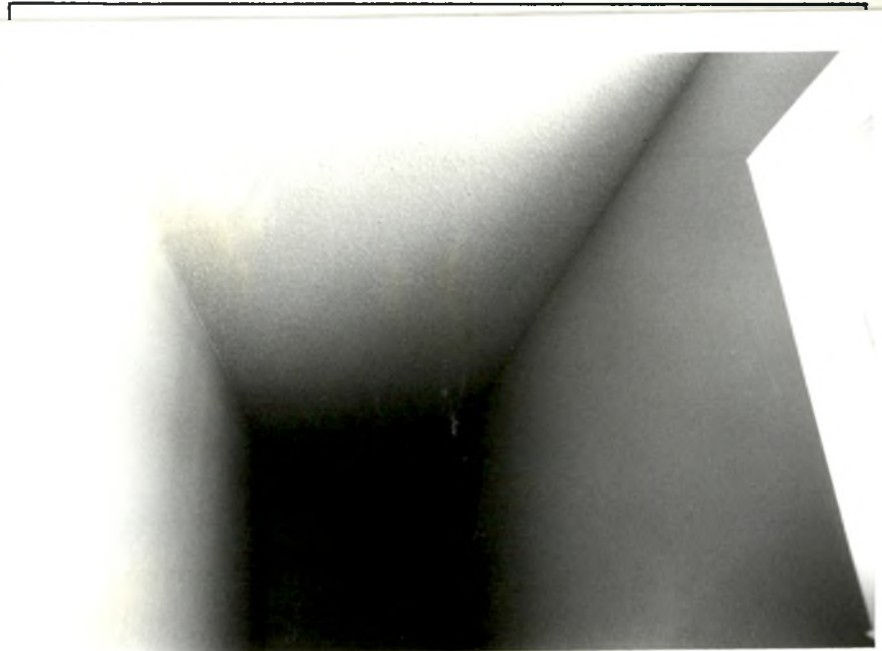
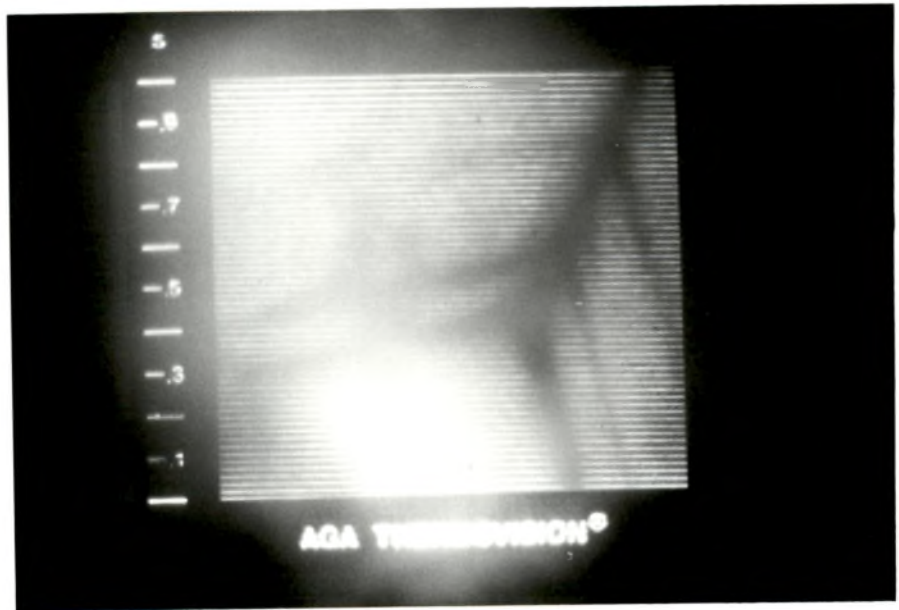
Stair ceiling
from 1st to 2nd
Floor

likely ineffective A/V
barrier at this point
is causing excess
condensation & perhaps
air leakage @ ceiling.

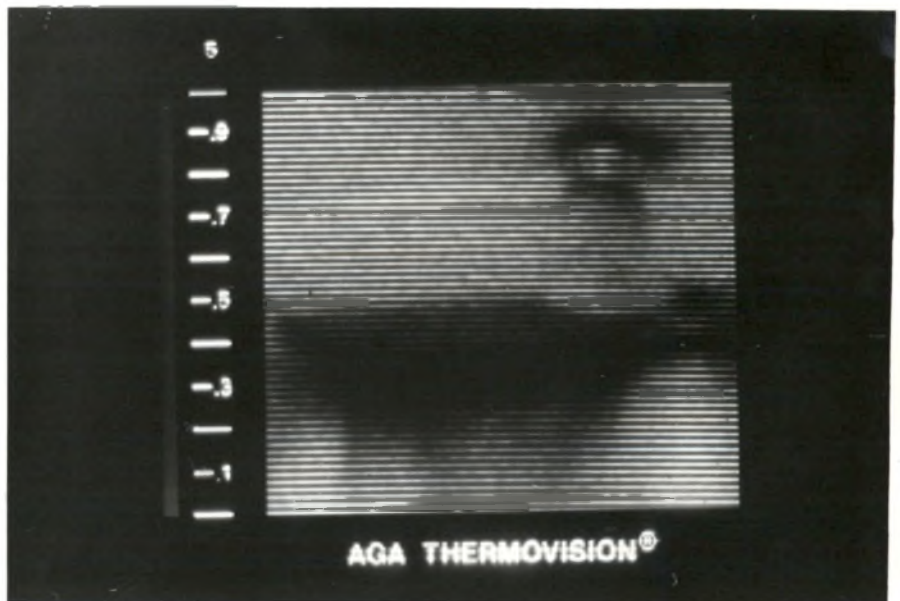
Master Bathroom

poor A/U barrier @ ceiling.

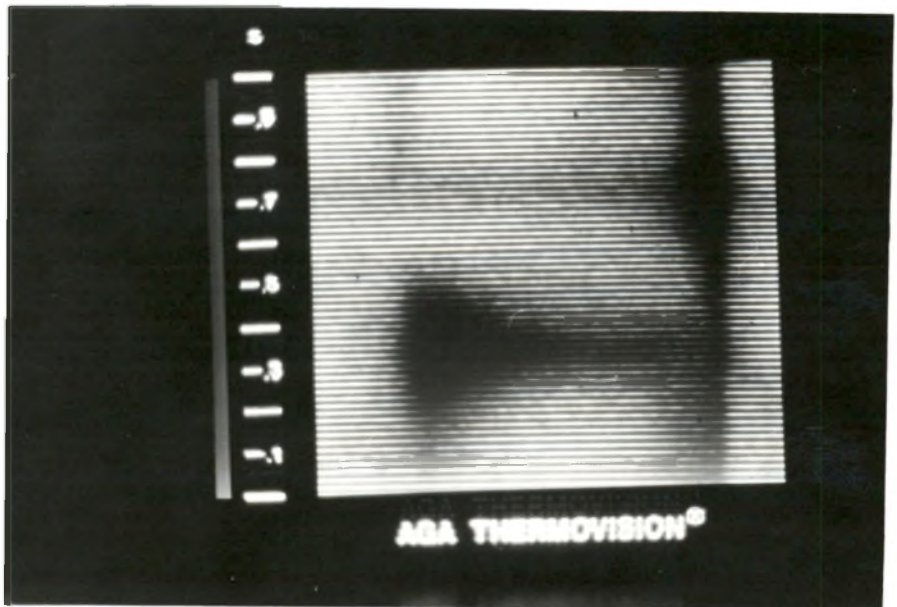
likely void in
insulation and
ineffective A/U
barrier causing
air movement.

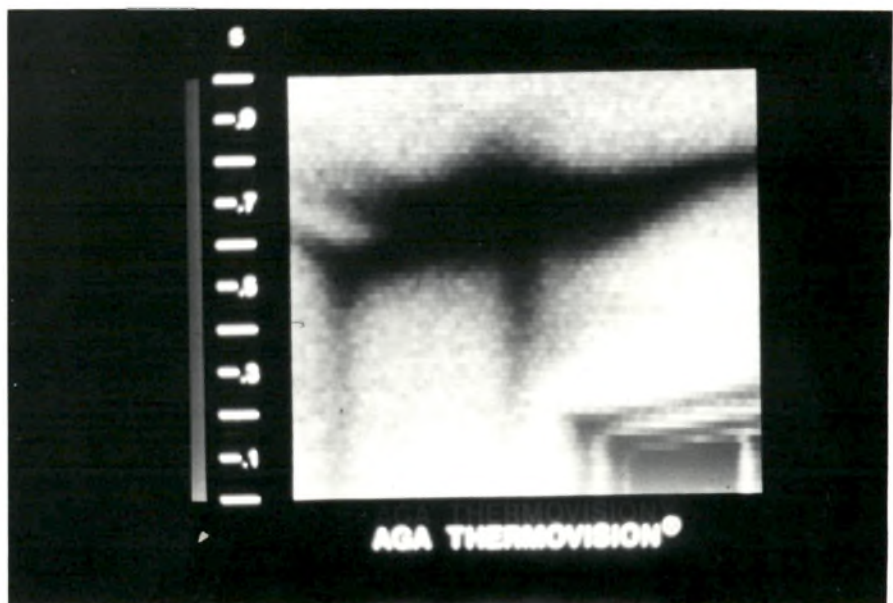
unadequate insulation and considerable air poor A/V barrier

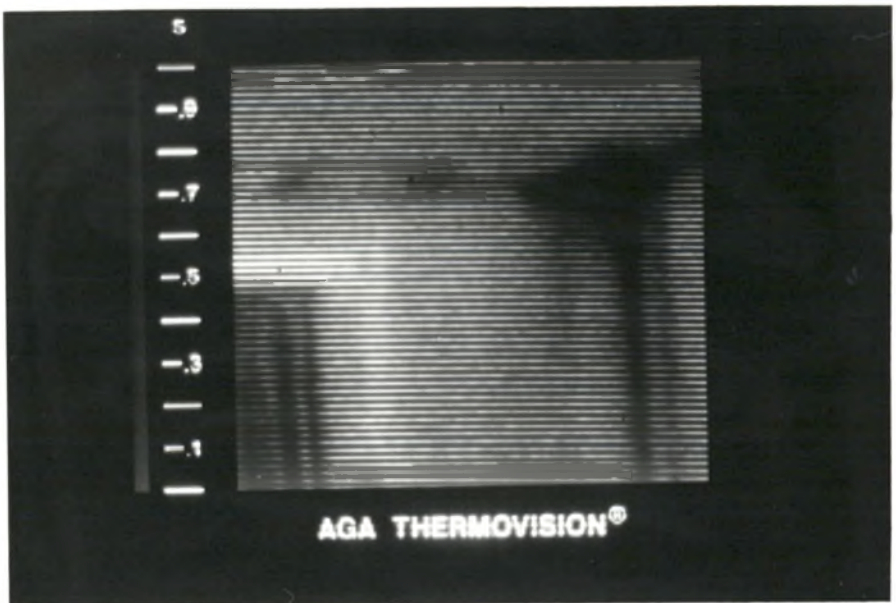
likely insufficient
vapor barrier causing
some air leakage and
condensation

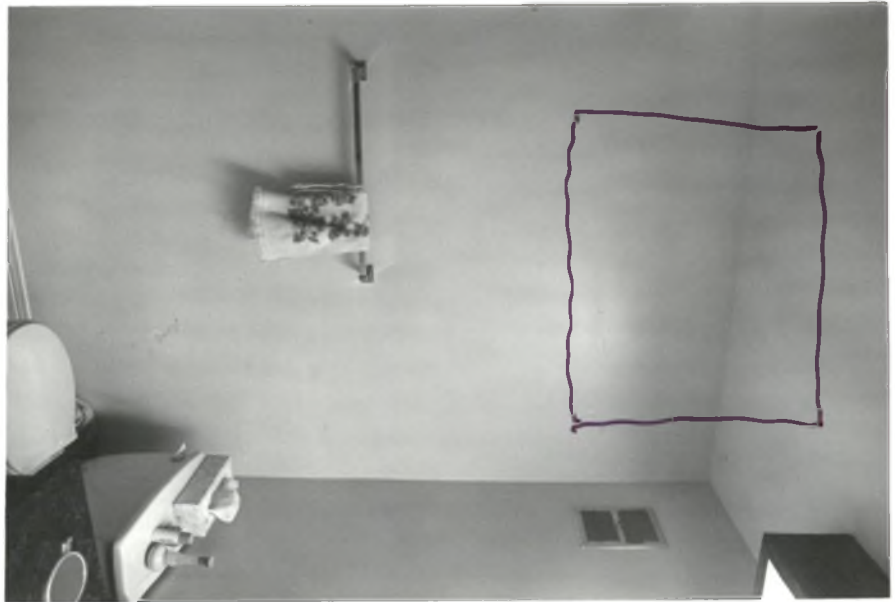
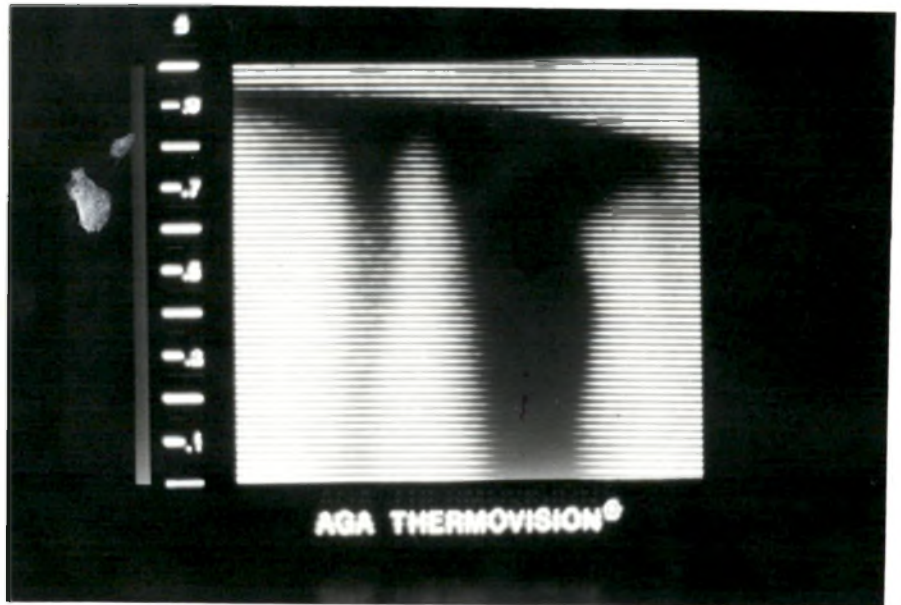
Main Bathroom
NORTH WALL

Cold air leakage
down bathroom
wall (exterior wall)

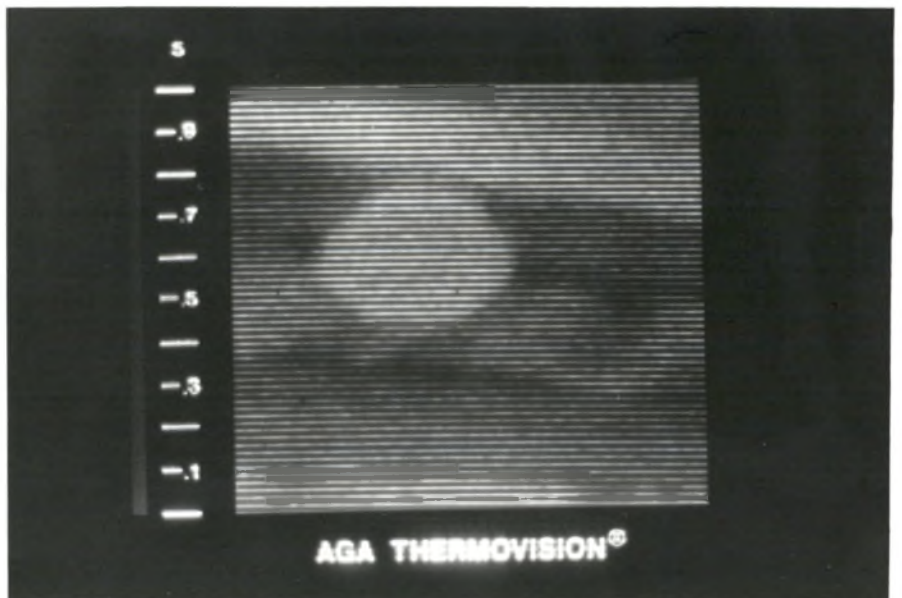
likely due to infiltration coming in from walls

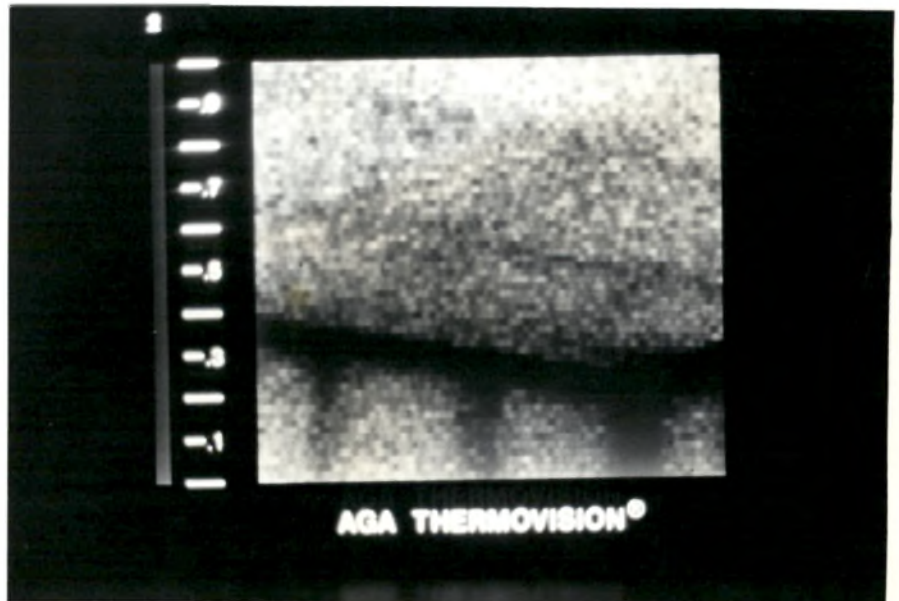
POOR AIR BARRIER
AT PLATE
