FIELD MONITORING OF CELLULOSE
IN WALLS - EDMONTON

Prepared for:

Canada Mortgage and Housing Corporation
Project Implementation Division
682 Montreal Road
Ottawa, Ontario
K1A 0P7

January 8, 1990

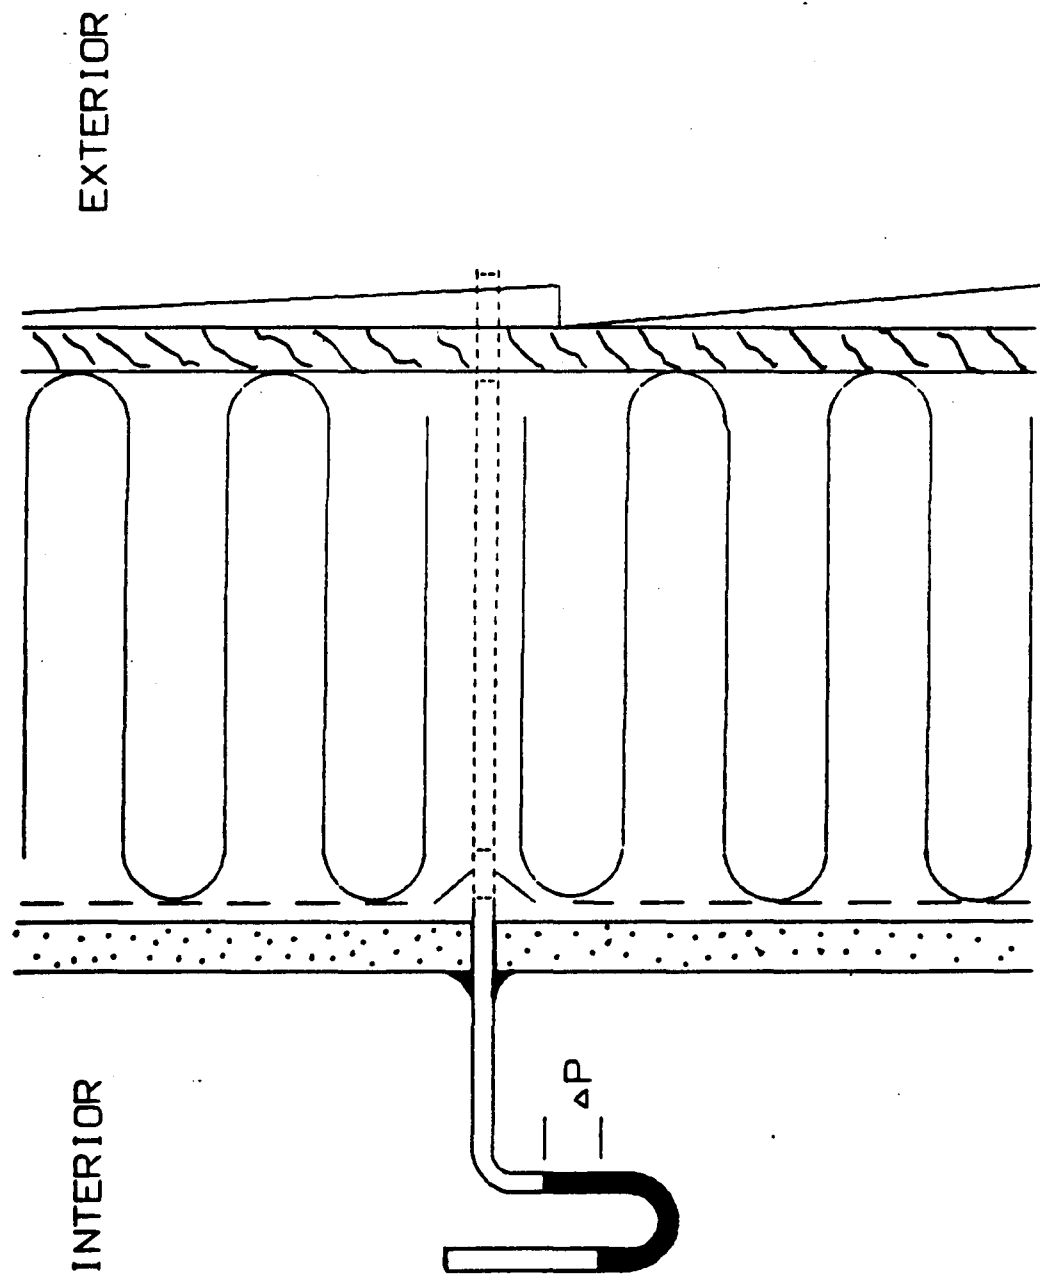
FIGURE 14 - PRESSURE DROP TESTING

Six tests were completed across various wall sections. Table 3 presents the pressure drop data. Sections tested with gypsum board, but without polyethylene installed, indicated pressure drops equal to those with the gypsum board and polyethylene combined. Testing from exterior to interior produced similar values.

It should be noted that resistance to air flow, varied by up to 15 % with each wall section tested. Installation of pressure taps during construction would have provided more accurate results as some errors are anticipated due to imperfections in the pressure tap seal. These results are not conclusive and may vary with each house built.

Table 3 indicates that, for this test home, the exterior sheathing was the principal air barrier. Gypsum board, polyethylene and cellulose provided further air resistance, in decreasing magnitudes. Subsequent inspections noted that the plywood joints, originally 3 mm in width, were nearly tight, contributing to the air tightness of the exterior sheathing. Interior gypsum board had various electrical penetrations through it, while cavities were interconnected by holes for wiring.
