CHBA 43rd National Conference/Exposition
Business Session 5B
Field Research: Commonsense Solutions
to Practical Problems

Canada Mortgage
and Housing Corporation

**COMBUSTION VENTILATION HAZARDS IN HOUSING -
FAILURE MECHANISMS, IDENTIFICATION TECHNOLOGIES, AND REMEDIAL MEASURES**

By
Sebastian Moffatt
Sheltair Scientific Ltd.
Vancouver, B.C.

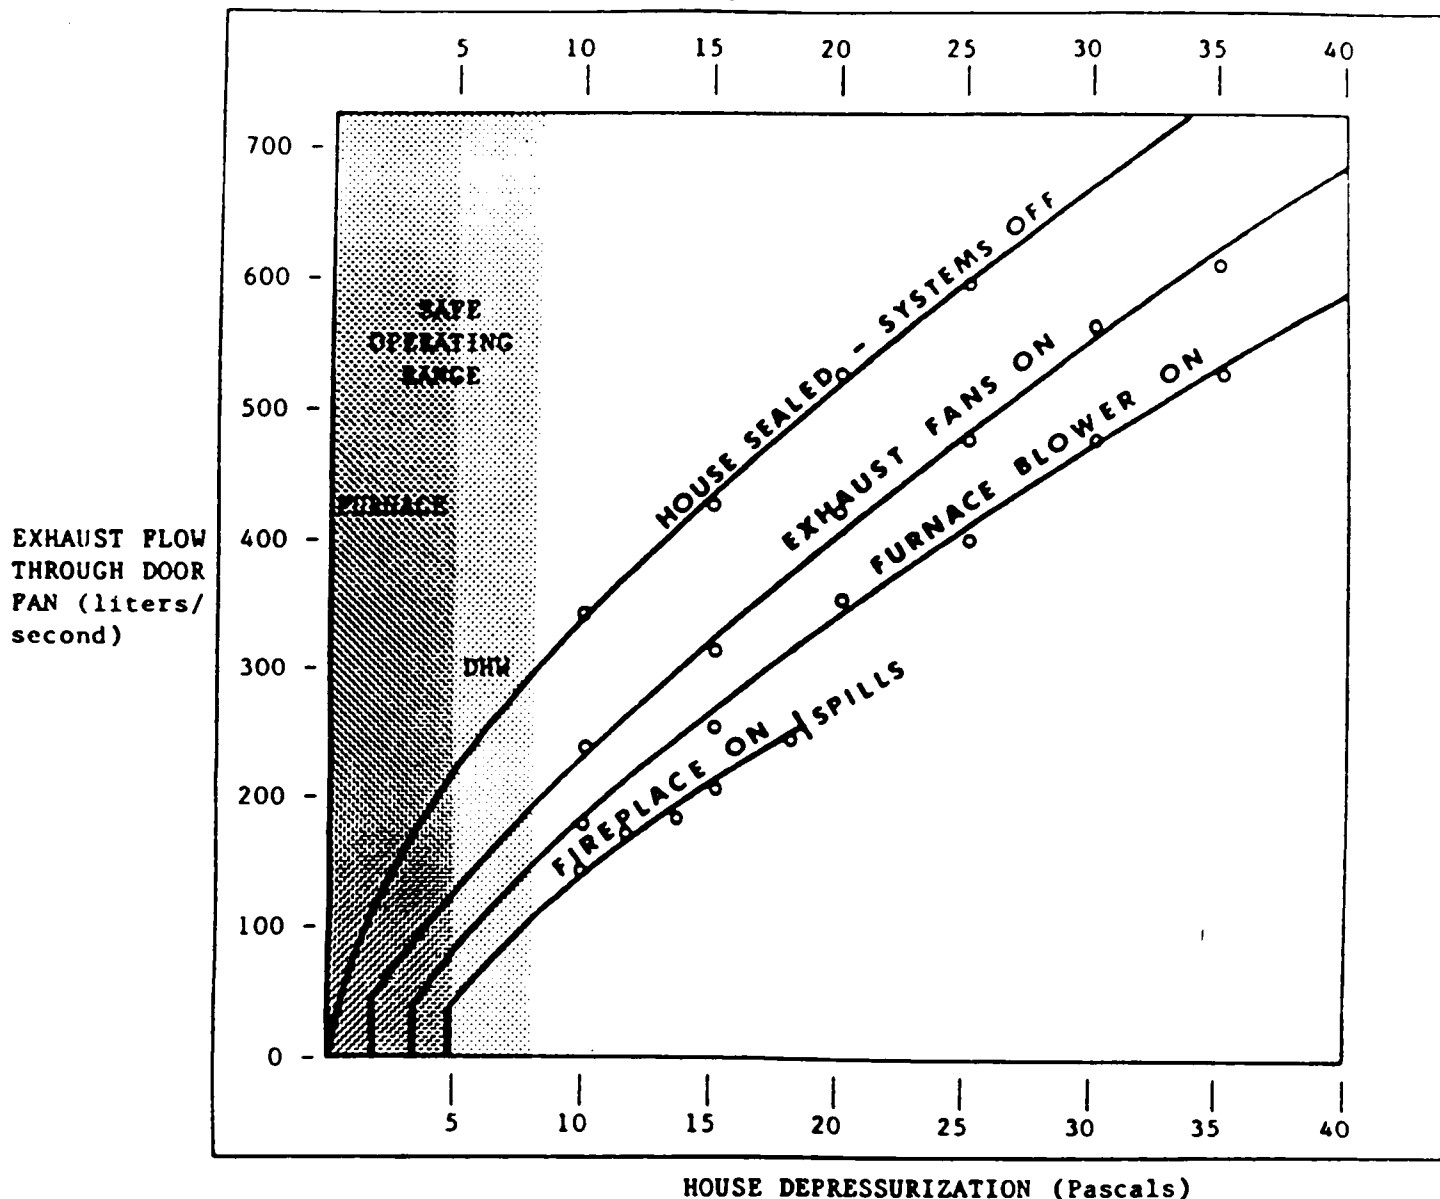
FIGURE 1 A SAMPLE VENT/PRESSURE PROFILE:
Illustrating house pressures, exhaust flows, and chimney
failure pressures for House #36

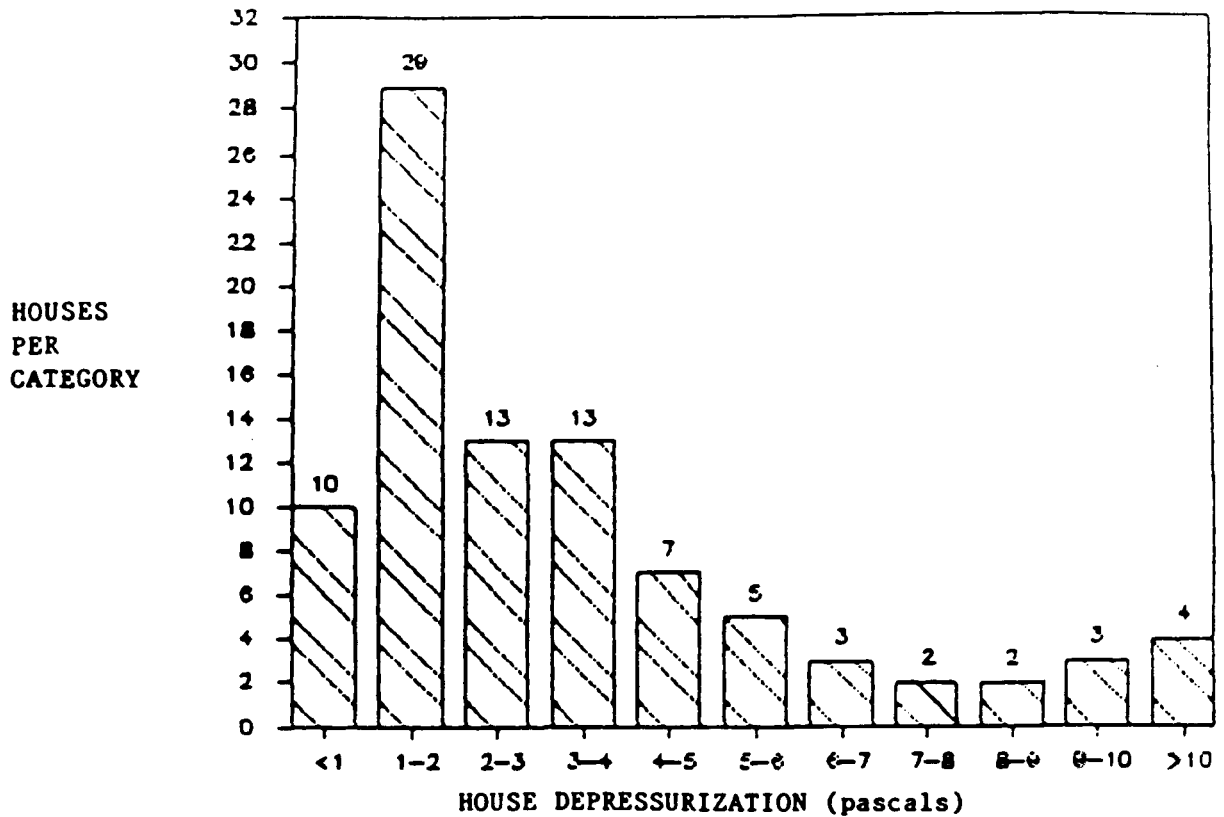
Thirty-six per cent of the houses failed the furnace room backdraft test by exceeding the MAD limits. Depressurization levels were accurately read to 0.2 Pa (except under very windy conditions). Average depressurization by mechanical exhaust systems was 3.2 Pa with slightly less than one third falling in the 1 to 2 Pa range (figure 2). When fireplaces were added to the exhaust, the average depressurization rose to 4.5 Pa (figure 3). Seven houses experienced more than 10 pascals of depressurization, four were above 15 Pa, and one house recorded 22.2 Pa.

FIGURE 2 DISTRIBUTION OF HOUSE SAMPLE BY DEPRESSURIZATION FROM MECHANICAL EXHAUST DEVICES

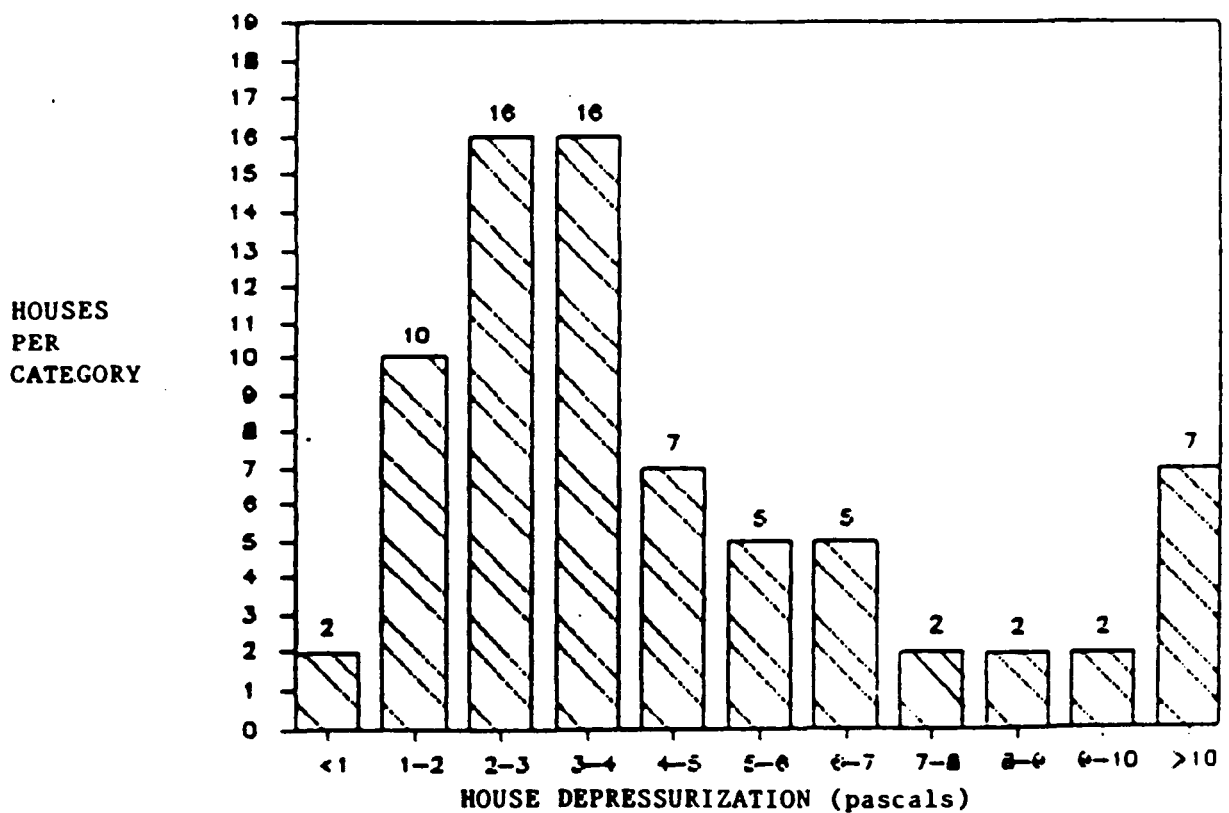
Only one house failed the heat exchanger leakage test (Part 3). Seventeen houses failed the operating spillage test (Part 4). In 35 houses, depressurization of the fireplace room (Part 5) exceeded the allowable limit of 3.0 Pa. The extent of fireplace room failures is understated because multiple failures occurring in parts 2, 3, and 4 complicated the procedures.

FIGURE 3 DISTRIBUTION OF HOUSE SAMPLE BY DEPRESSURIZATION FROM MECHANICAL EXHAUST DEVICES AND FIREPLACES
