**FINAL REPORT
FOR
FIELD INVESTIGATION OF DOMESTIC HOT
WATER TANKS AS SPACE HEATING
APPLIANCES**

**Rick Thrall
and
William J. Mayhew, P.Eng.**

**HOWELL MAYHEW ENGINEERING, INC.
15006 - 103 Avenue
Edmonton, Alberta
T5P 0N8**

April 25, 1989

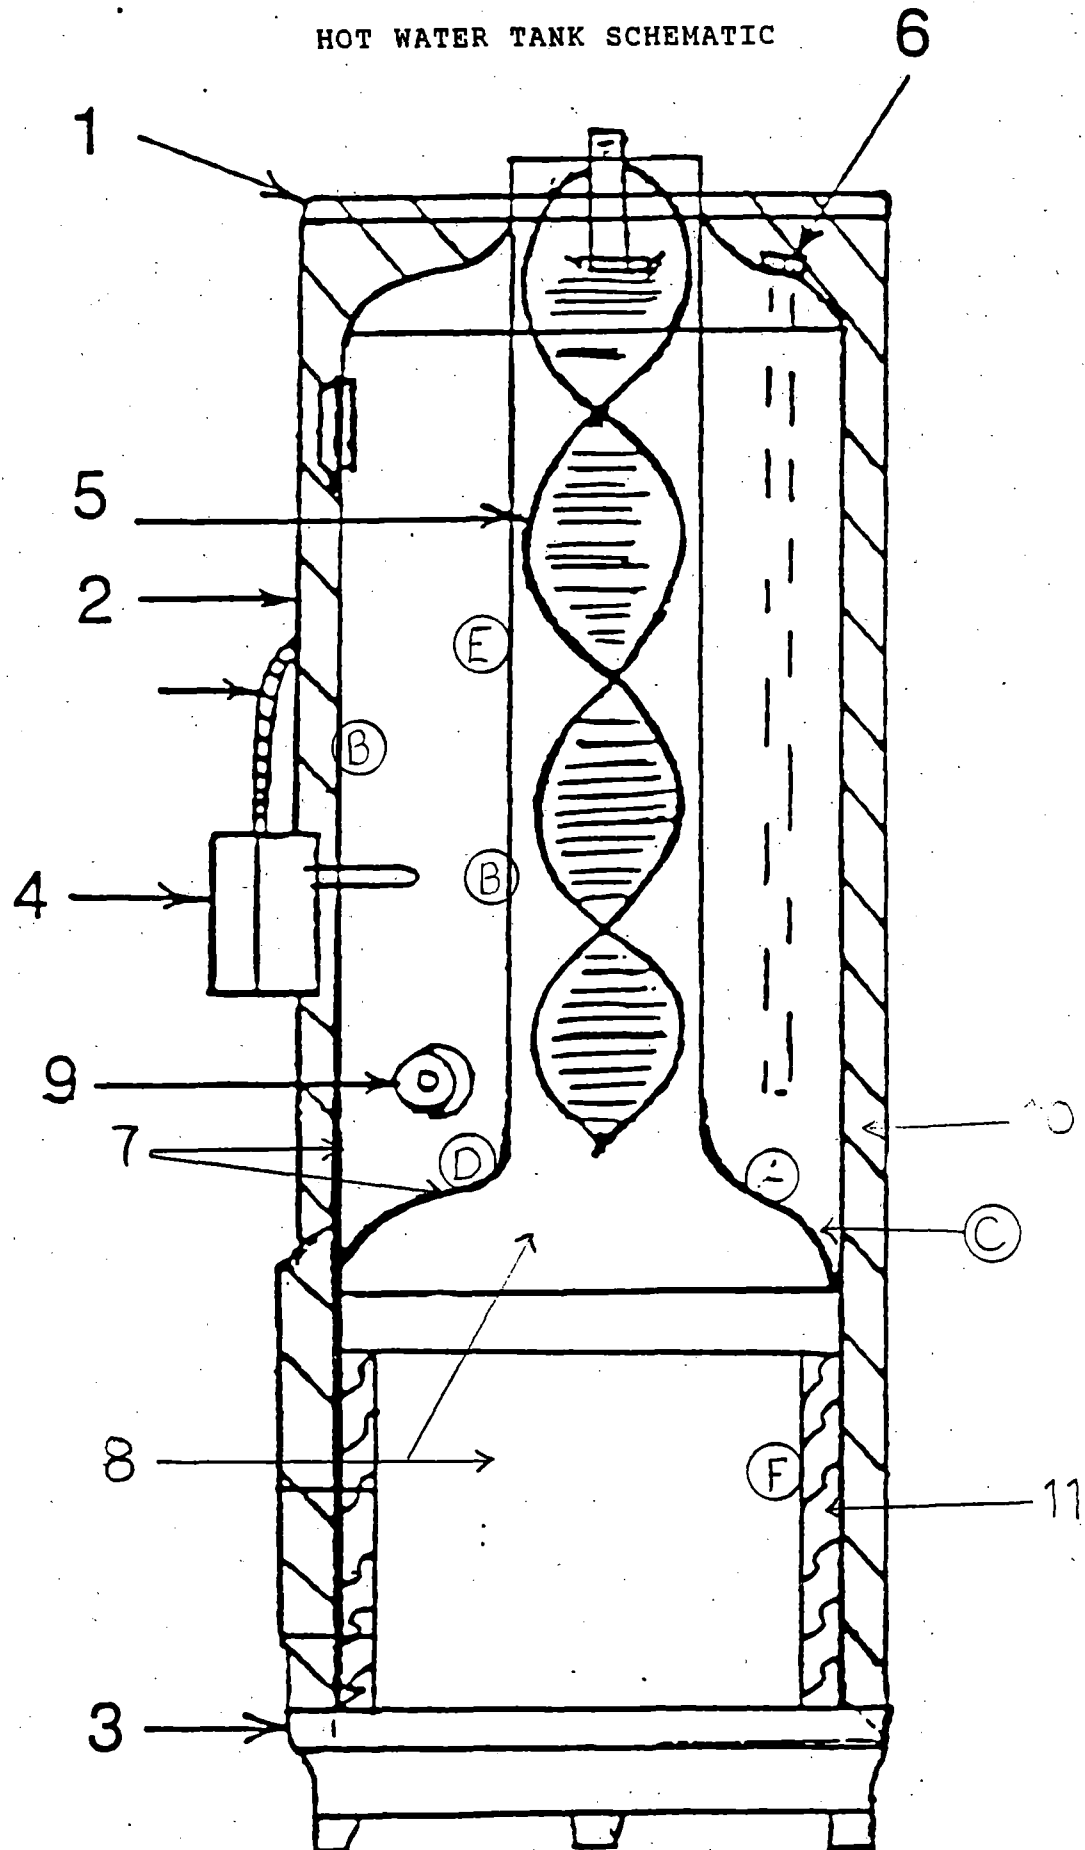
HOT WATER TANK SCHEMATIC

- o The fire pot or fire chamber is made up of flexible, white, fireproof blanket material which has a tendency to become brittle and crack when exposed to extreme heat over long periods. The fire pot in the two tanks showed very little wear, although hairline cracks had begun to form. These cracks were normal and the fire pot was thought to be in excellent condition.

| <u>ITEM NUMBER</u> | <u>DESCRIPTION</u> |
|---|---|
| F | Fine Cracks in Fire Blanket |
