**EARTHQUAKE DAMAGE IN THE  
SAN FRANCISCO AREA AND  
PROJECTION TO  
GREATER VANCOUVER  
JANUARY 1990**

### Earthquake Damage in the San Francisco Area and Projection to Greater Vancouver

Report No. CR-6026.1

Report date: 2 January 1990

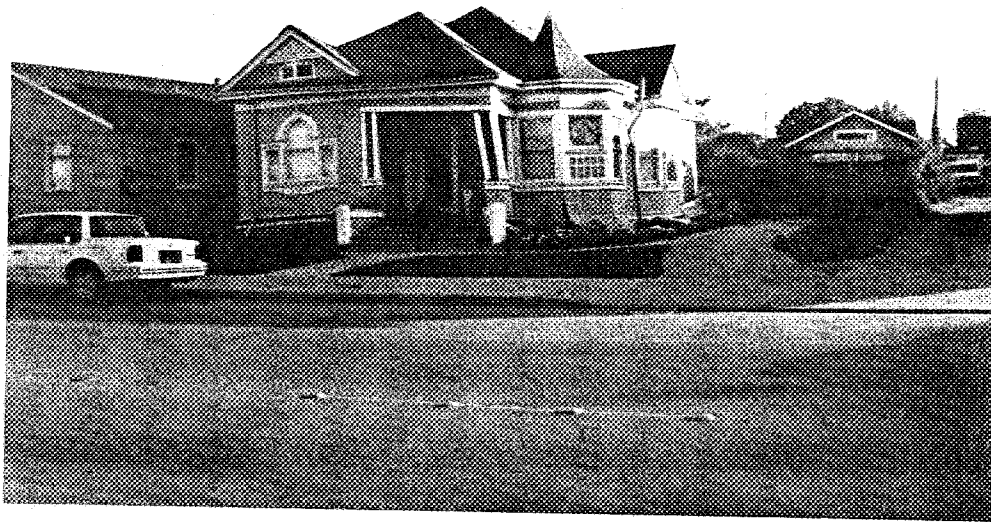
"Cripple" foundation walls (or "pony" walls) failed in many old wood frame houses in the epicentral area (e.g. in Watsonville and in Los Gatos) causing serious damage. Cripple walls are stud walls which form the connections between foundations (concrete or masonry) and the first floor framing (see Fig. 6). They are usually short, but in some modern wooden houses could reach a height of one full storey. Older buildings of 50 years or more appeared to not have enough lateral resistance to withstand severe shaking.

Improper bracing and inadequate connections to the foundations as well as to the first floor framing had caused them to be moved laterally off their foundations. The cripple walls were in some cases laying flat on their side. An example of the cripple wall failure is presented in Figs. B2 and B3. A residence, approximately 60 years old, at 114 Brennan Street in Watsonville is situated about 12 km of the epicentre. This area experienced high frequency shaking, the acceleration reaching 0.40g during approximately 16 seconds. Failing cripple walls shifted the overall wood frame structure off the foundations and caused the partial loss of its integrity. Although these walls were sheathed or sided with horizontal boards, nailing was sparser than required by the code. The panels could not provide the lateral resistance to prevent racking and in some instances this led to the complete failure of cripple walls. Also, large openings (e.g. porches) collapsed due to lack of lateral resistance and settlement of the foundations. Figure B4 shows a complete failure of a cripple side wall of the residence, with the porch completely destroyed. Another example of damage to a single family wood frame house is shown in Figs. B5, B6 and B7. This is an old residence with cripple wall which is not anchored to the foundation. This house was moved laterally by about 45 cm. The porch partially collapsed and caused damage to the ceilings (Figs. B5 and B7).

Fig. B2: Old house with cripple wall failure affecting the integrity -  
114 Brennan Street in Watsonville

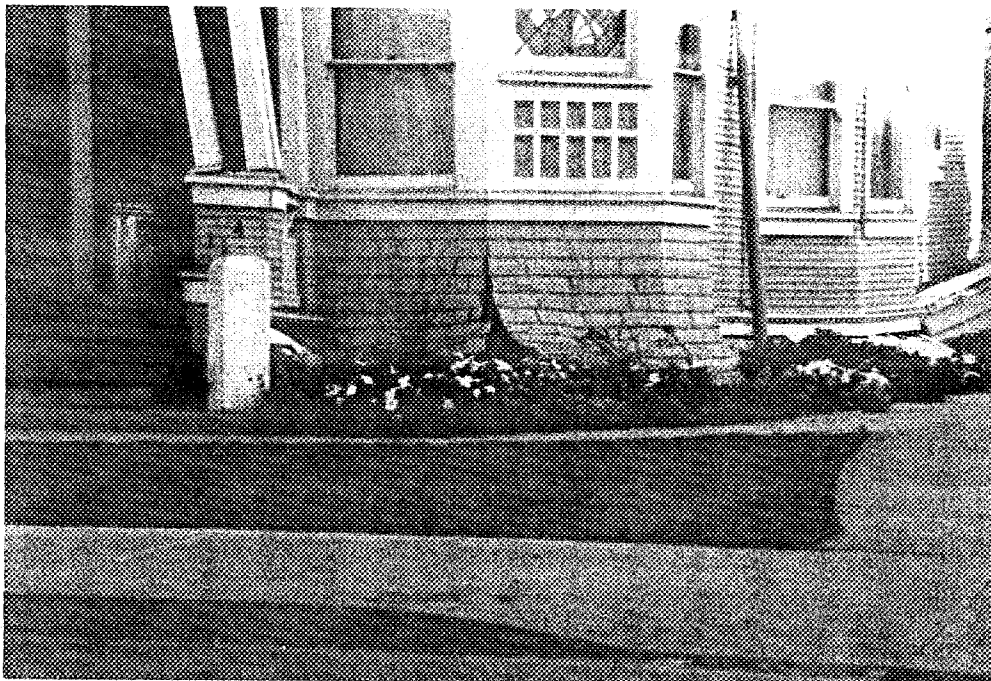
Fig. B3: Close-up of cripple wall failure - 114 Brennan Street in Watsonville

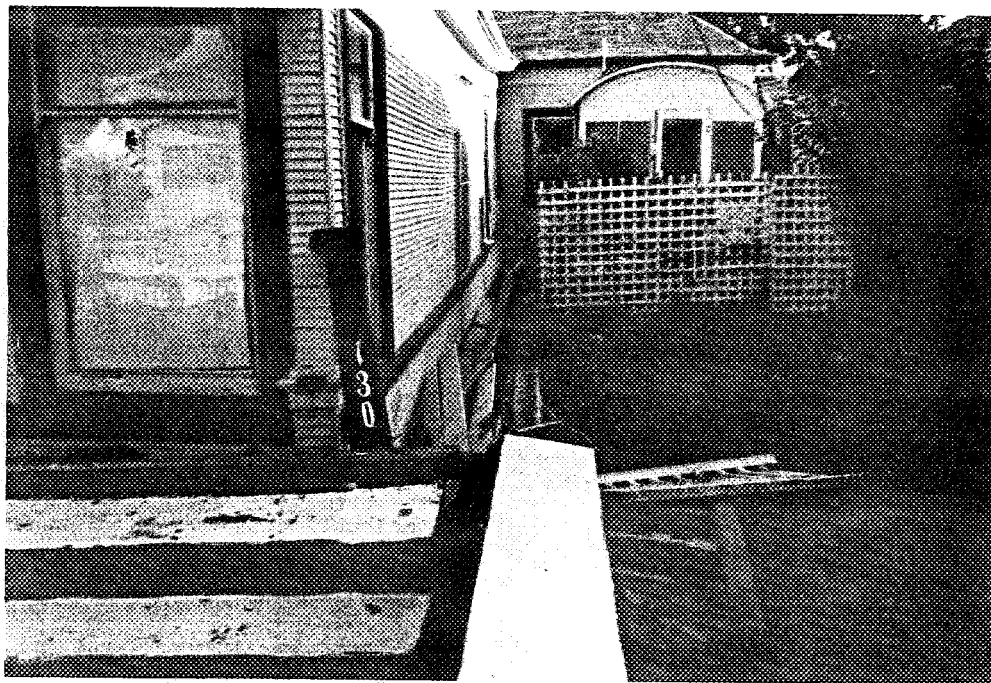
Fig. B4: Complete collapse of cripple wall and destroyed porch partly due to foundation settlement - 130 Brennan Street in Watsonville

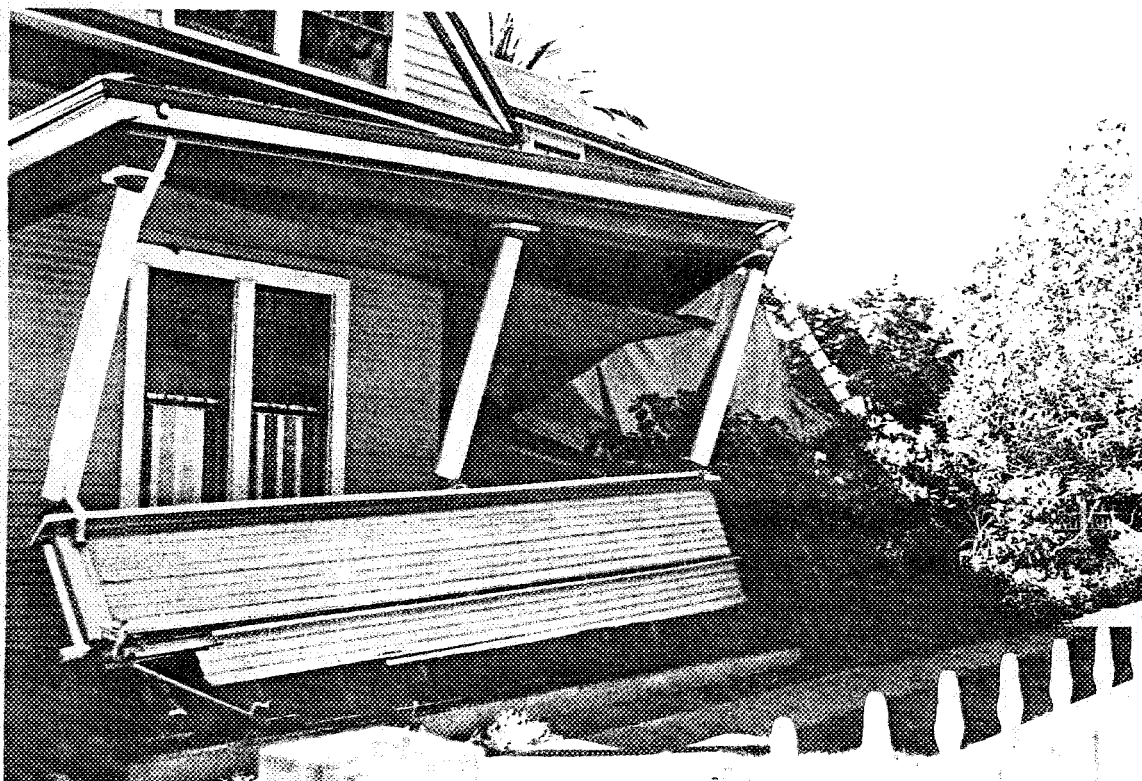
Fig. B5: Collapsed Cripple wall and porch in the residence at Main Street in Los Gatos

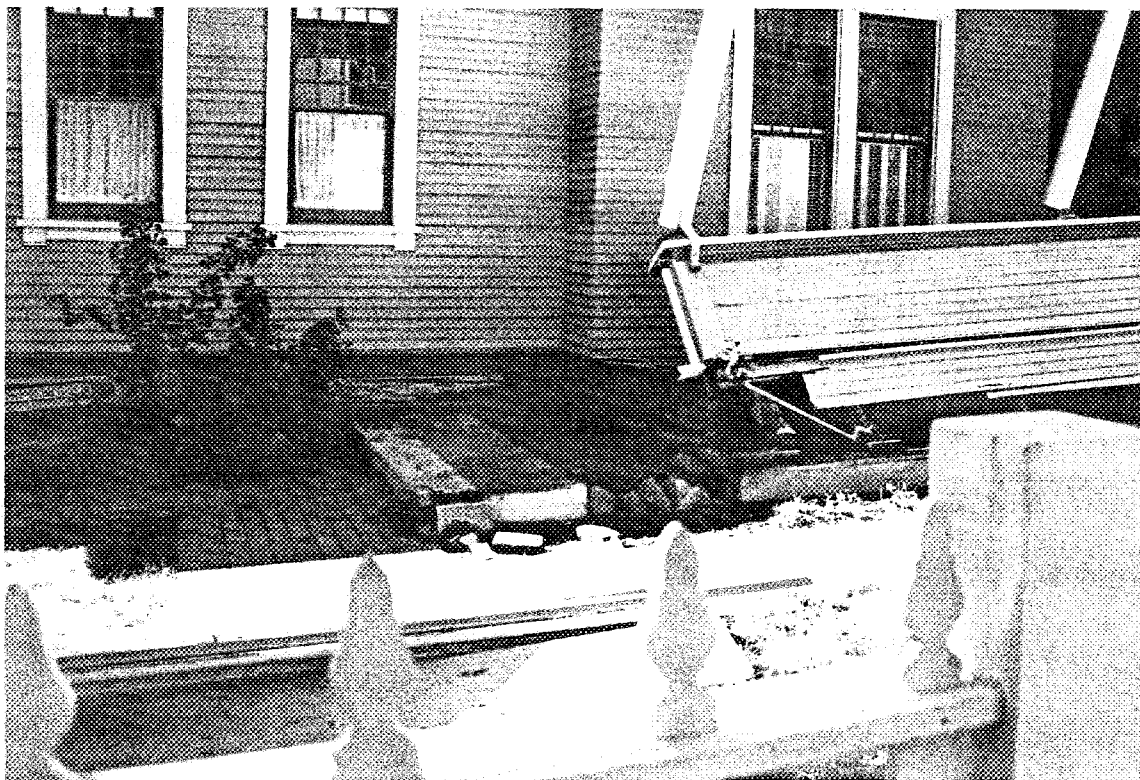
Fig. B6: House was shifted from the foundation by approximately 18' - residence at Main Street in Los Gatos

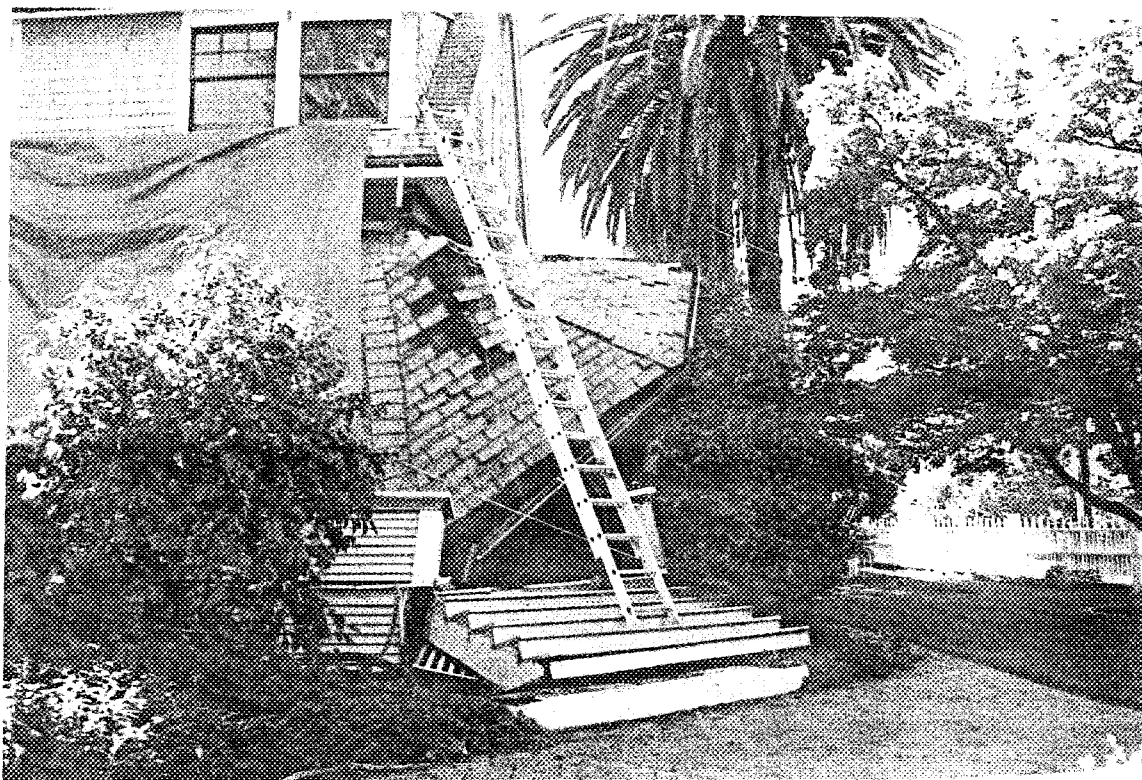
Fig. B7: Partially collapsed porch in residence at Main Street in Los Gatos

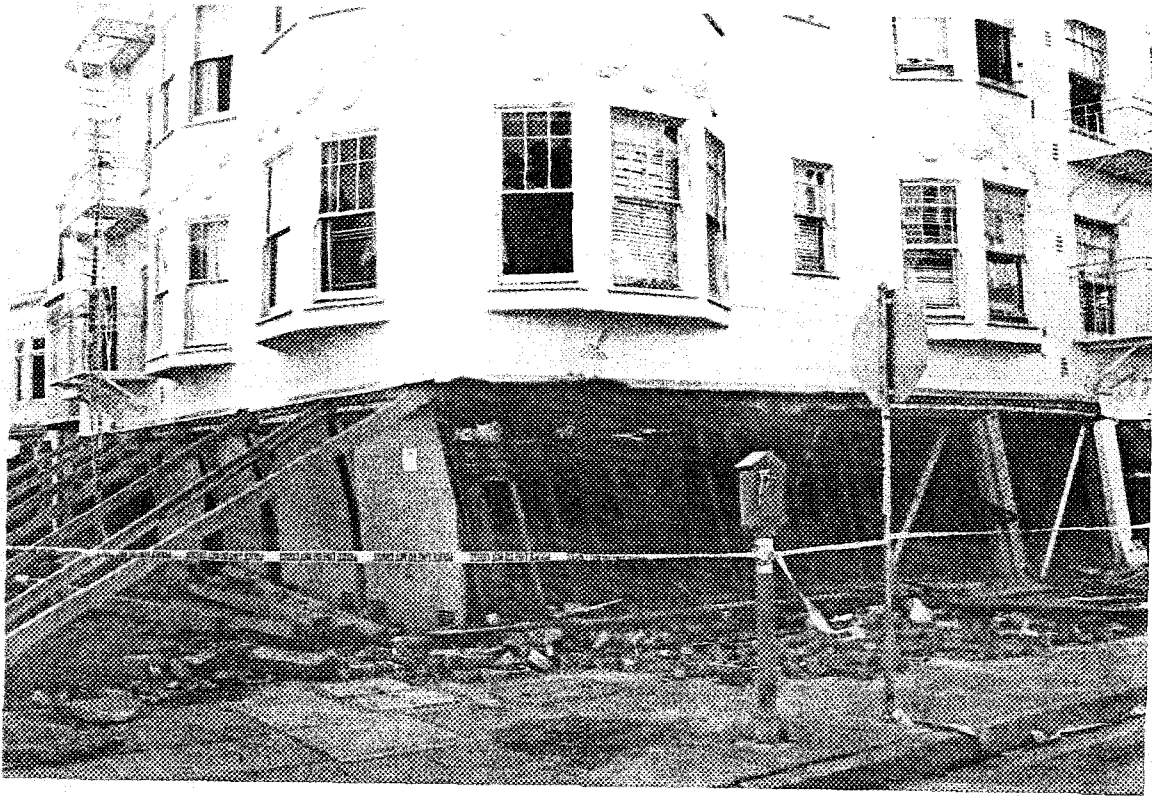
Figures B8 and B9 show examples of the "soft storey" effect. A 4-storey apartment building was shifted horizontally by more than 50 cm. Note that the corner bracing is inadequate to prevent the shift in this direction. Another corner building with first storey entirely taken up by garages is presented in Fig. B10. A close-up of the connection between a post and second floor framing is shown in Fig. B11. For corner buildings where more horizontal resistance is provided by sheathed walls, the damage is much smaller (Fig. B12).

Fig. B8: Damage to a 4-storey wood frame apartment building at the corner of beach and Broderick Streets, Marina District, San Francisco

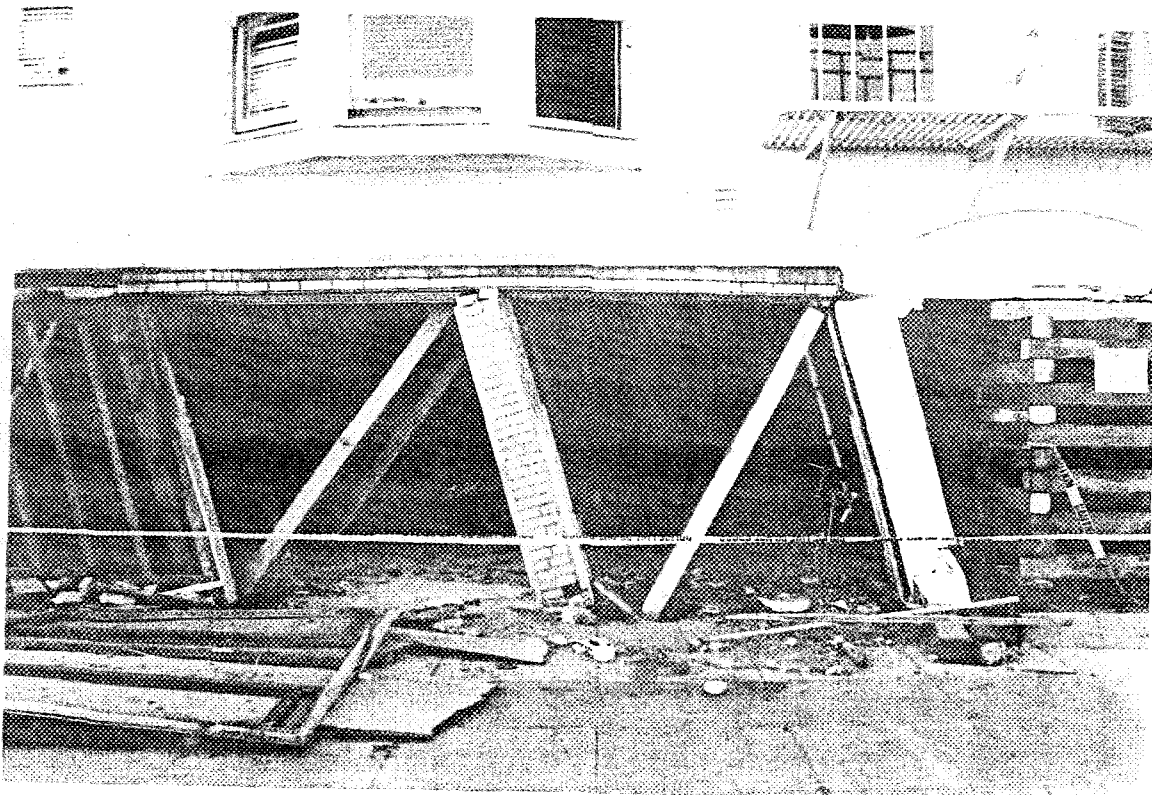
Fig. B9: Soft story effect in Marina District, Beach/Broderick Streets, San Francisco

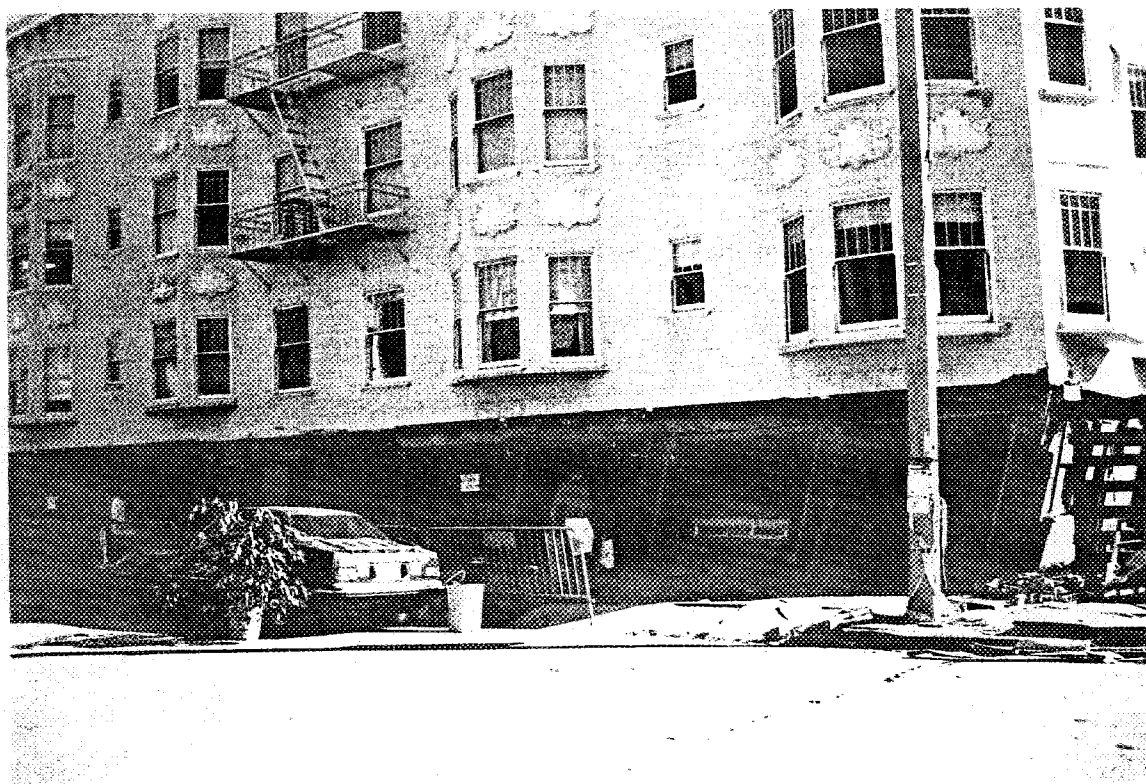
Fig. B10: Another example of soft story effect on Jefferson St., Marina District, San Francisco. Note horizontal boards on posts and over the garage doors

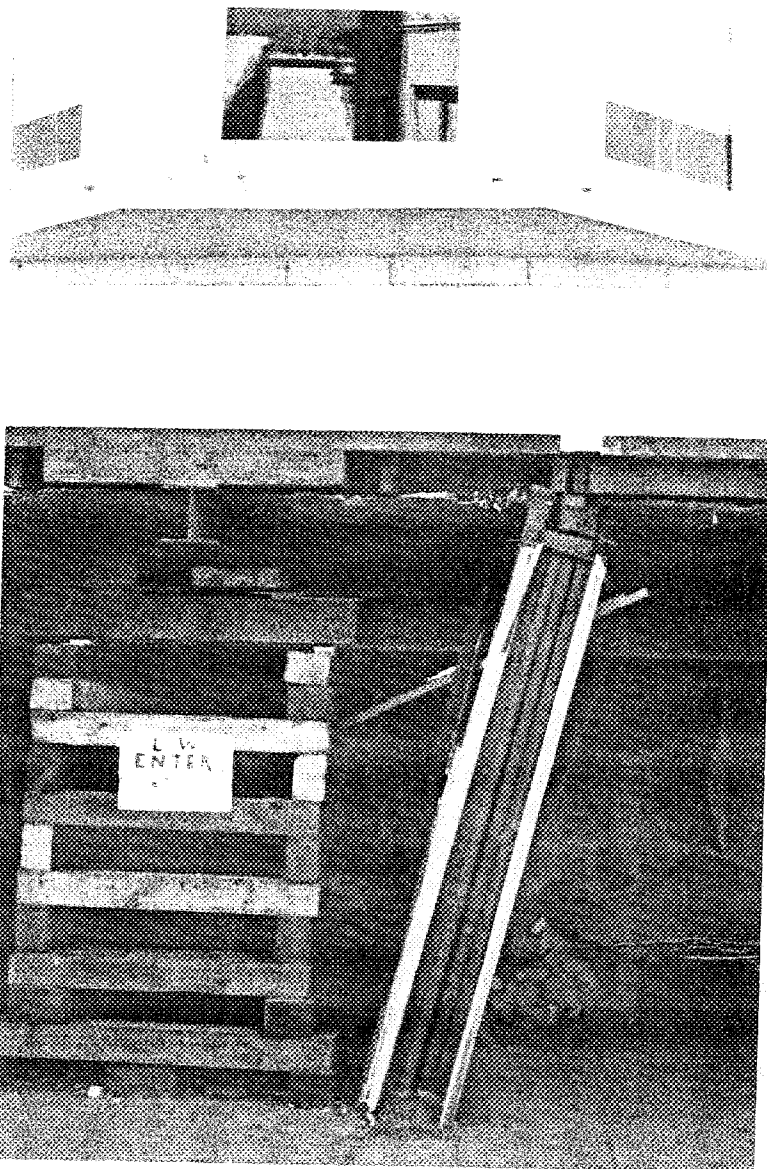
Fig. B11: Inadequate connection between post and second floor framing in the corner 4-storey apartment building in Marina District, San Francisco

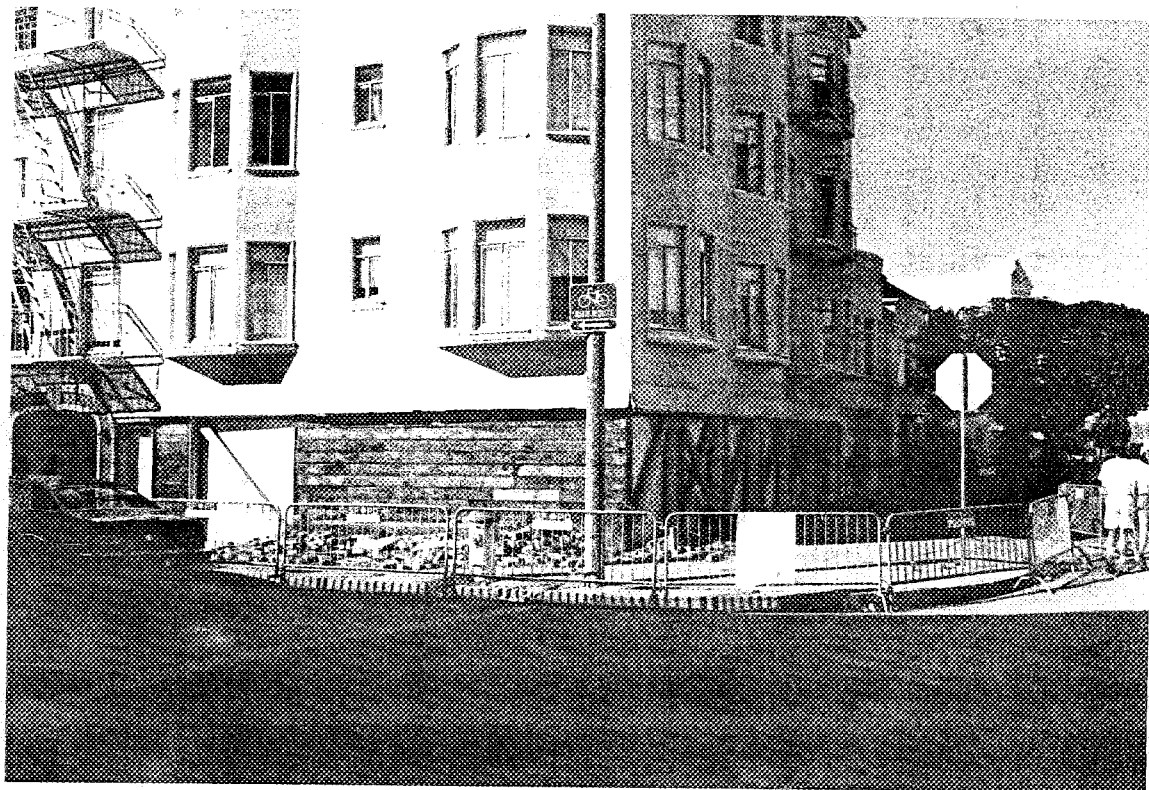
Fig. B12: 4-storey buildings with more sheated walls (horizontal boards) sustained less damage and less horizontal shift - Marina District, San Francisco

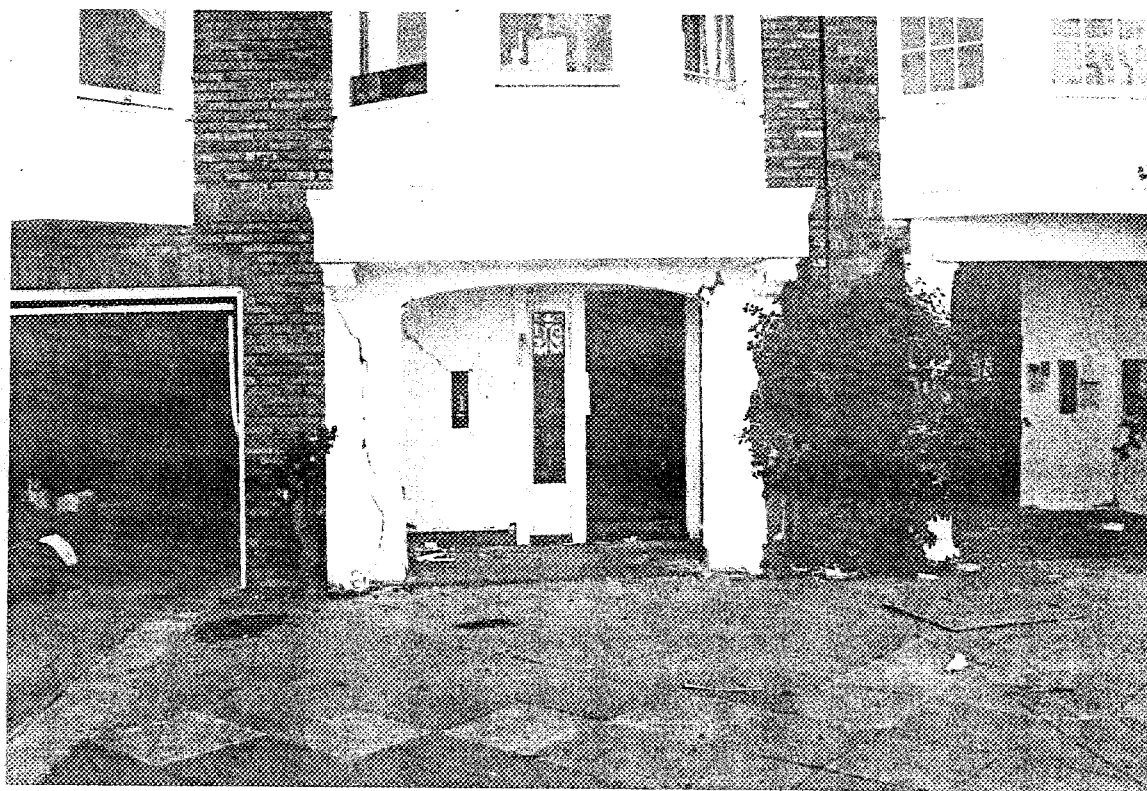
Figures B13 and B14 show some cases of damage to 2-storey houses located within the city block. In one case, large windows were destroyed. In general, upper floors sustained little or no structural damage although the entire ground floor of the building shifted.

Fig. B13: 2-storey buildings within block structure experienced some damage - Marina District, San Francisco

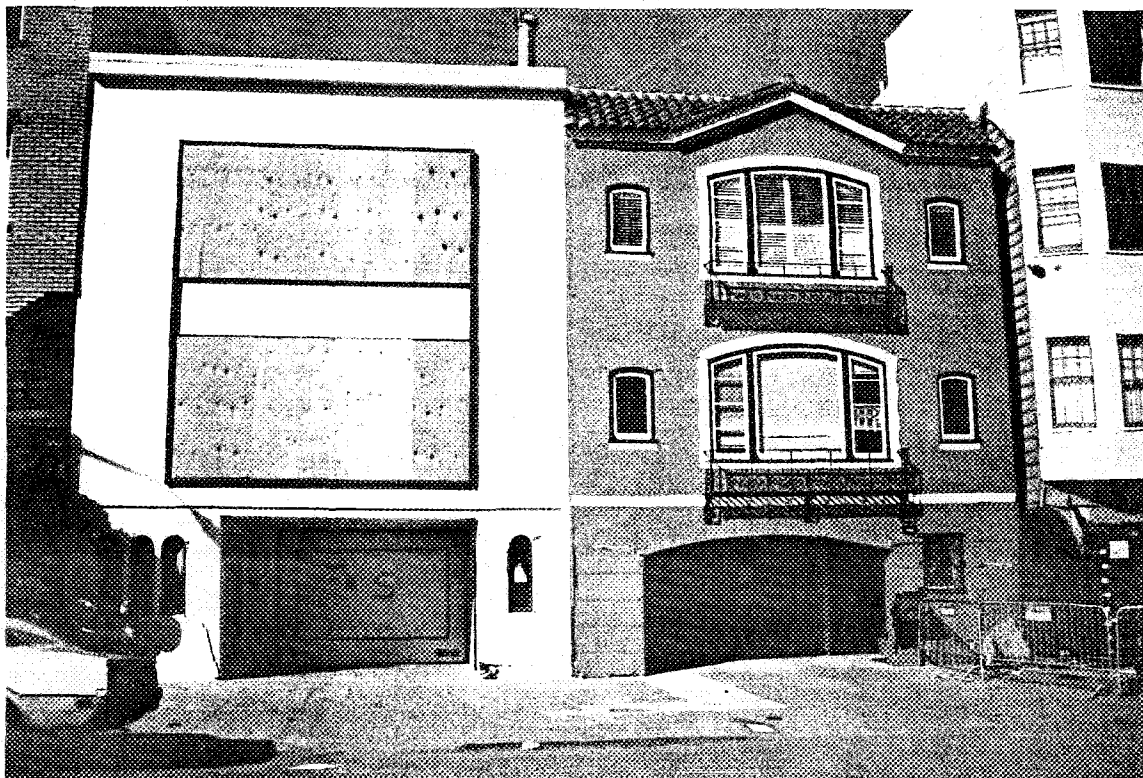
Fig. B14: Large openings (garage doors or windows) invoked some damage in 2-storey buildings in Marina District, San Francisco. Note the shift of the adjacent corner 4-storey building

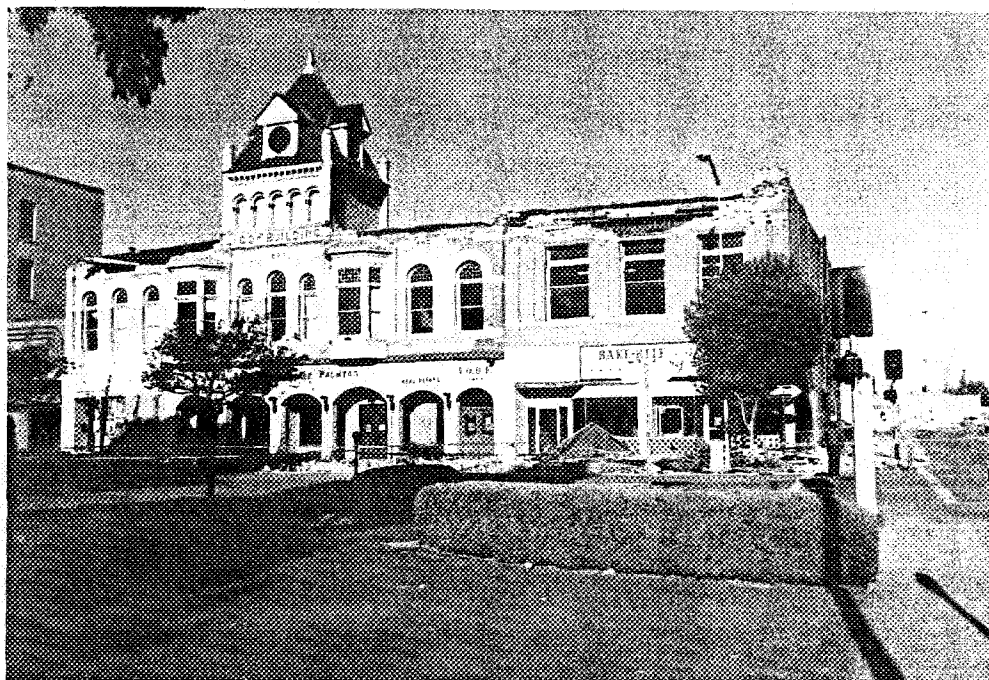
Unreinforced masonry buildings built at the turn of this century suffered severe damage. Many of these structures in the older parts of Santa Cruz, Watsonville and Los Gatos were heavily damaged or have partially collapsed (Figs. B15, B16 and B17).

Fig. B15: Damage to an old unreinforced building structure - I.O.O.F. Building  
Built in 1893 on East Beach Street in Watsonville

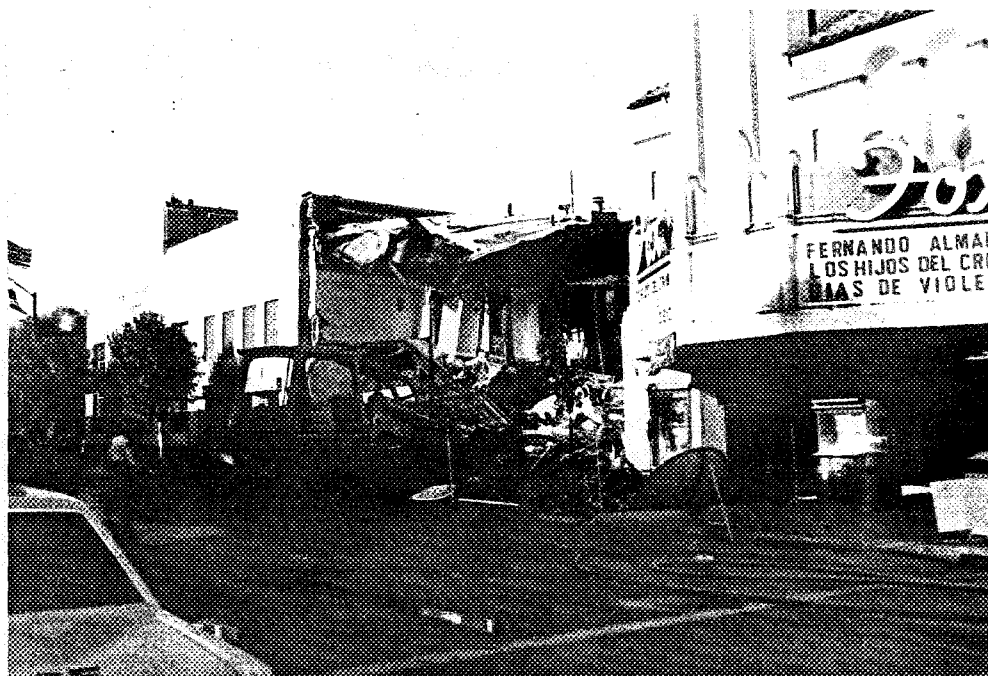
Fig. B16: Demolishing of the heavily damaged unreinforced masonry building on Main Street in Watsonville

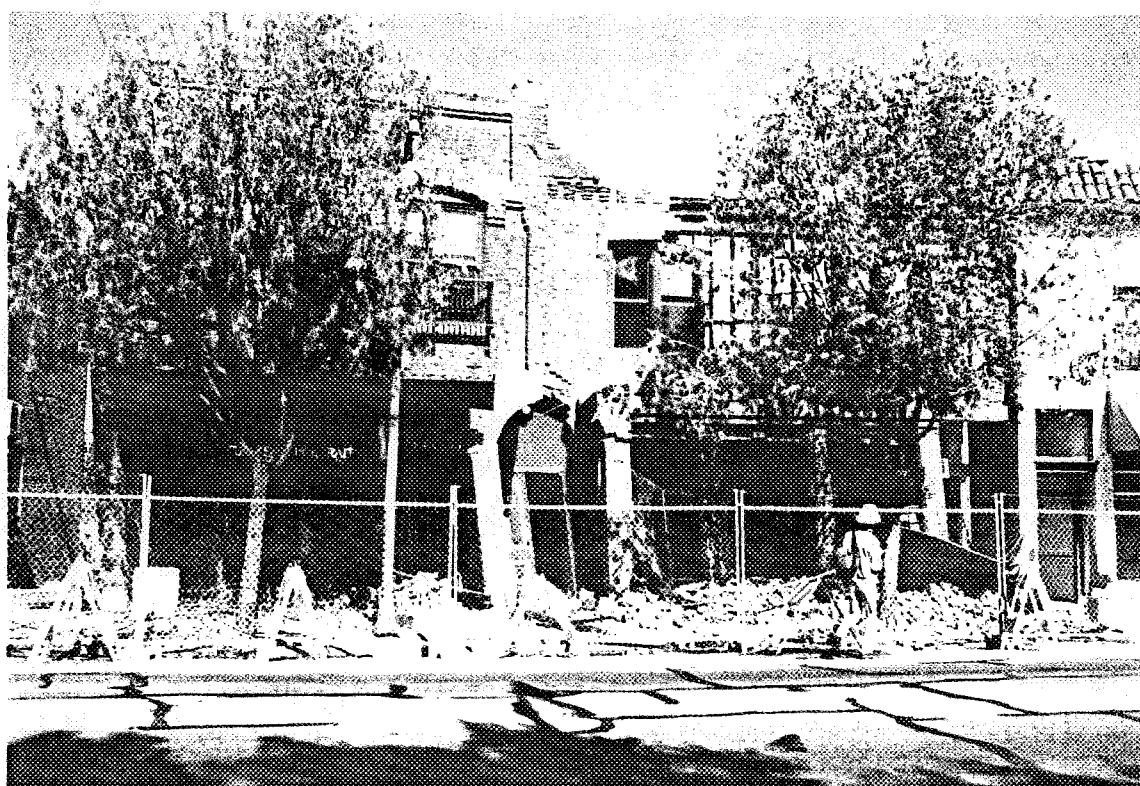
Fig. B17: Heavily damaged unreinforced masonry wall building - 39 Main Street, Los Gatos

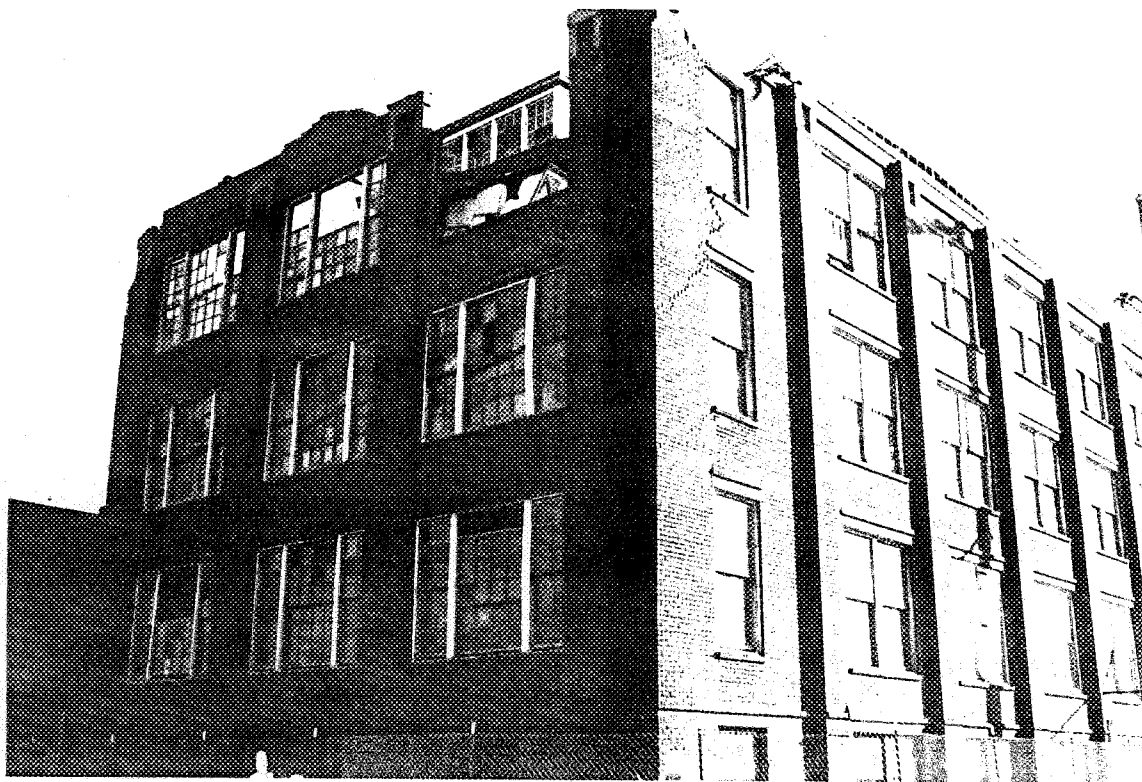
The out-of-plane failures of upper portions of walls and of parapets were common. In some cases the severe shaking on the level of the roof structure resulted in separation of the roof from the walls. The result was not only the collapse of upper portions of walls but also of the roof structure and this inflicted heavy damage to lower floors. An example of damage to an old unreinforced masonry storage building from Oakland near the collapsed Nimitz expressway is presented in Figs. B18 and B19.

Fig. B18: Collapsed roof caused damage to the lower floors in the unreinforced masonry building on Campbell Street in Oakland

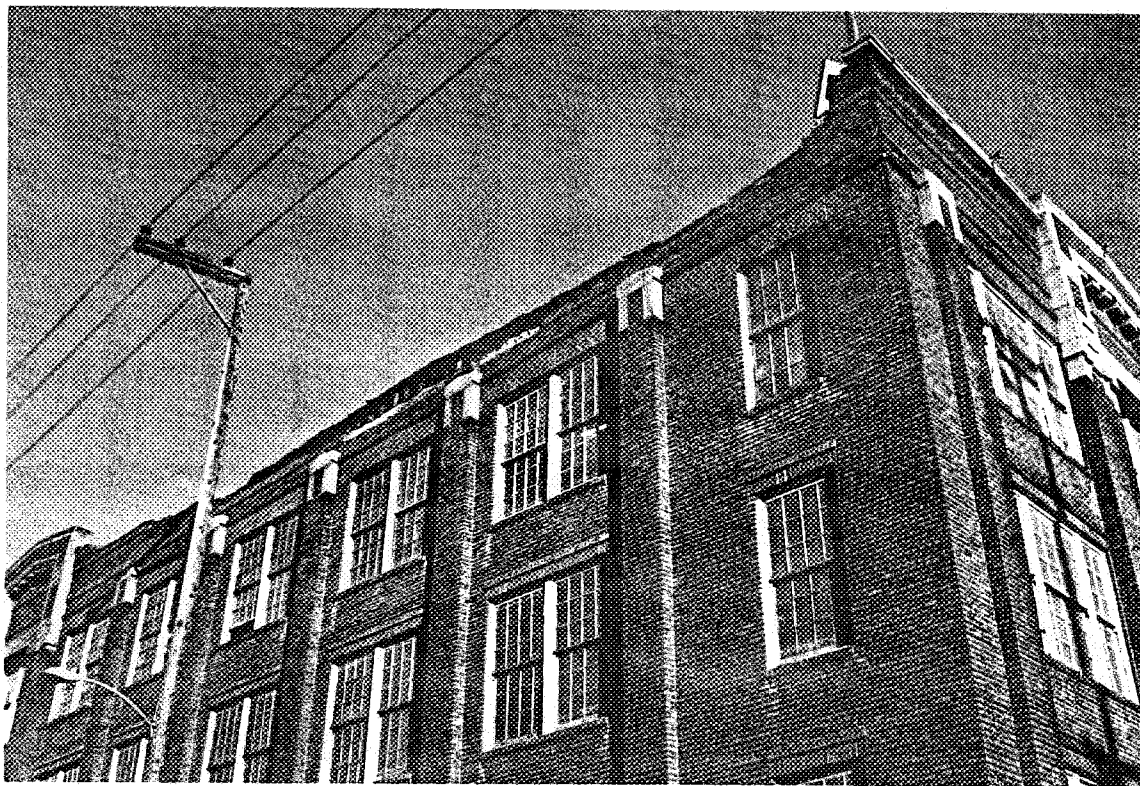
Fig. B19: Parapets fell down in this unreinforced masonry building on Campbell Street in Oakland

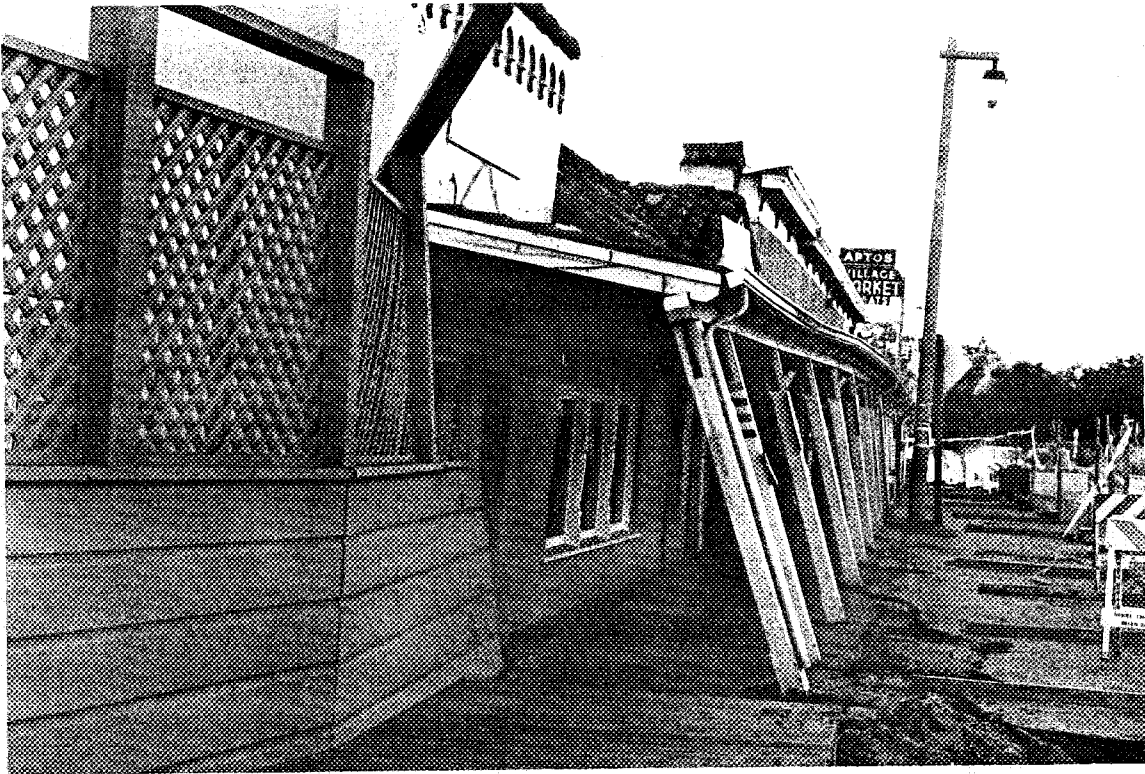
Liquefaction failure is a process in which soft saturated granular soil is transformed to a liquid as a result of earthquake shaking or by other dynamic disturbance. When this happens the soil beneath the surface is liquefied and, under pressure from the overburden, tends to eject the water and soil mixture through the ground surface. This will result in cracking of ground, ground heave, sand boils, building collapse and differential settlement. All these phenomena were observed over an extensive area (Figure 5) ranging from very near the epicentre to more than 100 km away. Examples of liquefaction failures are shown in Figures B20 to B23 in Appendix B.

Fig. B20: Partially collapsed building due to liquefaction, Aptos, 9.5 km from epicentre

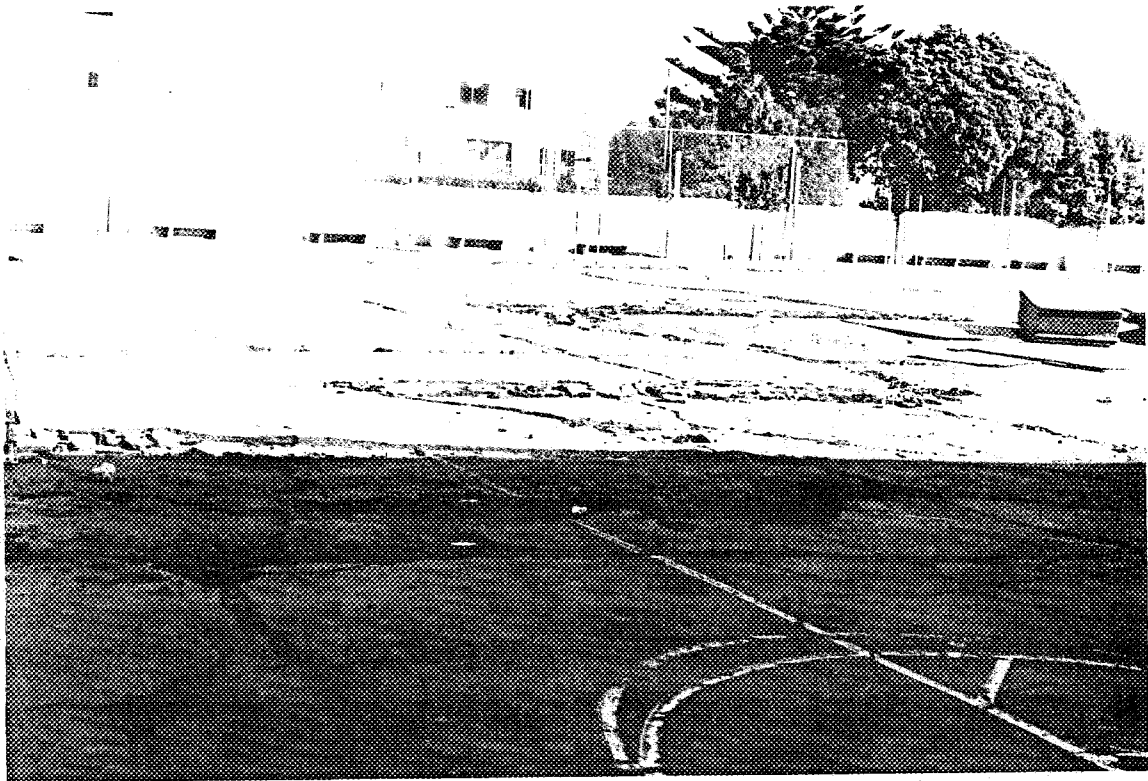
In the Marina District, liquefaction failure is widespread. More than 20 sand boils were noted by the visiting team. Differential settlement, bearing capacity failure, pavement damage and buckled sidewalks were observed. Buried utilities including gas lines were broken and led to spectacular fires. The material that flowed to the surface was a dark grey uniform sand with occasional sea shells indicating that the hydraulic fill placed on site liquefied during the earthquake. The whole area was evacuated and public access was restricted.

Fig. B21: Ground cracking, Marina District, San Francisco City

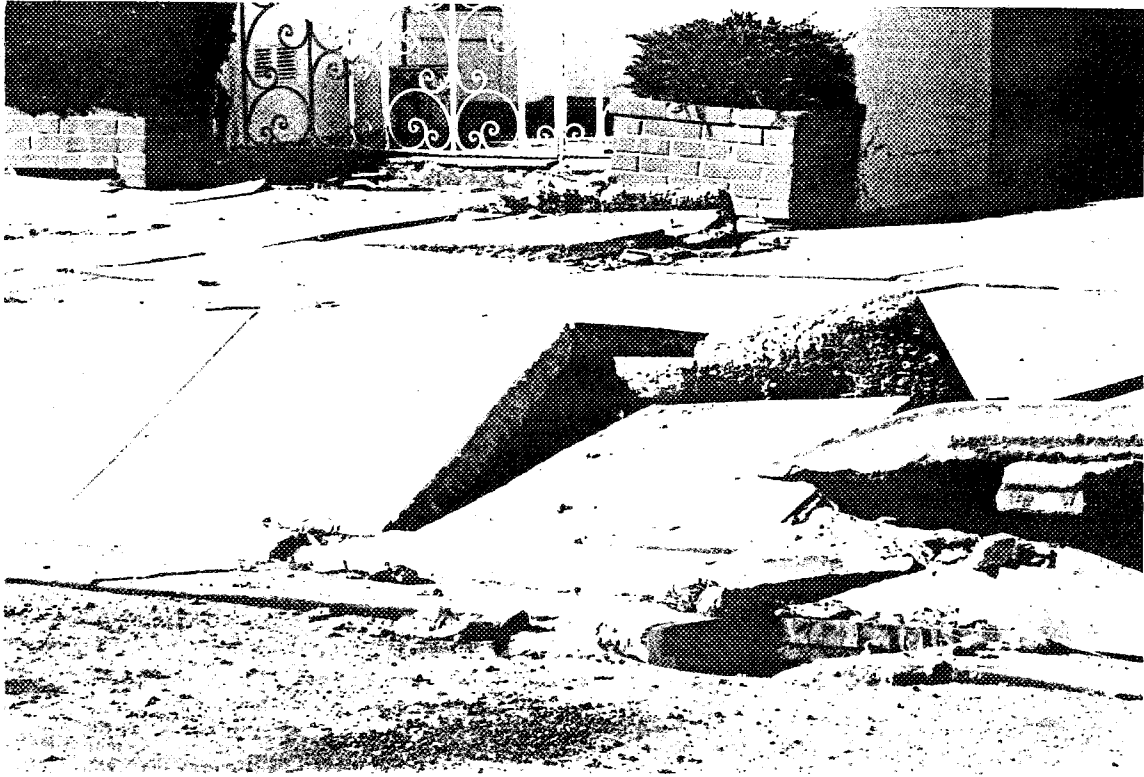
Fig. B22: Buckled pavement, Marina District, San Francisco City

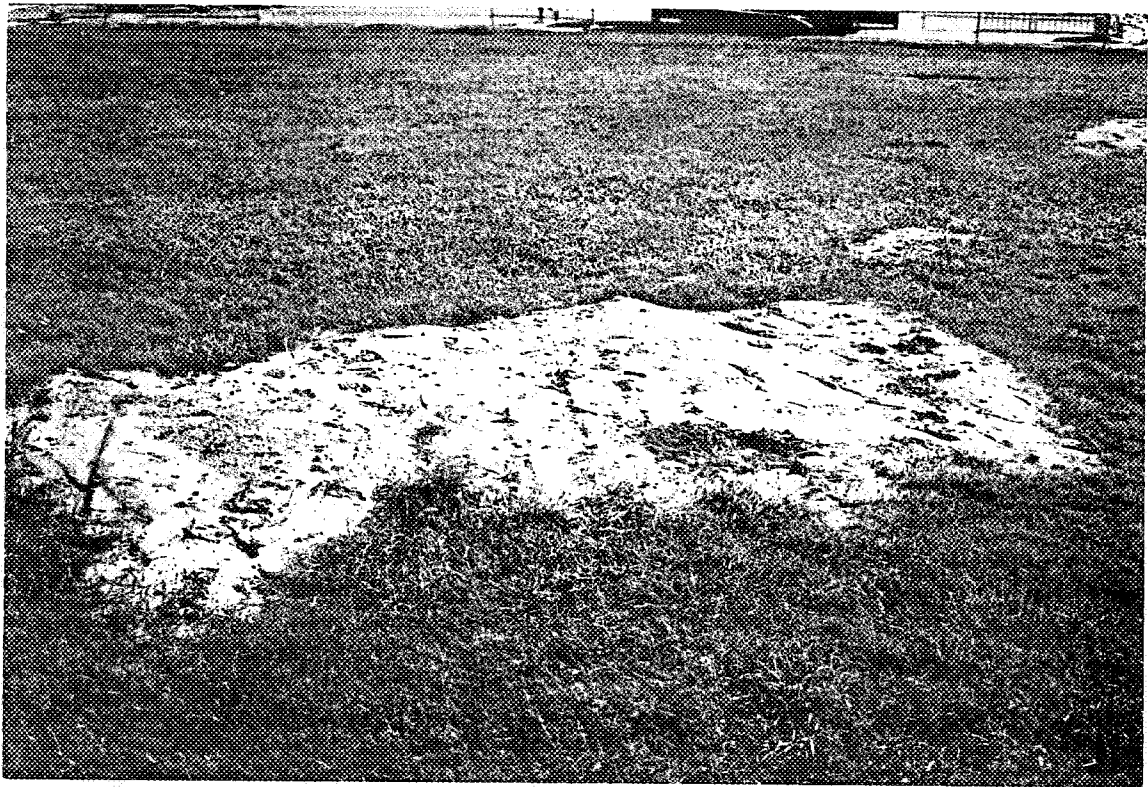
Fig. B23: Sand boil, Marina District, San Francisco City

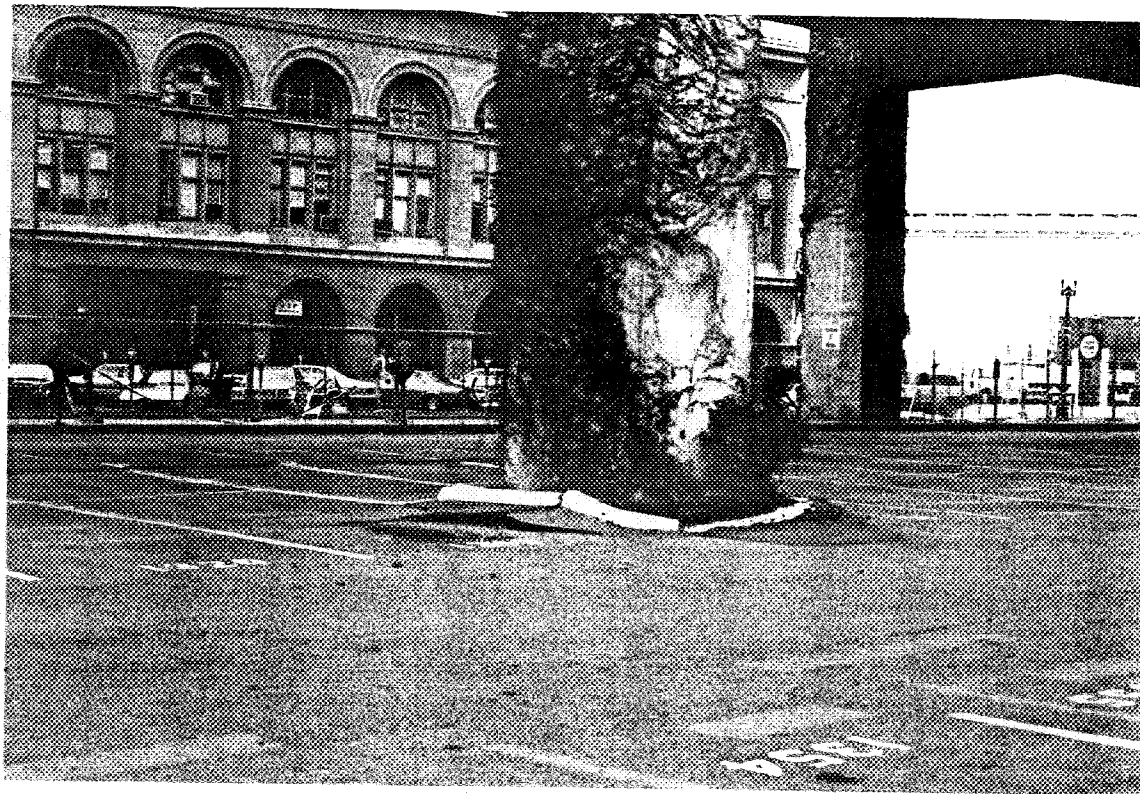
Loose granular deposit, both saturated or unsaturated, may densify leading to considerable settlement even without the phenomenon of liquefaction. A good example is found at Embarcadero Freeway on the northeastern coast of San Francisco. Here fills were placed on top of Bay mud. The structure of the freeway was damaged to the point of near collapse, again due to ground motion amplification. The footings for the structures and nearby buildings are apparently founded on pile-foundations. These footings probably vibrated during the earthquake but suffered from little permanent settlement. The paved ground surface, however, settled about 15 cm relative to the footings because of densification of the fill (Figure B24).

Fig. B24: Differential settlement due to soil densification under the Embarcadero Freeway, San Francisco
