# Air Transportation Safety Investigation Brief A16W0094

## **COLLISION WITH TERRAIN**

North American Aviation Inc. T-28B, C-GKKD  
Canadian Forces Base Cold Lake, Alberta  
17 July 2016

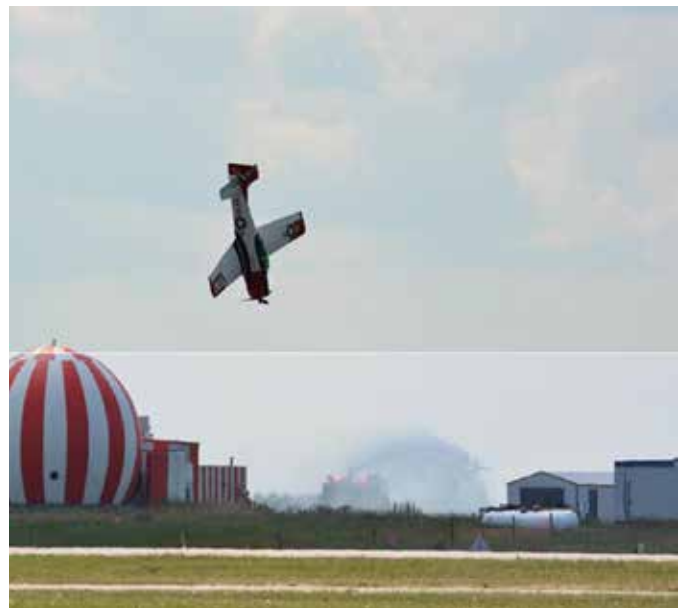
The pilot flew from show right to left at about 500 feet above ground level (AGL) within the defined airspace for the routine, then entered a roll just before show centre. As the aircraft reached the inverted position, the roll stopped and the nose began to pitch toward the ground. The aircraft elevator was seen to move to full up deflection as the aircraft continued toward the ground in an arc until its collision with terrain, in a near-vertical position with a slight right roll (Figure 1).

**Figure 1. Composite image of 2 photographs taken 3 minutes apart. The upper portion of the image was photographed just prior to impact, and the lower portion during the emergency response.**

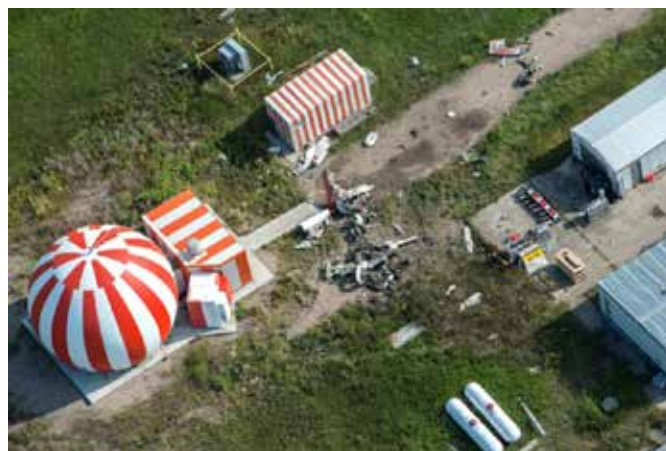
The aircraft struck the ground at a high velocity, in a near-vertical attitude. It was destroyed by impact forces. The impact site was located among several structures used for provision of airfield services. These included the buildings that housed the precision approach radar equipment and its backup power generator, and twin 1000-gallon propane tanks (Figure 2).

Debris from the aircraft penetrated the walls of the backup power generator building; however, there was no significant damage to any of the infrastructure and it remained operational.

Figure 2. Aerial photograph of the accident site, located near the precision approach radar facility (Source: Department of National Defence)
