Air Transportation Safety Investigation Report A17C0147

COLLISION WITH TERRAIN

Piper PA-23-250 Aztec, C-FIPK
Baldur, Manitoba, 5 nm E
15 December 2017

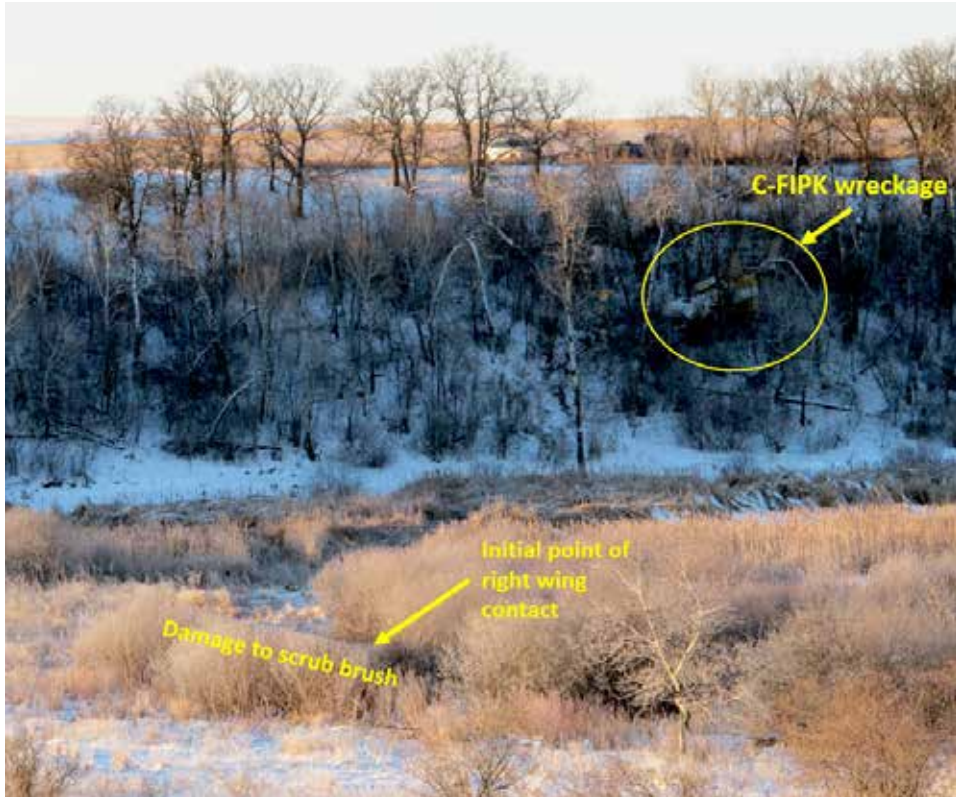
Figure 3. View of the initial impact site and wreckage

The right wing contacted scrub brush roughly 8 feet from the marsh surface (Figure 3). Damage to the scrub brush indicates that the aircraft was in a 5° descent while banking approximately 23° to the right.

The right wing-tip and fuel tank were torn away on contact with the frozen marsh. The aircraft travelled across the marsh for about 300 feet before colliding with the steeply rising tree-covered terrain on the southwest side of the valley. The left outer wing-panel had broken away after contacting a tree, at a height of about 15 feet, and lay on the right side of the wreckage trail, near the side of the valley. The aircraft came to rest, inverted, halfway up the side of the valley, approximately 425 feet from the initial point of contact with the marsh surface. The aircraft was destroyed by impact forces.

Spilled fuel was evident along the wreckage trail at locations coincident with burst fuel tanks. Calculations indicate that the aircraft would have had approximately 45 minutes of fuel remaining. Both propellers exhibited damage consistent with substantial power being produced by the engines. The engine-driven dry vacuum-pump drive adapters were intact and the carbon rotors of both pumps were in good condition. There was no indication that the flying surfaces had accumulated any ice during the flight.

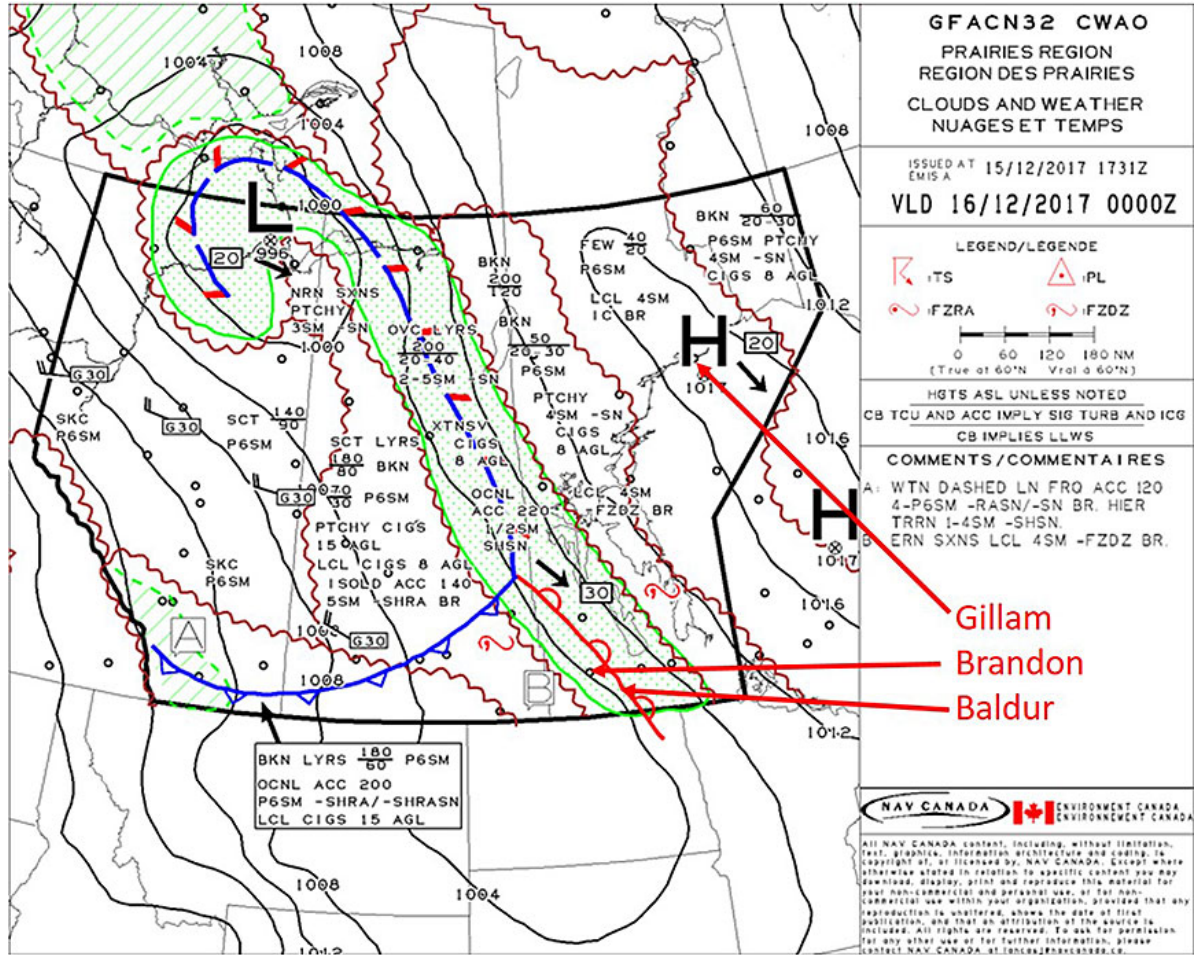
Figure 4. Graphical area forecast (Source: Environment and Climate Change Canada, with TSB annotations)

The weather at CYGX at the time of the aircraft's departure was reported as clear sky conditions, light winds, temperature of -26°C and an altimeter setting of 29.92 in. Hg. The forecast weather, available at the time of departure and based on the graphical area forecast, indicated that extensive ceilings of 800 AGL with visibility of 2 to 5 sm in light snow with occasional visibility of $\frac{1}{2}$ sm were expected for the Baldur area (Figure 4).
